AIRCOOLED MOTORS

48-50-1 Franklin Applies to All Bellanca 14-13, 14-13-2 and Universal (Stinson) 108, 108-1 Aircraft Equipped With Franklin Model 6A4-150-B3 and B31 Engines With Serial Numbers 11000 to 14000 Inclusive.

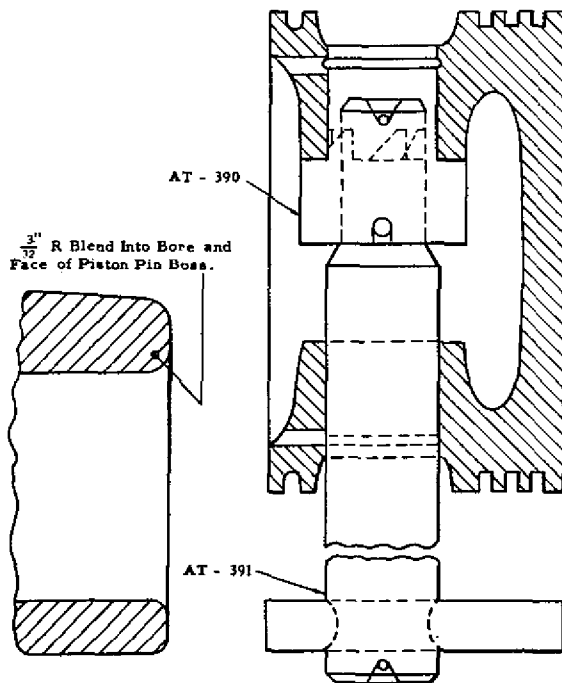
FIGURE 1

(b) Inspect pistons to ascertain if a $\frac{3}{32}$ -inch radius has been added at the inner ends of the ID of the piston pin bosses. Pistons which do not incorporate this radius should be modified as shown in Figure 1 in order to relieve stress concentrations. Pistons with cracks in this location which cannot be removed by the following modification should be discarded also.
