BEECH

47-6-8 Beech (Was Service Note 1 of AD-757-2 and Service Note 1 of AD-2-582-2.)

Applies to AT-11 and C18S Aircraft.

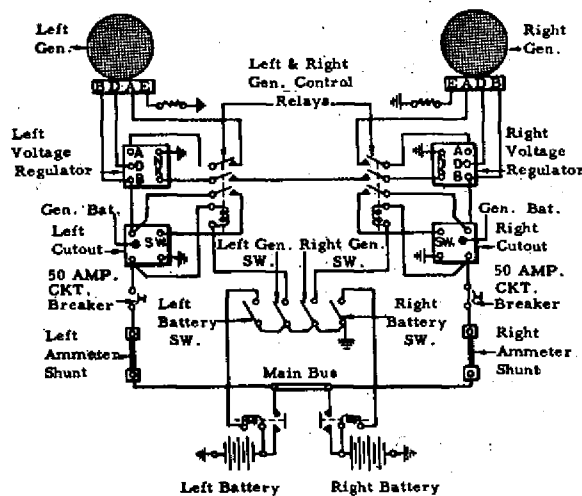
FIGURE 1

47-30-6 Beech (Was Mandatory Note 2 of AD-2-582-2.) Applies Only to AT-11 Airplanes Equipped With M-3 Generators Which Do Not Have Three-Pole-Single-Throw Relays Installed for Generator Control.

In accordance with Figure 1 install a three-pole-single-throw relay, General Electric No. CR2791-B100G3 or equivalent, for the control of each generator. The operating coil of the left generator relay should be controlled by a single-pole-single-throw "ON-OFF" switch mounted on the pilot's control panel adjacent to the left battery switch, and should be labeled "LEFT GEN. SW.". The operating coil of the right generator relay should be controlled by a single-pole-single-throw "ON-OFF" switch mounted on the pilot's control panel adjacent to the right battery switch and should be labeled "RIGHT GEN. SW.". The battery and generator switches should be located adjacent to each other in the order shown on Figure 1,

and should be provided with a suitable gang-bar such that pilot can throw the four switches to the "OFF" position in a single operation.

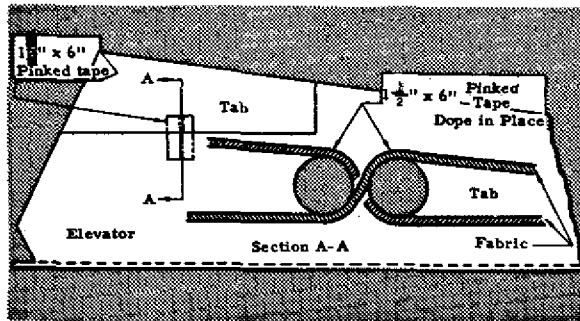
FIGURE 1

As a result of a recent failure of the elevator trim tab in flight, the modification of the trim tab attachment to the elevator as shown

in Figure 1 should be made.
