CALLAIR

60-7-3 **CallAir** Amdt. 119 Part 507 Federal Register March 25, 1960. Applies to All CallAir Models A-4, A-4 Modified, A-5 Up To and Including Serial Number 292 and A-6 Aircraft Serial Numbers 202, 244, 248, 252, 262, 264, 268, 269, 270 and 271.

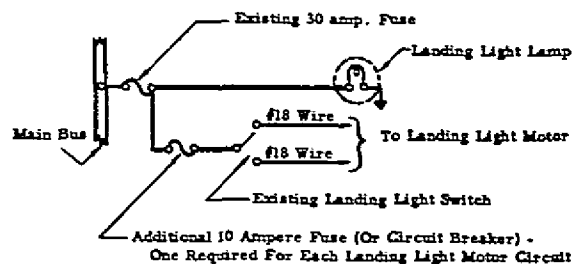
FIGURE 2

To guard against the possibility of fire or smoke due to inadequate electrical protection of the landing light motor circuits, install a 10-ampere fuse or circuit breaker, in the manner shown in Figure 2 for each motor circuit.

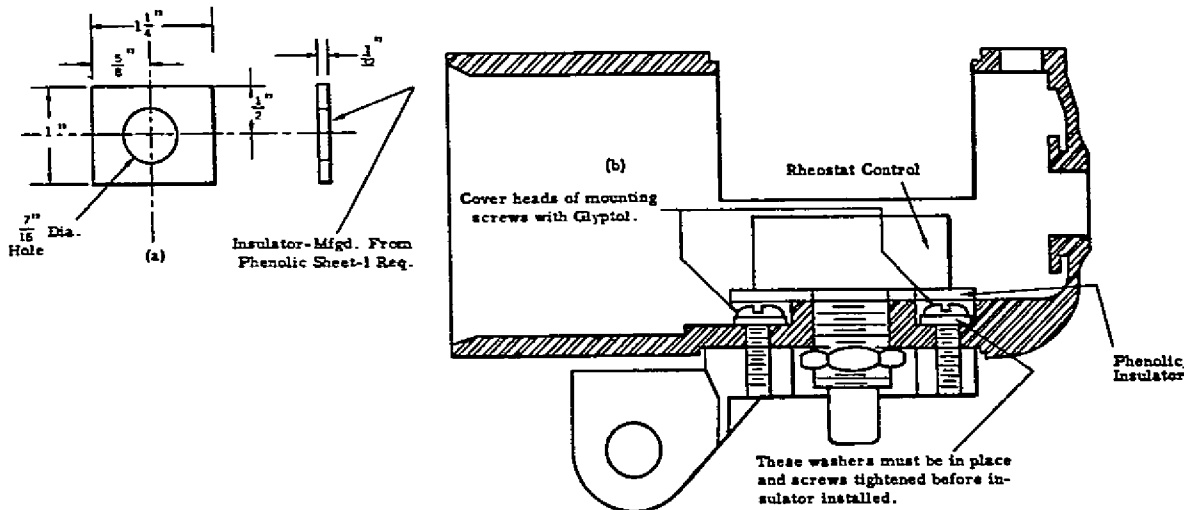
FIGURE 2

SECTIONAL VIEW OF COCKPIT LIGHT CASE - TYPE C-4A & C-4, WITH RHEOSTAT INSULATOR INSTALLED.

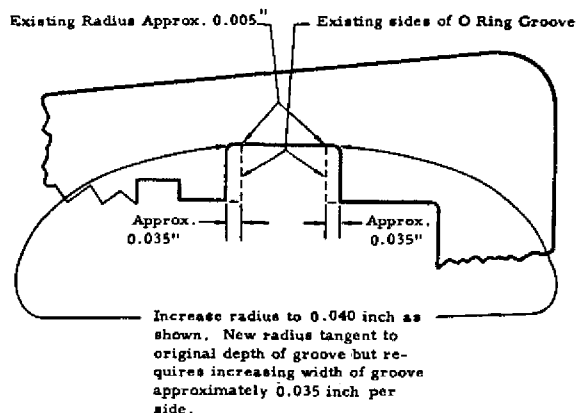
FIGURE 4

Remove the landing gear retraction cylinder head and inspect the upper and lower radii of the O ring groove for cracks by means of a dye penetrant. If cracks are found the part should be replaced. In the event no cracks are present the upper and lower radii of the O ring groove should be increased to 0.040 inch as shown in Figure 4 and again inspected by means of a dye penetrant. If no cracks are found after this

inspection, the part may be returned to service; however, if cracks are evident, the part should be replaced.

NOTE: Smooth machine finish (RMS-32 or better) with no tool marks or discontinuities. No change in size of O ring necessary.
