53-7-1 de Havilland Applies to Model DHC-2 (Beaver) Aircraft, Serial Numbers 1 to 483 Inclusive.

53-9-2 de Havilland Applies to All Model DHC-2 Beaver Aircraft.

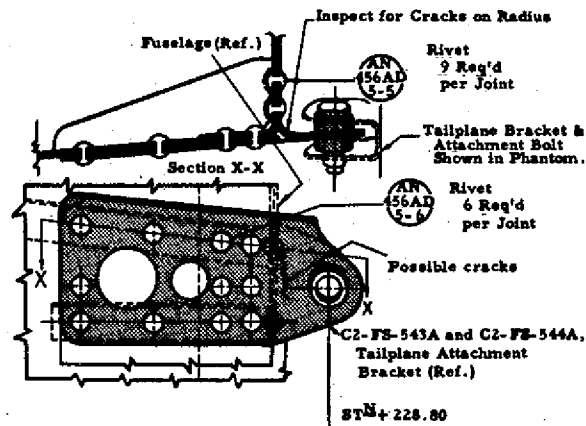
FIGURE 3

Inspect subject brackets for cracks and distorted rivets at the location indicated in Figure 3 and replace the tailplane front attachment $\frac{1}{4}$ -inch diameter bolts P/N NAS 54AN12 at intervals not exceeding 1,000 flying hours.

**MODIFICATION TO FUSELAGE
TAILPLANE ATTACHMENT BRACKETS**

If brackets are defective, replace with new parts. If existing $\frac{1}{8}$ -inch diameter rivets are distorted, replace with $\frac{3}{32}$ -inch diameter rivets as outlined in Figure 3.

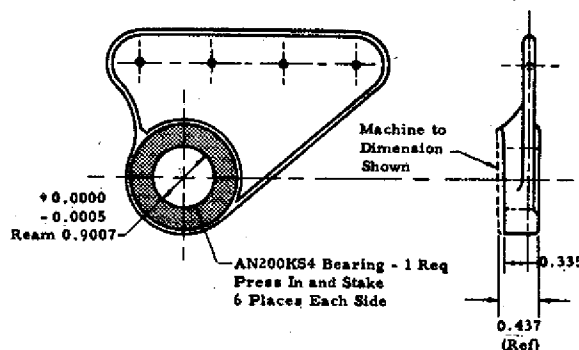
FIGURE 1

To reduce the possibility of failure of the wing bulkhead assemblies and subsequent loss of the ailerons:

1. Machine face of boss on fitting assemblies P/N 4154028 and 4154028-1, to 0.335 inch, and ream bore to 0.9007 ± 0.0000 , -0.0005 inch. (See Figure 1.) Replace bearing AN 209K4A with self-aligning bearing, P/N AN 200KS4 and stake in six places each side. Install reworked fitting assemblies, P/N 4154028 and 4154028-1, on original bulkheads as follows:

(a) On installations using two screws, P/N 1029421-416-11, or two bolts, P/N AN 4-6A, and three rivets, enlarge the rivet holes in the fitting and bulkhead to 0.191-inch diameter and countersink the holes in bulkhead 100° . Install fitting using two screws, P/N 1029421-416-11 or NAS 214-11, or two bolts, P/N AN 4-6A, originally installed, two washers, P/N AN 960D416, and two nuts, AN 365-428, in the top and bottom holes, and three screws, P/N S-1029421-10-12, three washers, P/N AN 960D10, and three nuts, P/N AN 365-1032, in the three remaining holes.

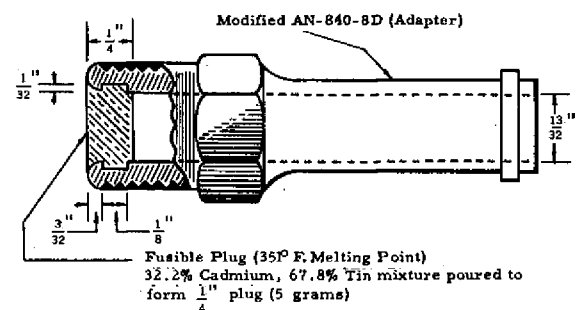
FIGURE 2

To guard against the possibility of excessive air temperatures in the vacuum system discharge line, one of the following modifications must be accomplished to this system:

VACUUM SYSTEM FUSIBLE PLUG

1. Install a fusible plug in the side of the vacuum pump discharger port at the right angles to the axis of the discharge port boss. Some pumps incorporate a plugged hole in the discharge port which may be enlarged to a $\frac{3}{8}$ -inch pipe tapped hole to accommodate the fusible plug. This plug should employ an AN 840-8D fitting with a binary eutectic mixture of 67.8 percent tin and 32.2 percent cadmium, which has a melting point of 351° F. Figure 2 describes the design of such a plug. The $\frac{3}{8}$ -inch fusible plug fitting is intended for pumps such as the Model 3P-211 and 3P-

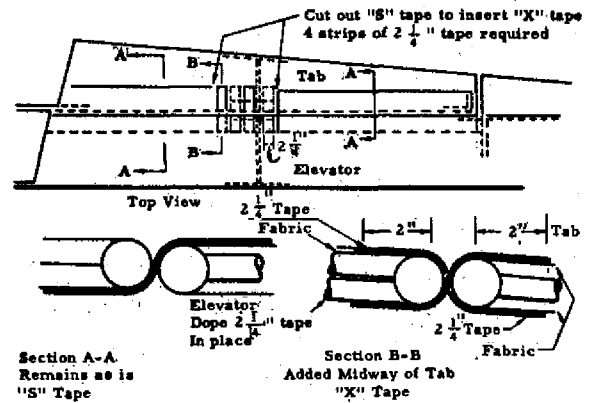
FIGURE 1

Inspect elevator trim tab system for looseness by checking free play of the trim tab. Total free play of the tab trailing edge at the maximum chord should not exceed 0.20 inch. Excessive free play may be due to excessively worn parts and/or looseness in the adjustment of the trim tab system. Excessive free play can usually be removed by accomplishing the following:
