GENERAL DYNAMICS

46-6-4 Convair (Was Service Note 3 of AD-2-571-2.) Applies Only to BT-13 Series Airplanes Equipped With a Propeller Spinner.

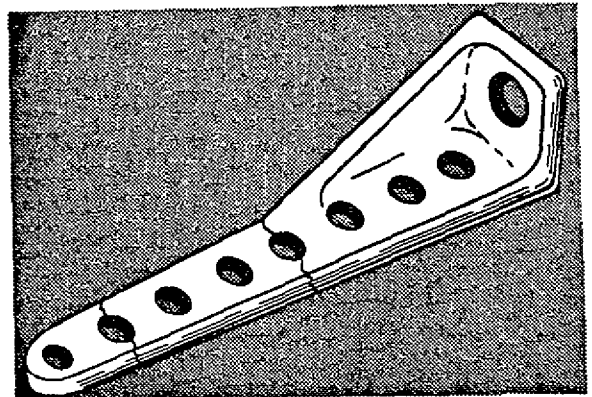
FIGURE 1

(1) Inspect visually the rear spar to center section attachment fittings on both sides of the rear spar for evidence of cracks. All cracked fittings (see Figure 1) should be replaced with new fittings of equivalent or greater strength.
