## NAVAL AIRCRAFT FACTORY

## NAVION

**47-11-1 Navion** (Was Mandatory Note 1 of AD-782-3.) Applies Only to Serial Numbers NAV-4-2 to NAV-4-550, Inclusive. To be accomplished immediately.

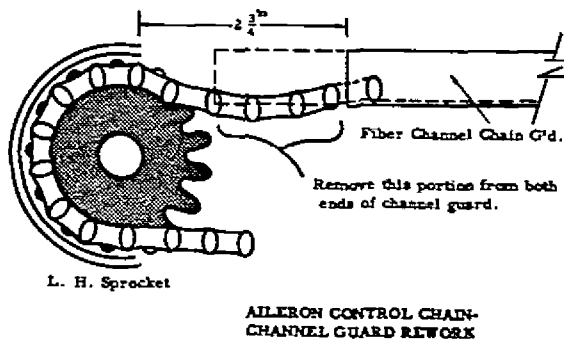
FIGURE 1

In order to eliminate the possibility of the aileron control chain jamming, each end of the fiber channel chain guard should be reworked as shown in Figure 1. The chain and guard are on the control column.

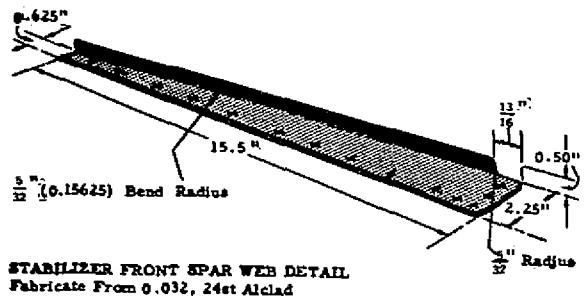
FIGURE 2

Inspect as soon as practical, but not later than February 1, 1953, and at 100-hour inter-

vals thereafter the area in the vicinity of the stabilizer fuselage attachment for cracks. Particular attention should be given to the stabilizer spar web (gusset) immediately outboard of the root rib and the fuselage attaching fitting. If cracks are found in the fuselage fitting, P/N 143-31004-13, the entire part should be replaced. Cracks in the root rib may be repaired in accordance with CAM No. 18. Cracks in the spar web (gusset) require the replacement of the gusset with a new part made in accordance with Figure 2.

Periodic inspections of stabilizer spar web only may be discontinued after installation of new gussets.
