SCHLEICHER

61-13-3 Schleicher Amdt. 299 Part 507
Federal Register June 24, 1961. Applies to
Model K-7 Gliders With Serial Numbers Up
To and Including 935 and Serial Number
984.

SIKORSKY

47-32-15 Sikorsky (Was Mandatory Note 1 of AD-2H-1.) Applies to Model S-51 Helicopters.

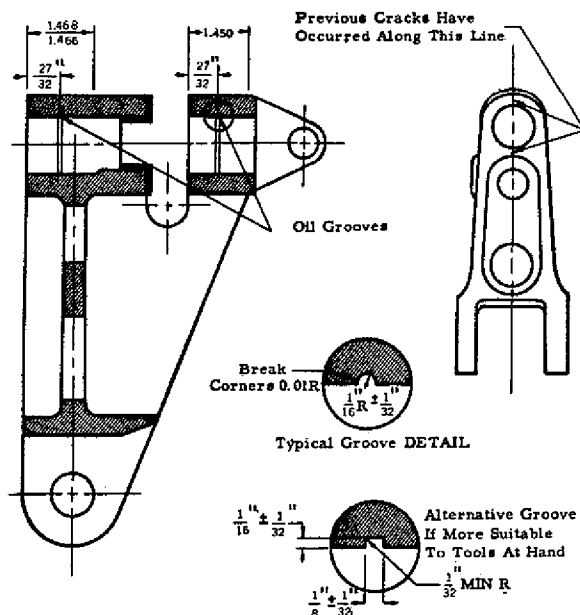
FIGURE 1

2. Visually inspect main rotor links, P/N VS 36181 by one of the following methods for cracks around link pin hole and longitudinally along what was the flash line in original forging. (See Figure 1.) If cracks are present, links should be scrapped.

3. Machine oil grooves. (See Figure 1.)

4. Remove burrs and clean after machining.

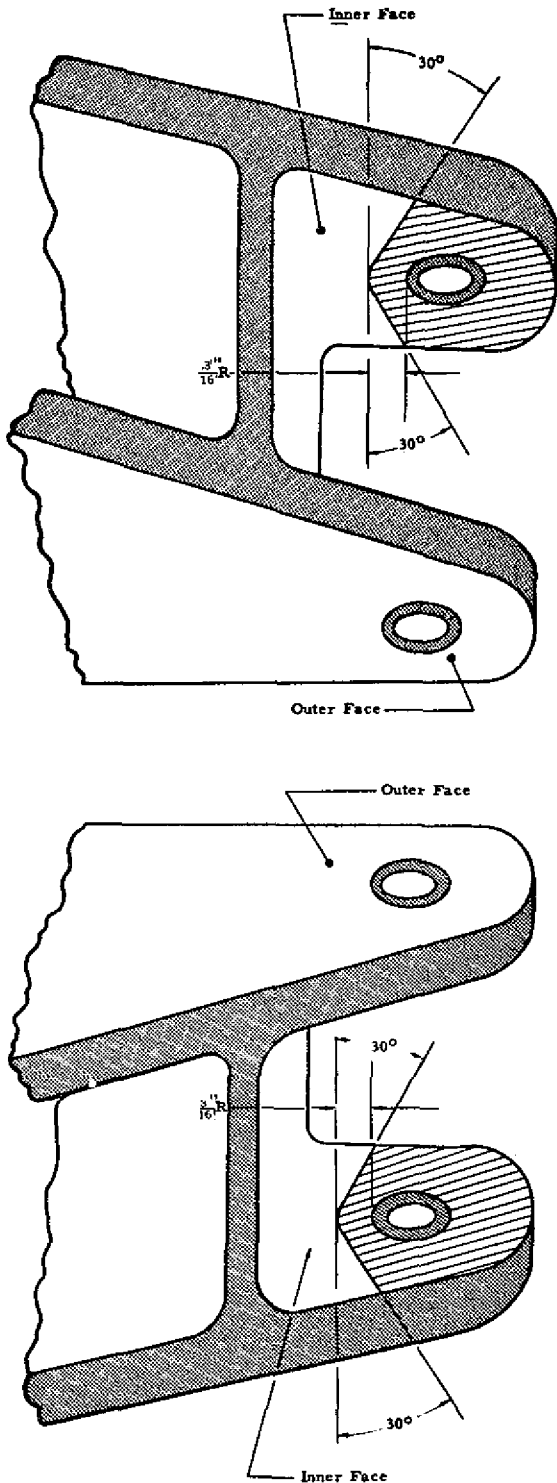
FIGURE 6

Inspect all main rotor link assemblies (P/N S510348) received from the manufacturer between June 1 and September 6, inclusive for location of the identification stamp "F". Links with the "F" metal-stamped in the critical area on the inner faces of the ears should be retired from service. Those with the "F" stamped on the outer faces or on noncritical areas of the inner faces of the ears should be polished locally with emery and crocus cloth to remove the "F" and the links may be returned to service. (See Figure 6.)
