UNIVERSAL

46-23-4 Globe (Was Mandatory Note 1 of AD-766-5.) Applies to Models GC-1A, GC-1B Aircraft Serial Numbers 33 to 54 Inclusive, Plus 54, 56, 57, 58, 60, 61, and 64.

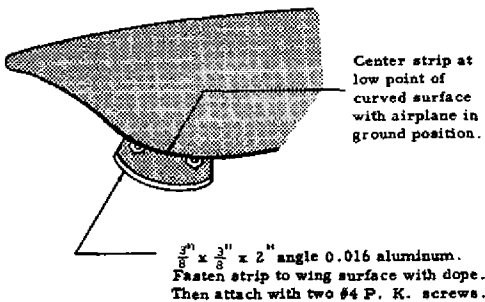
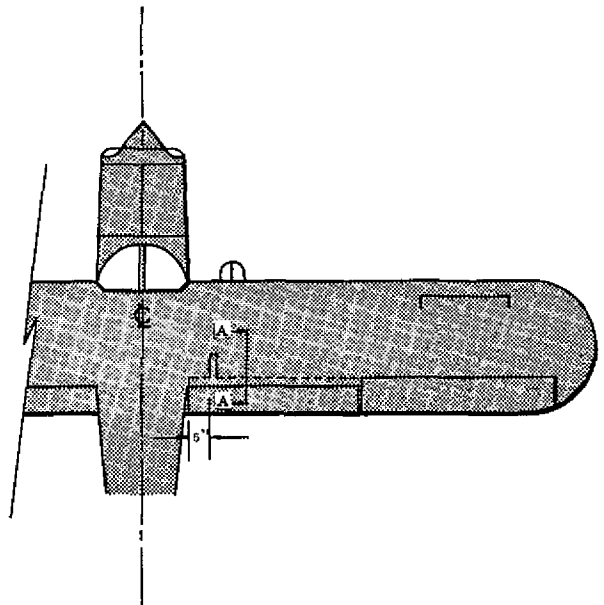
FIGURE 1

Reports have been received of fuel seepage into the space between the inner cabin trim and the outer fabric covering of the fuselage. This results in soaking of insulating material in the cabin wall. The source of the fuel can be spillage during filling of tanks, thermal expansion of fuel in full tanks, or tank leakage. This fuel runs to the under surface of the wing, adhering to the lower curved surface of the trailing edge of the wing at the flap well, thence inboard to the fuselage and across the rear window. Since the window seal is often not perfectly tight the fuel may then enter the cabin wall.

To preclude the fire hazard of fuel soaked insulation within the cabin wall due to these causes, a drip strip similar to that shown in Figure 1 should be installed on the underside of each wing. This drip strip will prevent fuel from flowing from the wing to the fuselage.
