GEORGIA DOT RESEARCH PROJECT 17-29

FINAL REPORT

**DEVELOPMENT OF POSSIBLE SOLUTIONS TO
ELIMINATE OR REDUCE DECK CRACKING ON
SKEWED BRIDGES BUILT BY USING THE
ACCELERATED BRIDGE CONSTRUCTION METHOD**

1. Report No.: FHWA-GA-19-1729	2. Government Accession No.:	3. Recipient's Catalog No.:	
4. Title and Subtitle: Development of Possible Solutions to Eliminate or Reduce Deck Cracking on Skewed Bridges Built by Using the Accelerated Bridge Construction Method		5. Report Date: December 2019

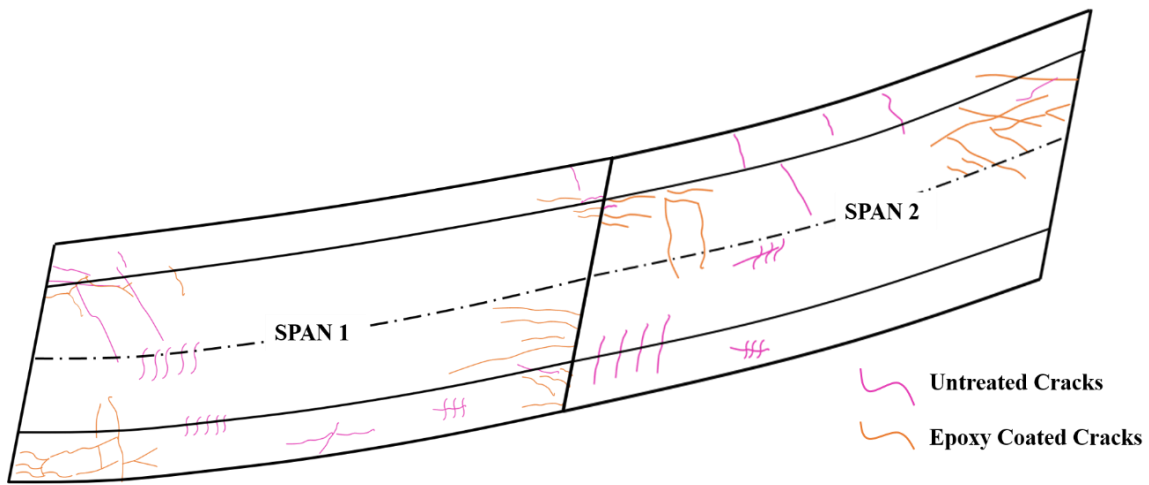
Figure 28 – New and old cracks on both spans of SR299 bridge.

presents crack patterns present on the bridge deck during the second visit. Specifically, Span 2 had a higher number of cracks at the acute corner on both the expansion side and the abutment side, and cracks ran across the expansion joint between Span 1 and Span 2, as shown in Figure 29. Several untreated cracks are shown in Figure 30 and Figure 31.

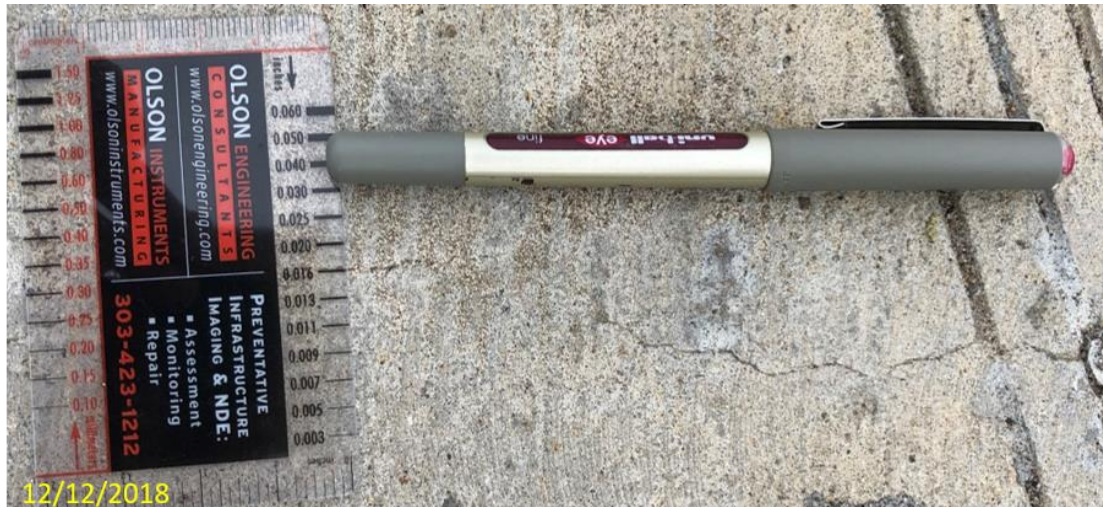
New crack widths ranged between 1/64 in. (0.40 mm) and 1/25 in. (1.02 mm). Cracks in the shoulder areas and at the skewed corners were wider than cracks in other areas. Figure 32 through Figure 36 show crack widths measured with a crack width gauge. In reviewing these photos, it is important to recognize that crack width varies along the length of the crack.

Figure 32 – Crack width measurement (0.016 in. or 0.41 mm).

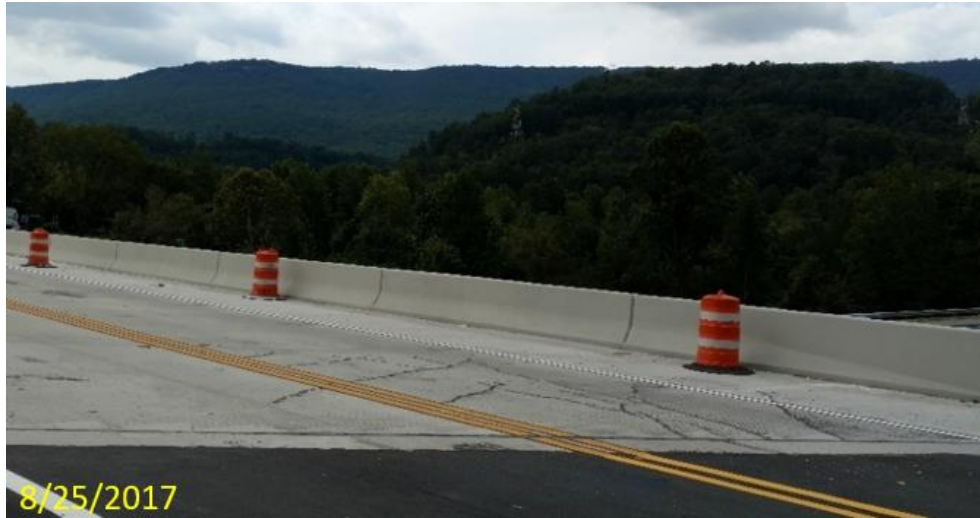
Figure 37 – Old photo showing cracks at eastbound corner of Span 2.

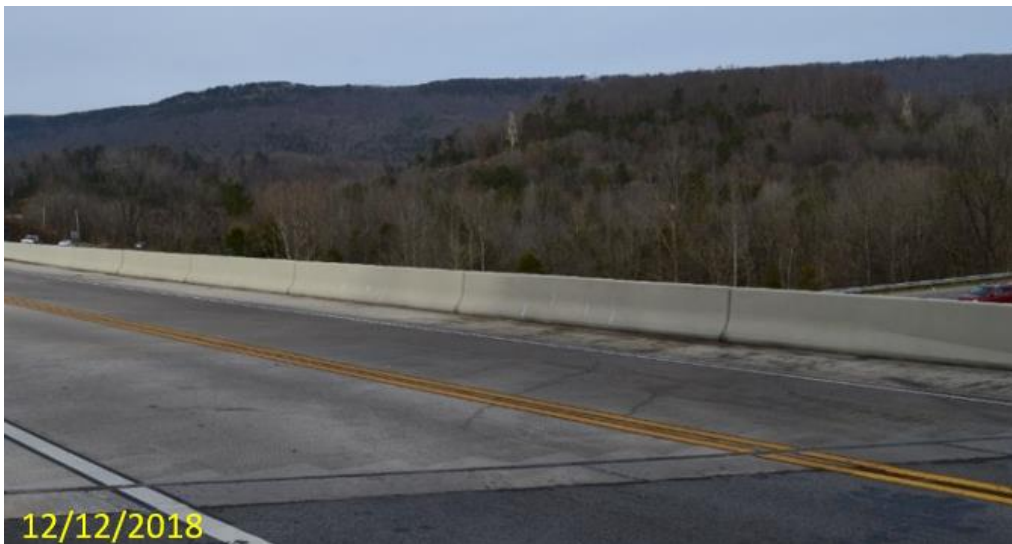
Figure 38 – New photo showing cracks at eastbound corner of Span 2.

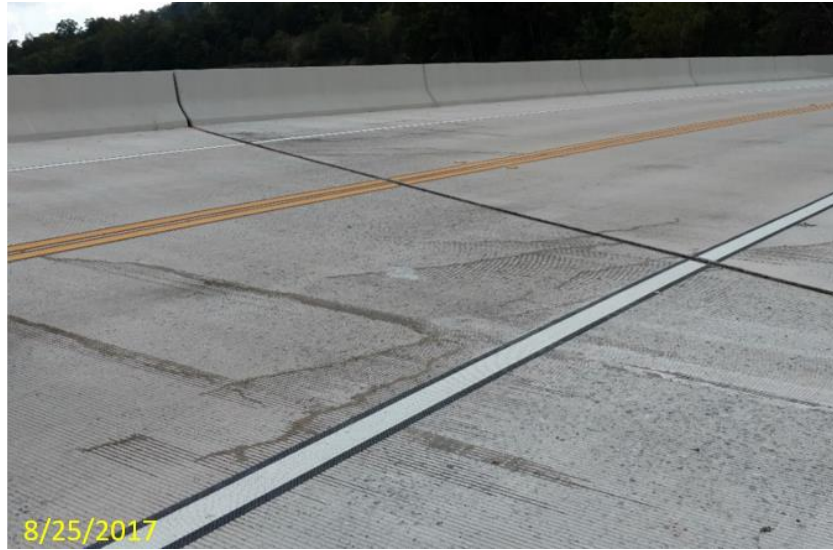
Figure 39 – Old photo showing cracks in eastbound lane at Span 2 end.

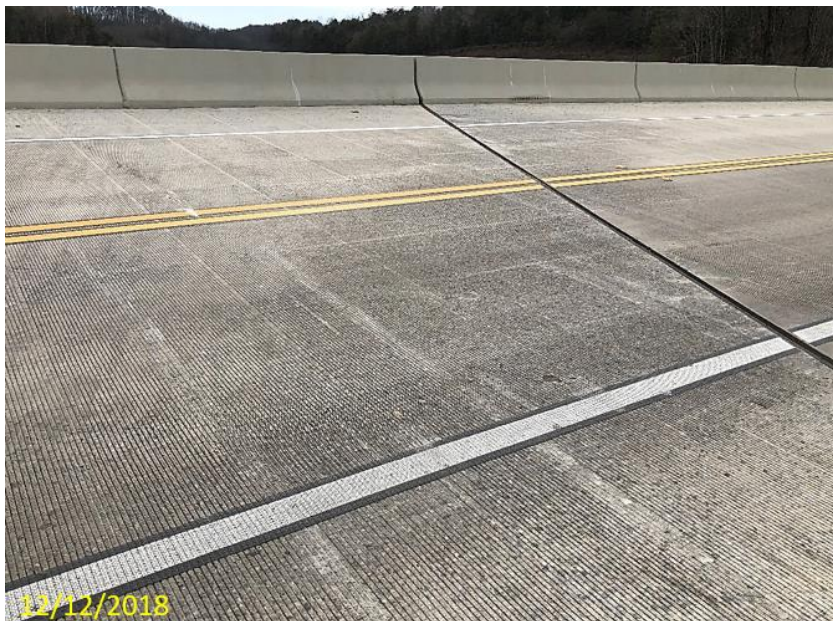
Figure 40 – New photo showing cracks in eastbound lane at Span 2 end.

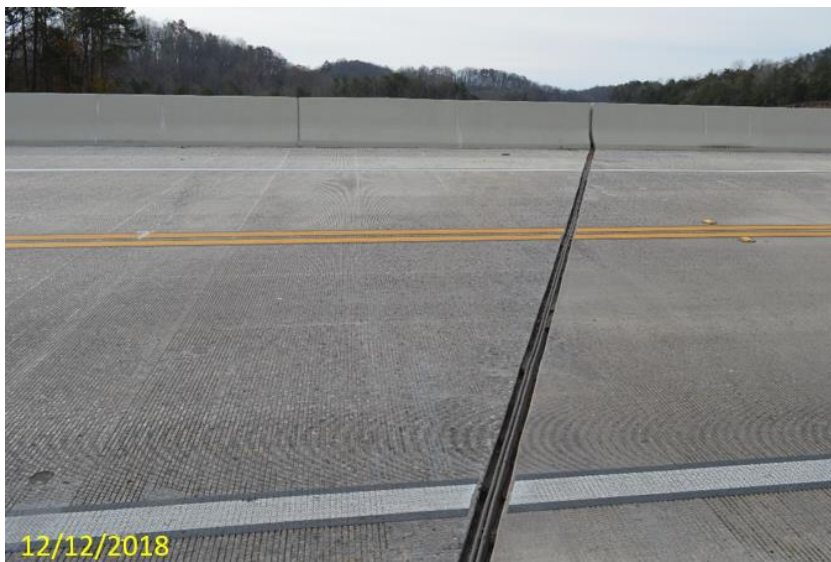
Figure 42 – New photo showing cracks thru expansion joint between Spans 1 and 2.

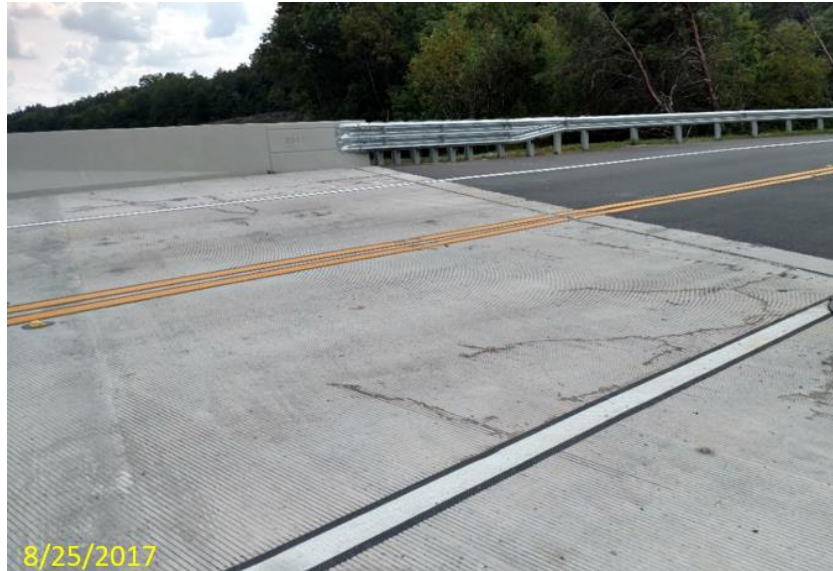
Figure 43 – Old photo showing cracks at the obtuse corner of eastbound Span 1.

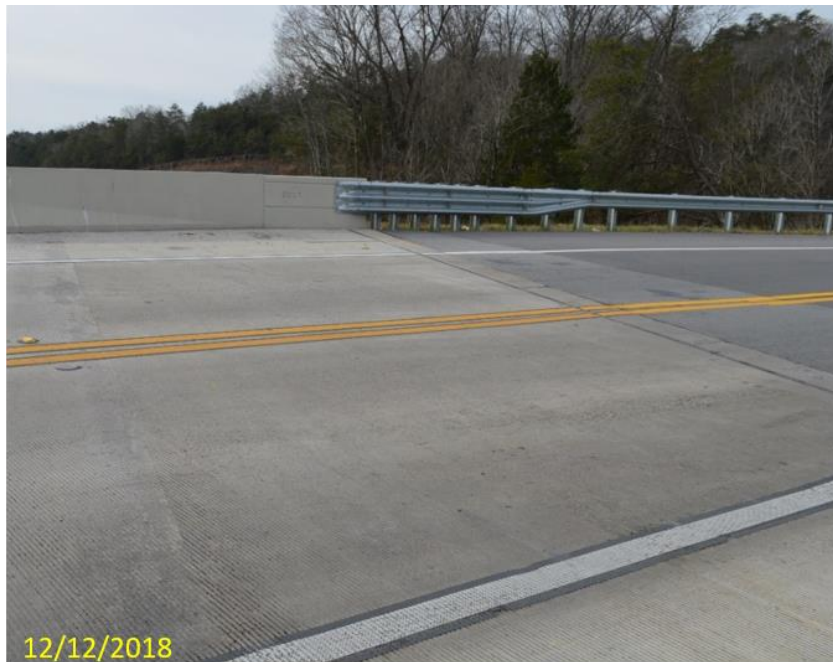
Figure 44 – New photo showing cracks at the obtuse corner of eastbound Span 1.

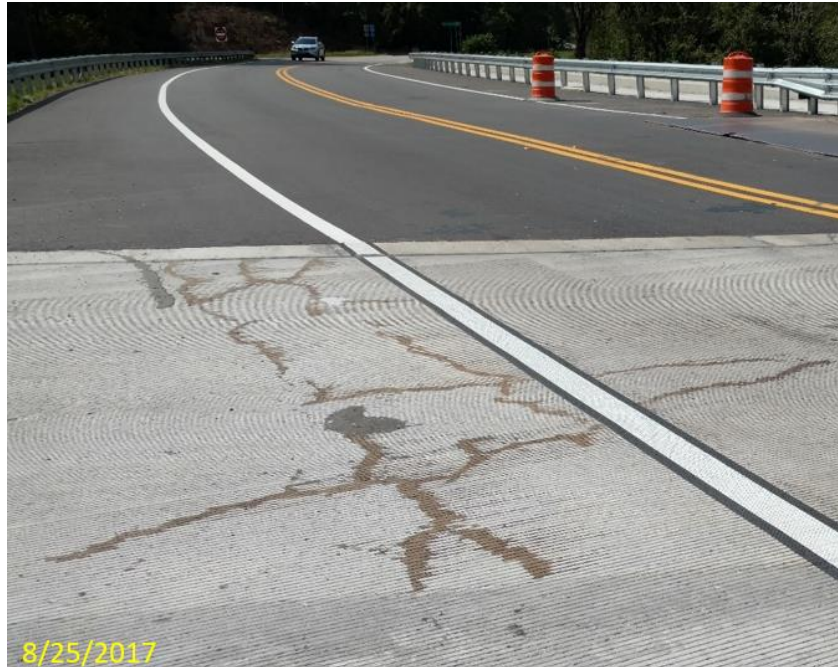
Figure 45 – Old photo showing cracks at the acute corner of westbound Span 1.

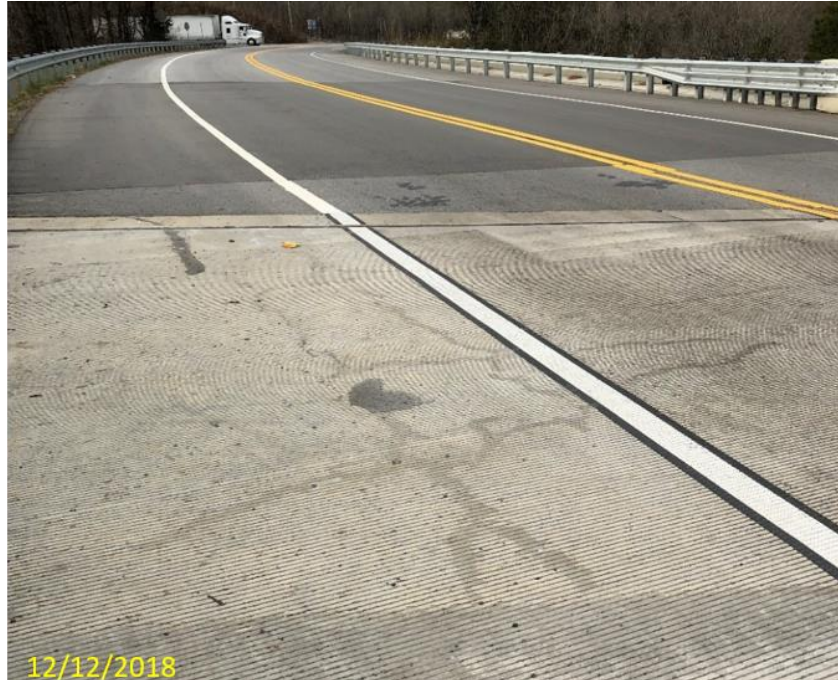
Figure 46 – New photo showing cracks at the acute corner of westbound Span 1.

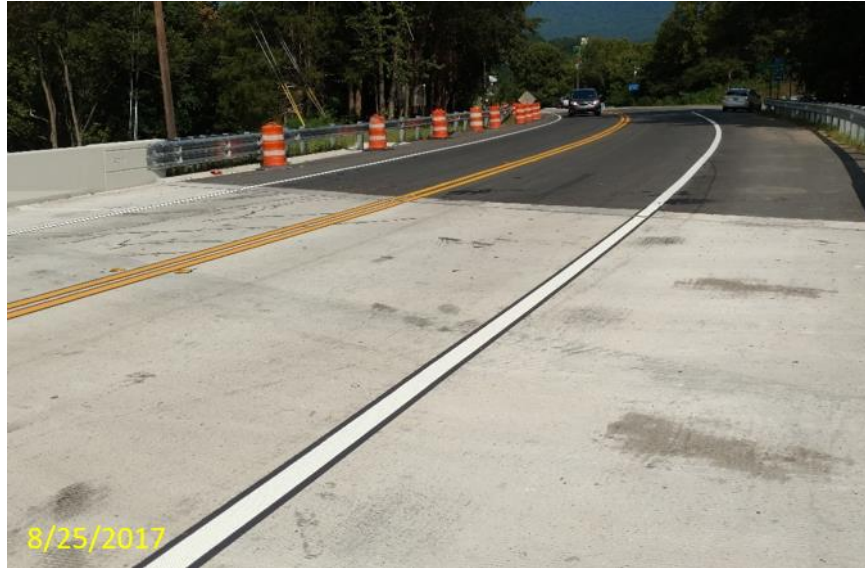
Figure 47 – Old photo showing cracks from westbound lane of Span 2.

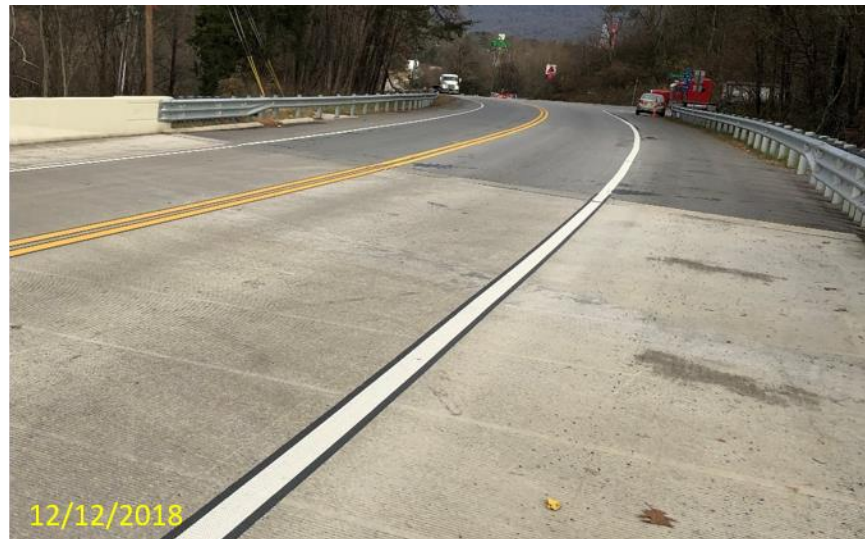
Figure 48 – New photo showing cracks from westbound lane of Span 2.

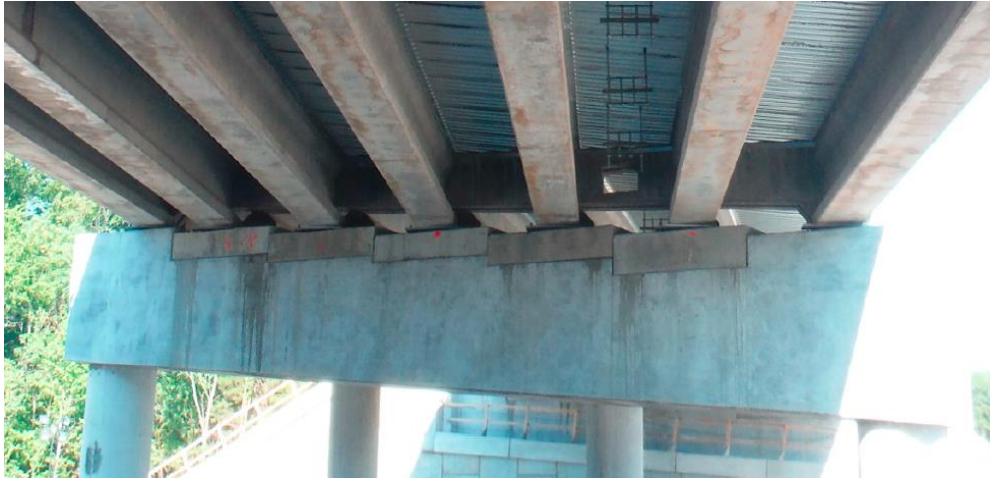
(b) Bearing conditions during the first bridge inspection by GDOT (GDOT BIR, 2017).

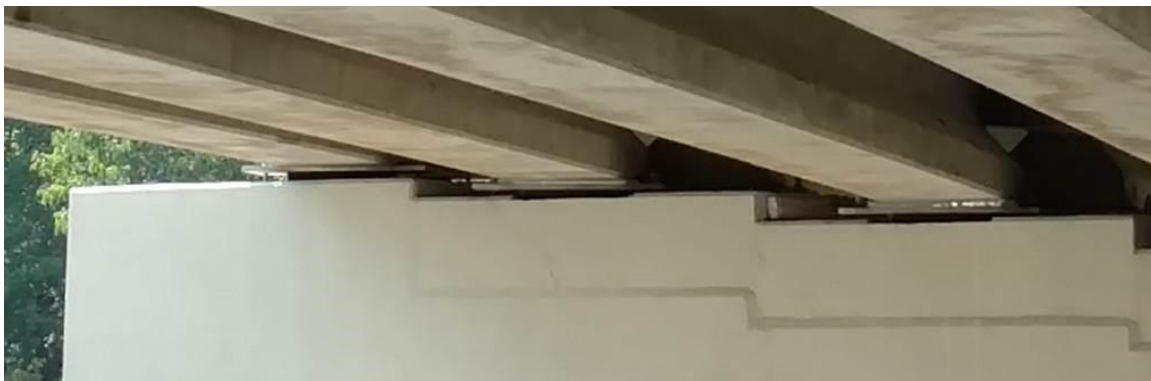
(d) Bearing conditions enlarged from the photo shown in (c).

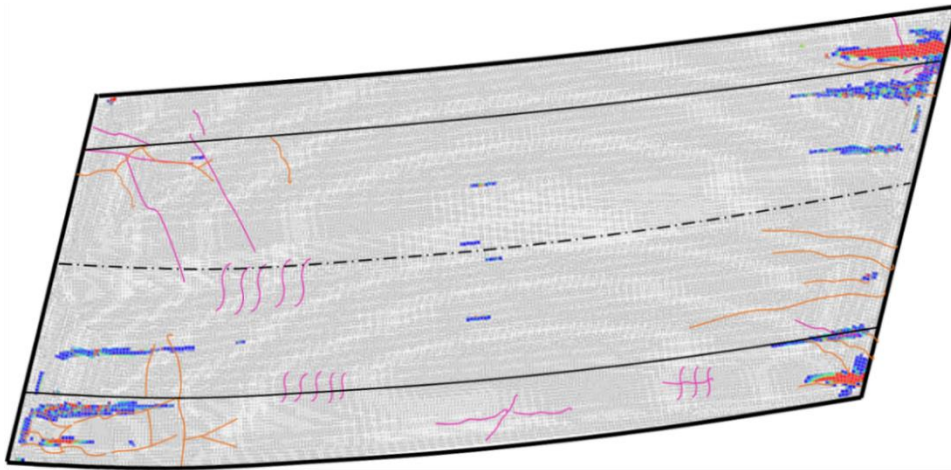
Figure 206 – Observed and computed cracks on SR299 bridge deck (Span 1).

Figure 206 shows a crack map obtained from the field investigations (see Section 3.5.3.2, Figure 28) compared to the Span 1 results from the analytical investigations (see Section 5.3.3.1, Figure 145). Similarly, Figure 207 compares a crack map obtained from the field investigations (see Section 3.5.3.2, Figure 28) with a crack pattern map for Span 2 predicted from the FEA (see Section 5.3.4.1, Figure 166).

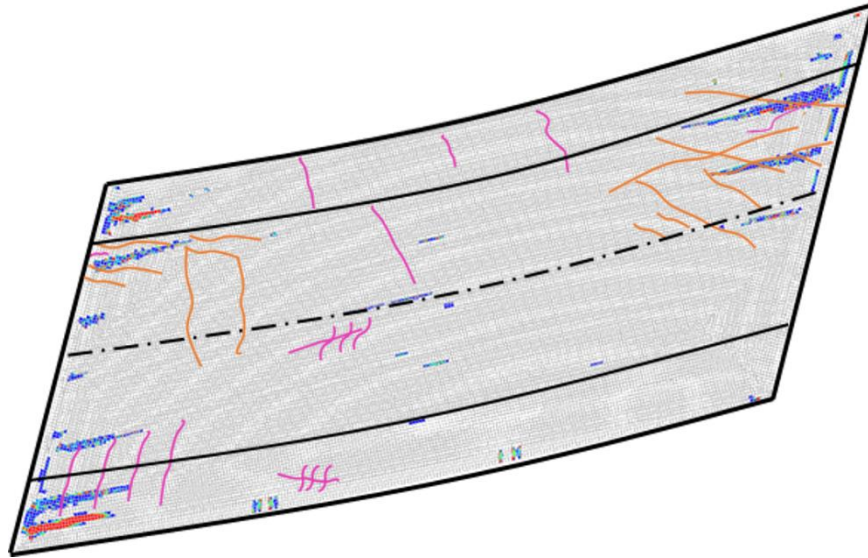
Figure 207 – Observed and computed cracks on SR299 bridge deck (Span 2).

Note: Orange and pink lines indicate cracks observed from the first and second site investigations, respectively, whereas the blue and red color scheme indicates elements identified as cracked from the FEA.
