Experimental and Analytical Evaluation of Residual Capacity of Corrosion-Damaged Prestressed Concrete Bridge Girders

Via Department of Civil and Environmental Engineering
Virginia Tech

Final Report VTRC 21-R6

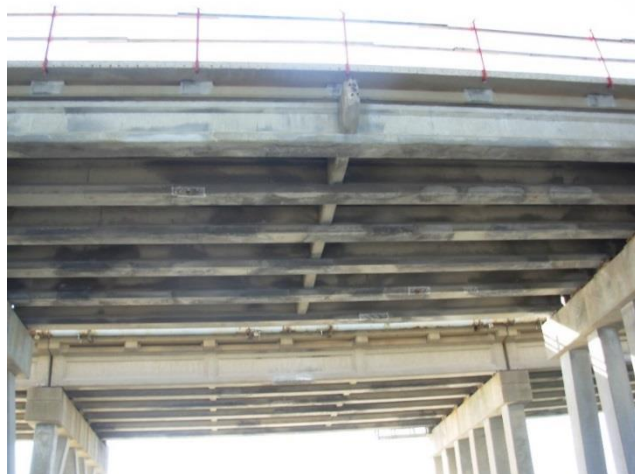
After almost 50 years of service, the bridge was demolished and replaced beginning in 2016. In the spring of 2017, nine beams were retrieved during the demolition process and delivered to Virginia Tech for testing. The slab between the beams was saw-cut to allow for the retrieval of beams to include a section of their cast-in-place composite deck. Figure 1 is a photograph of Span 7, showing the extent of deterioration in typical beams. The Lesner Bridge was repaired several times over the years, so patching is evident in many locations.

Figure 1. Typical Deterioration on the Lesner Bridge

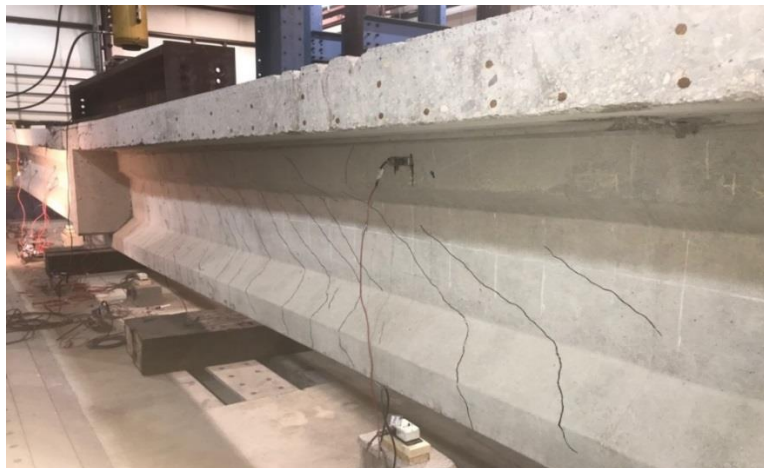
Figure 44. Residual Deflection after Testing I-Beam 7

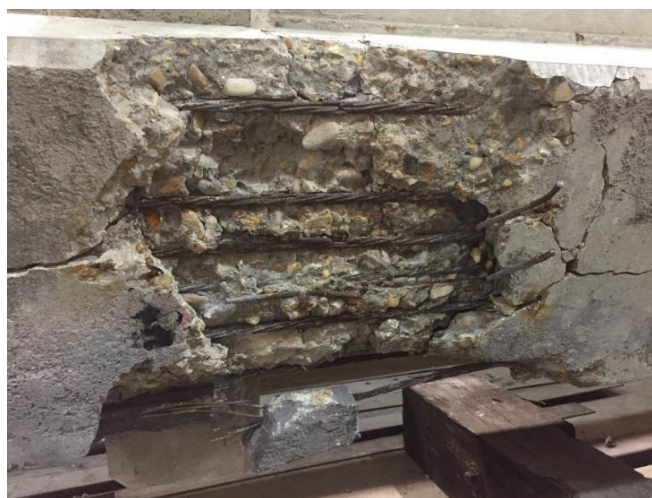
After testing was completed, the concrete on the bottom flange was removed to investigate the condition of the strands, as shown in Figure 52. Upon careful inspection, it was determined that five of the six bottom row strands showed signs of severe corrosion with most wires broken, apparently due to the aforementioned corrosion. A few wires appeared to have broken during testing and showed a shiny surface. Interestingly, the fourth strand, counting from the top of Figure 52, showed no evidence of corrosion damage. The bottom strand in the photo, still embedded in a piece of the patch material, showed evidence of being broken before testing, and most likely at the time the patch was applied. The strand in the same position, but in the second row, was also in the patch and was in similar condition.

Figure 52. Bottom Flange of I-Beam 6 after Testing

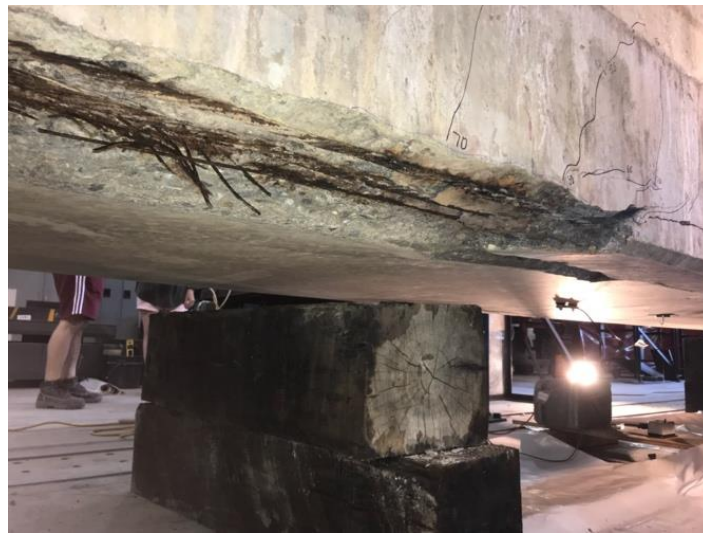
Before the test, severe corrosion was observed in the three bottom strands on the west side of the beam (see Figure 61). The cracks during the test were marked and the propagation was observed (see Figure 62 and 63). Figure 64 shows the beam at the completion of testing.

Figure 61. Condition of the West Side of Box Beam 1 Before the Test

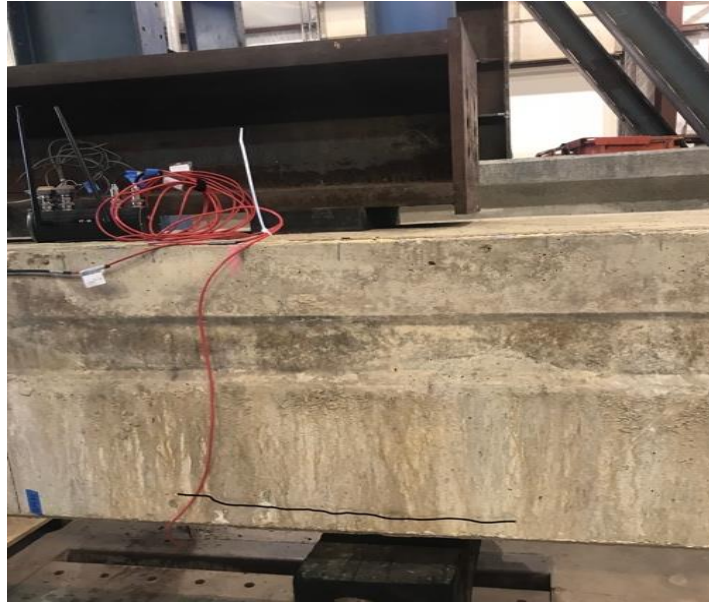
Figure 66. Box Beam 4 East Side Before Testing

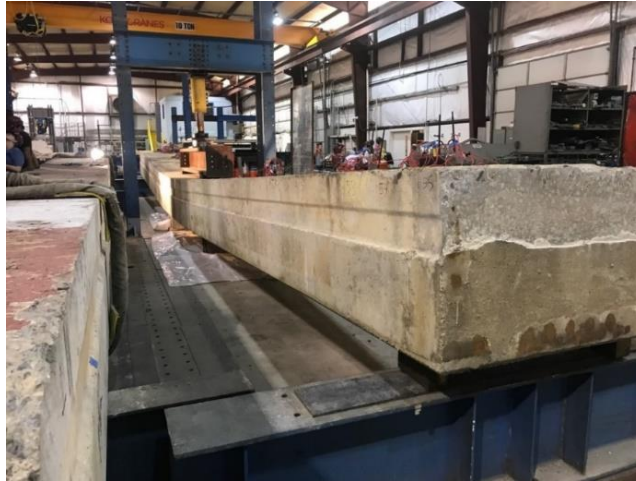
Figure 74 shows the very large deflection in the beam during the test. Figure 75 shows the severely corroded lower strand in the east side, which was observed before the test. After testing, the researchers found that the other strands were relatively undamaged.

Figure 74. Large Displacement of Box Beam 2

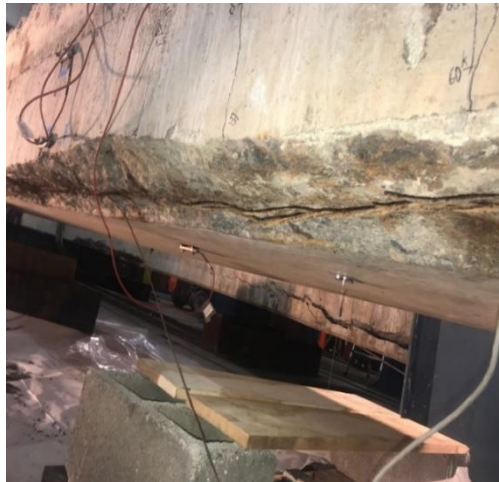
Figure 75. Corroded Strand on Bottom of Box Beam 2
