# Corrugated Metal Pipe Culvert Invert Repair Using Engineered Cementitious Composite

**Final Report VTRC 21-R5**

**CORRUGATED METAL PIPE CULVERT INVERT REPAIR USING ENGINEERED  
CEMENTITIOUS COMPOSITE**

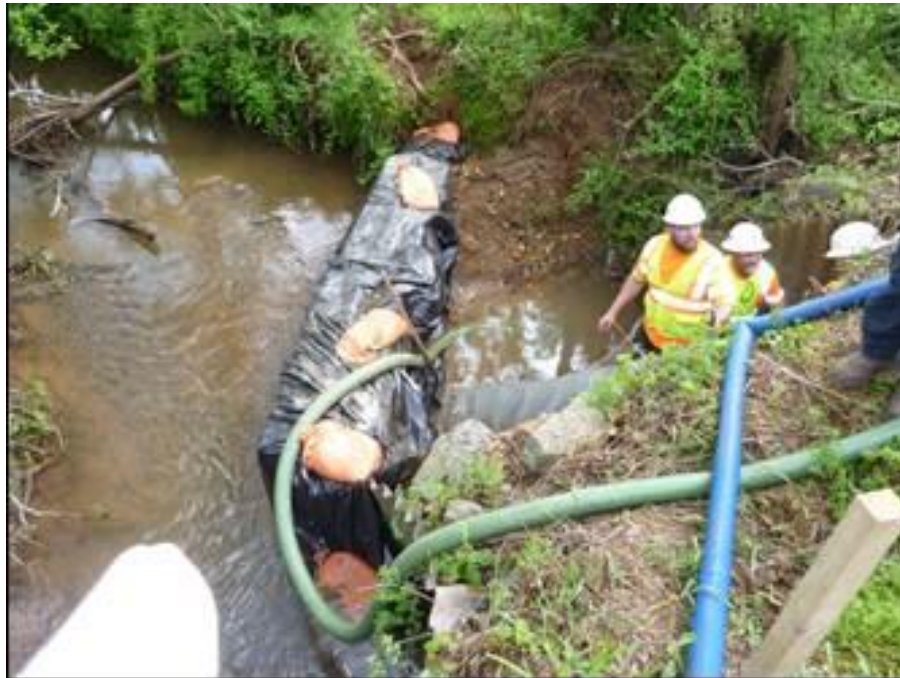
**Figure 2. Dewatering**

Before the repairs, the water flowing through each culvert was diverted. As shown in Figure 2, ground and surface water was prevented from entering the culvert using a pump. The inverts and sides of the pipes were cleaned by removing debris, mainly silt, with low pressure water hoses; sweeping; washing the second time; and then blowing with air before the placement of the geogrid and the application of ECC. Loose rust and extra puddles of water in the valleys of the culvert were also removed.

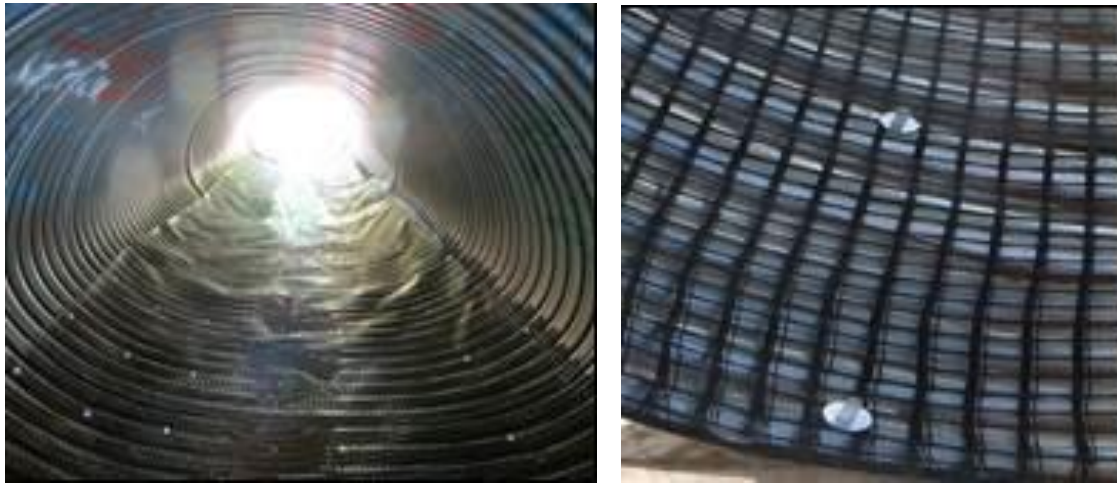
**Figure 3. Geogrid Attached (Left), Screw With Spacer (Right)**

Synthetic biaxial geogrids, PVA in the first culvert and polypropylene in the rest, with a 1-in aperture size were used in the field. The geogrid was attached to the top of the corrugations with a screw at 1.5 to 2 ft spacings; the screws had spacers to ensure that a maximum 1-in thickness was maintained, as shown in Figure 3. Geogrid was used on all culverts except for a 20-ft section of Route 611, which had lost some of the corrugations and was first repaired with rapid set cement, which closed the missing and existing corrugations before the placement of ECC. Water diversion, geogrid placement, and the repair of the holes were done before the placement of the ECC and required about 2 days.

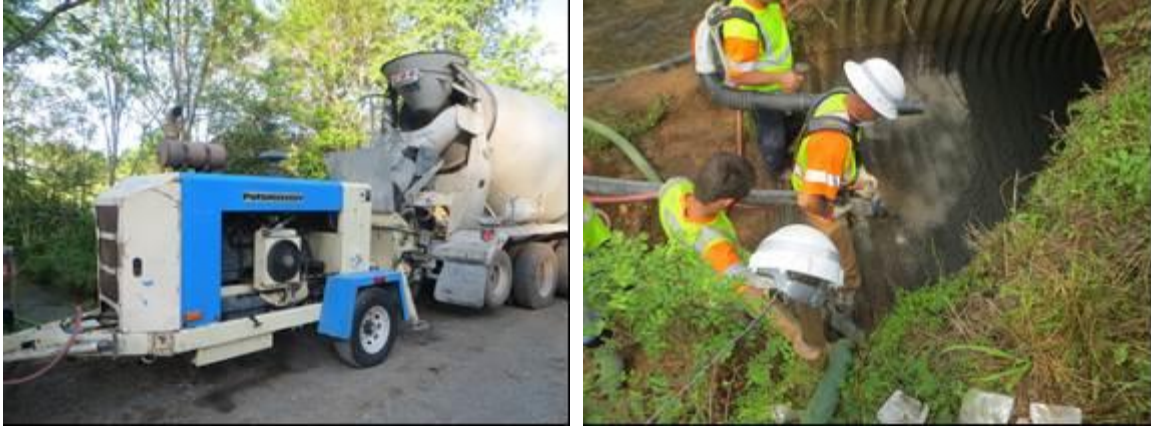
**Figure 4. Trailer Pump (Left), Spraying Engineered Cementitious Composite (Right)**

Batches 1 and 2 were self-consolidating concrete. In these wet mixtures, ECC flowed down the sides of the culverts, even with the geogrid. Therefore, stiffer mixtures, that were not self-consolidating, were prepared for Batches 3 and 4. The stiffer mixtures, with a reduced amount of HRWRA, attached to the sides without flowing down. Batches 5 and 6 were not self-consolidating but had high slump values. To reduce the slump further, ECC placement was delayed by keeping the material in the trucks for a while.

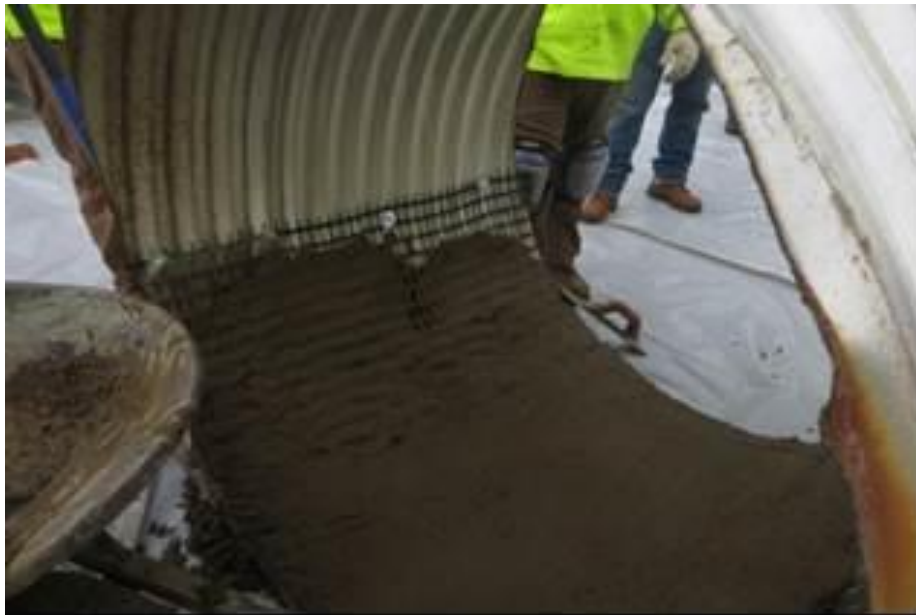
The trial batch had 1.8% PVA fibers and was retarded extensively with a retarding admixture to enable sufficient delivery and placement time. This wet mixture flowed down the sides of the culvert piece, as shown in Figure 10. The trial batch was tested for fresh concrete properties and handling characteristics.

**Figure 10. ECC From Trial Batch Flowing Down Sides in Ripples. ECC = engineered cementitious composite.**

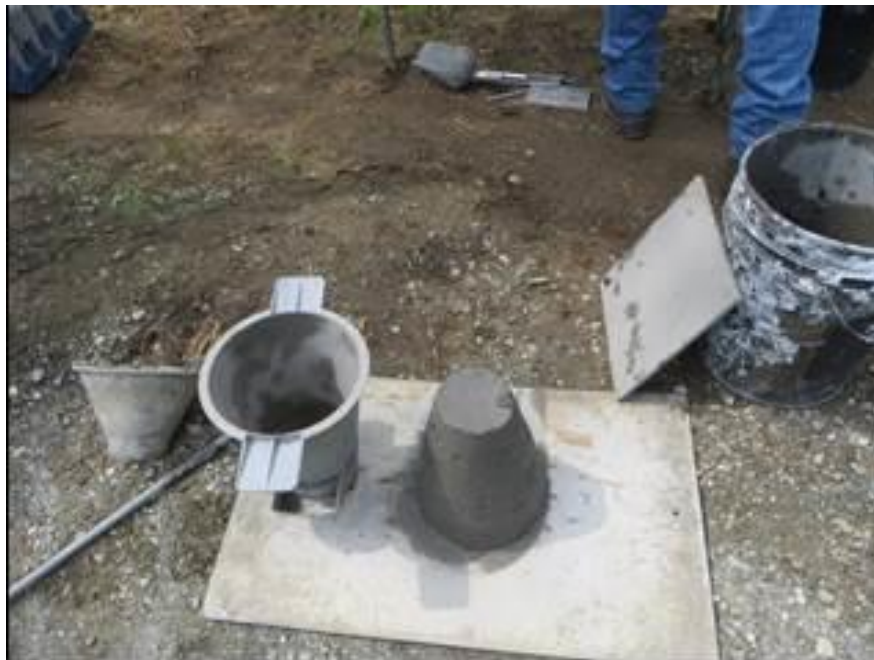
With Batch 3, by reducing the amount of admixtures and reducing the w/cm, a stiffer mixture was made, as illustrated by the slump test in Figure 11. Batch 3 with 1.5% fiber was used in one of the barrels of a 51-ft-long culvert at Route 774. The second barrel of this culvert was repaired 1 week later with Batch 4. Batch 3 was too stiff to go through the grate of the pump and had to be pushed with a shovel through the grate. For Batch 4, which was also a stiff mixture, a vibrator was placed on the grate to facilitate the flow of ECC through the grate. In Batch 4, more fibers (1.8%) were added to the mixture to improve the post-crack behavior. The stiff mixtures sprayed well and stuck to the sides without flowing down; the trailer pump had no difficulty spraying the stiff ECC, even with 1.8% PVA fibers. Pump operators preferred stiffer mixtures. Spraying was very efficient in the placement of the culverts; each barrel was repaired within 1 hour.

**Figure 11. Slump Test for Stiff Batch 3**

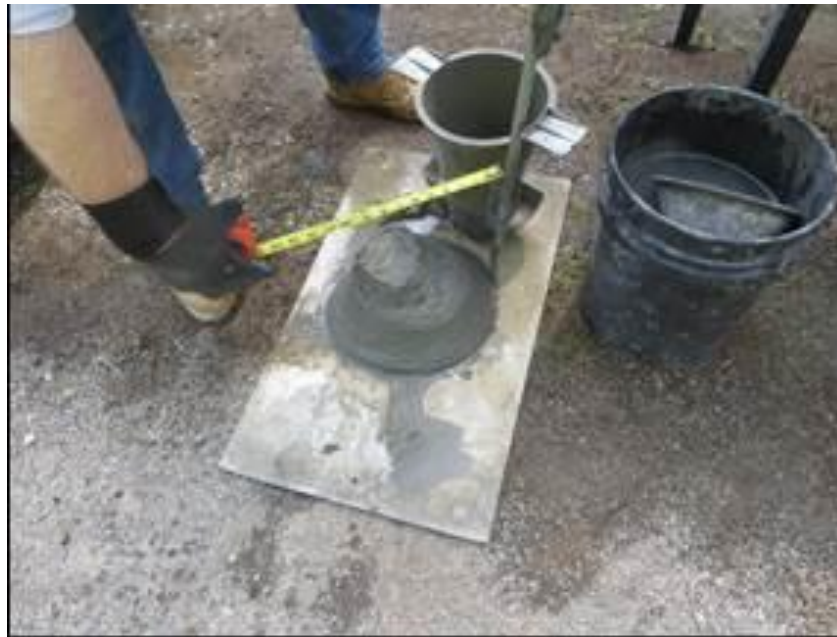
Batches 5 and 6 were used in the first and second barrels, respectively, of the Route 611 culvert; they also contained 1.8% fibers. Both barrels were repaired the same day within 2 hours. Batches 5 and 6 were highly workable but not self-consolidating mixtures, as shown in Figure 12. ECC was kept in the truck for about one-half hour to reduce the slump to make it stiff to prevent it from sliding down the sides.

**Figure 12. Slump Test for Batch 5**
