Federal Highway Administration
Every Day Counts
Innovation Initiative

Safety Edge_{SM}
Demonstration Project
State Route 182
Columbus, Mississippi

Field Report
June 27, 2011

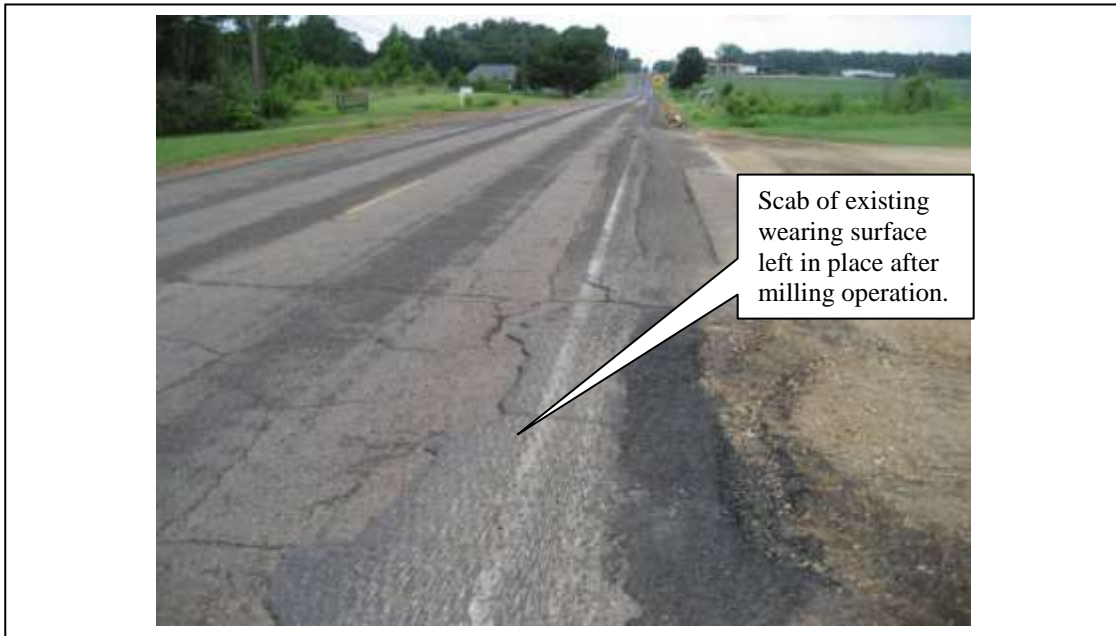
Figure 3. General overview of the existing HMA pavement after milling; heavily distressed area with cracking (view is towards the east).

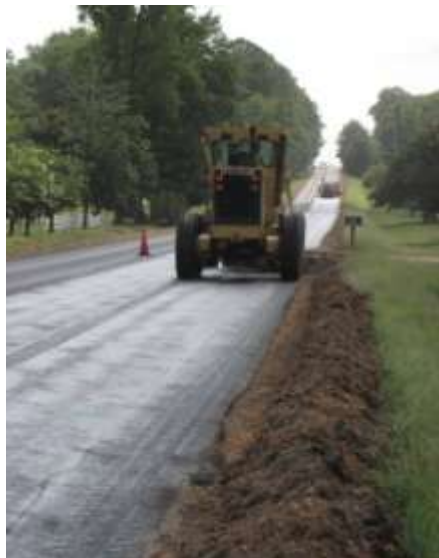
1. The edge of the pavement or shoulder was graded to level out the windrowed material, as shown in Figure 14. The edge of this windrowed material was not compacted prior to placing the Safety Edge_{SM}. In some areas, this material was loose.
2. The motor grader was followed by a broom to clean the surface, as shown in Figure 14. Cleaning the surface is considered good practice prior to placing the tack coat.
3. An emulsion was applied to serve as a tack coat for the HMA overlay. Figure 14 shows the emulsion being placed prior to paving. The application of the tack coat was uniform and covered the entire surface.

Motor grader was used to move and level the windrowed material along the edge of the pavement. In a few areas, the motor grader was used after the tack coat had already been applied.

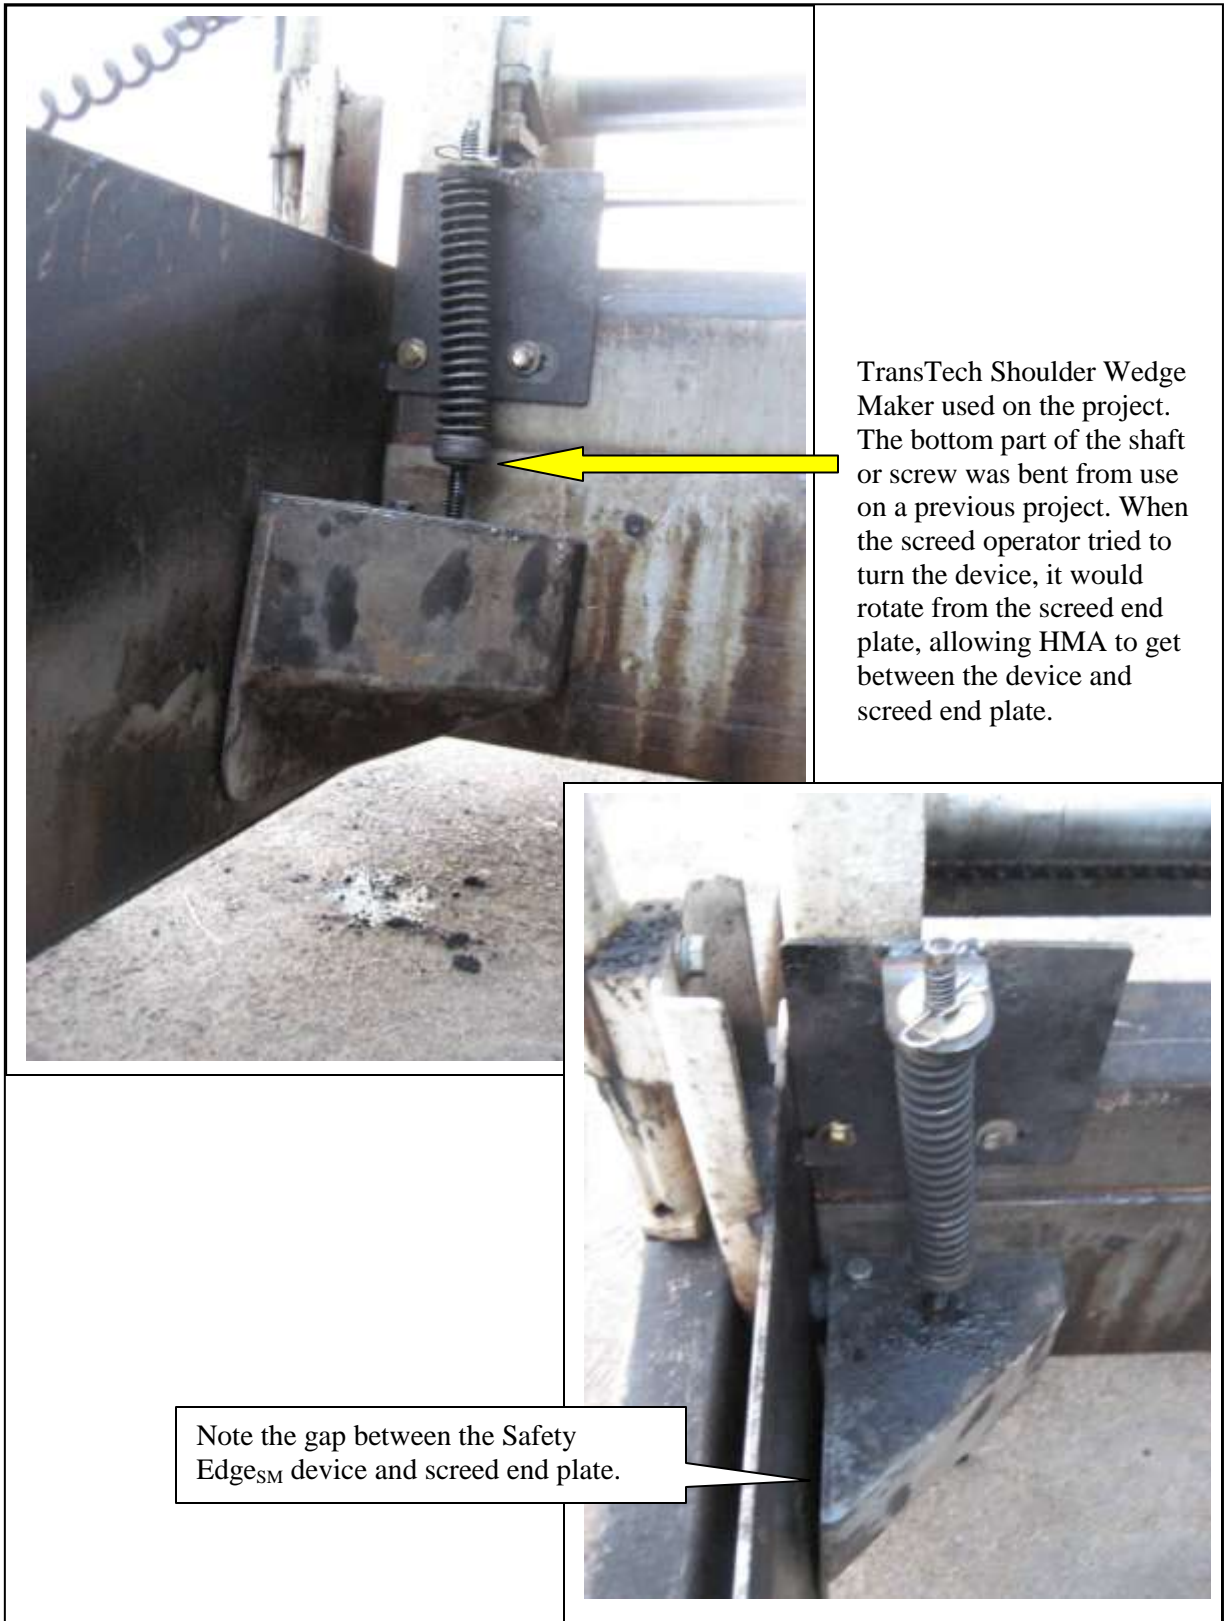
- The screed operator recommended that the Safety Edge_{SM} device be an automated system rather than manually turning the screw to raise and lower the Safety Edge_{SM} device.
- The shaft of the Safety Edge_{SM} device was bent during use on a previous project, such that when the screed operator turned the screw to raise or lower the device, the device would rotate creating a space between the end plate and Safety Edge_{SM} device. HMA material could then become lodged between the screed end plate and the Safety Edge_{SM} device. The screed operator continued to monitor this condition to prevent it from occurring, but in some cases HMA mix would push the device away from the screed end plate – increasing the slope. This condition may have resulted in some of the steeper slopes that were measured within the Safety Edge_{SM} Area #3 (refer to Table A-1 in Appendix A).

TransTech Shoulder Wedge Maker used on the project. The bottom part of the shaft or screw was bent from use on a previous project. When the screed operator tried to turn the device, it would rotate from the screed end plate, allowing HMA to get between the device and screed end plate.

Note the gap between the Safety Edge_{SM} device and screed end plate.

Figure 16. TransTech Shoulder Wedge Maker attached to the screed.

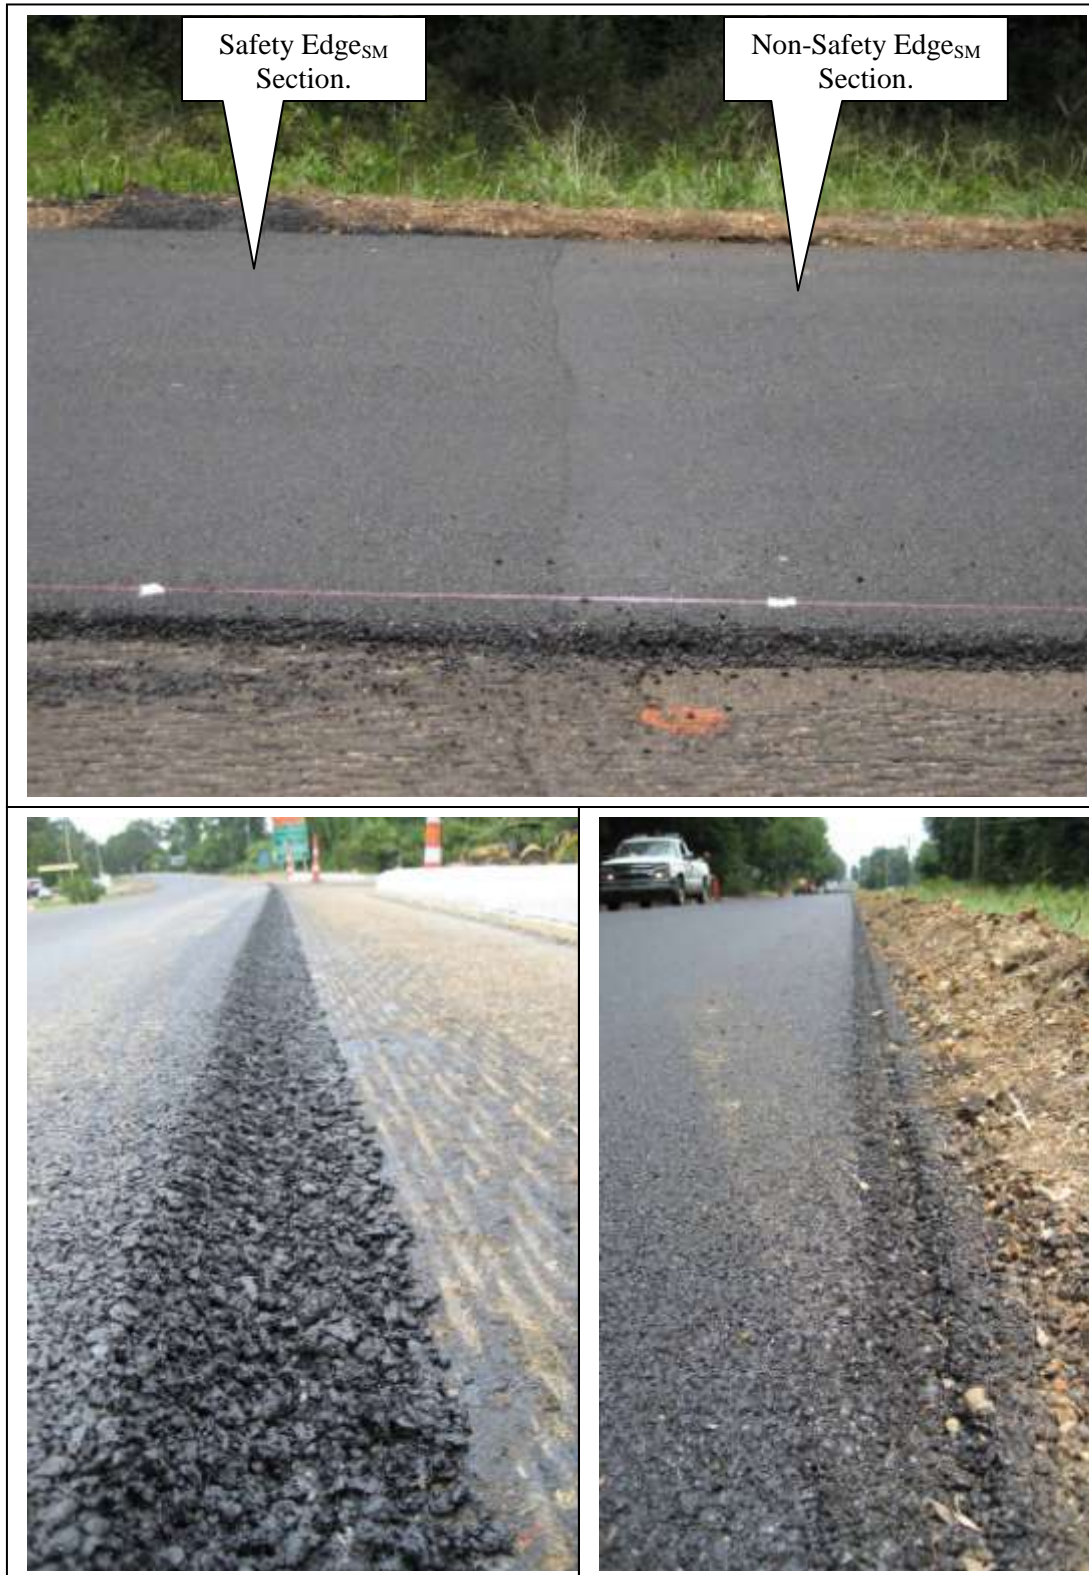
Figure 17 shows the slope and surface texture of the unconfined edge between the Safety Edge_{SM} and non-Safety Edge_{SM} sections.

Figure 17. Safety Edge_{SM} and non-Safety Edge_{SM} sections; different days of paving.

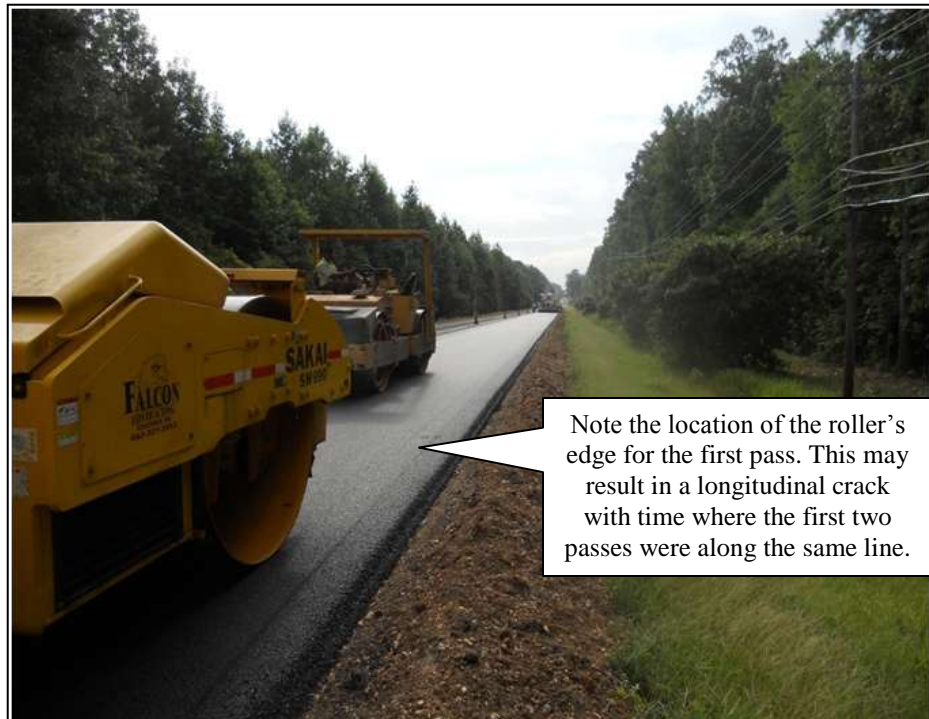
(b) First pass of Sakai roller is about 6 to 12 inches away from edge of the mat.

Figure 20. Rolling the unconfined edge with the vibratory steel wheel roller; pattern varied along the project.

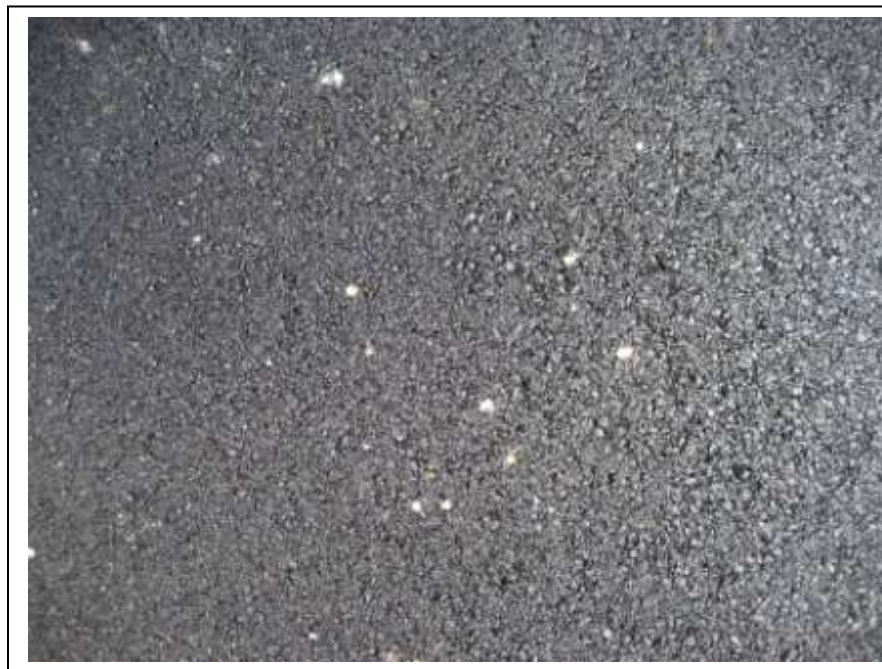
No visual signs of shoving or tearing of the mixture were noted or observed during the compaction operation. In addition, the Safety Edge_{SM} did not shove out, or stand up, during the compaction operation. Figure 21 shows the surface texture of the finished HMA mat along the project. The surface texture and condition was relatively uniform throughout the project.

Figure 21. Surface texture of the 9.5 mm HMA overlay after final rolling.

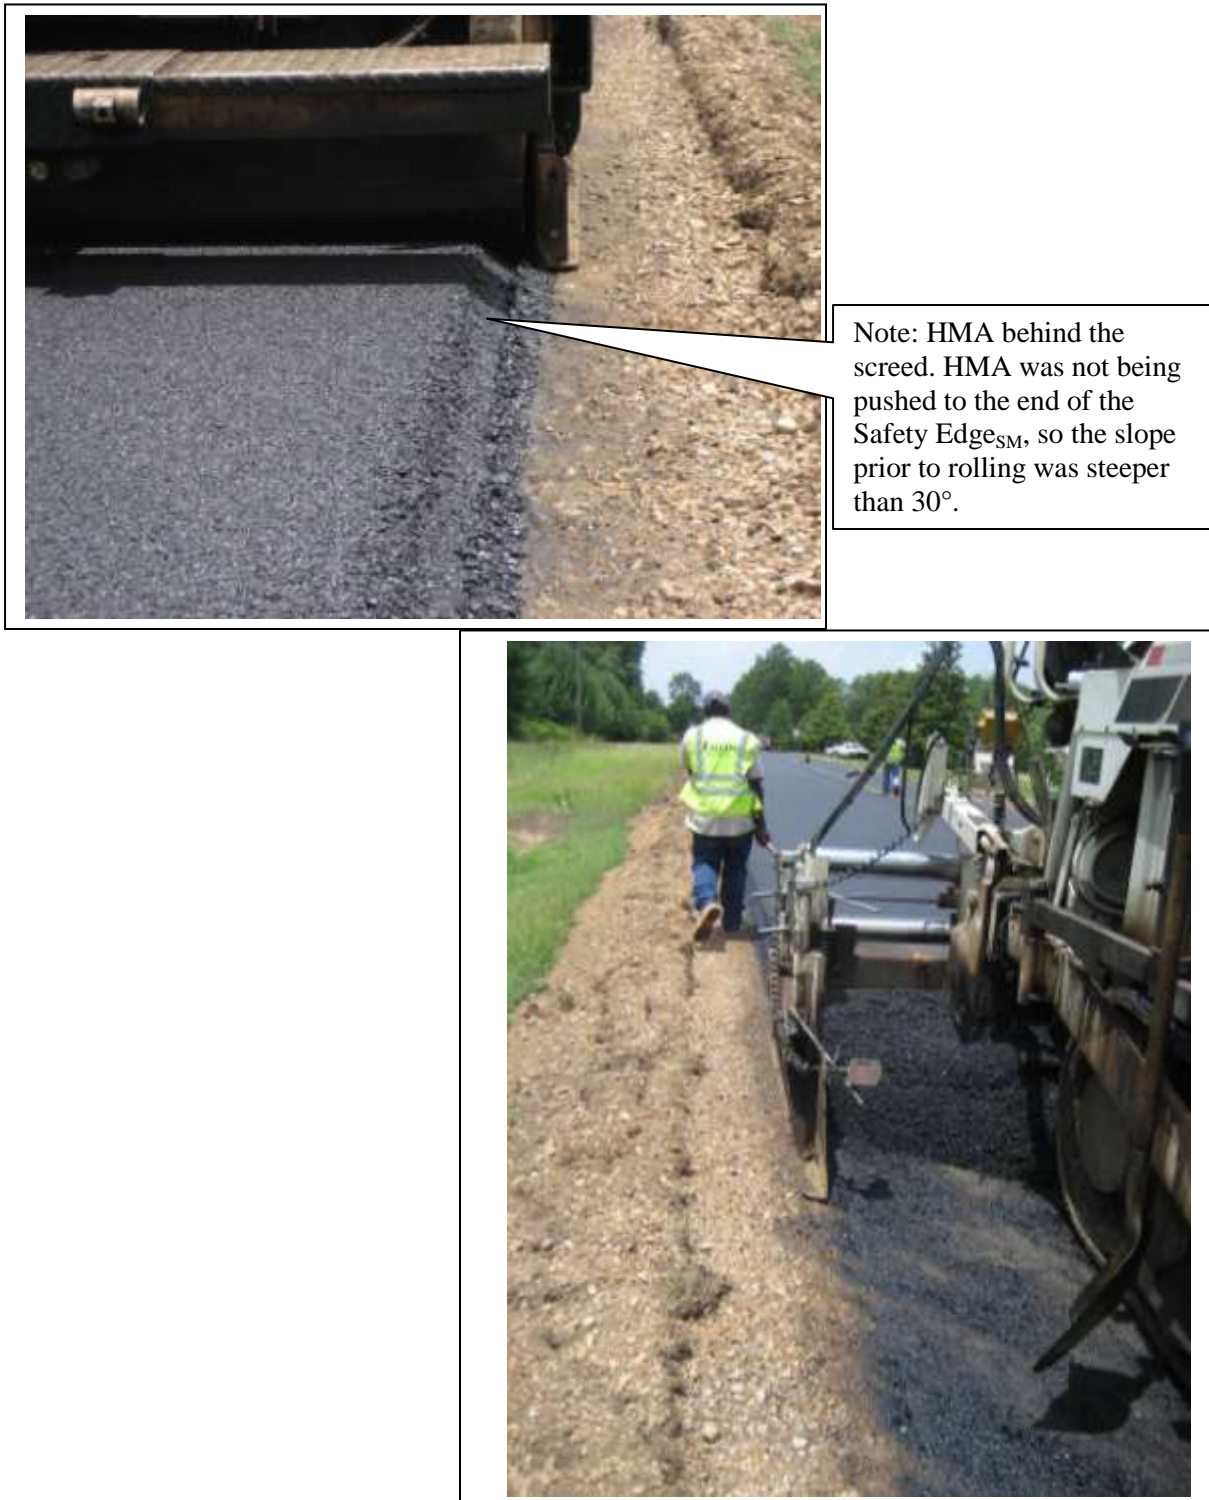
The distance between the end of the auger and screed end plate was about 18 to 24 inches. This distance should be less than 18 inches. The temperature of the HMA being delivered to the project site was reported to be 295 to 305 °F. Mix temperature and the distance between the end of the auger and screed end plate, however, are not believed to be contributing factors to the steeper slopes.

Observations made during paving showed that the HMA mixture was not being pushed to the end of the Safety Edge_{SM} device. Figure 22 shows HMA behind the screed and the Safety Edge_{SM} slope prior to rolling. The slope of the Safety Edge_{SM} was steeper than planned prior to rolling. A reason for the steeper slope, however, could be related to the bent shaft of the Safety Edge_{SM} device.

Figure 22. HMA under and behind the screed; the HMA was not being pushed to the end of the Safety Edge_{SM}, which resulted in a steeper slope prior to rolling.

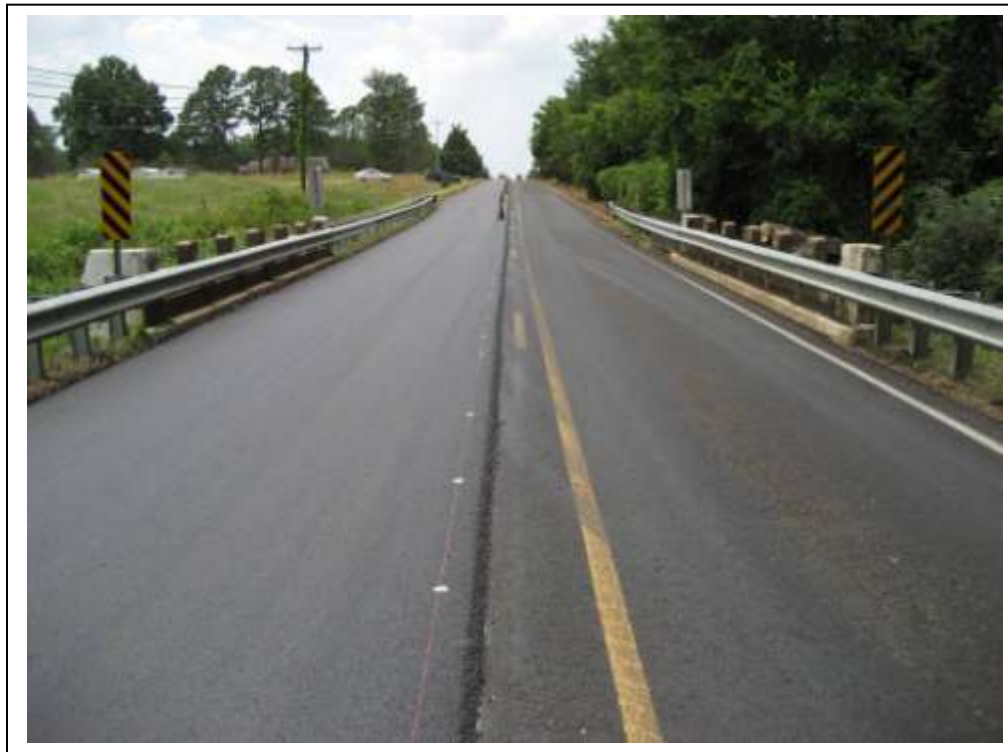
The contractor voiced a concern about being unable to retract the extension on the shoulder side of the paver sufficiently, so that the paver operator would not have to steer the paver closer to the centerline and retract the other extension. Steering the paver closer to the centerline and retracting the other extension could potentially create a longitudinal joint that would be difficult to match and compact (refer to Figure 23).

Figure 23. One of the narrow bridges located on the project (about 22-feet wide).
