Report No. FHWA/RD-80/158

STABILITY OF RELOCATED STREAM CHANNELS

March 1981
Final Report

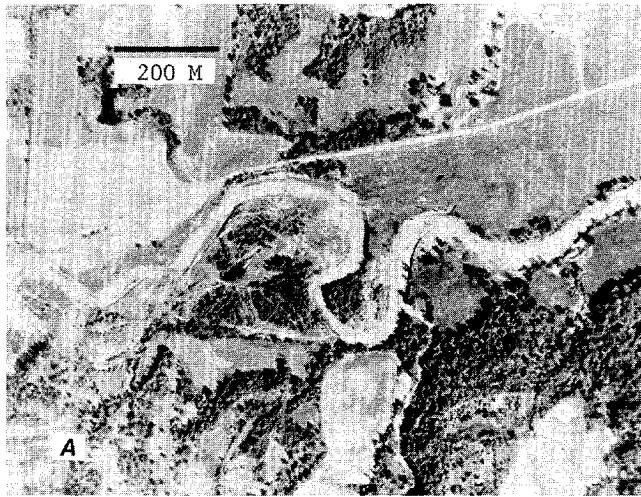
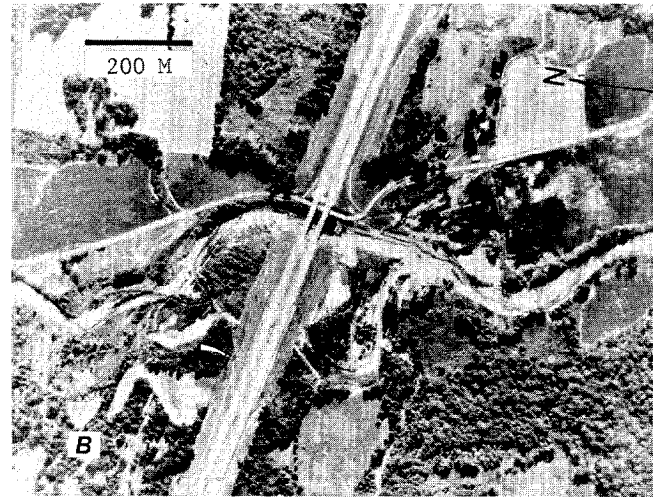
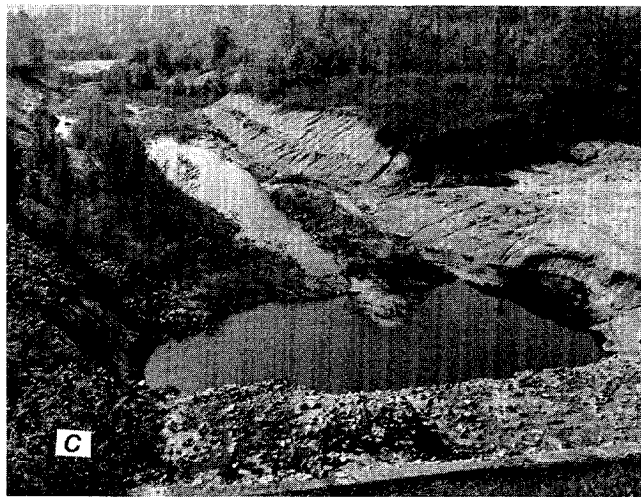
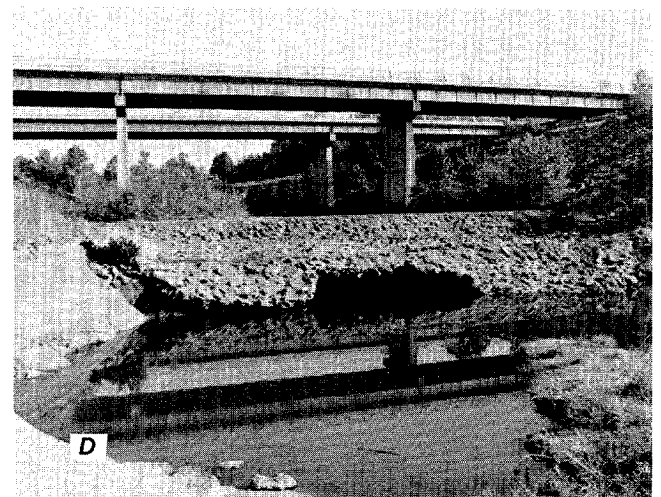
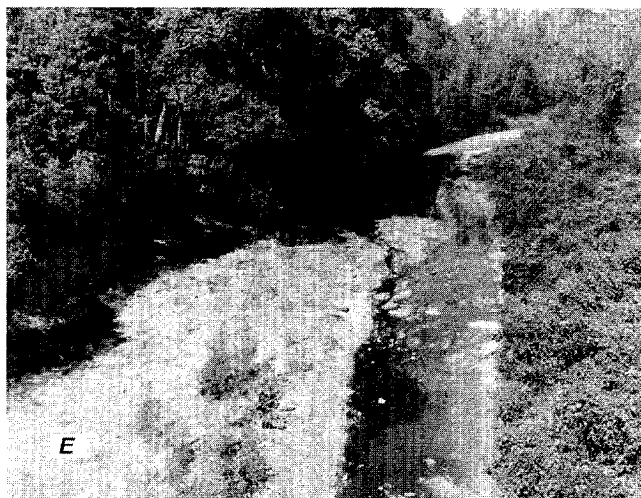
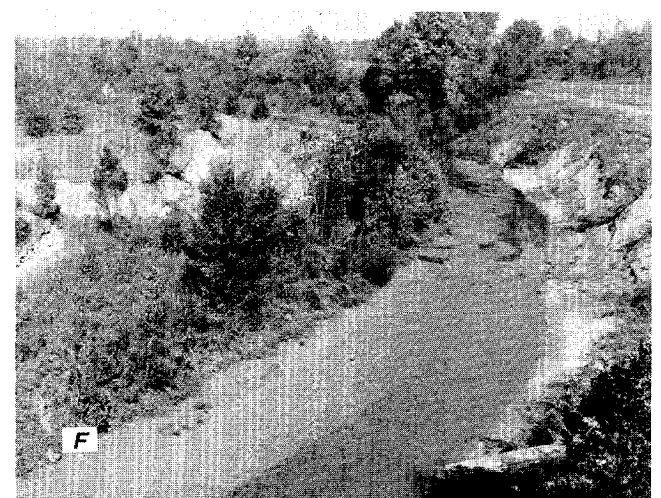
DISCUSSION--Instability, particularly with regard to degradation, of the natural channel was not taken into account in the design of pier foundations, and the check dam was added as a countermeasure. Although the check dam has prevented further degradation, it presents continuing problems of erosion and maintenance. If the bridges were located about 50 m upstream from the existing site, the danger of encroachment of the meander against the highway embankment would be removed and flow alignment at the bridges would be reasonably good without channel alteration. The high streambanks near the bridge could then have been stabilized by grading, placement of flexible revetment, and planting with vegetation.

Figure 41. Crow Creek at site 10. A, Airphoto of site in 1957, prior to relocation. Position of relocated channel shown in dashed lines. (From U.S. Dept. of Agriculture). B, Airphoto in 1968, four years after relocation. (From U.S. Dept. of Agriculture). C, Relocated channel as viewed downstream from bridge, in 1978. Check dam is in foreground. D, Scour at check dam, as photographed in 1978. E, Natural channel 2.7 km downstream from relocation, in 1978. F, Channel as viewed upstream from bridge in 1978.

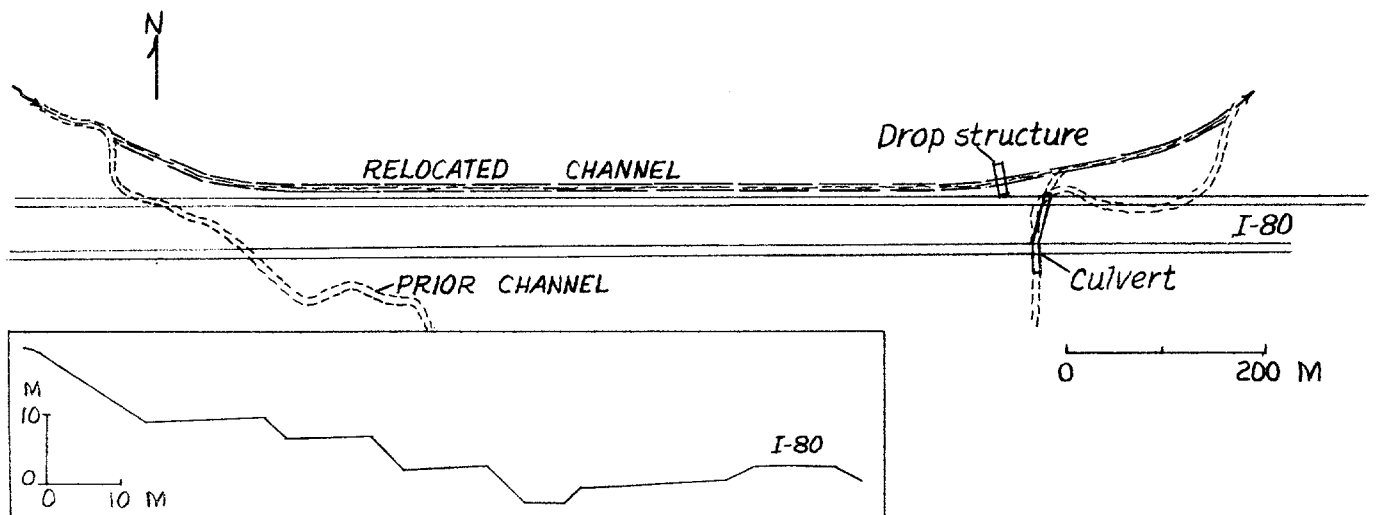
Figure 60. Plan sketch of Bear Creek channel relocation. Inset, typical cross section of relocated channel and adjacent slopes.

DISCUSSION--The length of the relocated segment was large in relation to stream size, and original channel length was reduced by a factor of 0.6. Serious channel degradation would probably have occurred without the drop structure. Terracing of the high cut has probably prevented more serious slumping and gullying.

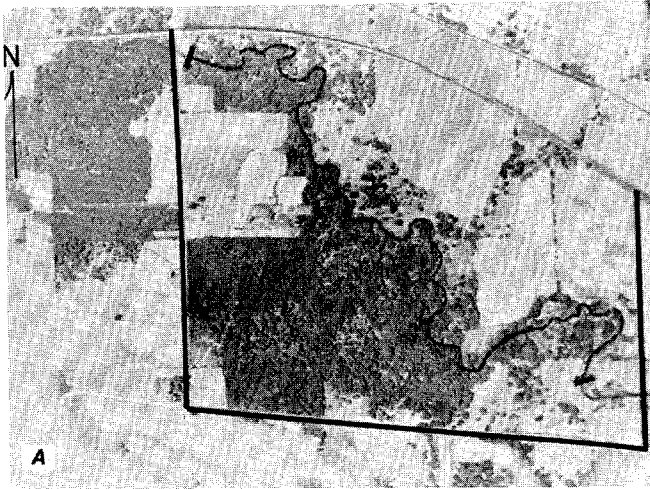
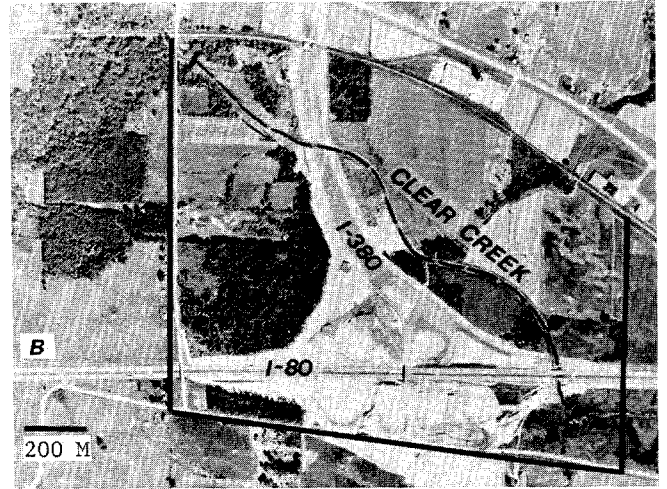
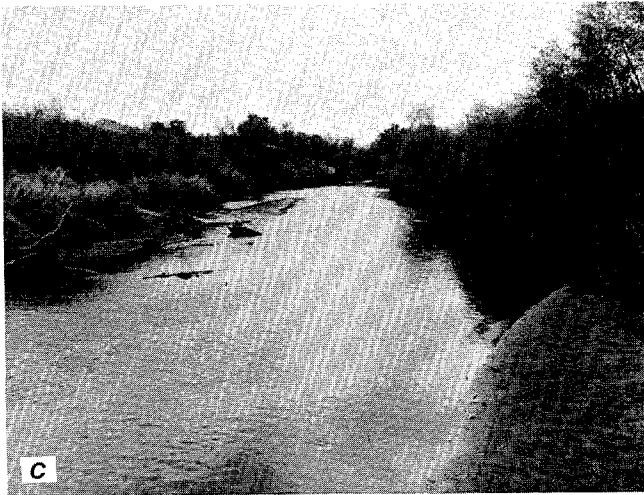
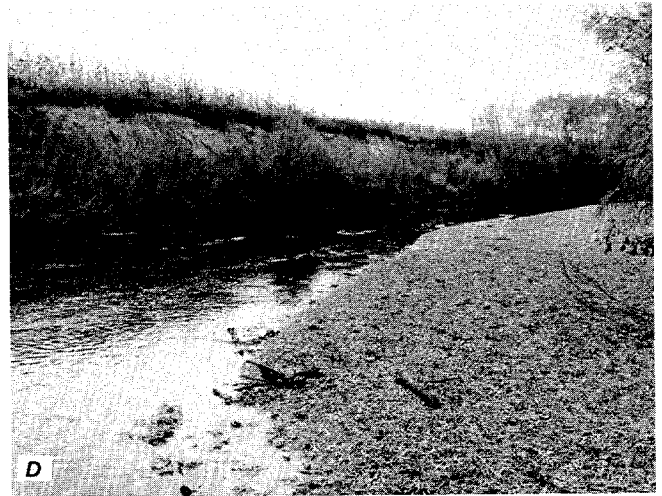
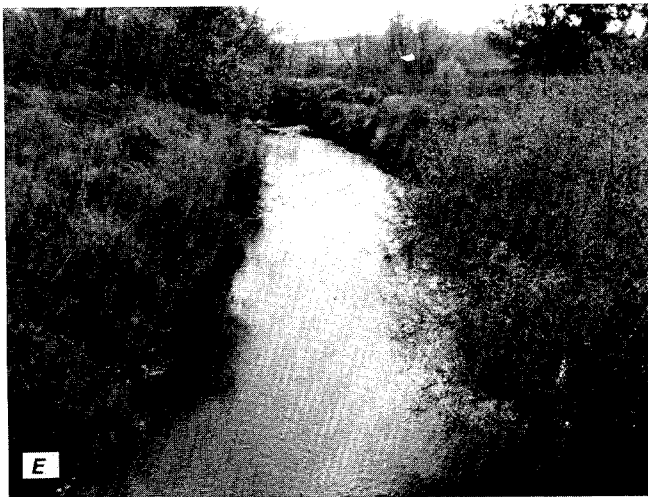
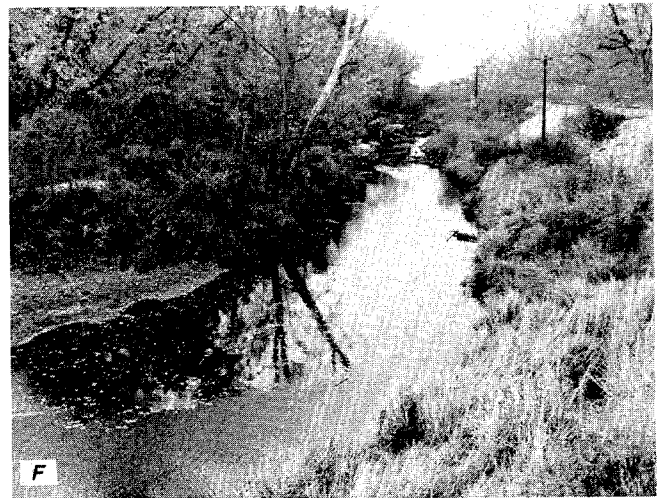
DISCUSSION--Establishment of vegetation along the berm at the toe of the bank is the only apparent factor in the halting of progressive bank erosion. The reason for little or no degradation is not apparent.

Figure 62. Clear Creek at site 21. A, Airphoto of site in 1956. Meandering course of Clear Creek is indicated by dotted line. Distance between vertical lines bounding area is 1,400 m. (From U.S. Dept. of Agriculture). B, Airphoto of Clear Creek site in 1970. Relocated course of creek is indicated by heavy dashed line. (From U.S. Dept. of Agriculture). D, Relocated channel at bend downstream from I-380 crossing, in 1979. D, Relocated channel at bend upstream from I-80 crossing, in 1979. E, Natural channel downstream from I-80 crossing, in 1979. F, Natural channel upstream from relocation, in 1979.

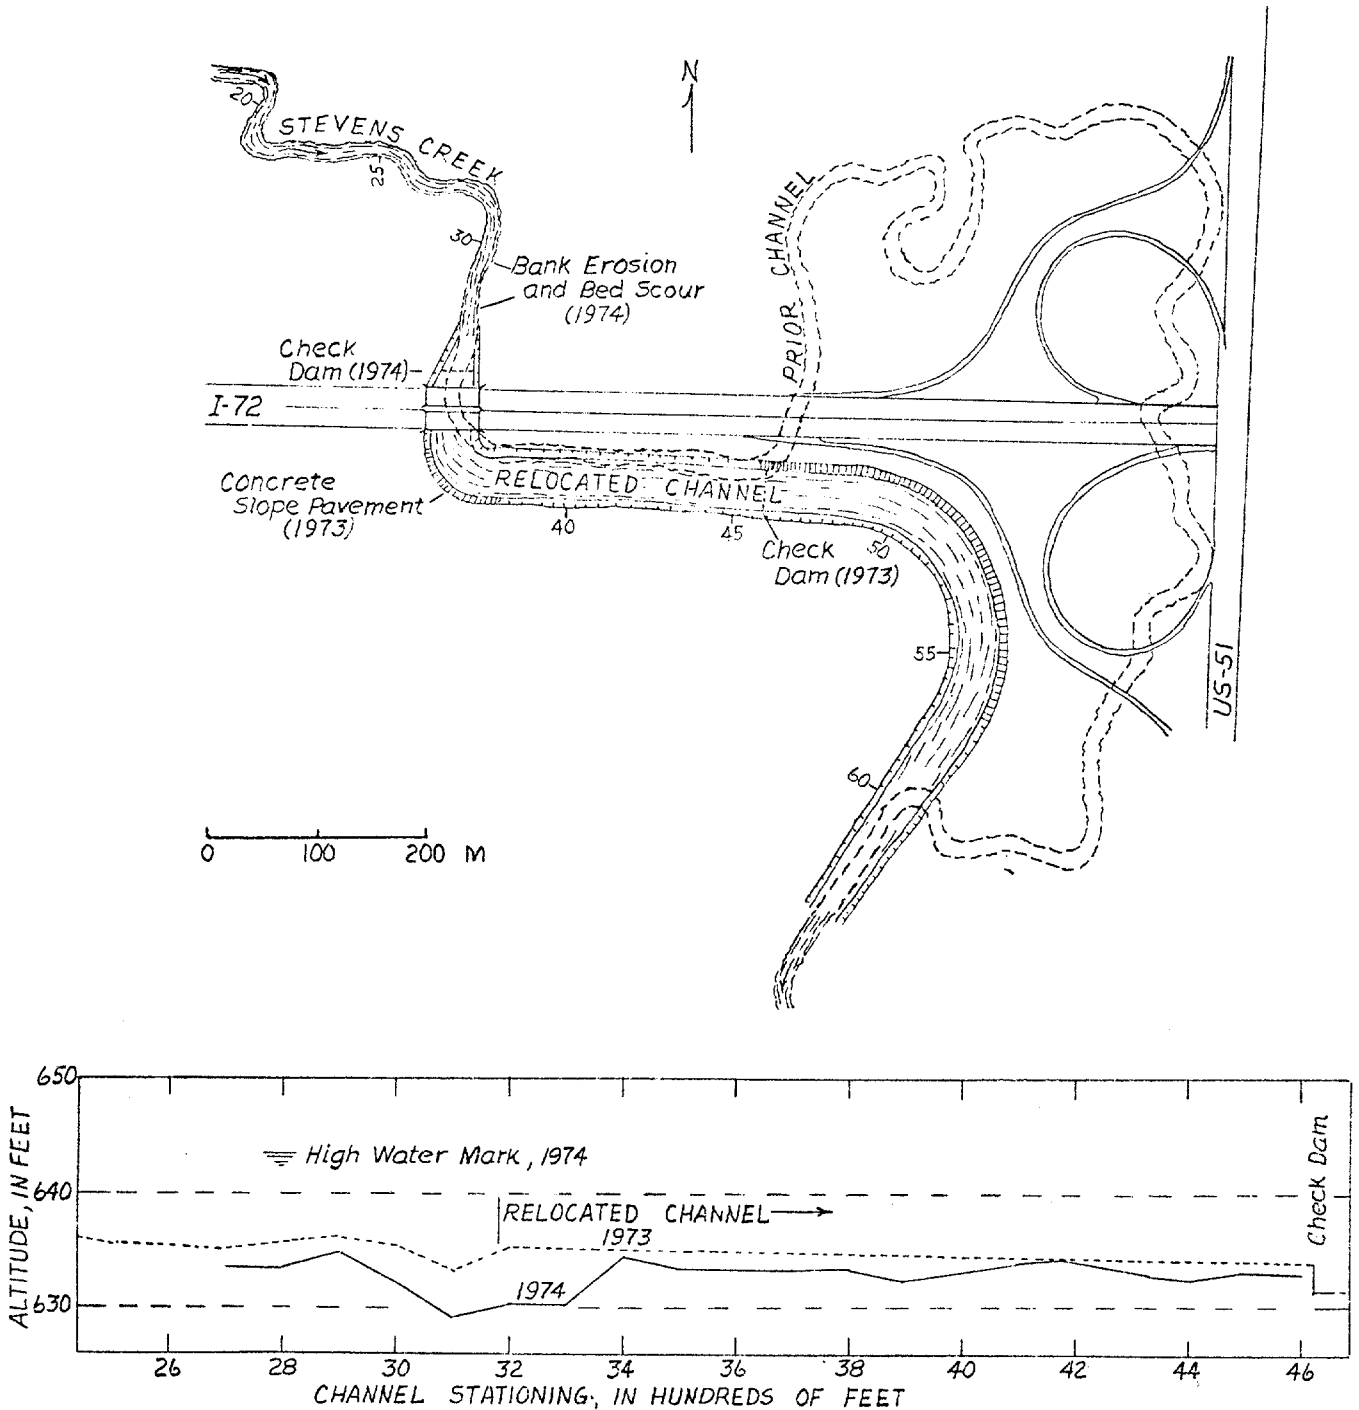
Figure 70. Top, plan sketch of Stevens Creek channel relocation. Bottom, longitudinal profiles of channel bottom before and after 1974 flood.

tion, amounting to about 0.6 m, extended upstream along the natural channel and downstream along the relocated channel as far as a concrete check dam. Lateral erosion also occurred at the toe of the concrete slope pavement just downstream from the bridge. Downstream from the relocation, the natural channel was apparently not much affected, as the extent of cut banks as observed in 1978 (fig. 71A) is not significantly different from that shown on a 1965 airphoto.

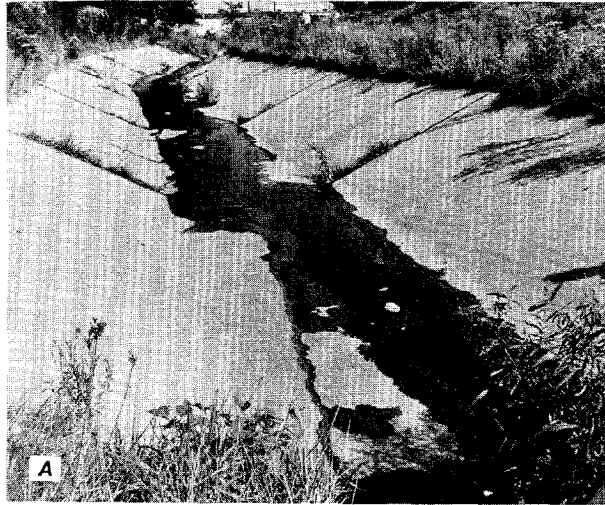
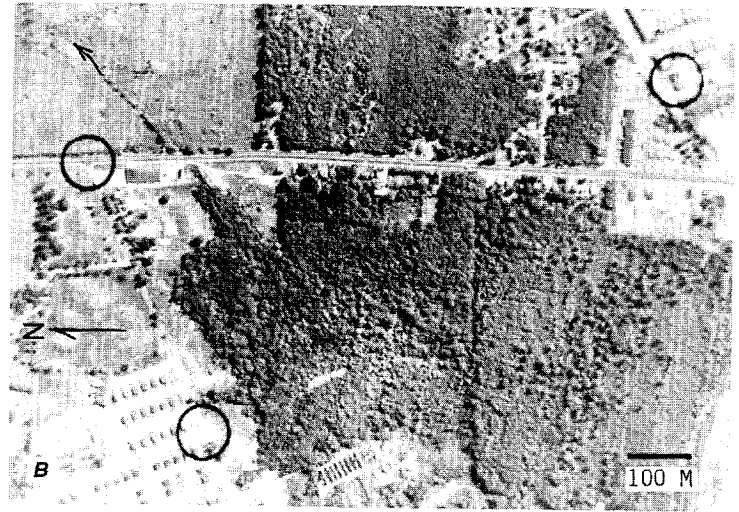
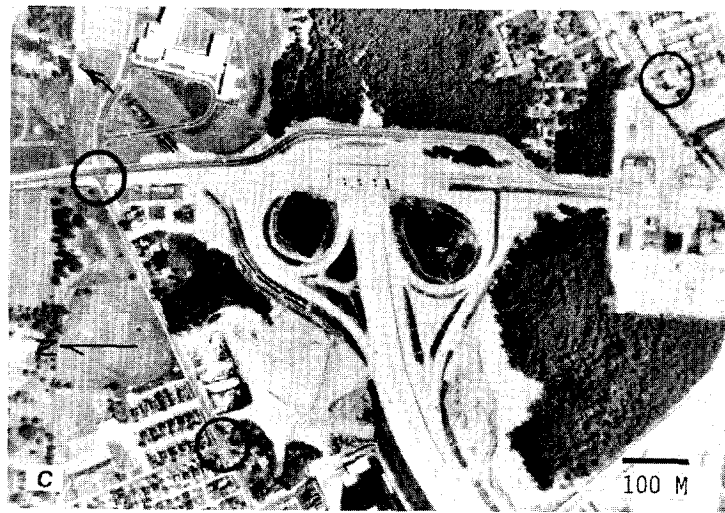
Figure 103. Tributary to Maiden Choice Branch at site 45. A, Original concrete lining of relocated channel, as photographed in 1978. Note bulging and cracking of bottom. B, Airphoto of relocation site in 1957. Reference points are circled for comparison with 1971 airphoto. (From U.S. Dept. of Agriculture). C, Airphoto of relocation site in 1971. Note bare side slope above bottom circled reference point.

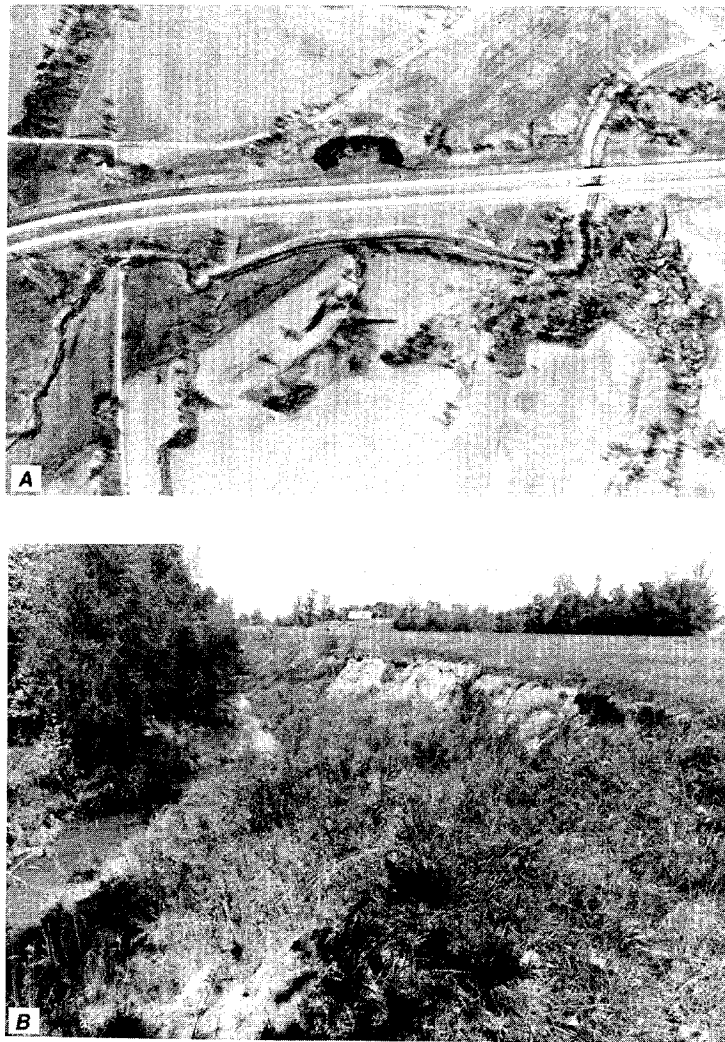
Figure 123. Ramsey Creek at site 56. A, Airphoto of channel relocation in 1965. B, Slumping of left bank, foreground, about midway along relocated channel, in 1978.

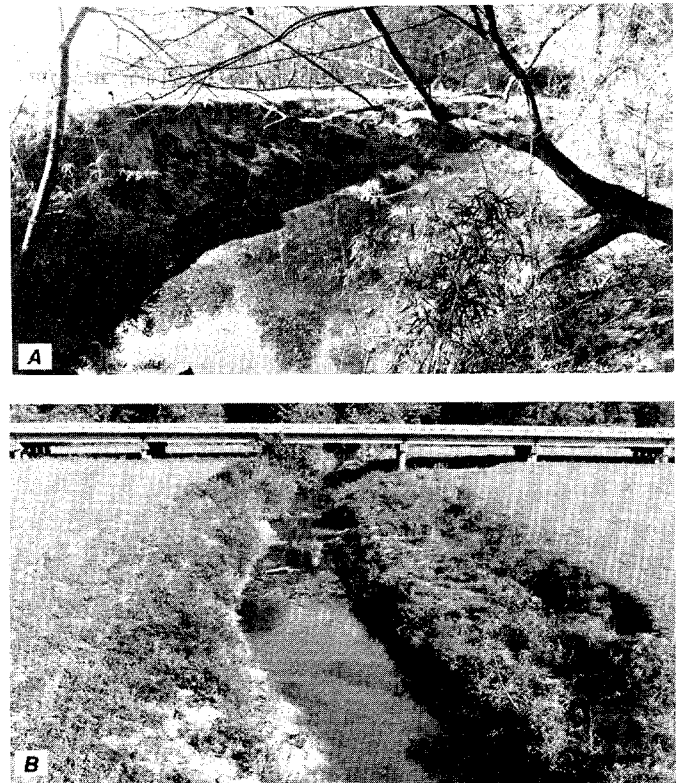
Figure 131. Turkey Creek at site 60. A, Relocated channel between interstate bridges, in 1979. B, Bank erosion at bend downstream from relocation, in 1979.

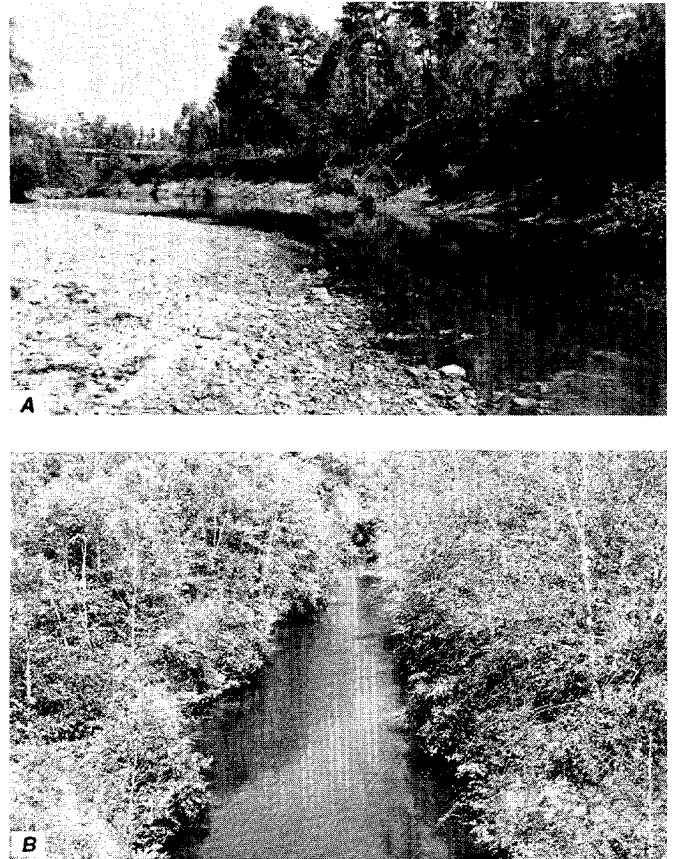
Figure 135. Tallahatta Creek at site 62. A, Relocated channel as viewed upstream from interstate bridge in 1979. B, Eroded left bank downstream from bridge, in 1979. Point bar is in foreground.

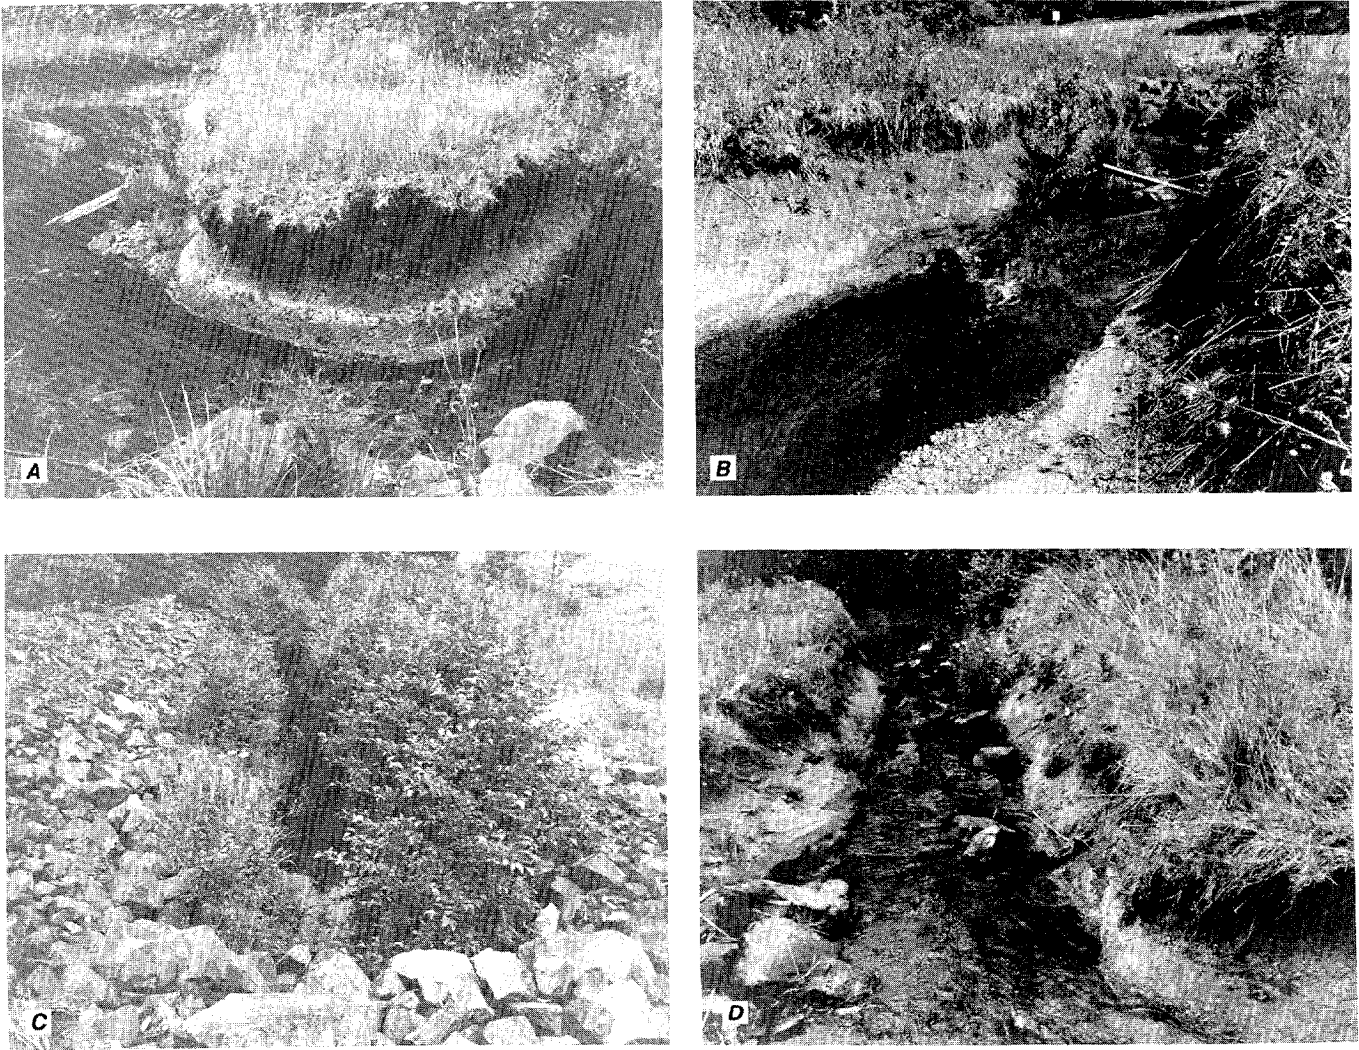
Figure 172. Gellatly Creek at site 85. A, Meander loop of relocated channel, in 1979. B, Reach downstream from apex of meander loop. Note small rapids, which may indicate degradation, and remains of introduced bed material. C, Straight reach of relocated channel. D, Downstream transport of large riprap, originally placed at apex of bend.

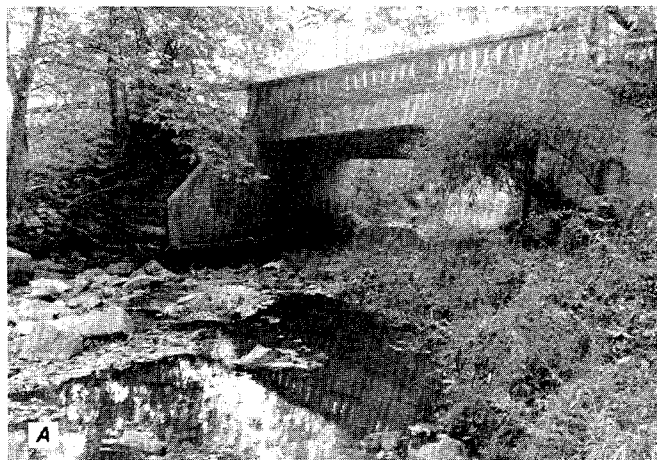
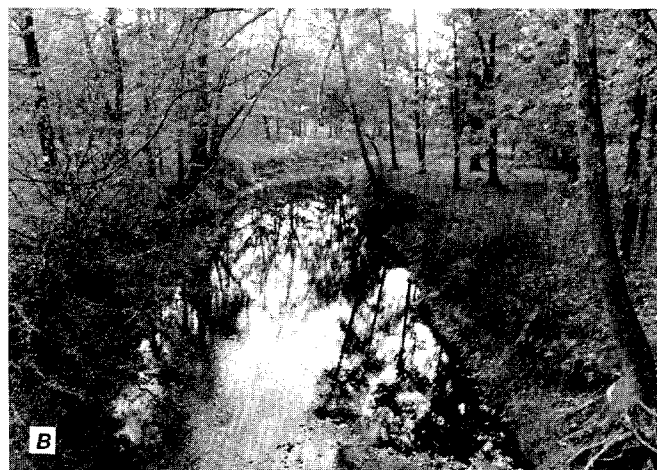
Figure 188. Black Creek at site 93. A, View downstream toward failed left bridge abutment in 1978. B, View from bridge, downstream along relocated channel, in 1978.
