Federal Highway Administration
Every Day Counts
Innovation Initiative

Safety Edge_{SM}
HMA Demonstration Project
Jasper County, Iowa

Field Report
June 6, 2011

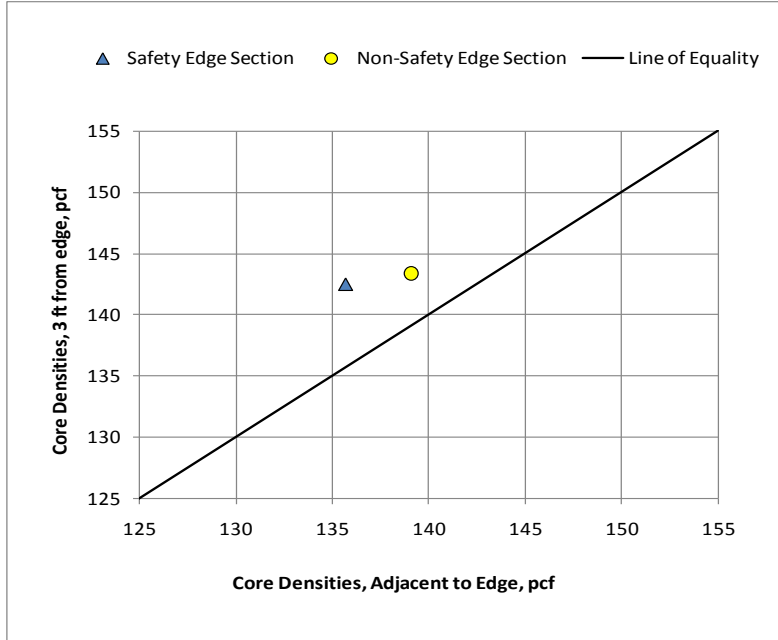
Figure 6. Comparison of core densities adjacent to the edge and 3 ft. from the edge.

Figure 6 shows the comparison of the core densities taken adjacent to the edge and at 3 ft. from the edge for the Safety Edge_{SM} and non-Safety Edge_{SM} sections. As expected the densities away from the edge where the mat received full coverage of the roller passes are significantly higher than near the edge of the pavement. This result reflects the relatively low degree of compactive effort applied to the Safety Edge_{SM} in comparison to standard compaction given to the non-Safety Edge_{SM} section.

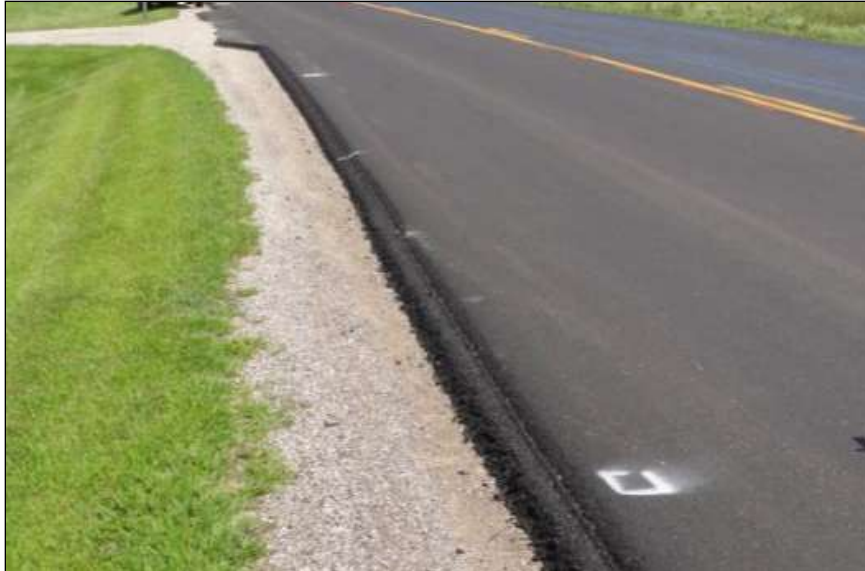
Nearly all of the existing granular shoulder material was free of vegetation or any debris that might interfere with paving operations. At this point in construction before the surface course was paved, new granular shoulder material had not been placed in some areas exposing the Safety Edge_{SM} from the base course upward. The contractor was allowed an extended time frame to pull up the shoulder material because of the use of the Safety Edge_{SM}. Normally the shoulder material would need to be placed in conjunction with each day's mainline paving. Figure 15 is a typical view of the project east of Sully showing the shoulder and the exposed Safety Edge_{SM} of the base and intermediate courses.

Figure 15. Typical view showing the base and intermediate course with Safety Edge_{SM} and granular shoulder material. Image taken east of Sully.
