Federal Highway Administration  
**Every Day Counts**  
Innovation Initiative

**Safety Edge<sub>SM</sub>**  
**Demonstration Project**  
**Kearney, Nebraska**

**Field Report**  
**May 24, 2011**

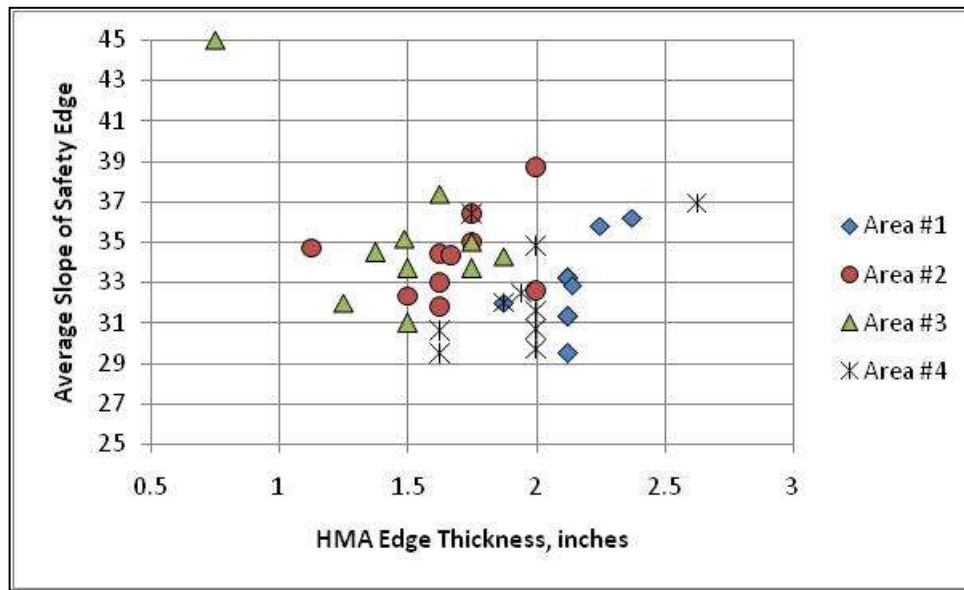
Figure 8. Comparison of the Safety Edge<sub>SM</sub> slope and thickness of the HMA adjacent to edge of the HMA overlay.

Figure 8 included a comparison between the HMA thickness (near the Safety Edge<sub>SM</sub>) and slope of the Safety Edge<sub>SM</sub>. The thickness of the HMA appears to have no effect or impact on the slope of the Safety Edge<sub>SM</sub>. Figure 13 shows a comparison of the density and HMA overlay thickness. As shown, there is also little correspondence between the overlay thickness and air voids or densities.

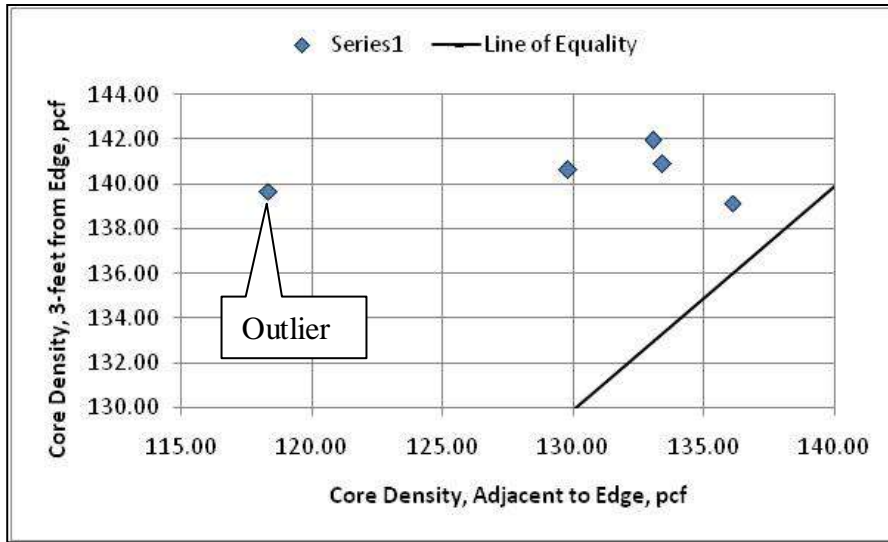
Figure 10 includes a comparison of the core densities taken along the edge and near the center of the steel drum roller for the Safety Edge<sub>SM</sub> and non-Safety Edge<sub>SM</sub> sections. As expected, densities near the center of roller are higher than along the edge of the mat (unconfined edge). As shown, one of the densities of the cores taken along the edge is extremely low and considered an outlier. The core densities taken along the pavement's edge are approximately equal for the Safety Edge<sub>SM</sub> and non-Safety Edge<sub>SM</sub> sections.

Figure 10. Comparison of core densities adjacent to the edge of pavement and near center of the steel drum rollers.

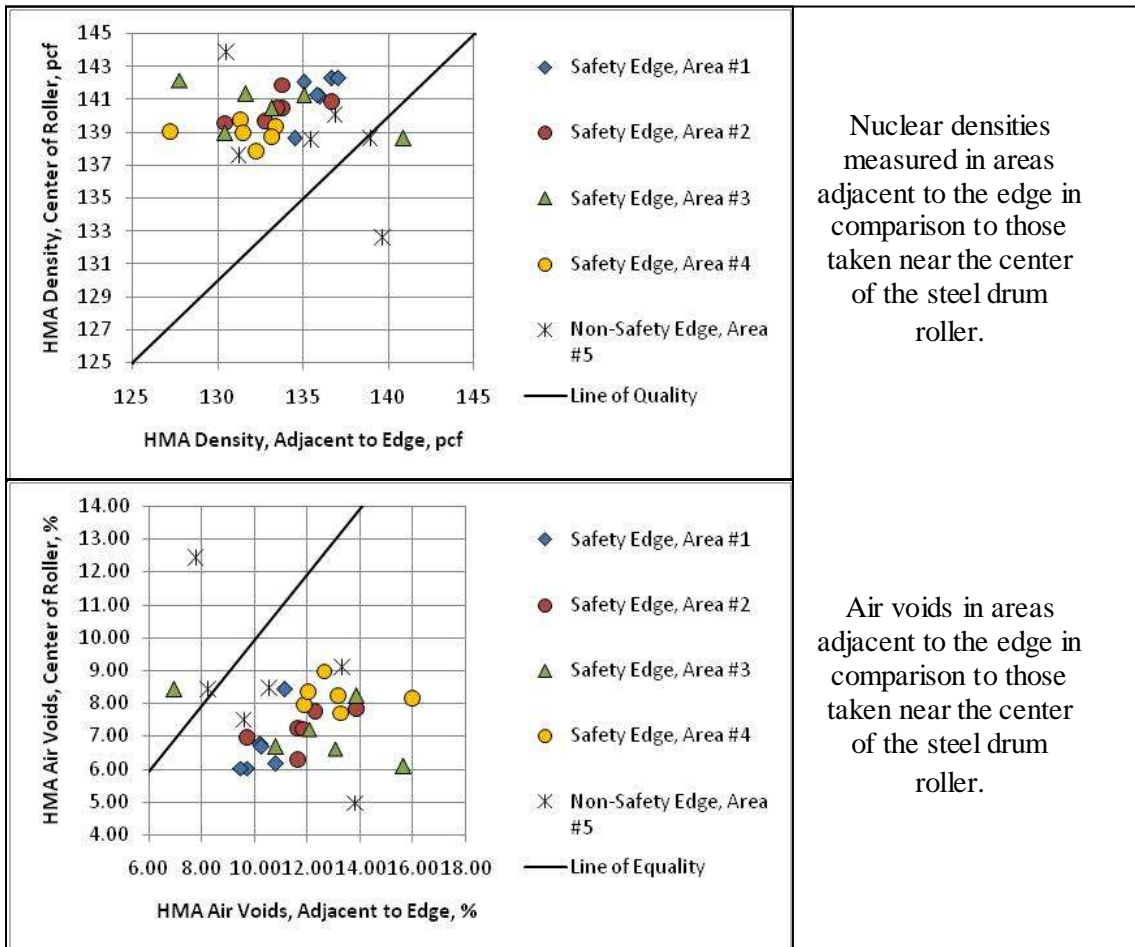
Figure 12 shows a comparison of the adjusted nuclear density gauge readings taken adjacent to the Safety Edge<sub>SM</sub> and in the center of the vibratory steel wheel roller. Figure 12 also includes a comparison of the HMA air voids between both of these areas. As expected, the air voids are higher adjacent to the Safety Edge<sub>SM</sub> in comparison to 3-feet from the Safety Edge<sub>SM</sub>. The other observation from this data and comparison is that the densities and air voids are similar between the Safety Edge<sub>SM</sub> and non-Safety Edge<sub>SM</sub> measurements adjacent to the edge of the HMA mat.

Figure 12. Comparison of the adjusted nuclear density readings and air voids between the areas adjacent to the edge and center of the steel drum roller.

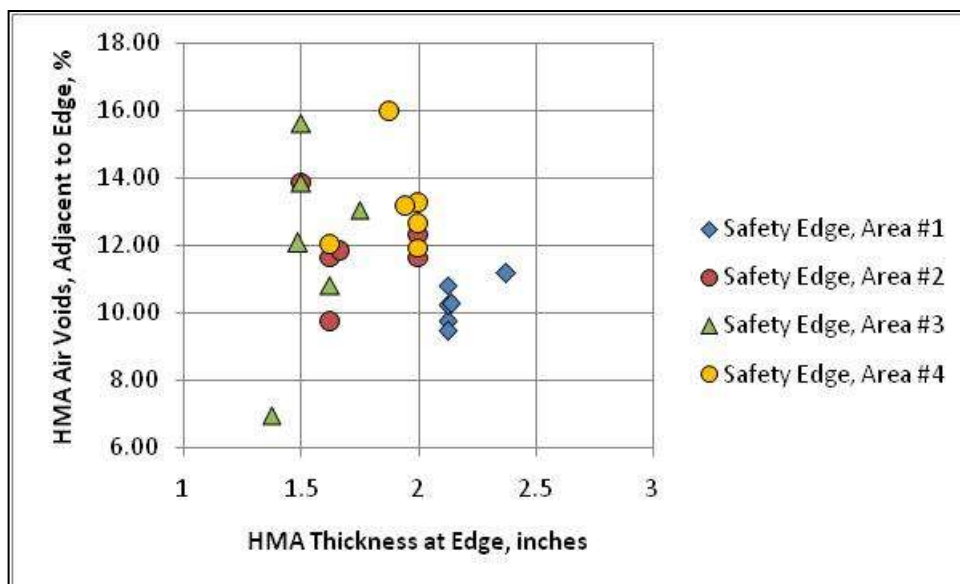
Figure 13. Comparison of HMA thickness at the edge of the mat and HMA air voids.

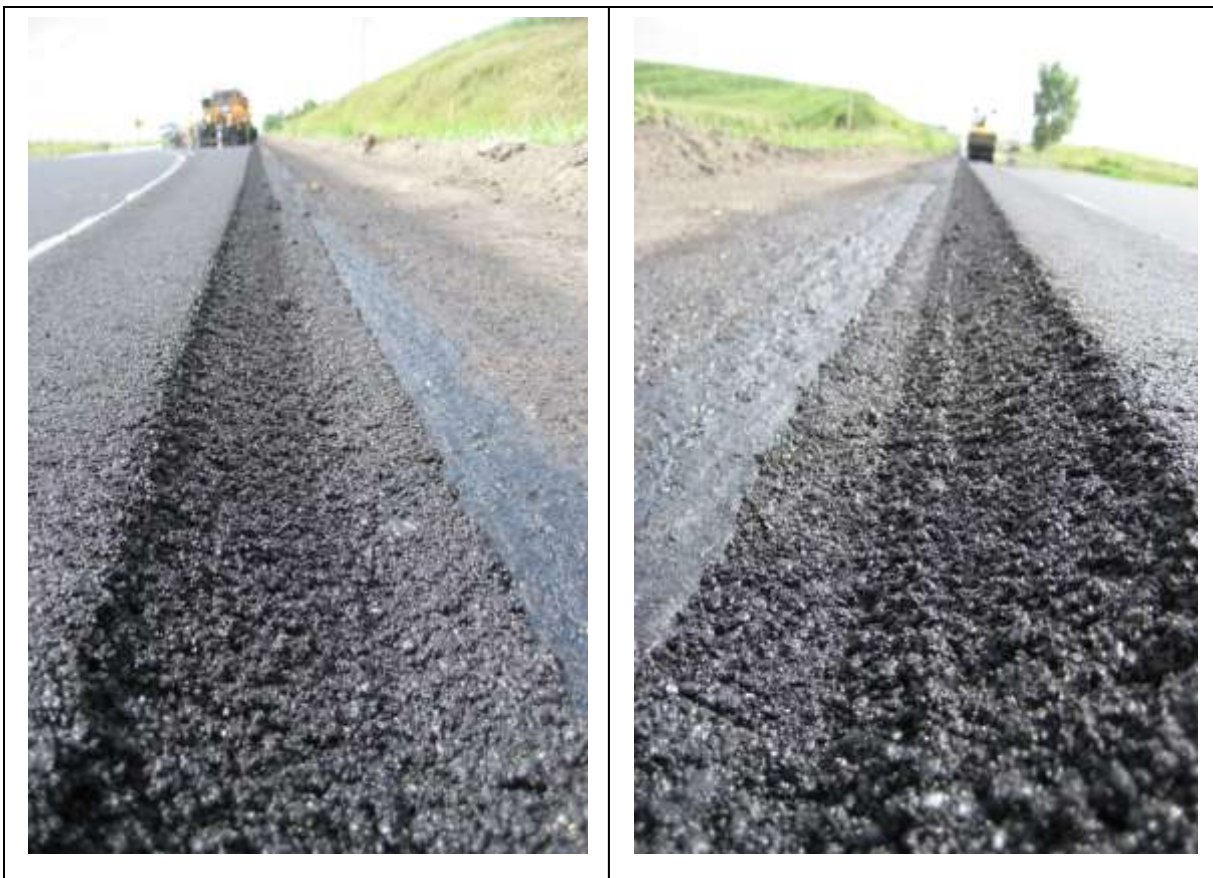
Figure 16 shows the slope and surface texture of the Safety Edge<sub>SM</sub>. The contractor superintendent/owner recommended that the Safety Edge<sub>SM</sub> device be an automated system rather than manually turning the screw to raise and lower the Safety Edge<sub>SM</sub> device.

Figure 16. Typical surface texture and slope of the Safety Edge<sub>SM</sub> sections.

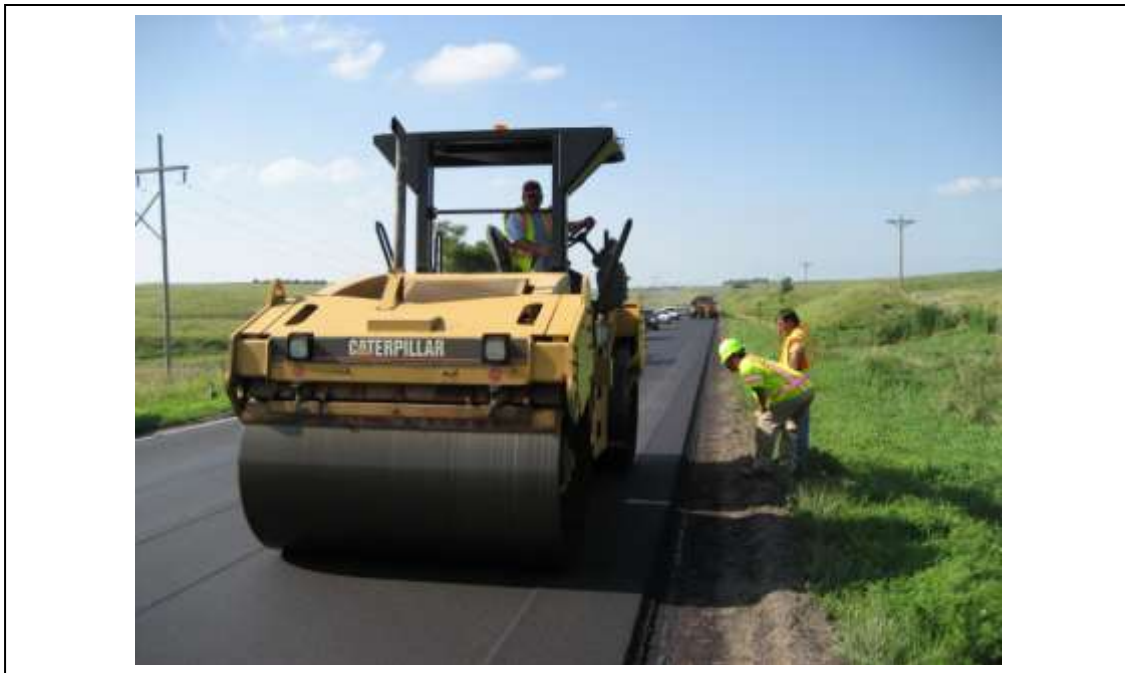
Pass #3 of Caterpillar roller is 6 to 12 inches from the edge of the mat.

Note the location of the roller's edge for the third pass. This may result in a longitudinal crack with time where the passes were along the same line and the rolling of the edge is delayed.

Figure 20. Rolling the unconfined edge with the vibratory steel wheel roller.

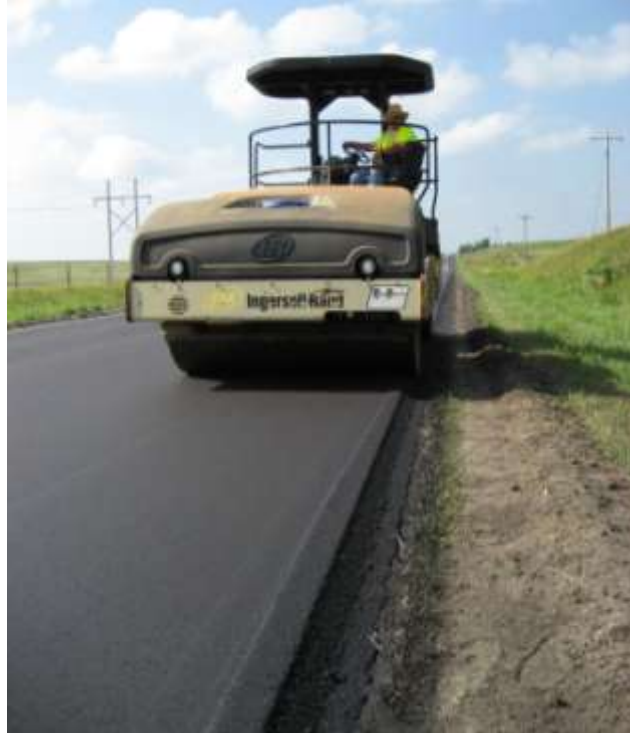
The delay in rolling the Safety Edge<sub>SM</sub> caused the roller operator to increase the speed of the breakdown roller to keep up with the paver. The increase in speed resulted in chatter in localized areas of the mat surface (roller being operated too fast for the frequency selected). The other important point is that the outer edge of the mat (6 to 12 inches from the Safety Edge<sub>SM</sub>) only received one pass of the breakdown roller in some areas prior to the first pass of the Ingersoll-Rand roller (refer to Figure 21).

Figure 21. First pass of the Ingersoll-Rand finish roller along the Safety Edge<sub>SM</sub>.

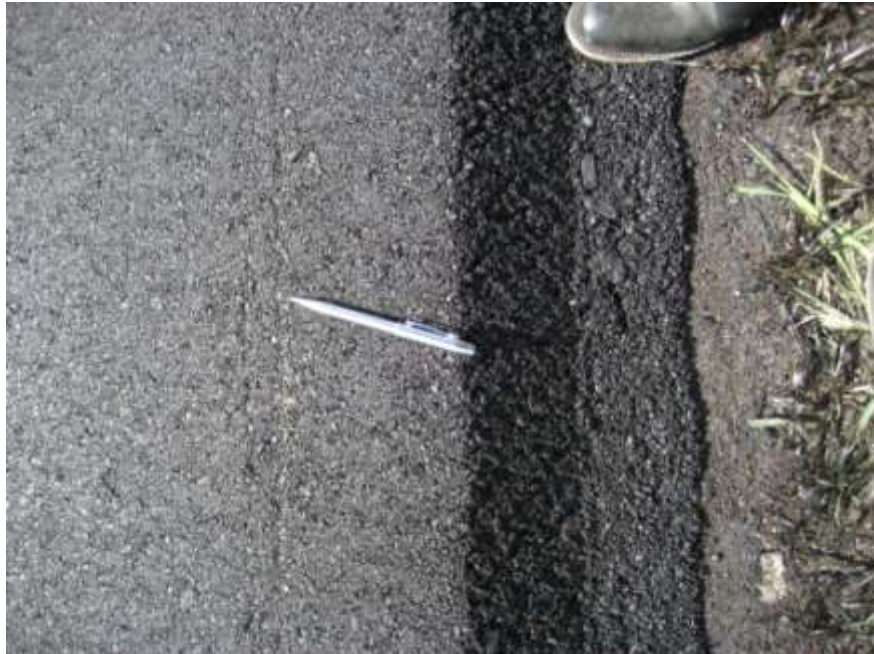
The finish roller appeared to remove most of the chatter caused by the breakdown roller. The finish roller did not eliminate the longitudinal roller mark left by delaying the breakdown roller along the outside edge of the mat (refer to Figure 22). It is expected that this mark will eventually result in a longitudinal crack along the edge of the mat.

Figure 22. Longitudinal mark left by delaying the breakdown rolling of the Safety Edge<sub>SM</sub>; image taken after finish rolling.

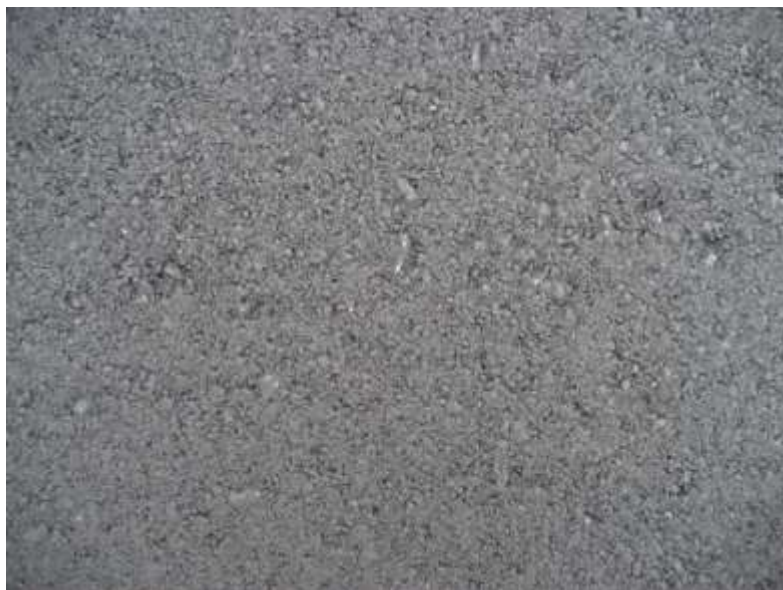
Figure 24. Surface texture of the 12.5 mm HMA overlay after final rolling.

- The 12.5 mm HMA mixture is considered a relatively fine aggregate mixture, and the surface texture was dense. Water beads were observed on the surface after rains that occurred just prior to the demonstration project. This observation indicates that permeability of the HMA overlay is low.
