Safety Edge_{SM}
Demonstration Project
Elizabethtown,
Pennsylvania

Field Report
May 24, 2011

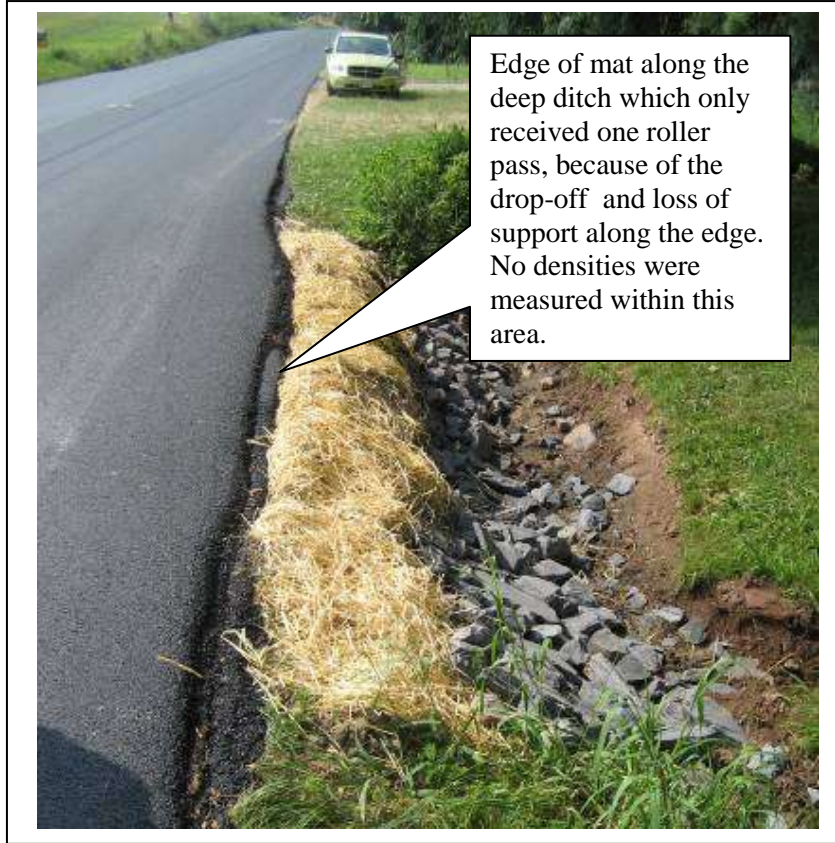
The ditches along the edge of the pavement were generally shallow or almost level with the existing pavement (refer to Figure 2), with the exception of a few areas (refer to Figure 3). An HMA base mix had already been placed on both sides of the road to widen the roadway. Some areas had narrow ditches that were approximately one to two feet in depth, but were covered or hidden in grass.

Figure 3. Localized area with deep ditches adjacent to the pavement.

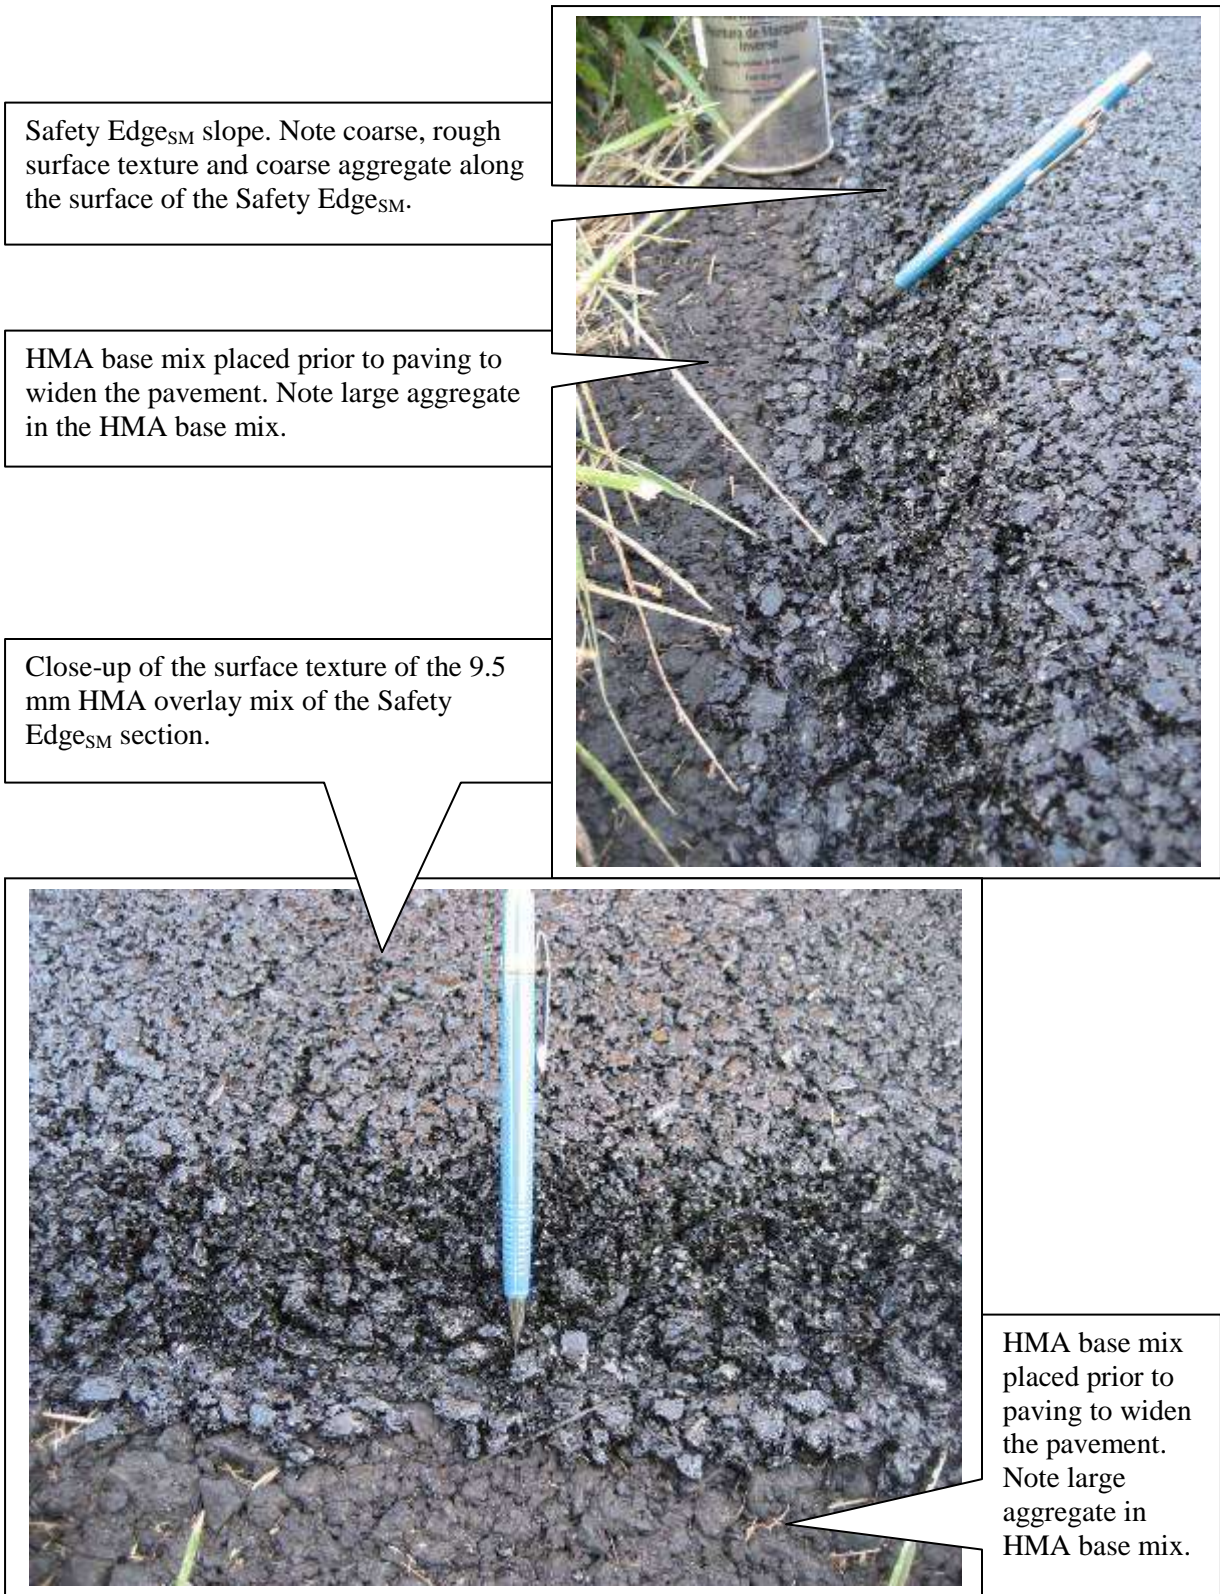
Figure 5. Surface of the HMA base that had been previously placed to widen the roadway.

The slope measurements were found to be variable, because it was difficult to locate the toe of the slope of the Safety Edges_{SM} in areas where some of the 9.5 mm mixture was under the screed end plate (refer to Figure 5). The screed operator did try to lower the screed end plate, but the end plate pulled dirt and weeds into the mix within the screed extension in some areas.

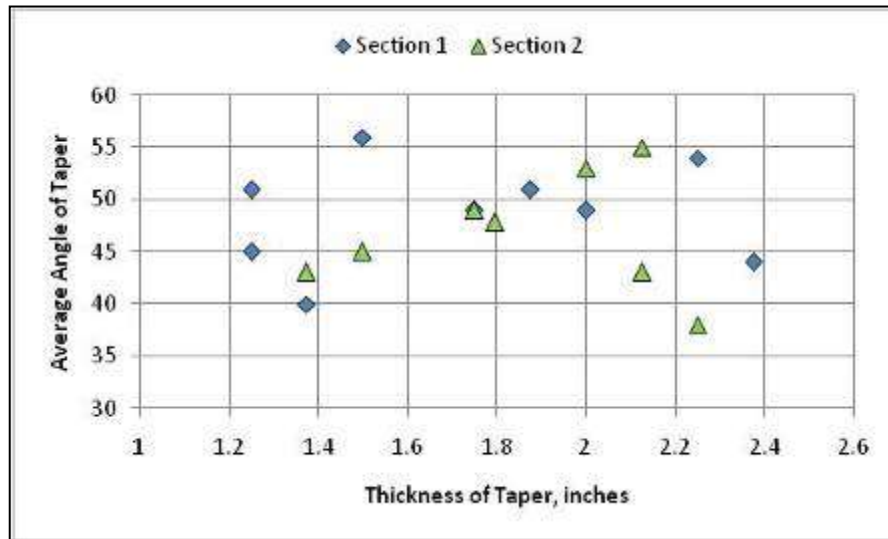
Figure 9. Comparison of the Safety Edges_{SM} slope and mat thickness adjacent to the edge.

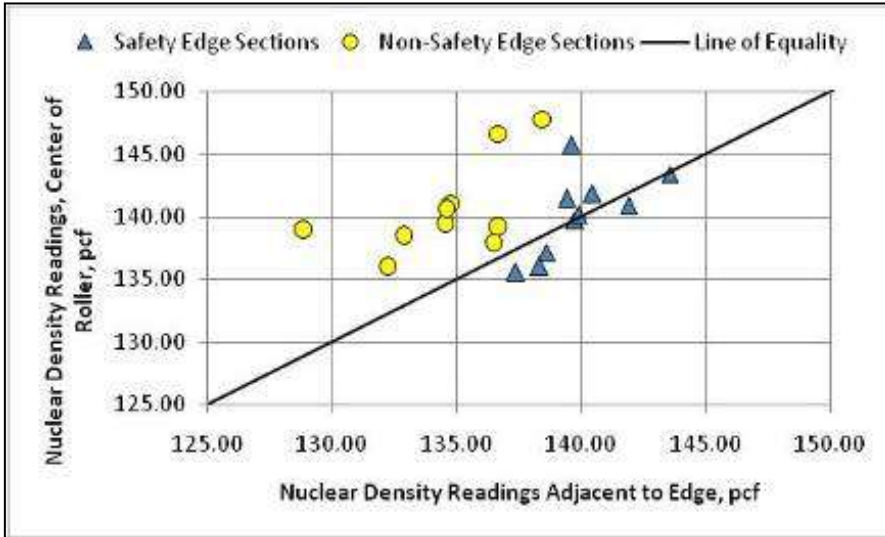
Figure 13 shows a comparison of the adjusted nuclear density gauge readings taken adjacent to the Safety Edge_{SM} and in the center of the vibratory steel wheel roller. Figure 13 also includes a comparison of the HMA air voids between both areas. As shown, the air voids are much higher adjacent to the Safety Edge_{SM}, but are higher than desirable for both areas. The other important observation from this data is that the density is higher and the air voids are consistently lower for the Safety Edge_{SM} sections, in comparison to the non-Safety Edge_{SM} section.

Figure 13. Comparison of the adjusted nuclear density readings and air voids between the areas adjacent to the edge and center of the steel drum roller.

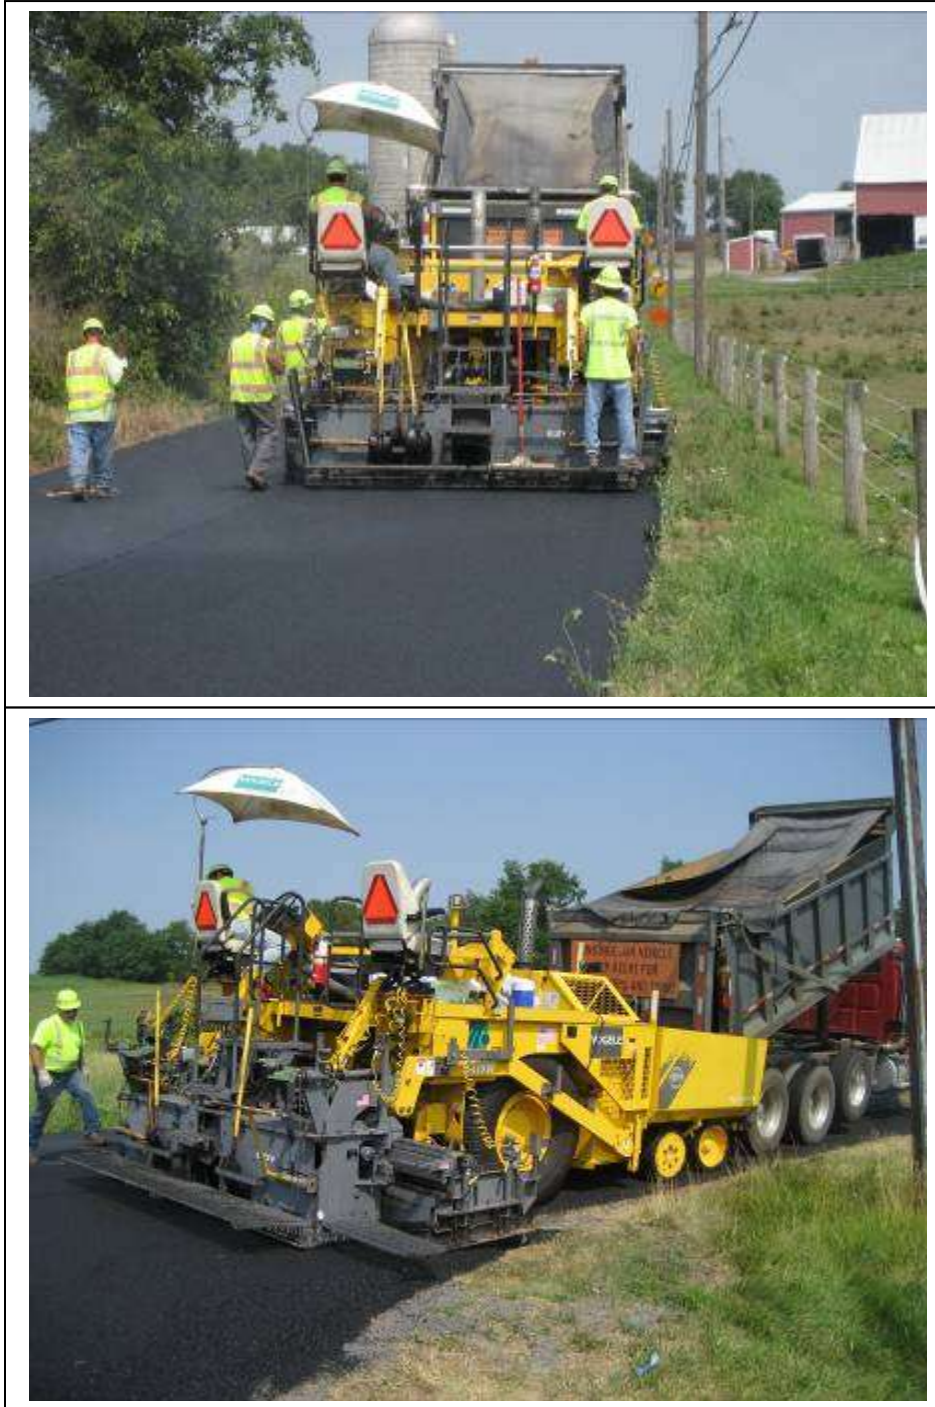
Figure 16. Photo illustrating the edge condition of the pavement.

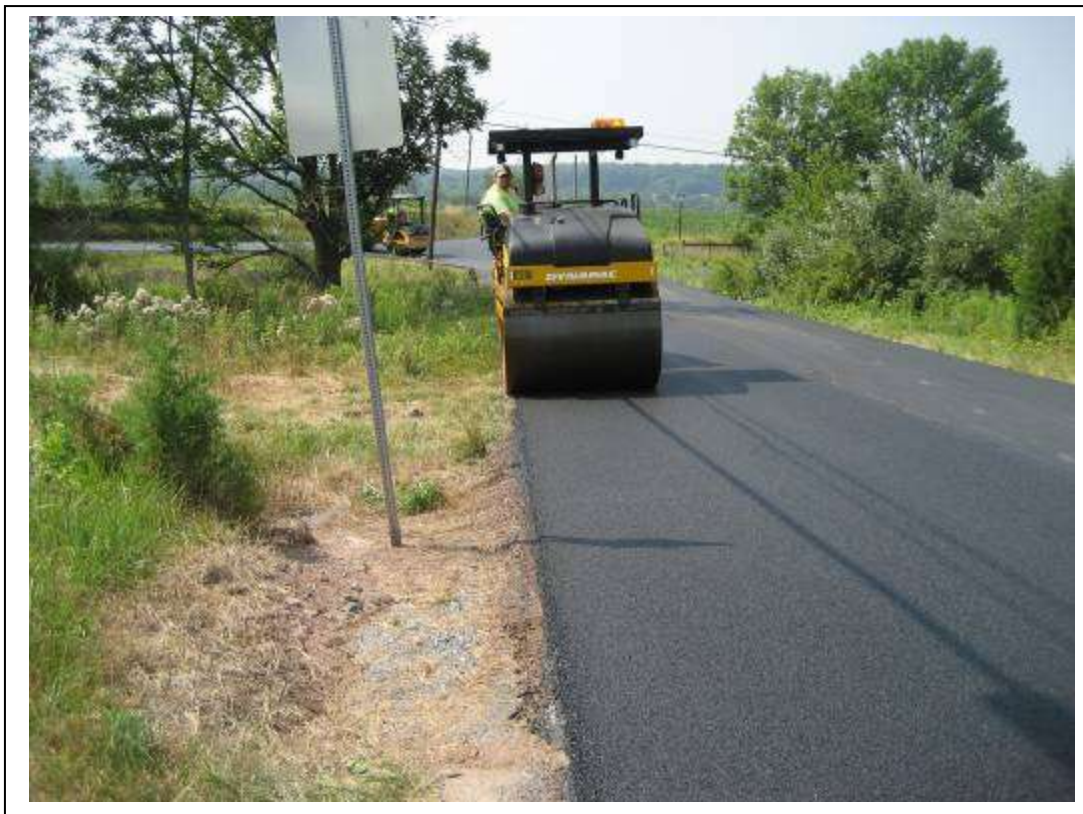
The Safety Edge_{SM} was rolled inconsistently during the project. The majority of the rolling pattern, however, was that the first pass of the breakdown roller was along the Safety Edge_{SM} with the roller extended over the edge of the pavement by about 4 to 6 inches (refer to Figure 22).

Figure 22. Vibratory steel wheel roller used in the breakdown position shown compacting the Safety Edge_{SM} – first pass overhung the edge about 4 inches.
