Federal Highway Administration
Every Day Counts
Innovation Initiative

Safety Edge_{SM}
Demonstration Project
Seaford, Delaware

Field Report
January 30, 2011

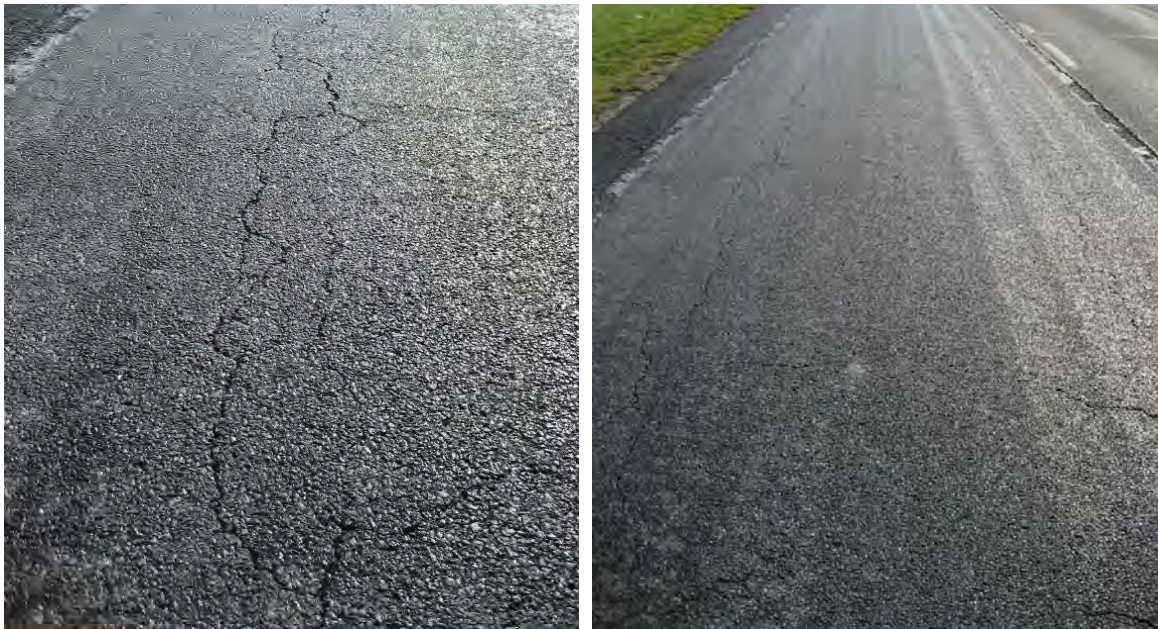
The project consisted of repairing some localized areas with extensive cracking and distortions, widening the roadway by 2 ft, and placing a 2-inch lift of a 9.5-mm WMA mix over the existing HMA pavement. Figure 2 shows the typical cracking and surface condition of the existing pavement along this project. Figure 3 provides a general view of the Figure 2 in WMA overlay and typical cross section of the pavement. In preparation for the WMA overlay, the following activities and repairs were made.

Figure 2. Typical condition of the existing surface (with tack coat applied).

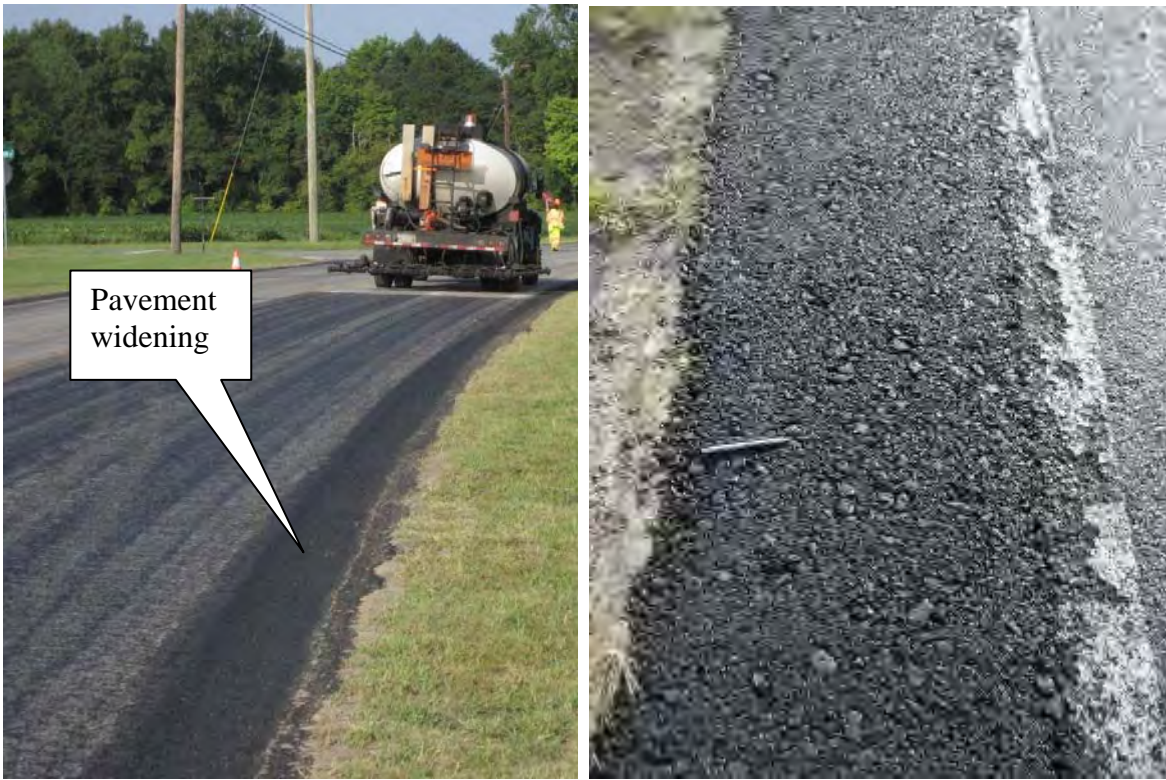
Figure 5. 1.0-ft widening strip placed on both sides of the roadway.

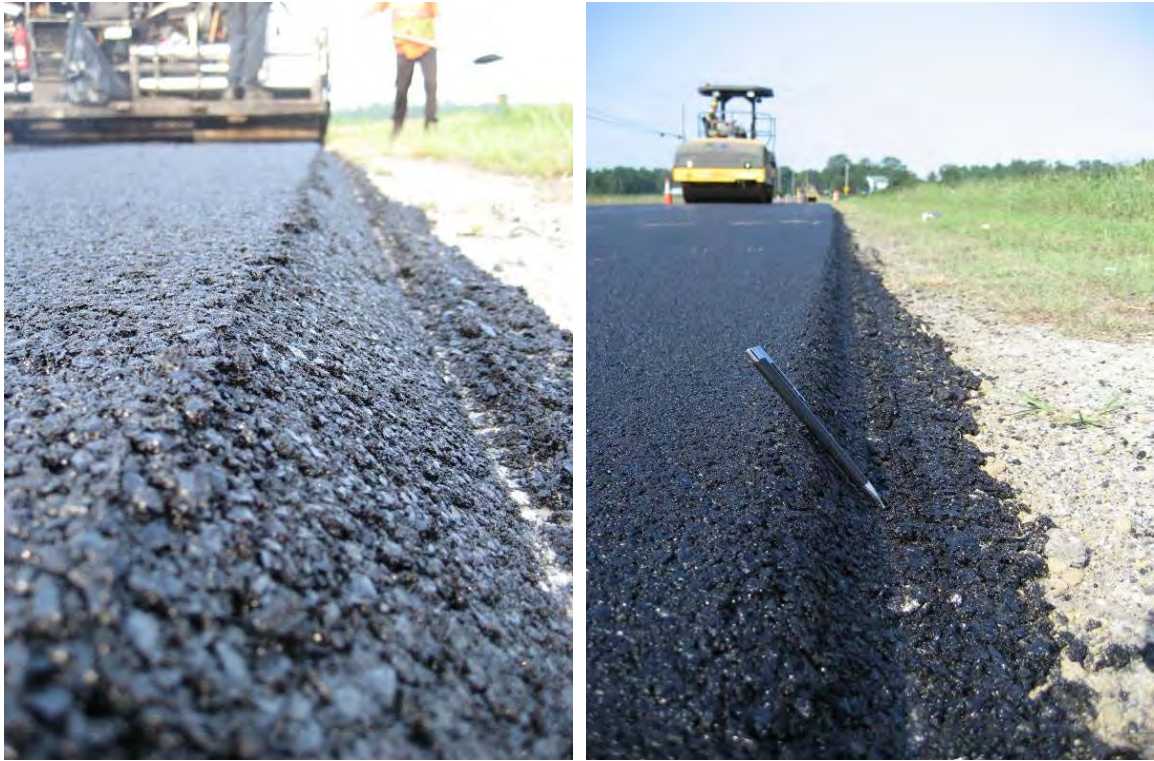
Figure 17. Typical surface texture and slope of the Safety Edge_{SM} sections.

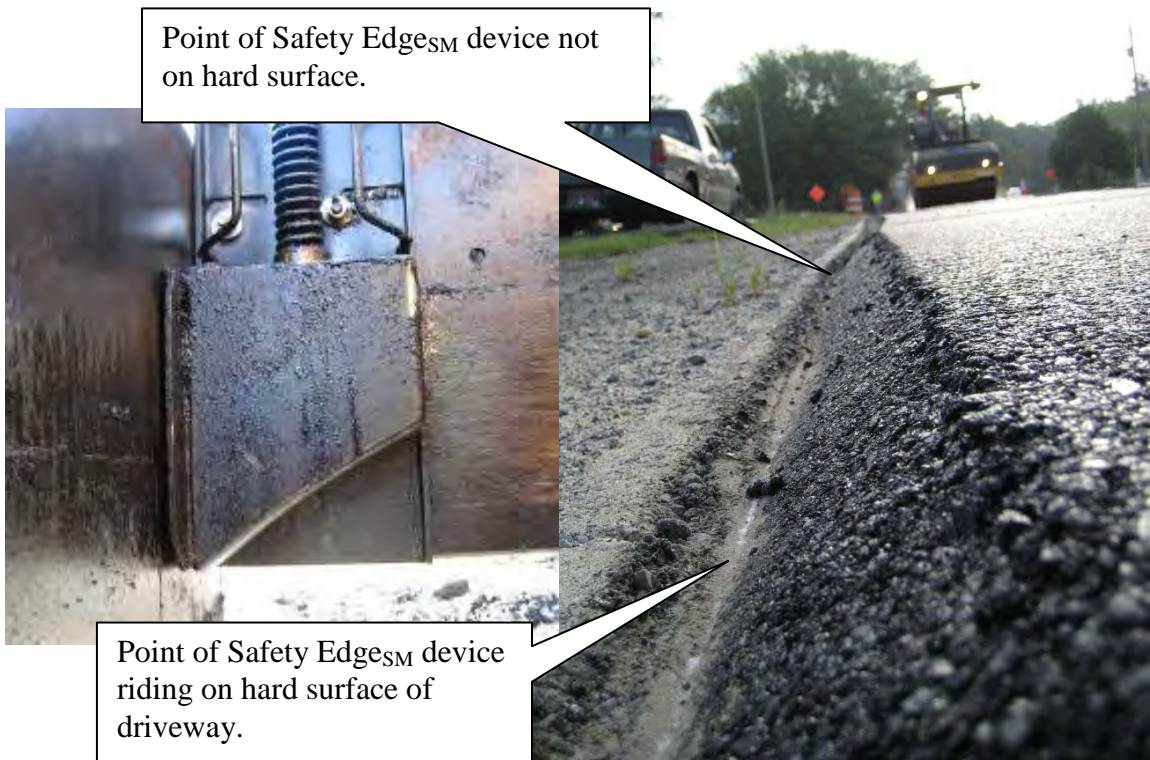
Both contractor and agency personnel stated the Safety Edge_{SM} device would raise the screed relative to the profile set by the longitudinal ski when paving across intersections or in areas with higher longitudinal profile with hard surfaces. In addition, both commented that it was difficult to get a good tie-in to existing driveways and other hard surfaces. Figure 18 shows the line caused by the tip of the Safety Edge_{SM} device along the edge of pavement over an intersection driveway.

Figure 18. Point of Safety Edge_{SM} scratching the surface of an intersecting driveway.

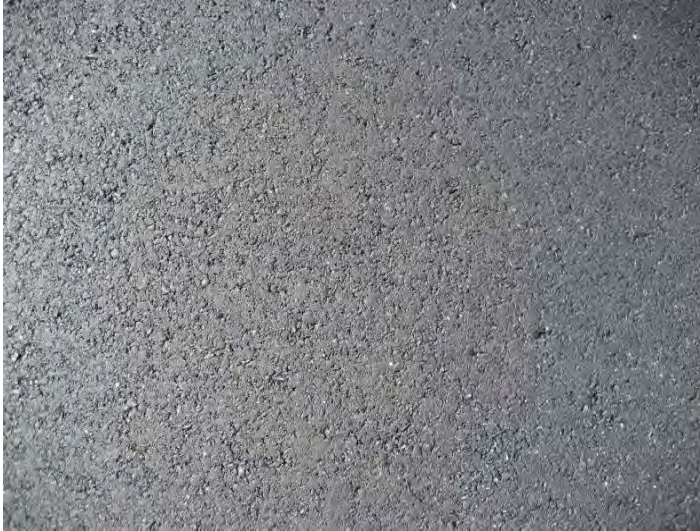
Example showing an area with a tight surface, fine texture of the mat; small surface voids.

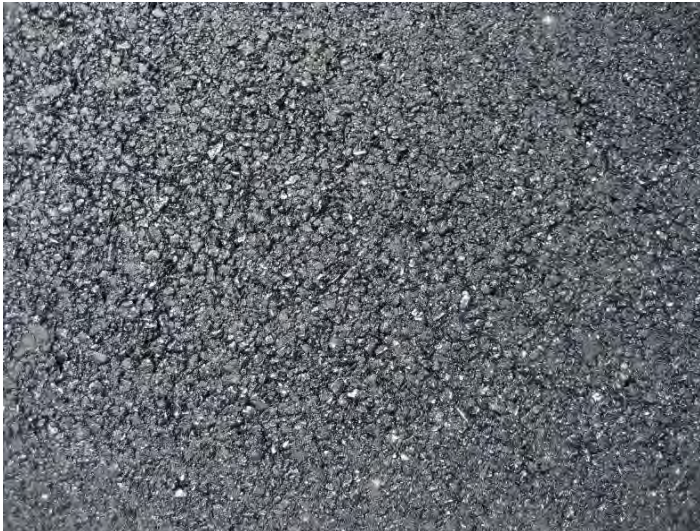
Example showing an area with a coarse surface texture of the mat; large surface voids.

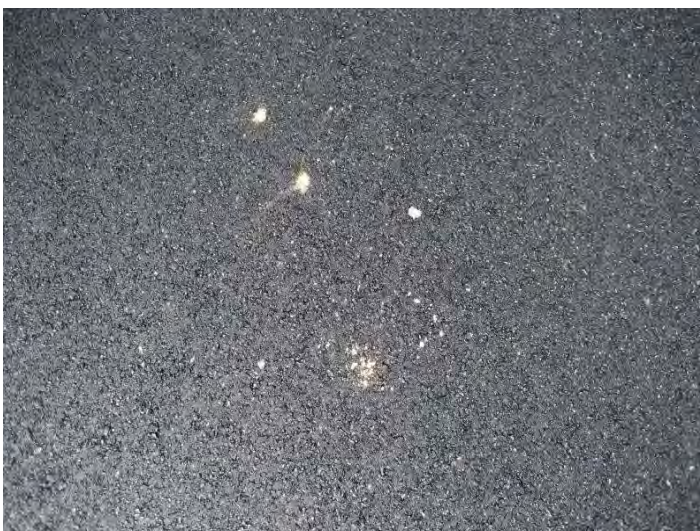
Example showing an area with localized crushed aggregate at the surface of the mat.

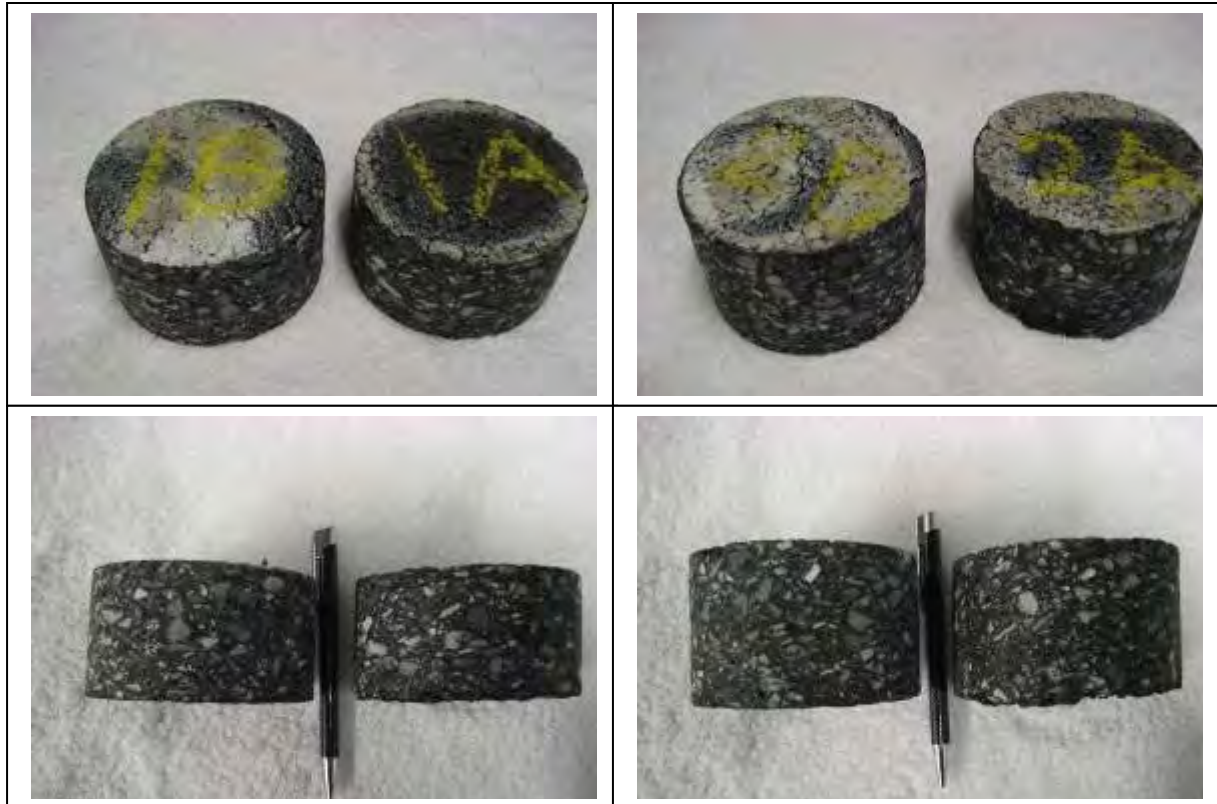
Cores 1B (3 ft from edge)
and 1A (adjacent to edge)

Cores 2B (3 ft from edge)
and 2A (adjacent to edge)
