FULL-SCALE UNINSTRUMENTED TEST OF BRICK MAILBOX STRUCTURES

Southwest Research Project No. 06-1917-205
Federal Highway Administration Order Number 06-00-113(88)

Frank D. Masch, Ph.D., P.E.

June 1988

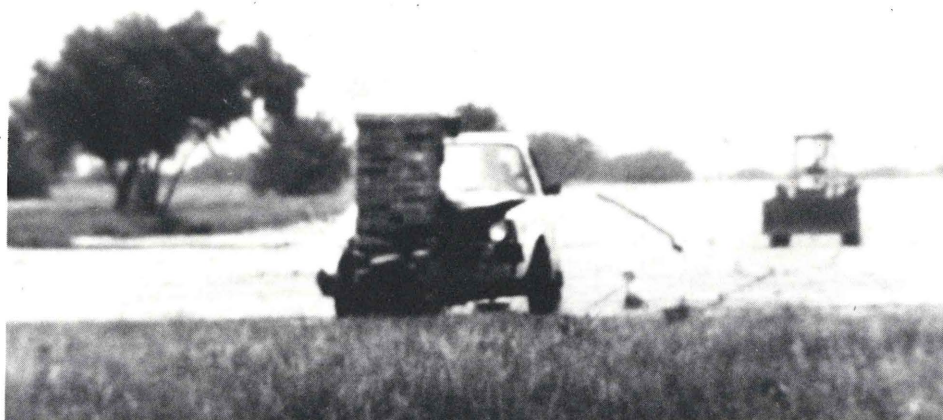
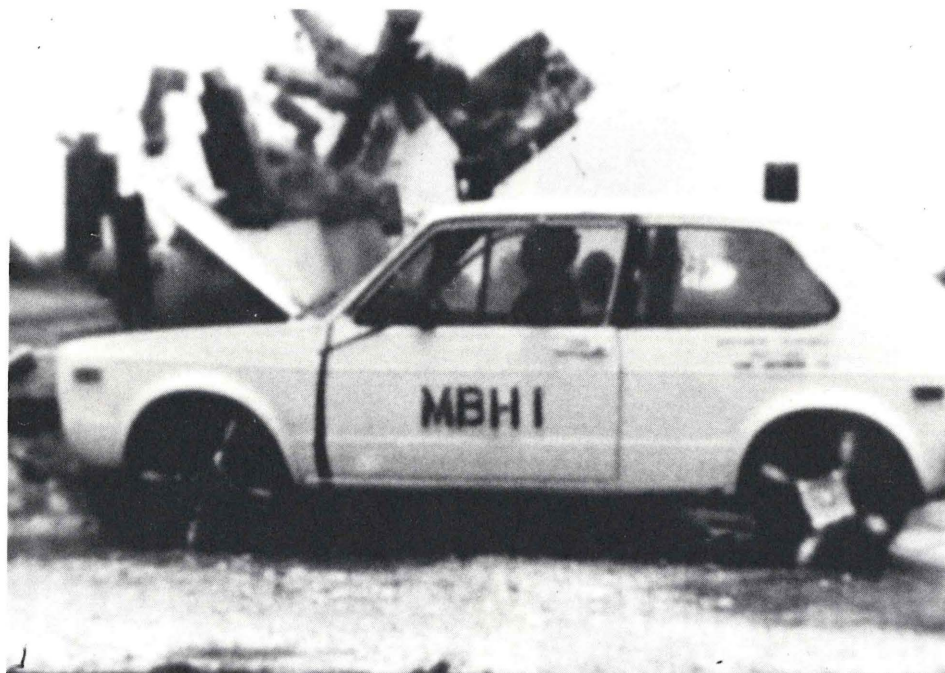
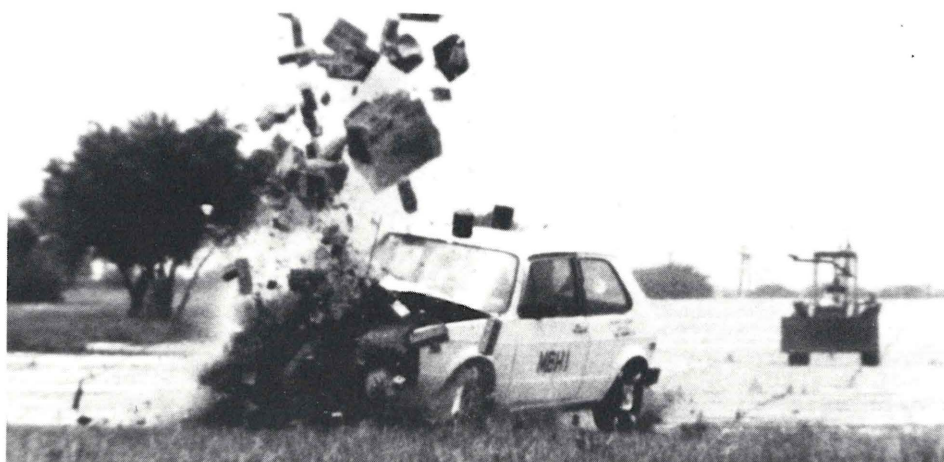
Figure 3. Mailbox Stand and Vehicle Impact Test MBH-1

PERFORMANCE: Impact conditions were 50.0 mph, with the vehicle offset to the right 19.5 inches from the centerline of the vehicle to the centerline of the stand. On impact, the vehicle shattered the brick mailbox stand, Figure 3. The vehicle continued through the stand, made a right hand spin and came to rest. The rear axial of the vehicle traveled 57 feet past the impact point before coming to rest. Figure 4 contains photographs of the mailbox stand and vehicle damage. Speed measurements were obtained from a motion analyzer, after impact. The measured speeds being 45.7 and 35.5 mph after traveling 4 and 8 feet respectively.

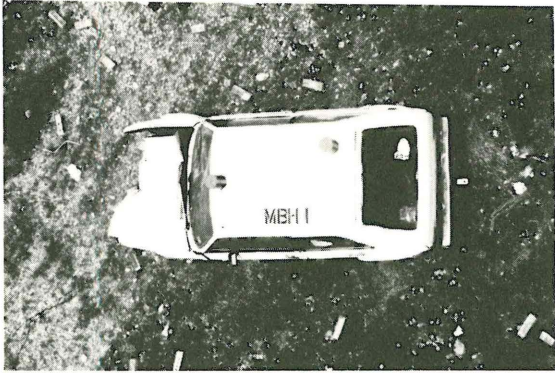
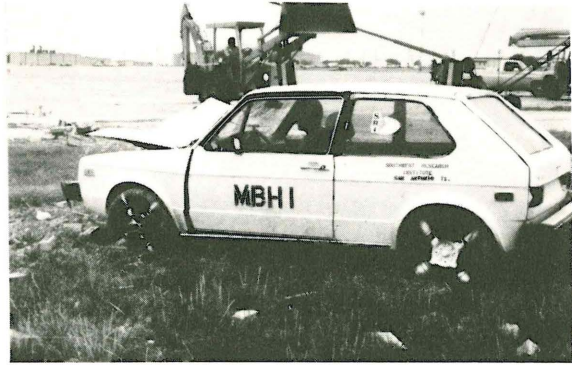
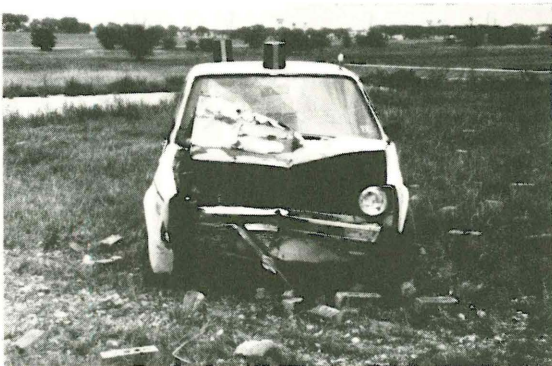
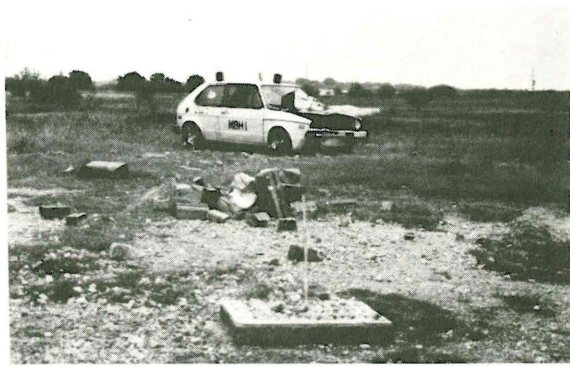
Figure 4. Mailbox Stand and Vehicle Damage
Test MBH-1

BARRIER DAMAGE: The mailbox stand was completely shattered, with only the mailbox base remaining after the test.

VEHICLE DAMAGE: The right headlight and grille were knocked out. The right side of the bumper was pushed back, deforming the right front fender, and buckling and crushing the hood. The left front fender was buckled at the door. The vehicle was not considered to be in operable condition after the test.

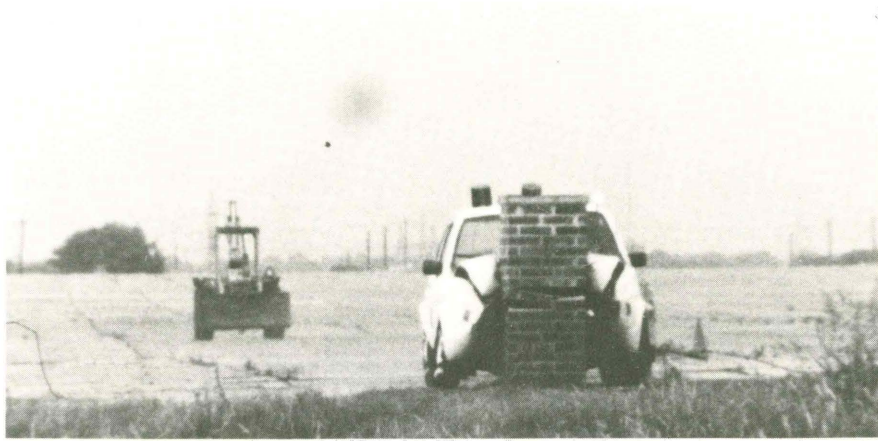
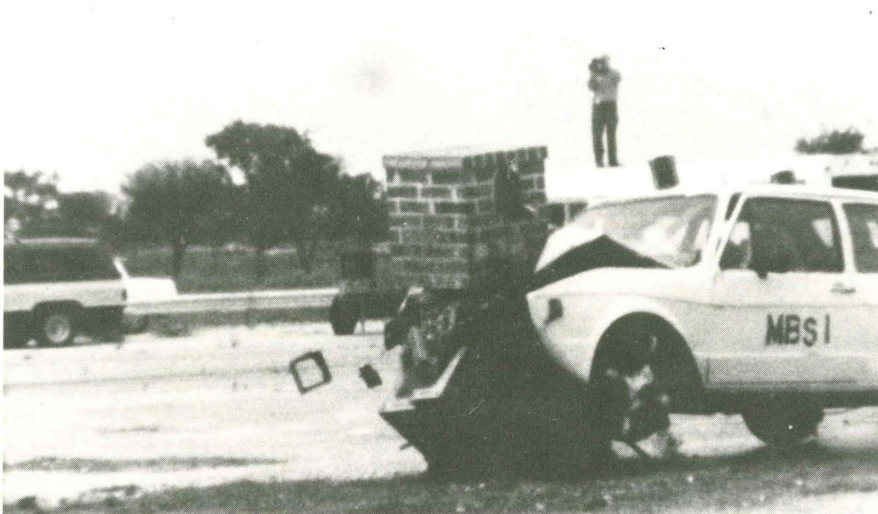
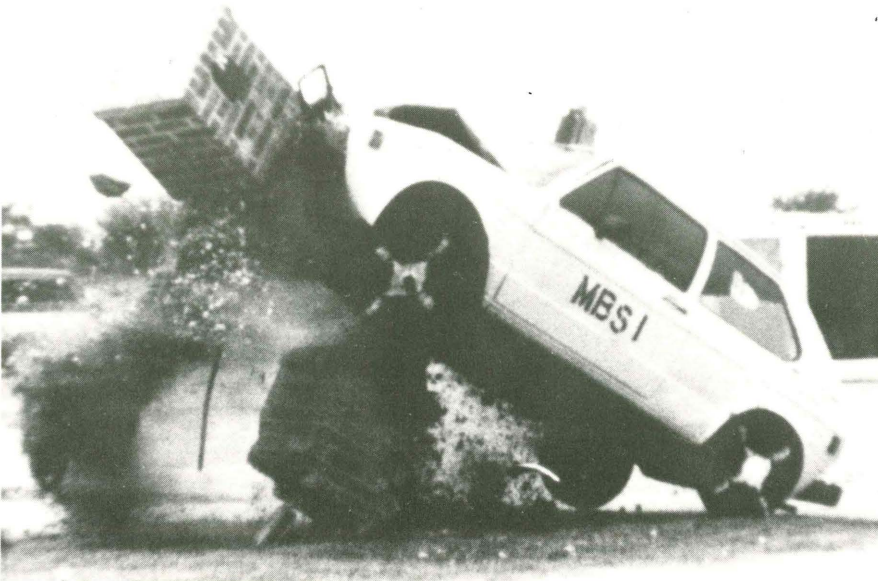
Figure 6. Mailbox Stand and Vehicle Impact Test MBS-1

PERFORMANCE: Impact conditions were 49.1 mph, with the vehicle hitting head-on into the mailbox stand. On impact, the stand was broken in half. The vehicle pushed the lower half of the stand over, climbing it, which stood the vehicle vertical on the rear bumper, Figure 6. The front end of the vehicle came back down over the stand, hitting the ground and popping the windshield out. The vehicle came to rest, with the rear axial on top of the stand. The distance from the point of impact and the rear axial of the vehicle was 2 feet. Figure 7 contains photographs of the mailbox stand and vehicle damage. Speed measurements were obtained from a motion analyzer, after impact. The measured speeds being 18.7 and 16.7 mph after traveling 4 and 8 feet respectively.

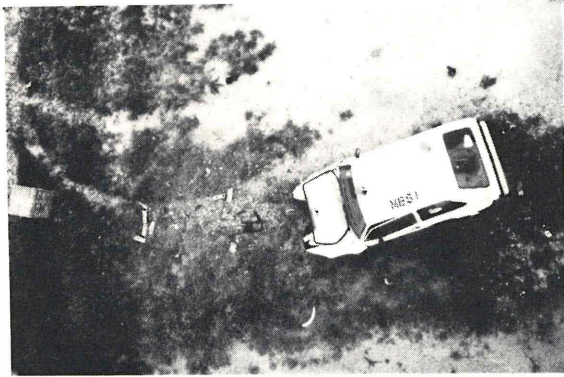
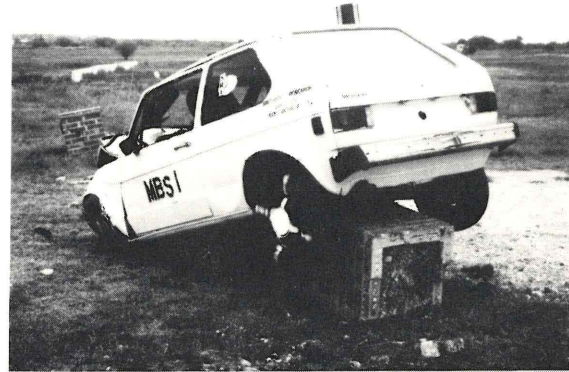
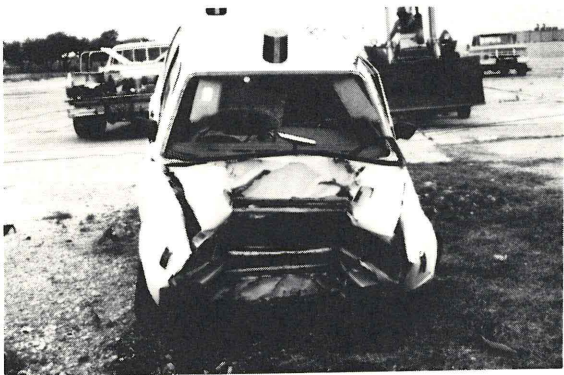
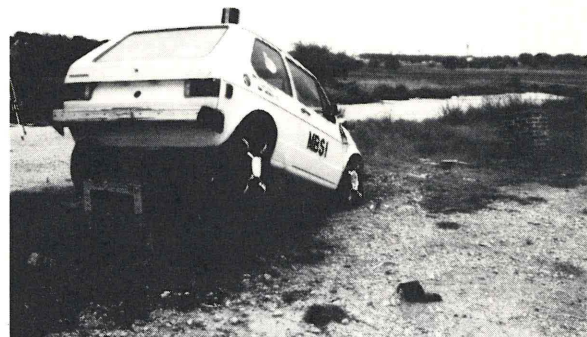
Figure 7. Mailbox Stand and Vehicle Damage

BARRIER DAMAGE: The mailbox stand was broken in half. The upper half being intact. The lower half of the stand was pushed off the base, but was also intact.

VEHICLE DAMAGE: The front end of the vehicle was deformed to the shape of the mailbox stand. The center portion of the vehicle was pushed back two feet. The front bumper was pushed back, both headlights were out, the grille knocked out, the hood was crushed back, both front fenders were buckled, the windshield popped out. The vehicle was not considered to be in operable condition after the test.
