# **Guardrail Testing Program**

## **Final Report**

**Publication No. FHWA-RD/FLP-90-087**  
**May 1990**

14. Sponsoring Agency Code	
15. Supplementary Notes FHWA Contract Manager: C. McDevitt (HSR-20)					
16. Abstract A series of crash tests were conducted to evaluate aesthetic guardrails, guardwalls, median barriers and bridge rails that have been designed for use on park roads, parkways and other Federal Lands roads.  Following two iterations of redesign, a steel-backed wooden guardrail showed acceptable performance when tested and evaluated in accordance with NCHRP Report 230. The successful system feature 10-in by 12-in by 7-ft (0.25-m by 0.30-m by 2.1-m) posts.  A rough stone masonry guardwall showed acceptable performance when tested and evaluated in accordance with NCHRP Report 230, following a modification consisting of raising the concrete core.  An artificial stone median barrier made of precast concrete showed acceptable performance when tested and evaluated in accordance with NCHRP Report 230. The excellent appearance of this artificial stone barrier makes it a very acceptable replacement for natural stone barriers. The use of this barrier could result in a great s

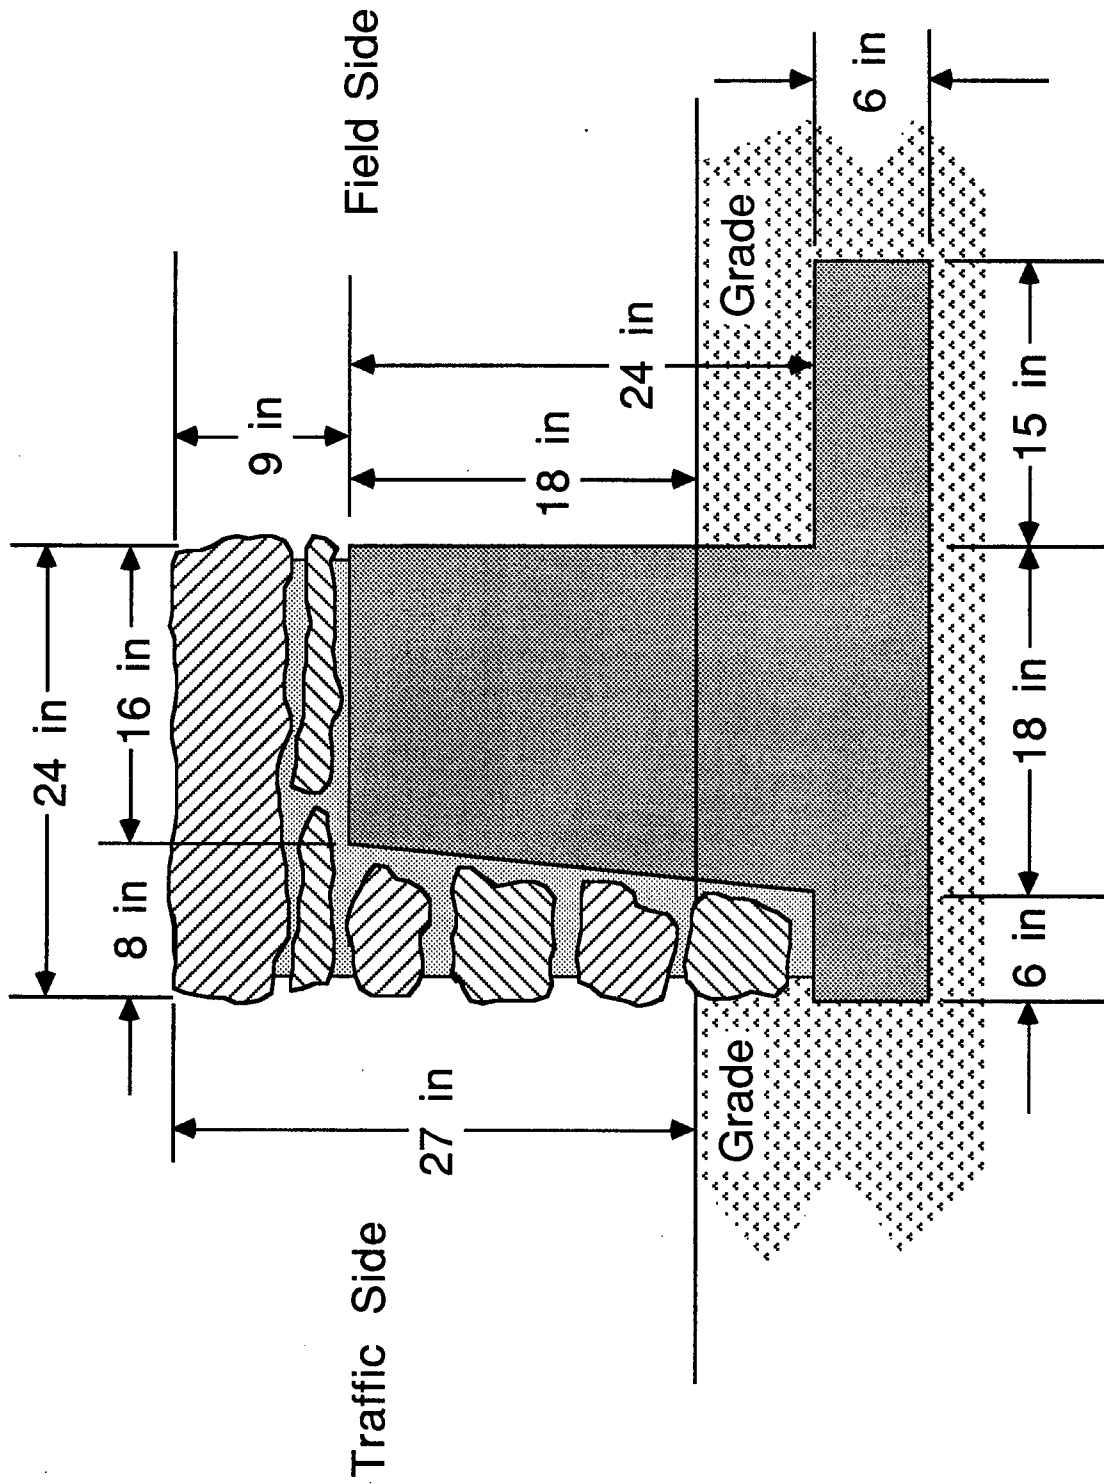
Figure 6. Stone masonry guardwall system.

As summarized in the full-scale test section, task E, the stone masonry guardwall was structurally inadequate under NCHRP 230 test 10 conditions. 15 ft (4.6 m) of coping stone was knocked 5 ft (1.53 m) behind the wall, 4 ft (1.22 m) of coping stone was angled back, and a one-piece coping stone was dislodged. Given that standard bumper heights for large sedans are 18 in (0.46 m) at the bumper center and the core height is 18 in (0.46 m) above ground level, the weakest point of the system is at the vertical impact point. The following recommendations are made to improve this design:

A second test was conducted on the rough stone masonry guardwall system after modification of the system. The core was raised to

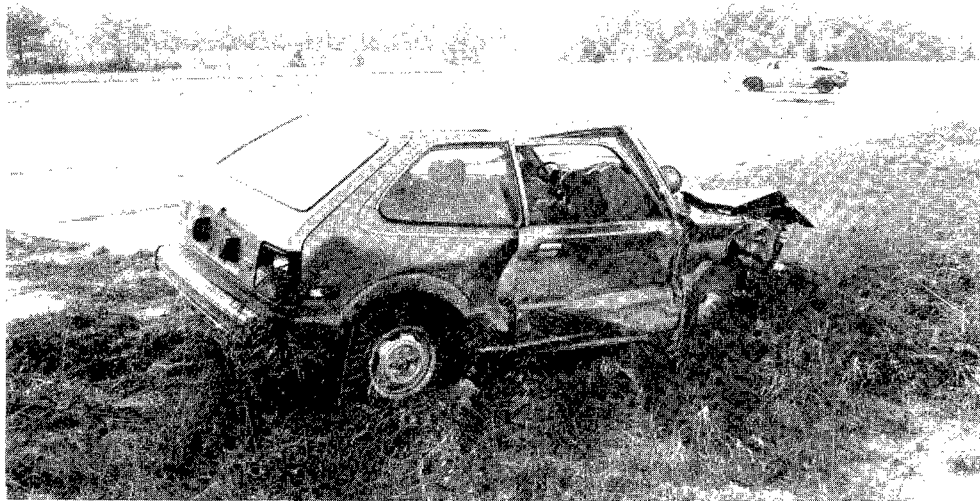
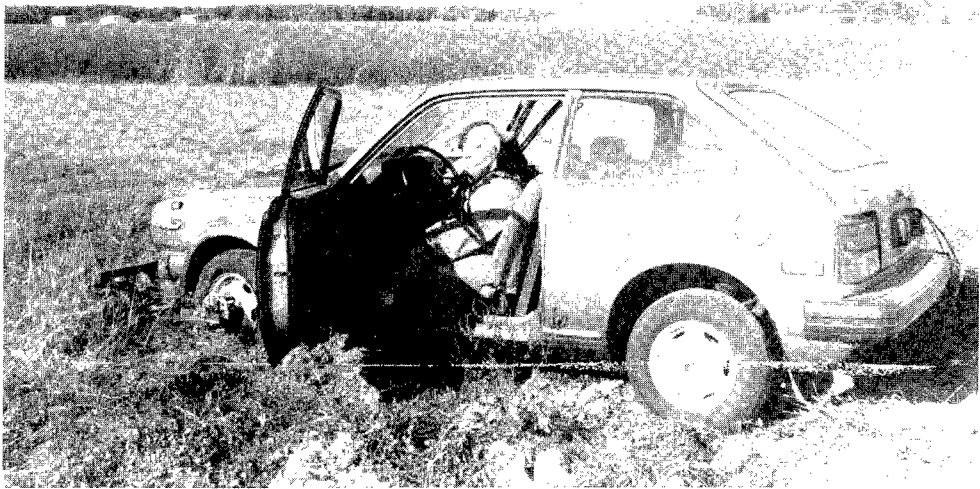
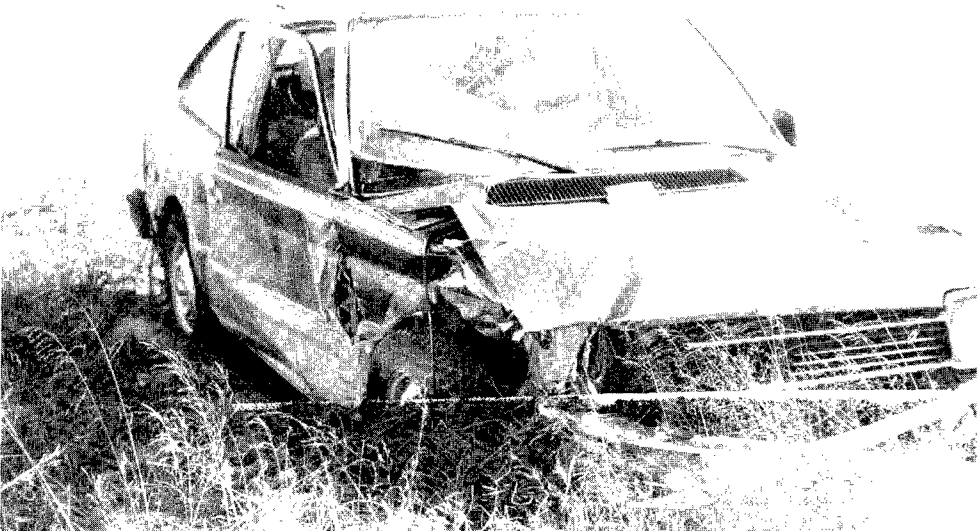
Figure 33. Posttest photographs of test vehicle,  
test 1818-5-3-87.

Vehicle damage occurred mainly to the right front fender, grill and bumper. The front right tire rim was damaged from impacting the wall, resulting in a flat tire. The passenger side door was wedged outward and the windshield was shattered on the passenger side due to the impact from the dummy. Windshield fragments were thrown 35 to 40 ft (10.7 to 12.2 m) behind the guardwall. Posttest photographs of the vehicle are shown in figure 33.

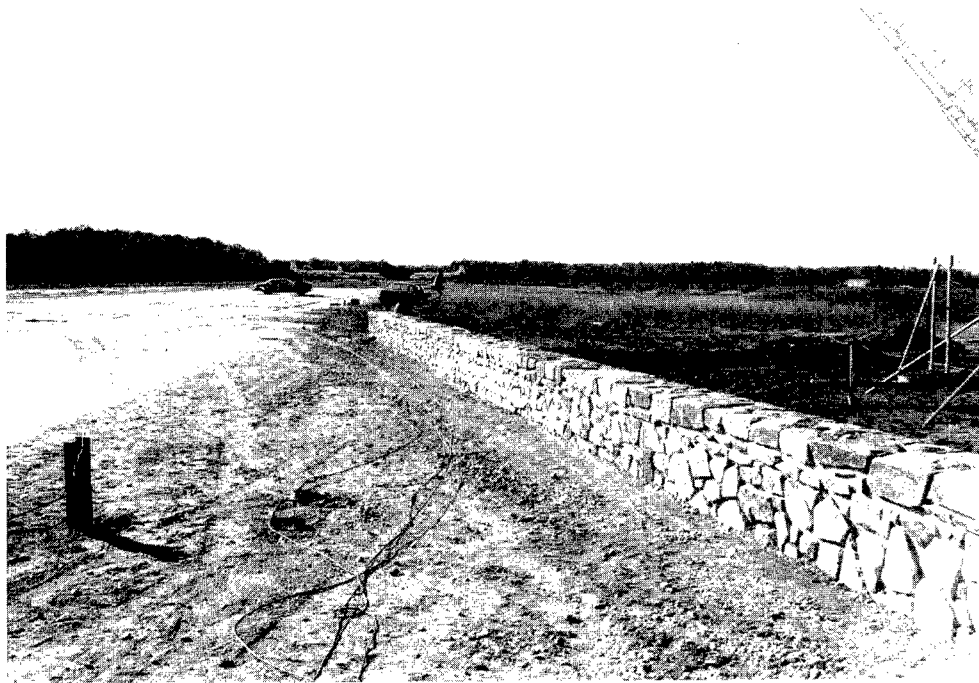
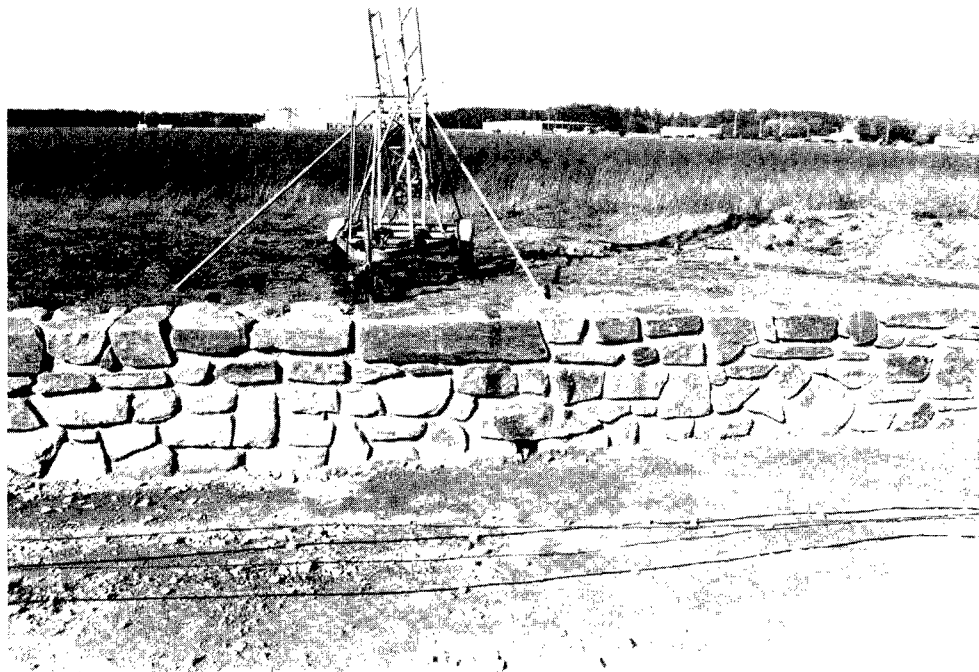
Figure 34. Posttest photographs of guardwall system,  
test 1818-5-3-87.

Upon impact, the front of the vehicle was deformed and skewed toward the non-impact side. The right front corner of the vehicle continued to crush. The vehicle rode up on top of the wall, knocking off approximately 15 ft (4.6 m) of coping stone.

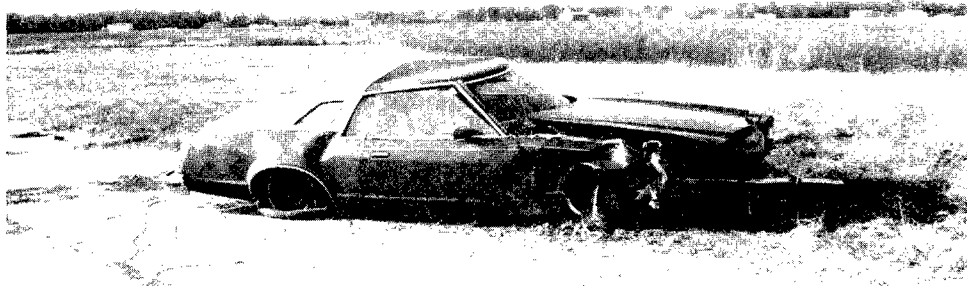
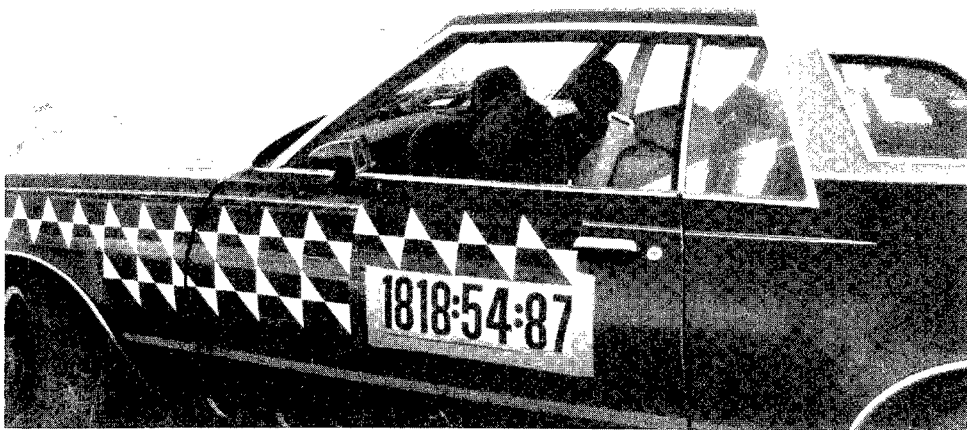
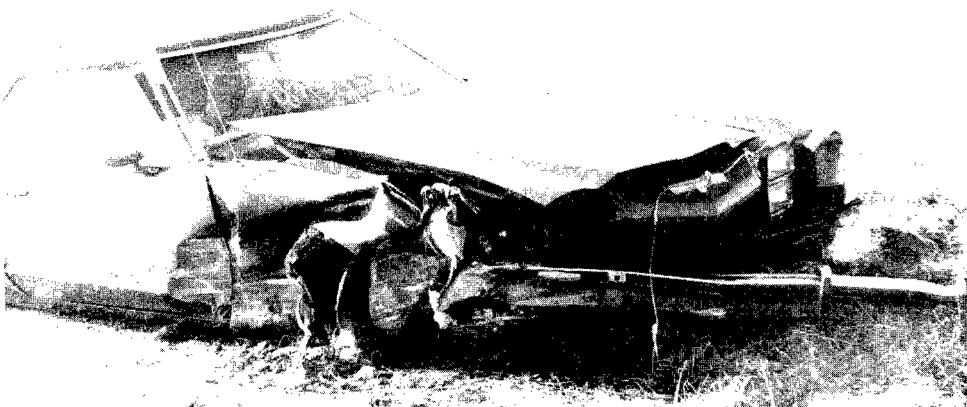
Figure 41. Posttest photographs of test vehicle,  
test 1818-5-4-87.

Vehicle damage occurred mainly to the right side of the car. The right front fender, grill, bumper, rear quarterpanel, and vehicle steering and suspension were damaged significantly. The two right wheels were damaged from impacting the rail thus, resulting in flat tires. The passenger side door was wedged outward and the windshield was shattered on the passenger side due to the impact from the dummy. Posttest photographs of the vehicle are shown in figure 41.
