Montana Demonstration Project: Innovative Culvert Rehabilitation Using Trenchless Technologies

**Final Report
June 2009**

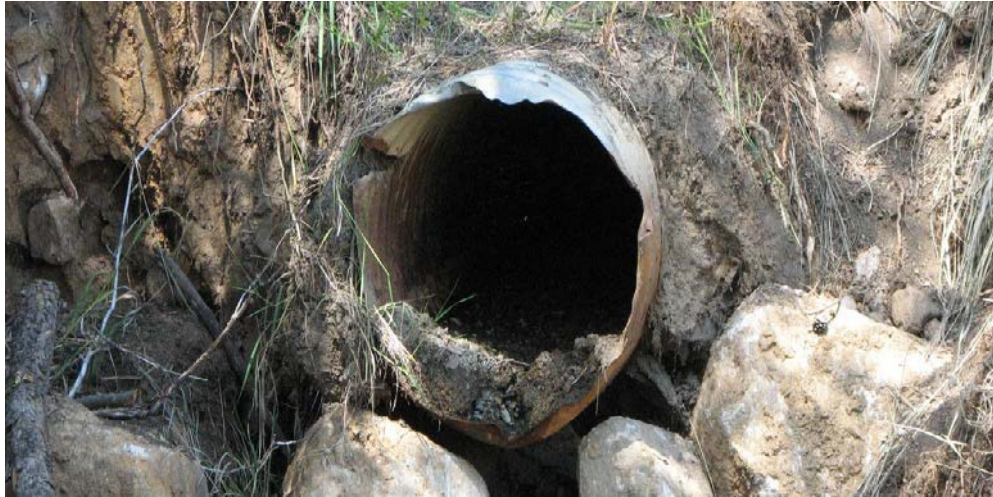
Figure 2. Existing condition of a typical culvert at the project site.

Ten of the corrugated steel pipes under U.S. 12 near Helena were in poor structural condition with deteriorated inverts and badly in need of replacement. Sand and debris were accumulating in these culverts, reducing their capacities and requiring constant care by maintenance forces. The poor condition of the culverts prompted MDT to take immediate mitigating measures. MDT had two options to address the problem. Option 1 was to excavate and replace the culverts, which would have required lane closures that interfered with traffic flow. Option 2 was to reline the culverts using trenchless technologies without impeding traffic flow. After exploring the two alternatives and evaluating project and user costs, MDT selected the trenchless technologies to rehabilitate the culverts under U.S. 12. The rehabilitation strategies included the following innovative techniques:

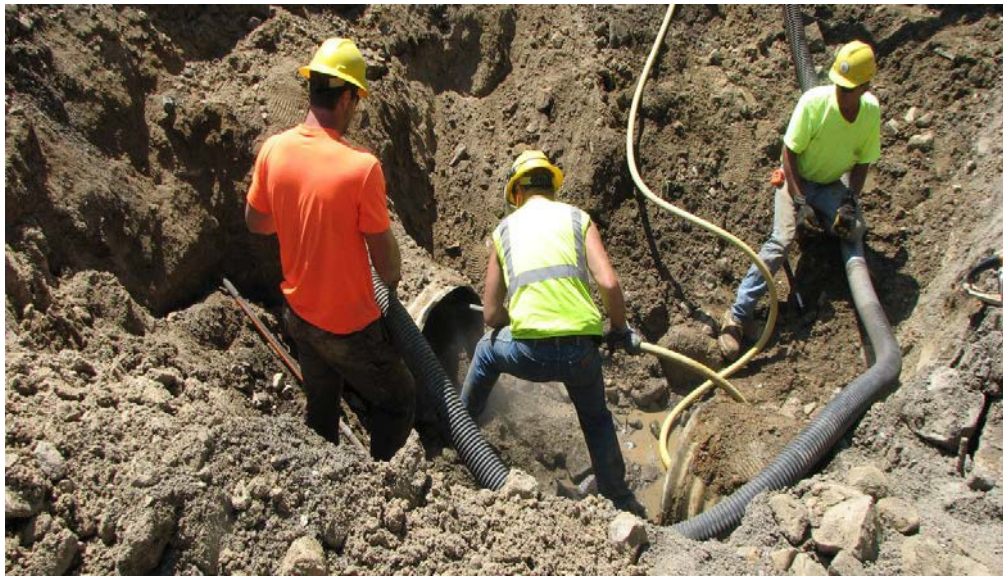
Figure 3. Cleaning and removal of debris from the existing CSP.

new installation. Several different lining materials can be used in sliplining, including high-density polyethylene, polyethylene, polypropylene, polyvinyl chloride (PVC), and ethylene propylene diene monomer. For this project, MDT used 18-in (457-mm) outside diameter HDPEP with a smooth interior and exterior and a wall thickness of about 0.75 in (19 mm). Before the pipes were inserted, debris was removed from the existing pipes (figure 2) using a high-pressure jet wash and a truck-mounted vacuum, as shown in figure 3.

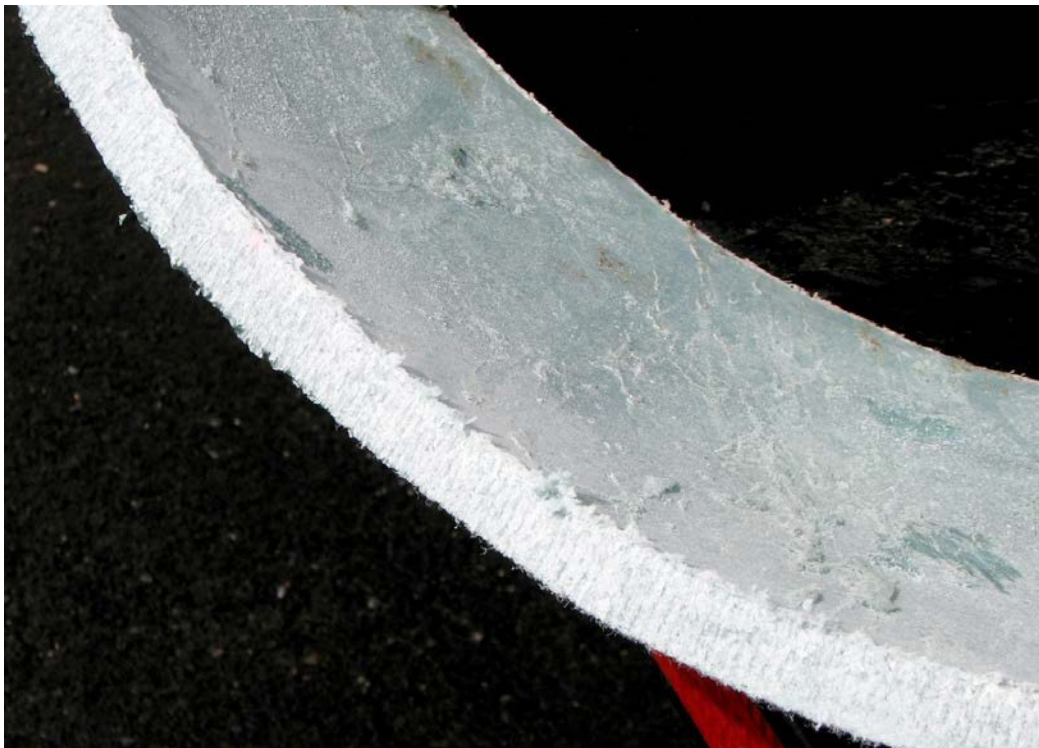
Figure 20. View of a fully cured CIPP.

- A close-up view of a fully cured CIPP liner is shown in figure 20. All three polyester layers of the liner are bonded, forming a composite monolithic rigid layer with an average thickness of 0.625 in (15.8-mm).

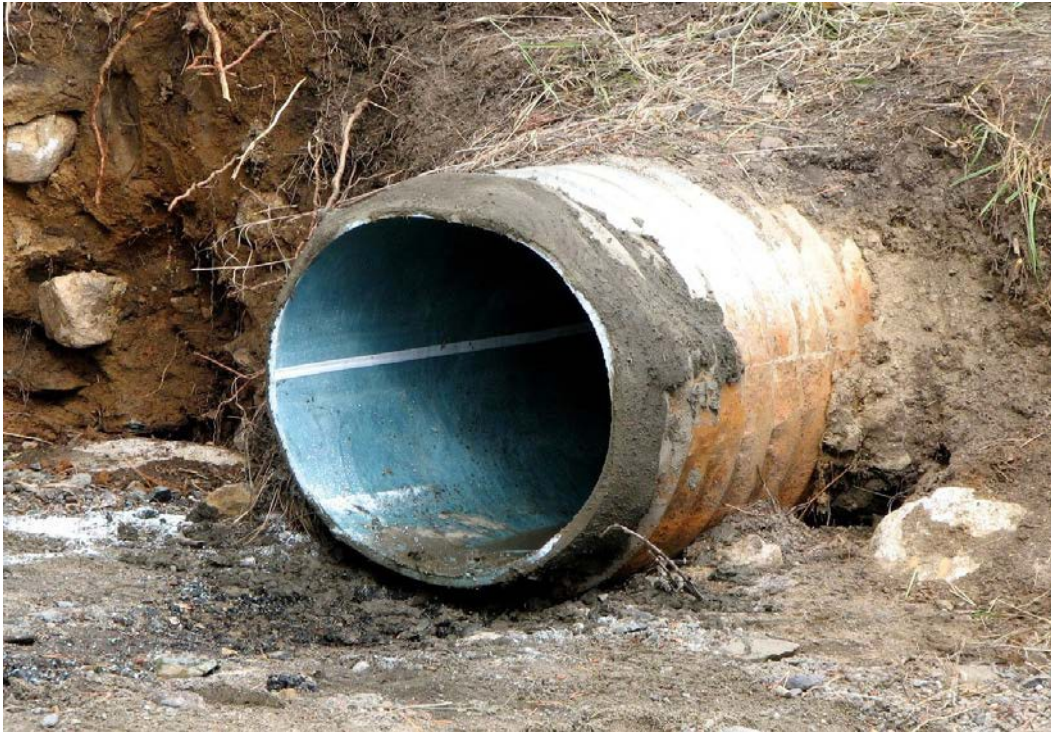
Figure 21. View of a fully installed CIPP liner (Note intimate contact of the liner with the pipe).

- After the application of the steam, the CIPP was allowed to cool. The rubber plug was removed, and the excess CIPP at the intake and outlet was trimmed to a proper length.
- Fiber meshed grout was used to seal the interface of the CIPP liner and the existing culvert at its intake and the outlet ends (figure 21).
- As shown in figure 22, the installation of the CIPP liner was monitored and inspected remotely by a tractor-mounted closed-circuit television camera to ensure proper placement.
