# Identification of Bridges with Fracture-Prone Details

Report Number: KTC-19-35/SPR18-553-1F

Kentucky Transportation Center  
College of Engineering, University of Kentucky, Lexington, Kentucky

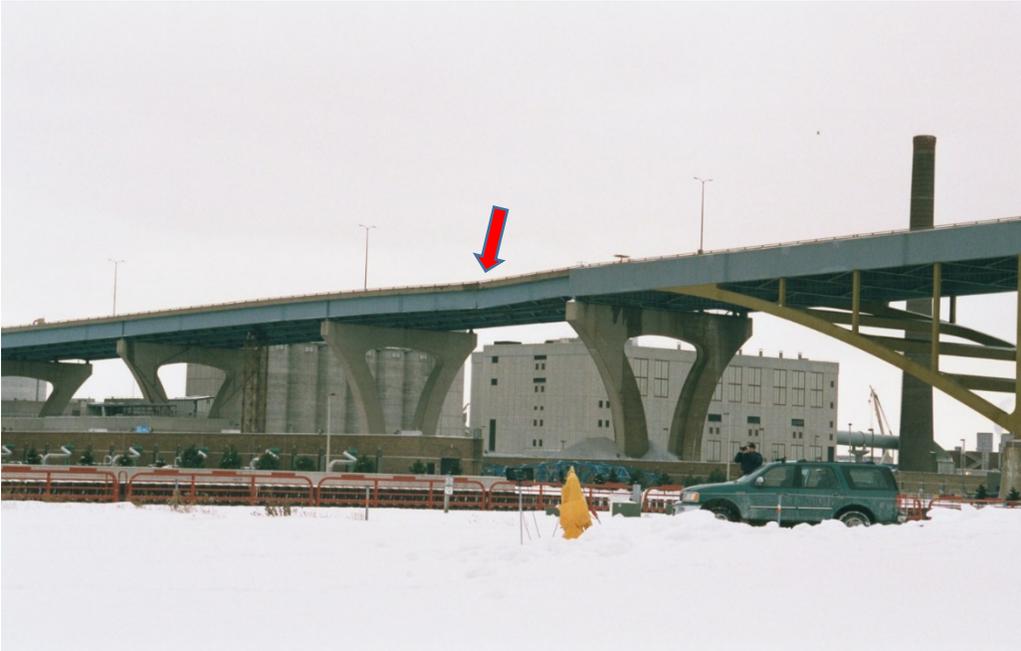
The seminal event related to CIFs was the I-794 Hoan Bridge fracture in Milwaukee, Wisconsin, on December 13, 2000. At that time, Winter conditions were present and the temperature was below freezing. Early that morning several trucks crossed the bridge, causing the third span of the southbound approach to sag. The bridge was promptly closed, and inspectors found that two of the three girders supporting the roadway were completely fractured along with a 30-inch long crack in the bottom portion of the web of the third girder (Figures 1, 2).

**Figure 1** The I-794 Hoan Bridge in Milwaukee, Wisconsin, after the girder fracture event (December 2000). Note the sag in the barrier wall and girder (arrow).

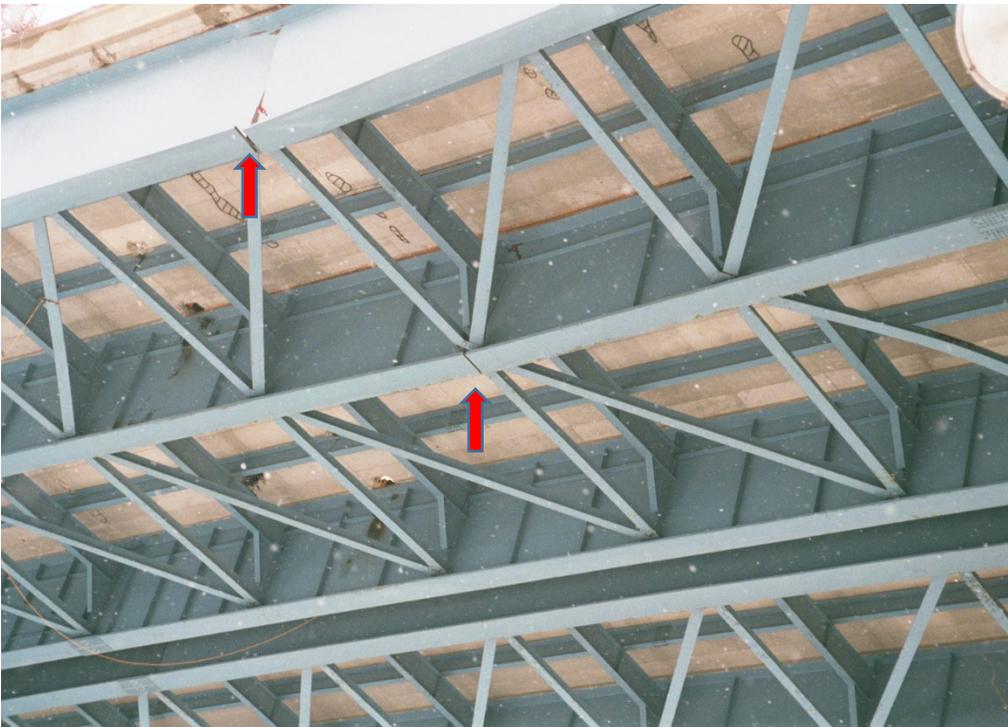
**Figure 2** Complete girder fractures in two of the three approach span girders (arrows).

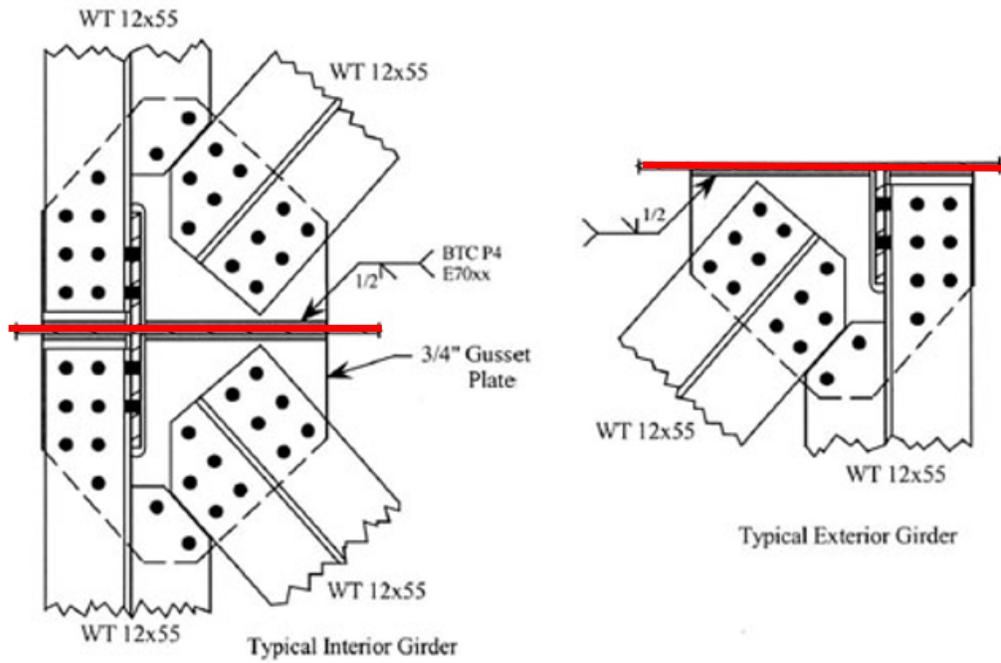
A follow-up investigation concluded that those fractures originated at the gusset plate area connecting lateral bracing to the girder webs (1). Two of these attachment details were involved in the fractures (Figure 3). Previously, the Wisconsin Department of Transportation (DOT) had detected arrested cracks at other approach span locations ranging in length from 6 to 36 inches. Those previously detected cracks were initially attributed to fatigue. A typical mock-up of similar lateral bracing connections is shown in Figure 4. With the lateral bracing removed, the mock-up shown in

**Figure 3** Plan views of girder attachment details of connections of girder webs (red lines) with lateral bracing - WT 12 x 55s (2).

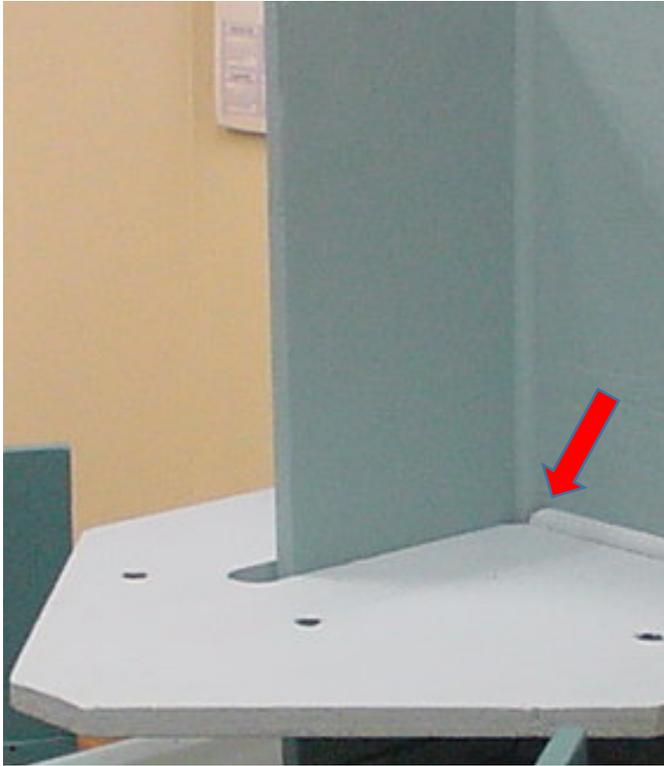
Figure 3 reveals that the gusset plate is slotted allowing it to straddle a vertical stiffener (also termed a transverse connector (Figure 5)). Both the vertical stiffener and the gusset are attached to the girder web by fillet welds. The gusset slot is slightly wider than the vertical stiffener to accommodate its thickness plus the legs (width) of the fillet welds. This creates a narrow gap between the stiffener and gusset that acts as a stress riser (the red arrow in Figure 5). This attachment type is now referred to as the *Hoan Detail*, but it does not address every weld detail that can produce CIFs. In some cases, the gap in the aforementioned slot may be eliminated by welding. That has proven problematic as well (2).

**Figure 5** Mock-up of Hoan Bridge-type fracture detail (light green) with bracing removed. The problematic gap lies between the vertical stiffener and gusset plate fillet welds (arrow).

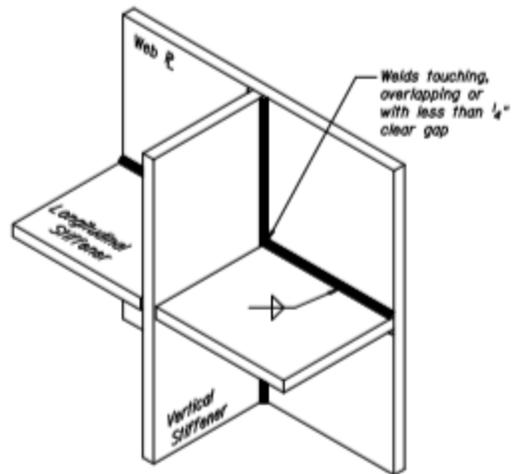
*Longitudinal stiffener terminations in areas of the web subject to tension are vulnerable to constraint-induced fracture if there is insufficient weld clearance.*

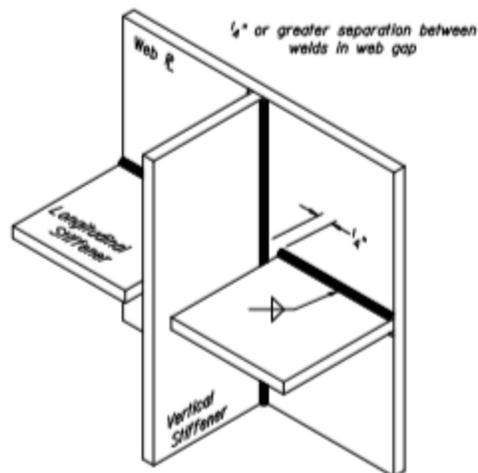
*Longitudinal stiffener terminations with 1/4" or greater clear gap between welds present a low risk for constraint-induced fracture.*

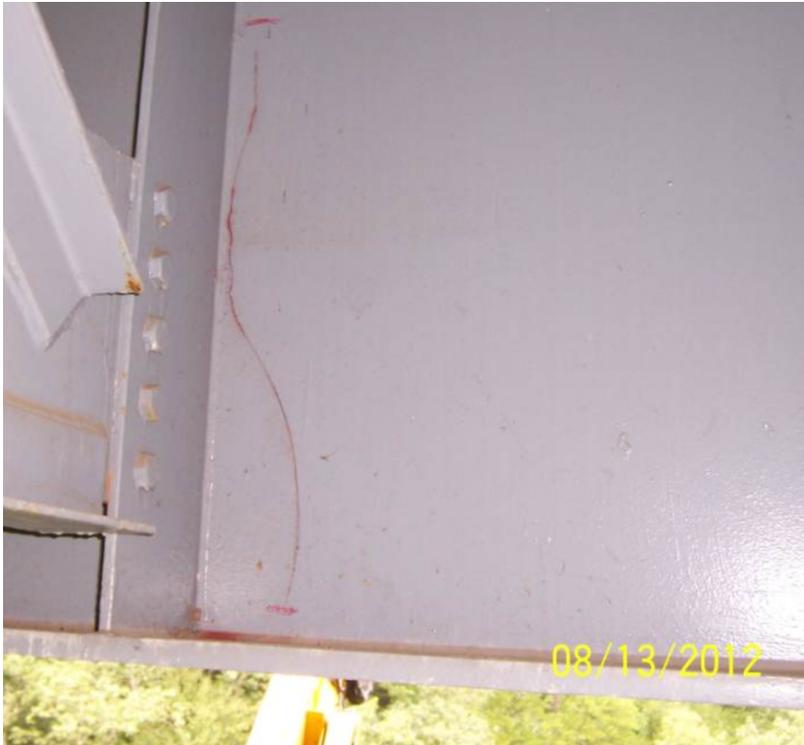
In 2012, KYTC discovered fractures on both the southbound and northbound I-75 bridges over Lynn Camp Creek in Whitley County (Figures 8, 9). They are continuous welded-plate girder structures with four girder lines. The fractures occurred in the girder webs near the center of the longest (200 ft.) spans. It appeared that the fractures emanated from potential CIF locations, similar to a detail shown in the Illinois DOT circular letter (see Figure 6, lower detail). The bridges were quickly repaired, however, there was no follow-up investigation. As the red arrow in Figure 9 indicates, the fillet welds attaching the horizontal and vertical stiffeners were in contact, indicating that a CIF fracture was possible.

**Figure 8** Fracture in interior girder of the northbound I-75 bridge over Lynn Camp Creek in Whitley County (2012).

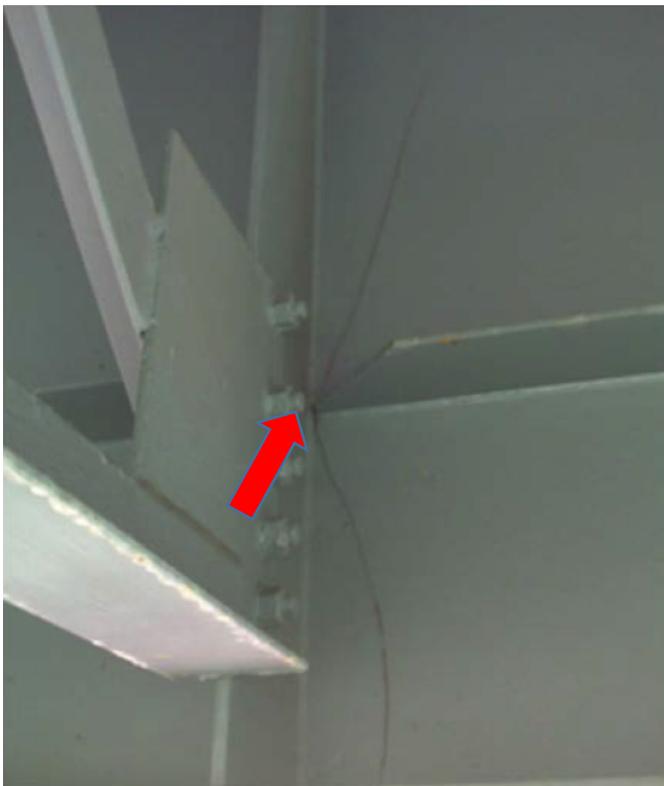
**Figure 9** Fracture in interior girder of the southbound I-75 bridge over Lynn Camp Creek in Whitley County (2012). Note that the fillet welds attaching the horizontal and vertical stiffeners to the web appear to be in contact (arrow).

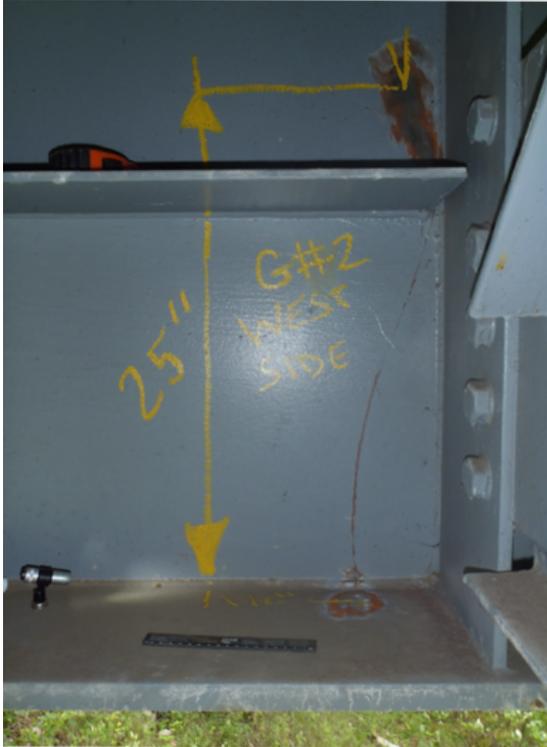
In June 2014 another fracture was found on the same girder (No. 2) of the northbound bridge that experienced a fracture event in 2012 one panel over (Figure 10). The 2014 fracture occurred in the same location as the 2012 fracture. Unlike the 2012 events, by the time this fracture was detected it had advanced into the lower flange and periodic monitoring revealed that it was growing by fatigue (Figure 11). KTC analyzed the girder at the time of its fracture (7).

**Figure 10** Fracture in interior girder of the northbound I-75 bridge over Lynn Camp Creek in Whitley County (2014).

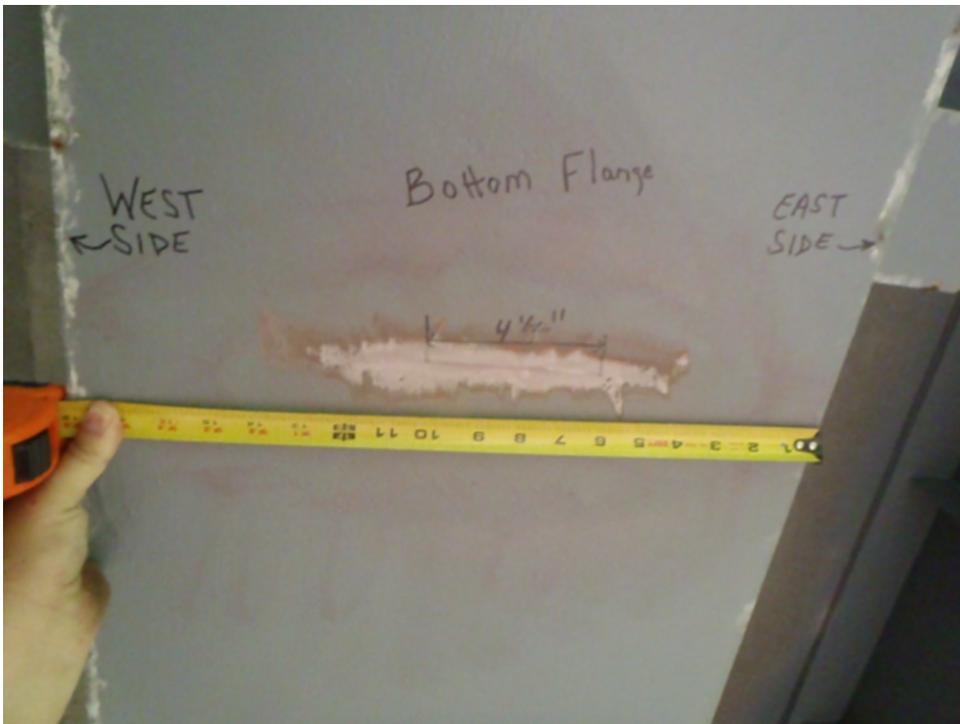
**Figure 11** Fatigue crack growth in the lower flange of the girder after the initial web fracture.

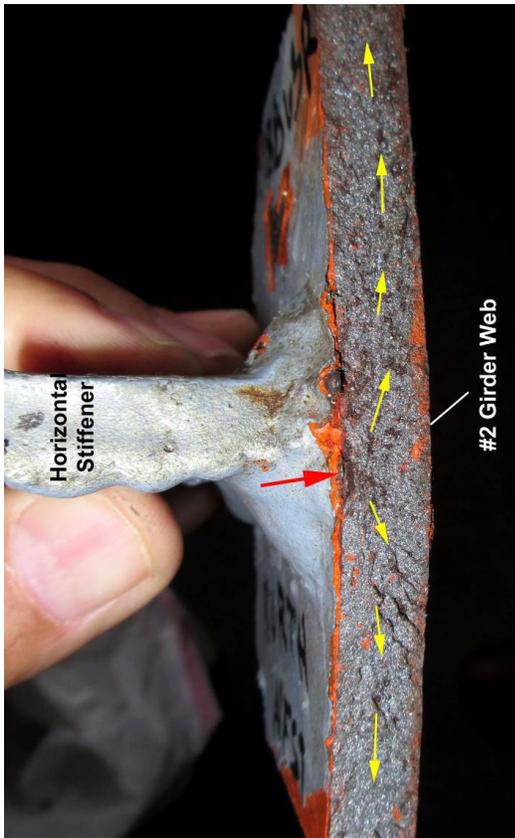
Pieces of the web and stiffeners were removed straddling the fracture, where the horizontal and vertical stiffeners were in close proximity. A fracture surface at that location indicated the web had experienced an unstable brittle fracture (Figure 12, yellow arrows) which originated near the termination of the horizontal stiffener-to-web fillet weld. Close study with a scanning electron microscope revealed a thumbnail-shaped fracture origin which KTC determined was a fatigue crack that subsequently drove the unstable brittle failure when it reached a critical size of only ~ 5 mm wide x 1 mm deep (Figure 13). While fatigue cracking precipitated the unstable brittle failure in the web, the presence of a CIF detail and small size of the fatigue crack at the point of instability led KTC researchers to speculate that constraint-induced fracture might have played a key role. It is unknown whether the 2012 events similarly involved fatigue cracking or simply brittle CIF fractures from crack pop-in.

**Figure 12** Fracture specimen showing web fracture surface and horizontal stiffener filler weld termination. Note the direction of the spreading unstable brittle fracture in the web (yellow arrows) and the fracture origin (red arrow).

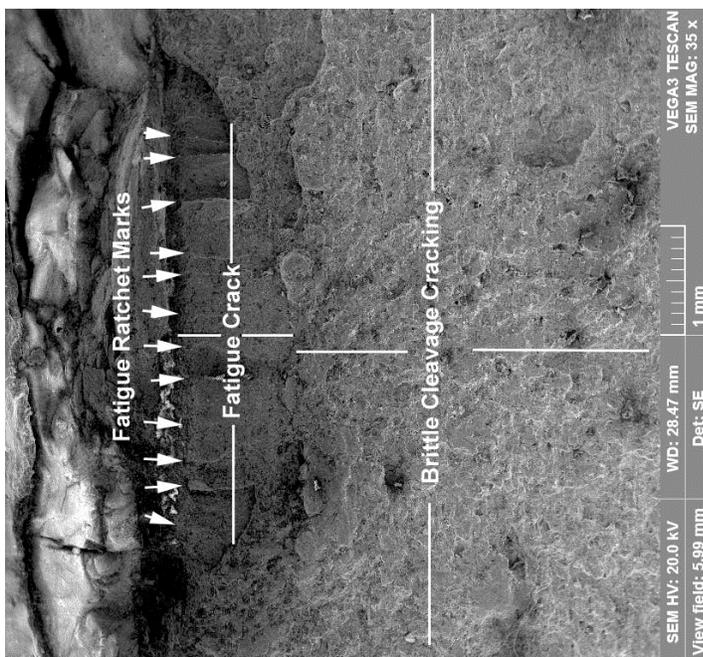
**Figure 13** Scanning electron microscope image of the fracture surface in the area of the red arrow in Figure 12. Note the small (~ 5mm x 1mm) fatigue crack that precipitated the unstable brittle fracture of the girder web.

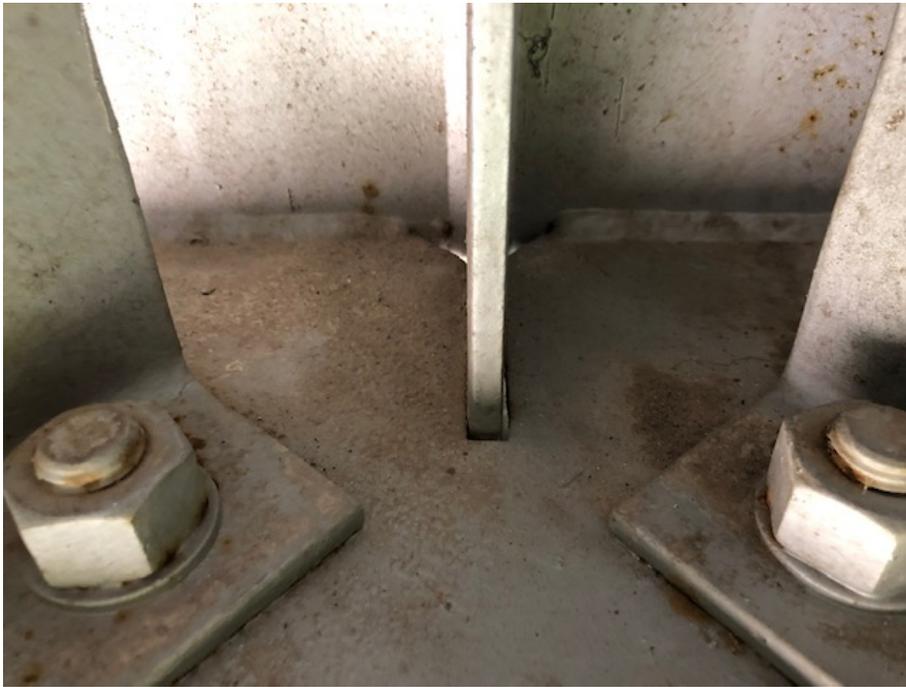
**Figure 14** Bridge 045B00049N in Greenup County showing Hoan Detail which is typical throughout entire structure.

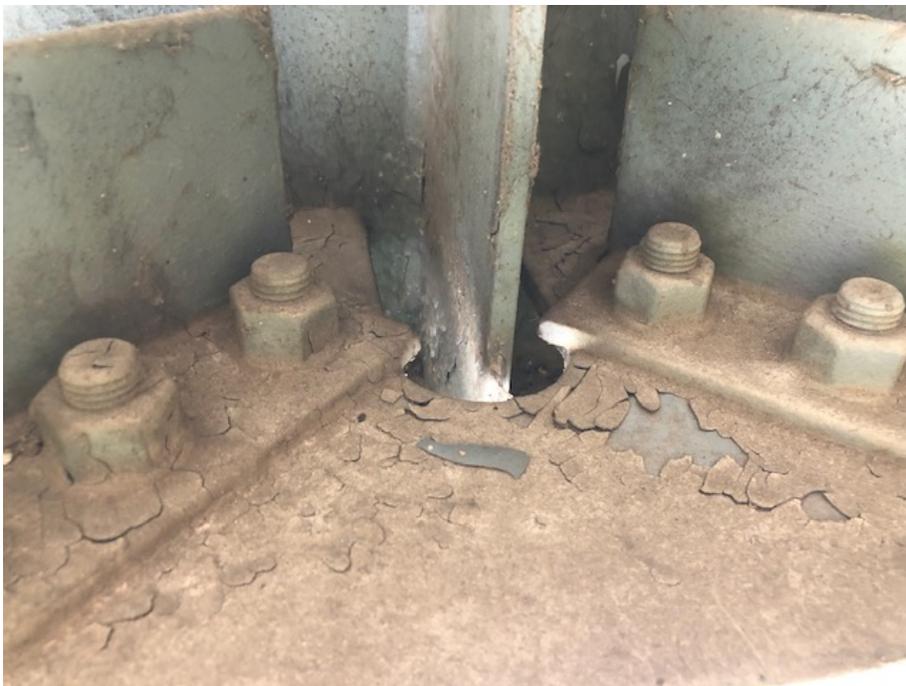
**Figure 15** Bridge 073B00120R in McCracken County showing Hoan Detail which is typical throughout entire structure.

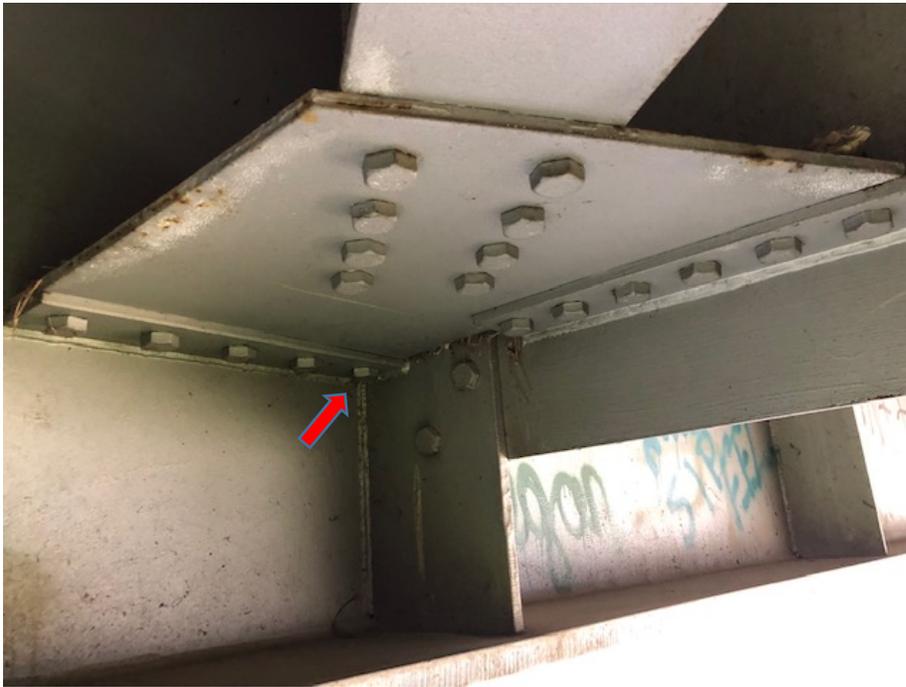
**Figure 16** Bridge 040B00028R in Garrard County showing problematic CIF detail related to the gap between perpendicular fillet welds attaching gusset mounting bracket and vertical stiffener to web (arrow).

**3. Mitigation actions are recommended if weld gaps are  $< 1/4$ " or the perpendicular welds are touching. Where cracks emanate from CIF details, crack mitigation should be promptly undertaken on the balance of the CIF details where the weld gaps are  $< 1/4$ ". The same recommendation holds for any problematic CIF details on fracture-critical bridges.**

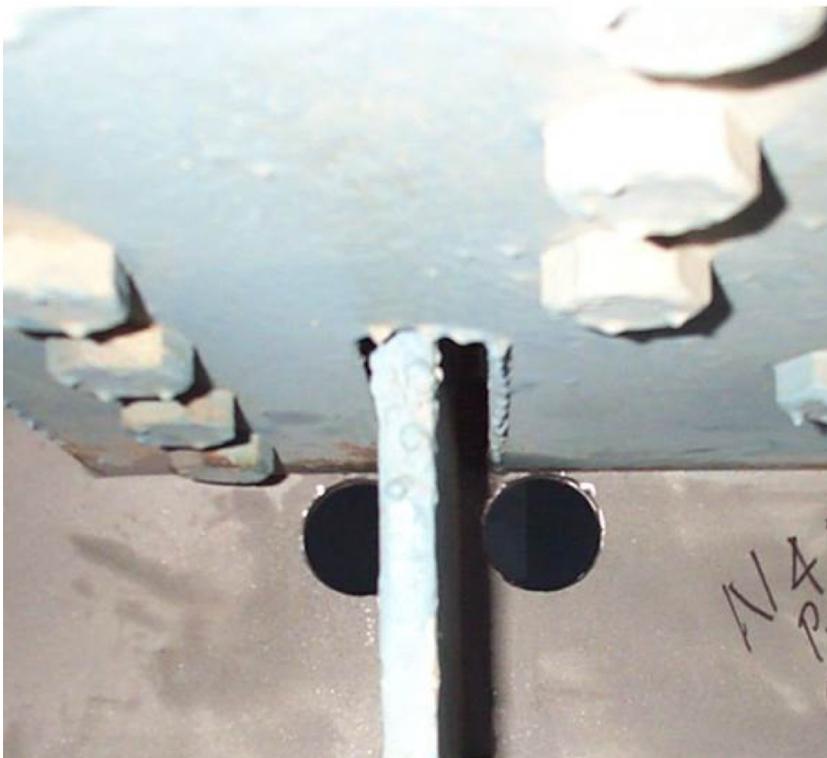
**Figure 17** Check holes placed bracketing weld gaps on gusset in the I-794 Hoan Bridge.

The simplest form of mitigation is to place check holes adjacent to the weld gaps as this intercepts any cracks that might emerge and prevents large-scale damage to girders (Figures 17 and 18). Other recommendations for potential repairs were provided by the FHWA in the 2001 Technical Advisory (3). These are:

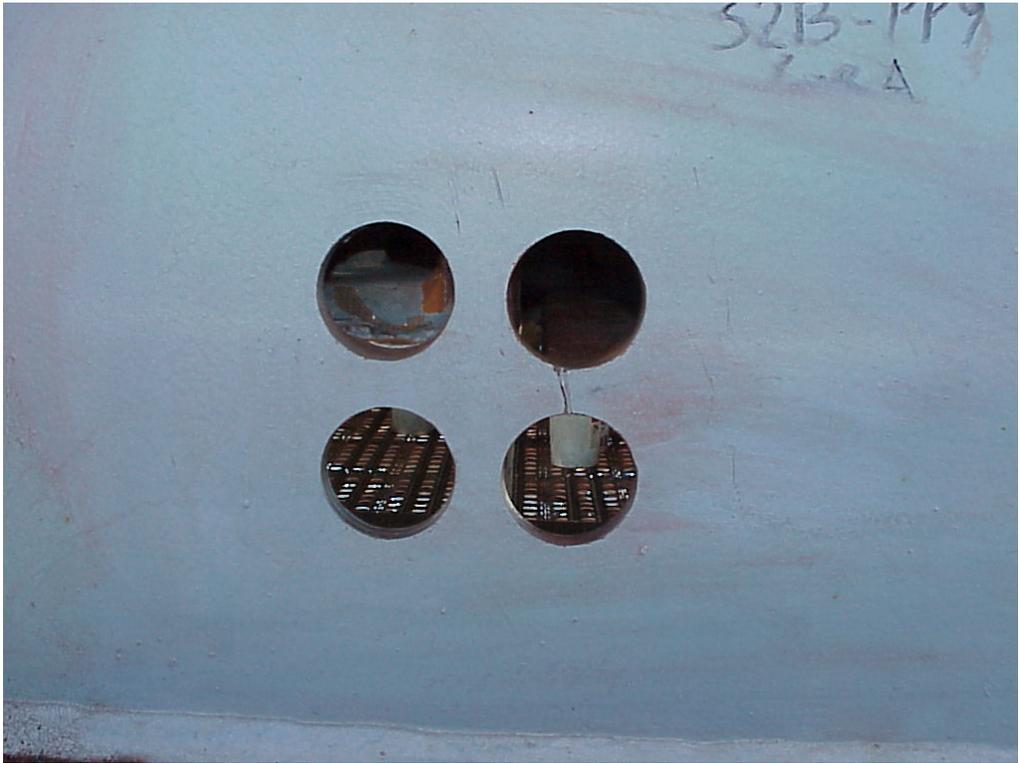
Figure 18 Check holes that arrested CIF crack in gusset weld gap on the I-794 Hoan Bridge.
