**Development and Validation of Methodologies for
Rapid Inspection and Assessment of Fatigue Damage**

FINAL REPORT
September 2020

16. Abstract <p>Causes of unusual fatigue cracking of a steel bridge owned by the New Jersey Turnpike Authority (NJTA) was investigated by Finite Element Analysis (FEA). The bridge is located on a strategic commerce route and is subjected to high Average Daily Truck Traffic (ADTT) consisting of significant fraction of overloaded trucks having Gross Vehicle Weight as high as twice the legal limit. The bridge originally built in 1950s and widened in 1971 is in service for more than 60 years. Fatigue cracking was observed in the top flange of the floor beams at deck expansion joints. The cracks developed at bearing stiffeners under the stringers and grew through the flange at some locations. Based on Weigh-in-Motion (WIM) studies performed at a nearby bridge, the bridge model was analyzed for 2.25 times the AASHTO fatigue design truck load plus 15% impact. The analysis showed that the maximum stress in the floor beam flange developed when the rear tandem axle of the truck loading crossed over to the deck on one side of the expansion joint. The maximum str

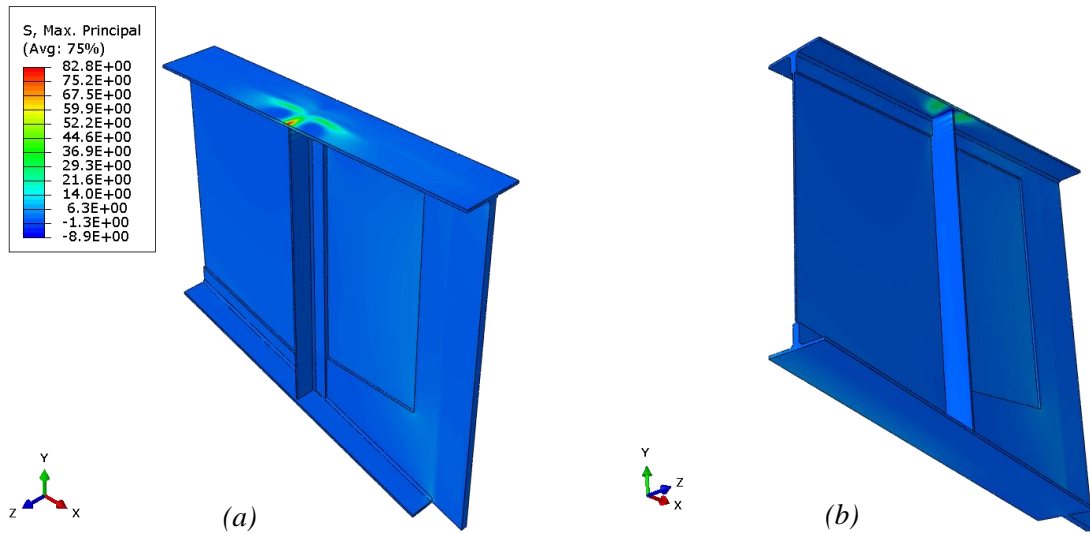
Figure 3-9 Contour of maximum principal stress in FB4 bracket for load case L3T1: (a) view from top; (b) view from bottom

Contour plots of the maximum principal stress in the top flange of FB4 bracket under S4 are shown in Figure 3-9 for the load case L3T1. Only the FB4 bracket (retained from the original construction) is shown for clarity. The high local stresses occurred due to bending of the top flange under S4 south bearing, as shown in Figure 3-10. The flange of the built-up FB4 bracket is made of two back-to-back $6 \times 4 \times \frac{1}{2}$ angles, with the 6 in. leg forming the flange. The flange angle leg is subjected to negative moment at the bearing stiffener ($5 \times 3 \frac{1}{2} \times \frac{3}{8}$ angles with the 5 in. leg protruding), and positive moment away from it. As can be seen, due to the eccentric loading on the south bearing of S4 (since the tandem axle is entirely on the deck south of the expansion joint in load case L3T1), the FB4 is experiencing some twisting deformation. Note that the deformation is shown in Figure 3-10 at 50× magnification.

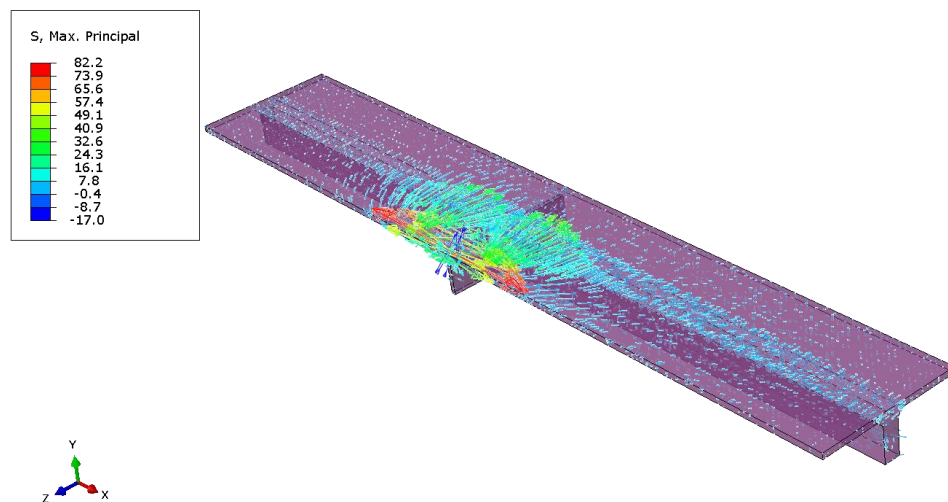
Figure 3-11 Maximum principal stress field in the top flange of FB4 bracket for load case L3T1

The maximum principal stress field in the top flange of FB4 bracket is further presented in Figure 3-11 to demonstrate the magnitude and direction. As is evident, the

maxima of principal stress, occurring over the bearing stiffener near the free edge of the flange was primarily along the flange or in the x-direction. Inside the flange, maximum principal stress of smaller magnitude occurred in the transverse direction of FB4, consistent with the bending of the flange like a cantilever supported on the web.

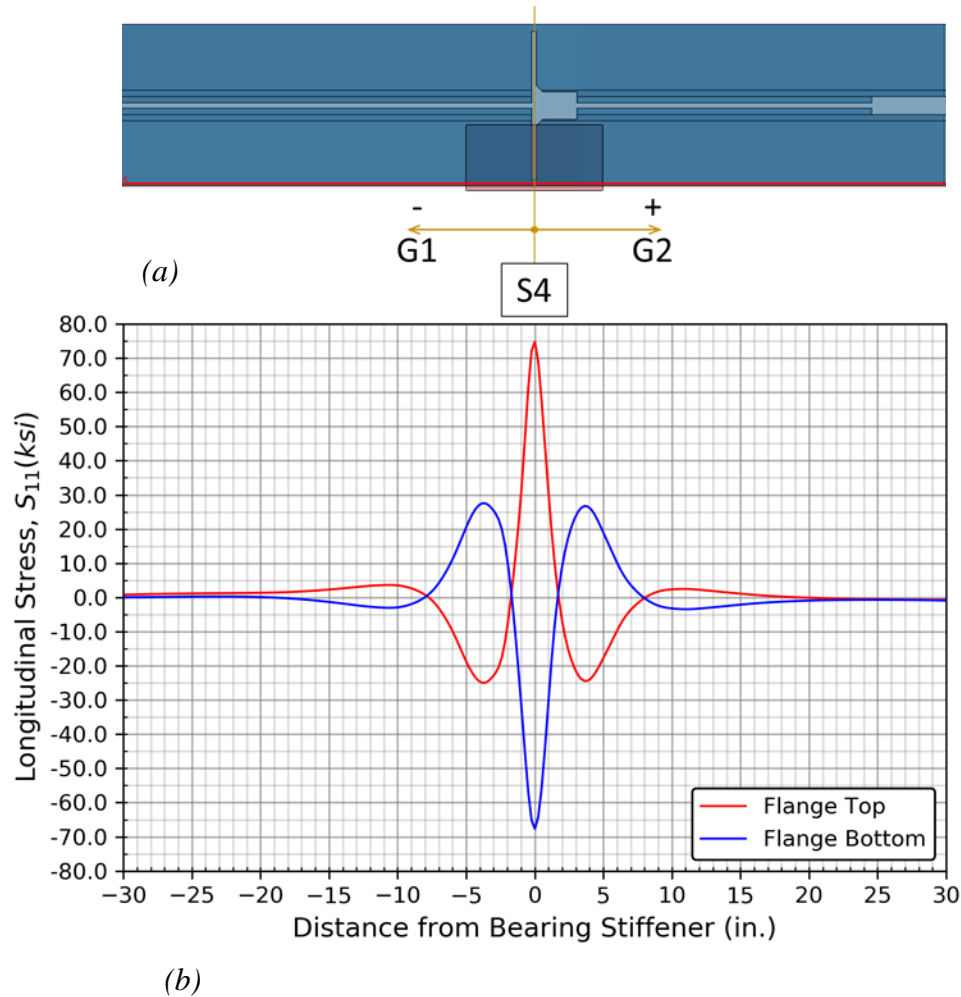
Figure 3-12 Longitudinal stress in the top flange of FB4 bracket for load case L3T1: (a) plan view of top flange showing path and origin; (b) plot of longitudinal stress along path

The plot of longitudinal stress S_{11} , along longitudinal paths on the top and the bottom of the flange (on the same vertical plane, adjacent to the free edge) towards the south side or the loaded span are shown in Figure 3-12. The plot is prepared with the centerline of the bearing stiffener protruding leg (considered as the centerline of the bearing stiffener) as origin, which also coincided with the centerline of S4. The distances are considered positive and negative respectively towards G2 and G1. The stresses were consistent with the bending behavior presented earlier. Stresses of almost equal magnitude and opposite signs were noted on the top and the bottom path, suggesting predominantly flexural deformation of the floor beam flange under the S4 bearing. The floor beam flange (protruding leg of the angle) experienced reverse flexure, with concave deformation over the bearing stiffener angle, rapidly changing to convex deformation under the bearing

footprint. The maximum tensile stress on top of the flange, occurring at the centerline of the bearing stiffener, is about 75 ksi (assuming elastic behavior), which significantly exceeded the yield strength of the material, assumed 36 ksi for the carbon steel that is specified in the original bridge plans. The maximum tensile stress at the bottom of the flange is about 25 ksi, which occurred at about 4 in. from the stiffener centerline. Note that the bearing is $10\frac{1}{2}$ in. wide and the bearing retaining bolts are located $2\frac{1}{2}$ in. from the centerline of the bearing stiffener. The tensile stress in the flange at the bolt holes is about 20 ksi. Considering stress concentration, the local stress at the edge of the hole likely exceeded the yield stress of the material (assumed 36 ksi).

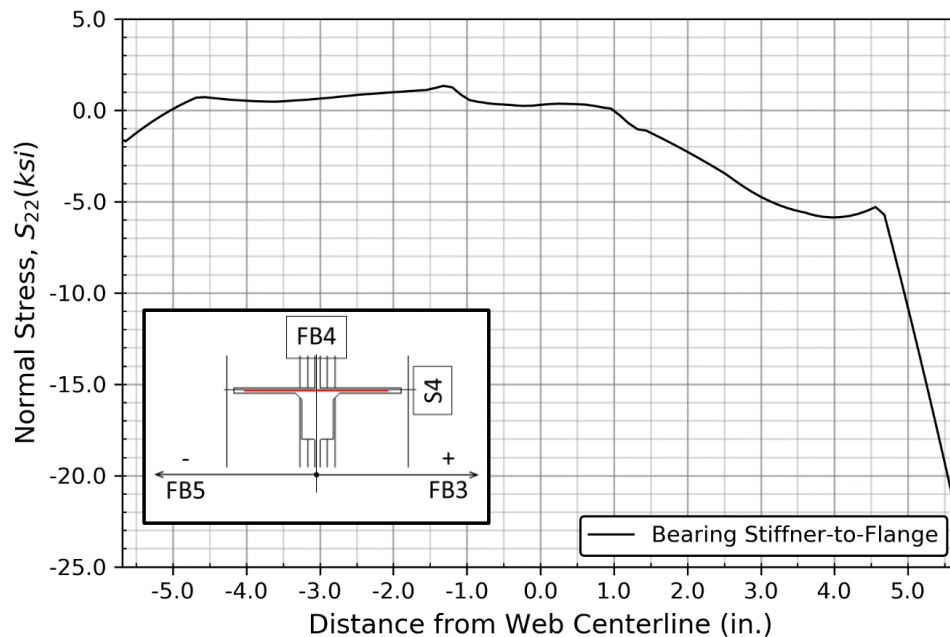
Figure 3-13 Vertical stress along path at soffit of FB4 top flange and the centerline of bearing stiffener under S4 for load case L3T1

The variation of vertical stress (stress in the Y or 2-2 direction), S_{22} at the bearing stiffener-to-flange interface is presented in Figure 3-13. The stresses are determined on a path along the centerline of the protruding leg of the bearing stiffener angle. The plot is prepared with respect to the centerline of FB4 as origin. The distances are considered positive and negative respectively towards south and north, i.e., towards FB3 and FB5. The south bearing stiffener under the loaded S4 bearing experienced bilinear compressive stress distribution that increased at a flatter rate up to about $4\frac{1}{2}$ in from the centerline of the floor beam web and then at a much rapid rate. The maximum compressive stress occurring at the edge of the bearing stiffener was about 22 ksi. The stress at the north bearing stiffener-to-top flange interface under the unloaded S4 bearing was insignificant. The north bearing stiffener, however, experienced tensile stresses as the floor beam twisted due to the eccentric loading.

As presented in Figure 3-13, that bearing stiffener under S4 bearing experienced compressive bearing stress range of 22 ksi at the stiffener edge. When the stiffener was milled to bear, this stress range was well within the yield strength of the material (assumed 36 ksi) and was unlikely to contribute to fatigue crack growth. However, when the stiffener was welded to the floor beam flange, this compressive stress range in the presence of tensile welding residual stresses would effectively be tensile and could lead to fatigue crack growth through the stiffener-flange weld throat. Although this mode of cracking was not noted in the weld-repaired stiffener, since the demand for the crack growth from the weld toe into the flange (discussed in the previous paragraph) was more severe, branching of the crack parallel to the flange after initiating at the weld toe was noted. Fatigue racking through the throat of the stiffener-to-flange weld near the stiffener edge was noted for the bearing stiffener under S3 within the 1971 widened section with welded fabrication, where the stiffeners were welded to the flange.

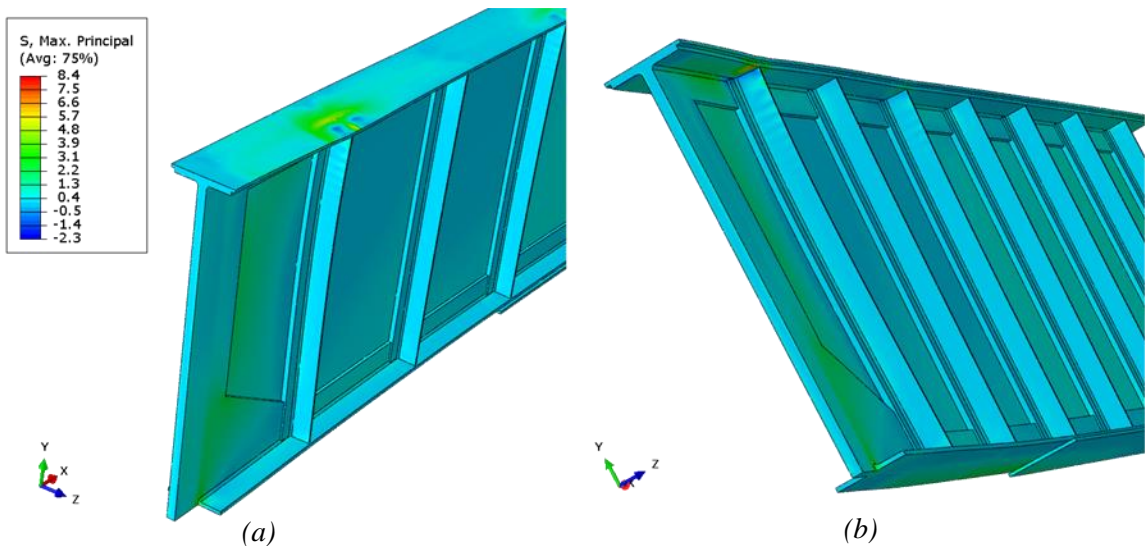
Figure 3-15 Contour of maximum principal stress in FB4 interior for load case L3T3: (a) view from top; (b) view from bottom

The maximum stress in FB4 flange under S5 occurred in load case L3T3. Contour plots of the maximum principal stress in FB4 for this load case are shown in **Error! Reference source not found.**. Only the part of the floor beam between G2 and G3 is shown for clarity. The deformation of the floor beam at 50× magnification is shown in Figure 3-14. Local bending of the flange under the bearing for S5 was noted that resulted in the maximum flange stresses. The response of the floor beam flange was similar to that under S4. The deformation was localized only under the south bearing, since the entire tandem was on the south side of the expansion joint (see Figure 3-8) and some twisting of the floor beam was noted due to this eccentric loading. The flange of the floor beam between G2 and G3 was built up of two back-to-back $6 \times 6 \times \frac{3}{4}$ inch angles and a $14 \times \frac{5}{8}$ in. cover plate.

The flange was subjected to deformation concave down at the bearing stiffener ($5 \times 3\frac{1}{2} \times \frac{3}{8}$ in. angles with the 5 in. leg protruding), and convex up away from it.

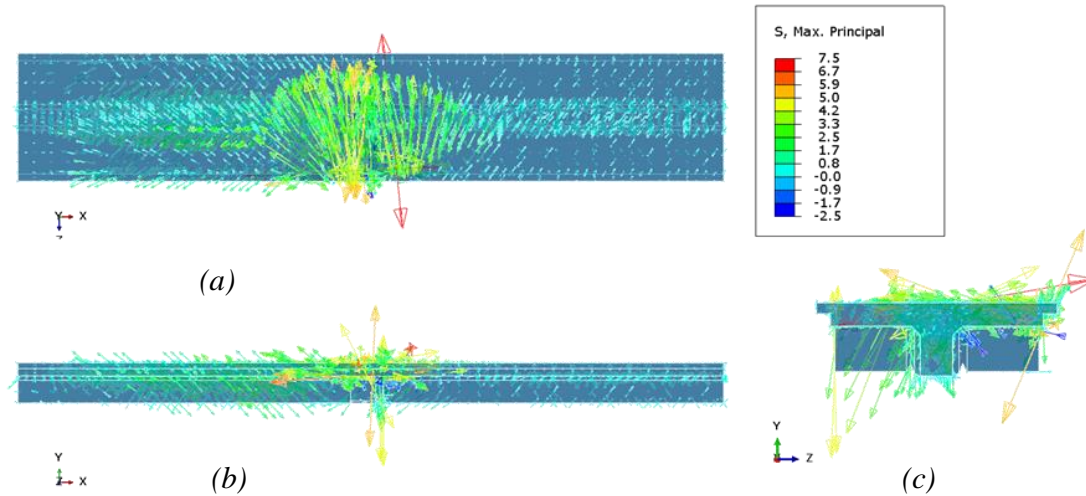
Figure 3-16 Maximum principal stress field in top flange of FB4 interior for load case L3T3: (a) plan view; (b) elevation view; (c) section view

The direction and magnitude of maximum principal stress in the top flange of FB4 between G2 and G3 is presented in Figure 3-16. Compared the distribution of principal stress under S4 as presented earlier, the stresses under S5 are more complex. Looking at the distribution of principal stresses in three orthogonal views (in X, Y, and Z –directions), it is evident that the maxima of principal stress is not oriented along the flange, but in the transverse direction at an angle. Maximum principal stress of comparable magnitude was also observed in the longitudinal direction (X or 1 direction), but at an angle with the flange plane. This complex distribution of maximum principal stresses under the S5 bearing

suggests existence of high shear stresses between the bearing stiffener and the flange, and the local flange bending was predominantly in the transverse direction. High maximum principal stress was also observed in the vertical direction (Y or 2 direction) at the bearing stiffeners under the S5 bearings.

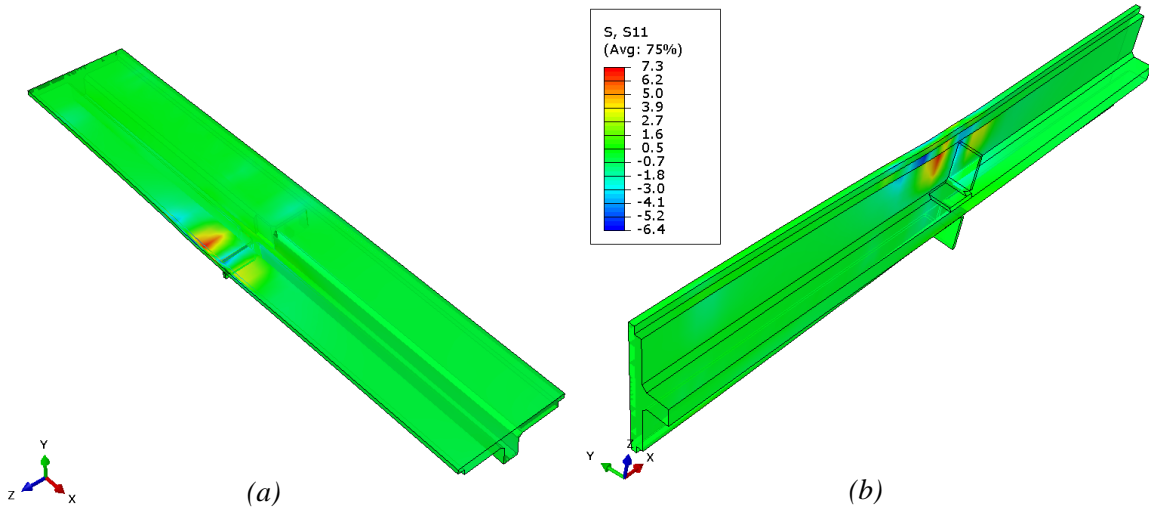
Figure 3-17 Contour of longitudinal stress in the top flange of FB4 interior for load case L3T3: (a) view from top; (b) view from bottom

The contour plot of longitudinal stress S_{11} in the floor beam flange adjacent to S5 bearing is presented in Figure 3-17. Variation of longitudinal stress along longitudinal paths on the top of the flange plate and the bottom of the connection angle (on the same vertical plane, adjacent to the protruding leg of the bearing stiffener angle) towards the south side or the loaded span is shown in Figure 3-18. The plot is prepared with the centerline of the bearing stiffener protruding leg (considered as the centerline of the bearing stiffener) as origin, which also coincided with the centerline of S5. The distances are considered positive and negative respectively towards G3 and G2. The variation of longitudinal stresses were consistent with the bending behavior presented earlier. Stresses of almost equal magnitude and opposite signs were noted on the top and the bottom path,

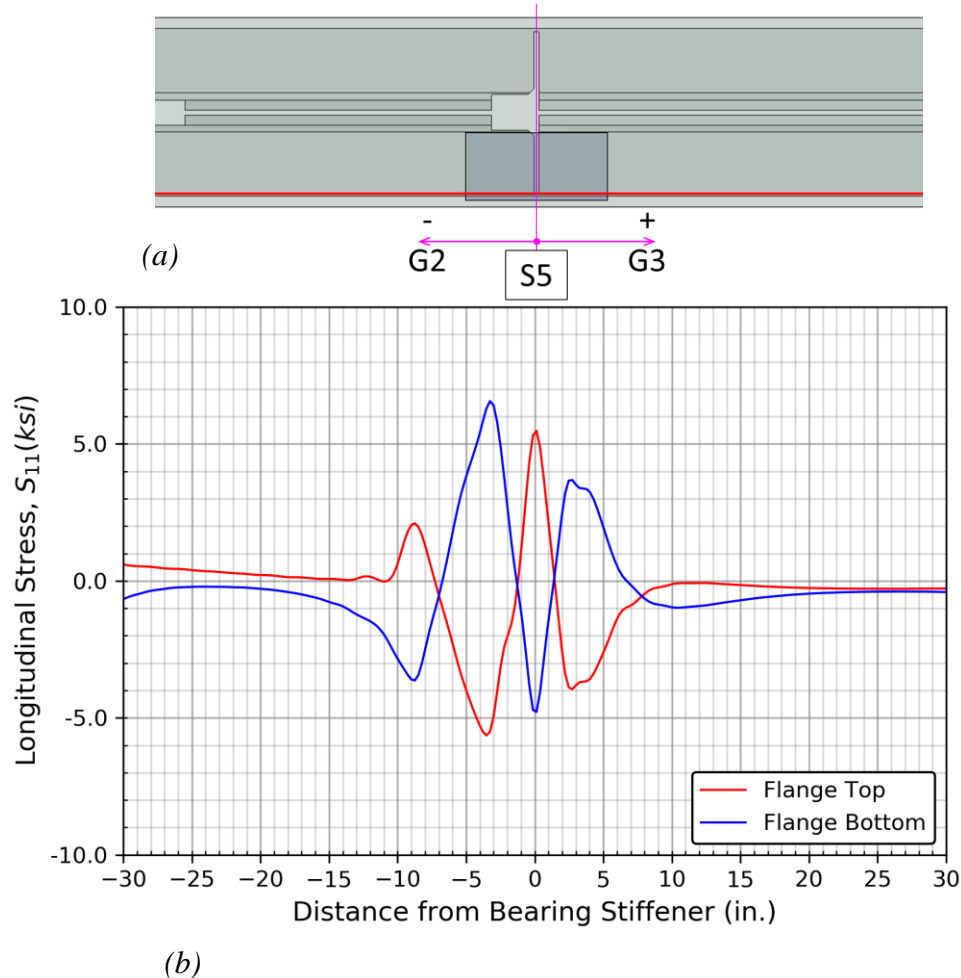
Figure 3-18 Longitudinal stress in the top flange of FB4 adjacent to S5 for load case L3T3: (a) plan view of top flange showing path and origin; (b) longitudinal stress along top and bottom paths

suggesting flexural deformation of the floor beam flange in the longitudinal direction under S5 bearing. The floor beam flange experienced reverse flexure, with negative moment (concave down deformation) over the bearing stiffener angle, rapidly changing to positive moment (convex up deformation) under the bearing footprint. The response was unsymmetric with respect to the bearing stiffeners, with the response to the west being slightly higher than the east. This is also evident from the contour plot of S_{11} presented in Figure 3-17. The maximum tensile stress on bottom of the connection angle leg, occurring at about 3.5 in. west of the bearing stiffener, was about 6.5 ksi. The maximum tensile stress at the top of the flange was about 5 ksi. Note that the bearing was $10\frac{1}{2}$ in. wide and the bearing retaining bolts were located $2\frac{1}{2}$ in. from the centerline of the bearing stiffener angle. The tensile stress in the flange at the bolt holes was about 4 ksi.

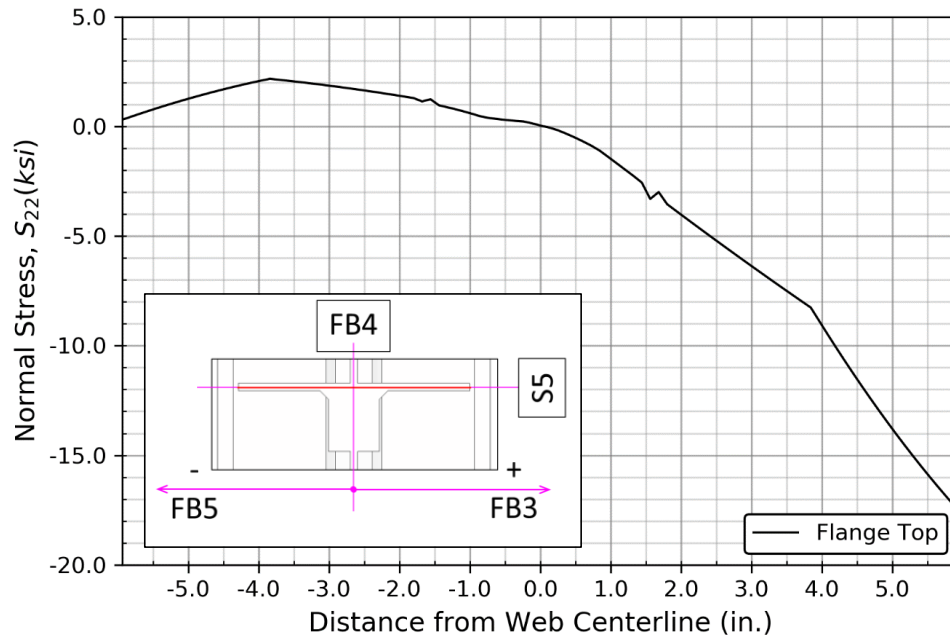
Figure 3-19 Vertical stress along path at soffit of FB4 top flange along centerline of bearing stiffener under S4 for load case L3T3

The variation of vertical stress (stress in the Y or 2-2 direction), S_{22} at the bearing stiffener-to-flange interface is presented in Figure 3-19. The stresses are determined on a path along the centerline of the protruding leg of the bearing stiffener angle. The plot is prepared with respect to the centerline of FB4 as origin. The distances are considered positive and negative respectively towards south and north, i.e., towards FB3 and FB5. The south bearing stiffener under the loaded S5 bearing experience compressive stress that increased almost linearly away from the centerline of the floor beam web. The north bearing stiffener was subjected to tensile stresses as the floor beam flange twisted due to the eccentric loading. The tensile stress increased up to about 4 in. from the centerline of the floor beam web and then decreased to almost zero. The maximum tensile stress was about 2 ksi.
