# **MASH 2016 TEST LEVEL 3 EVALUATION OF MNDOT BICYCLE AND PEDESTRIAN RAIL**

## **MINNESOTA DEPARTMENT OF TRANSPORTATION**

MwRSF Research Report No. TRP-03-443-20

December 11, 2020

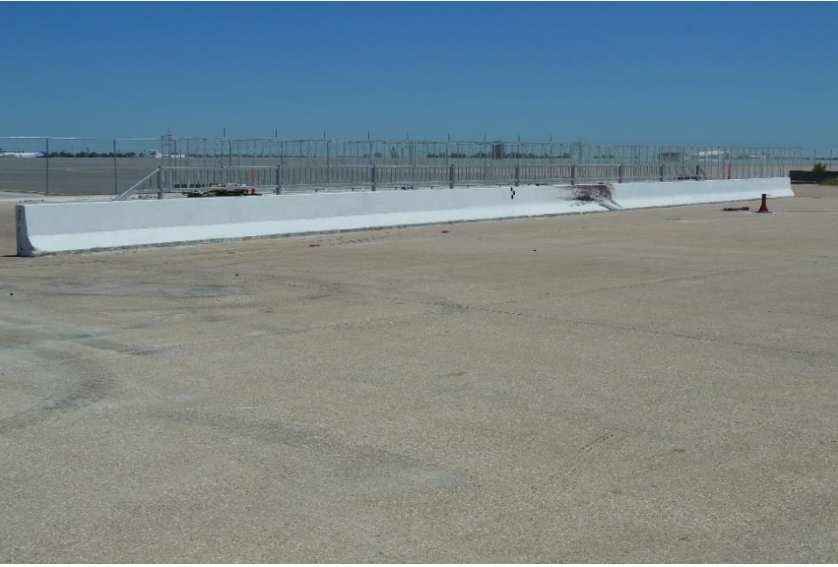
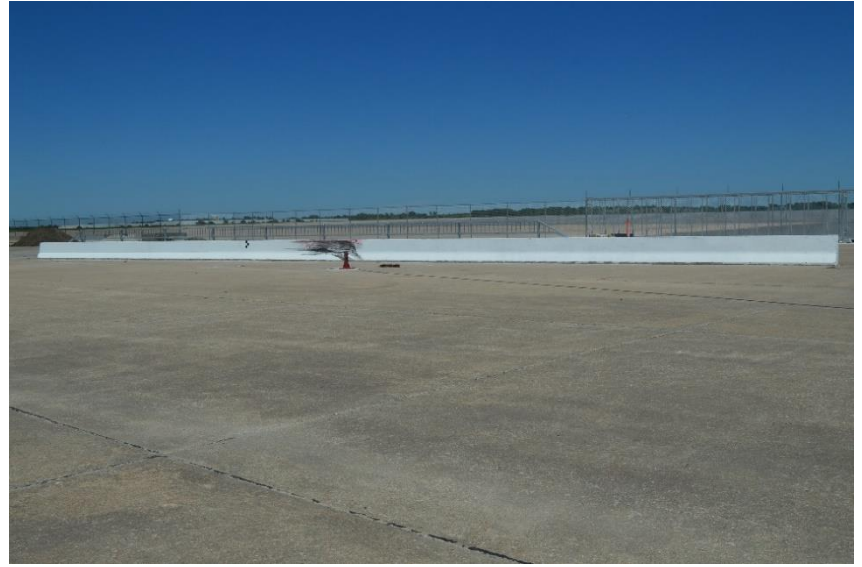
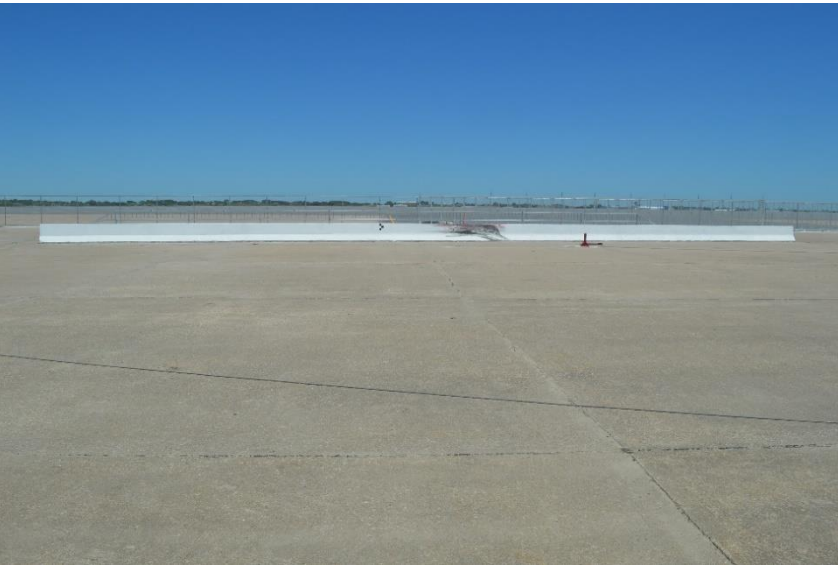
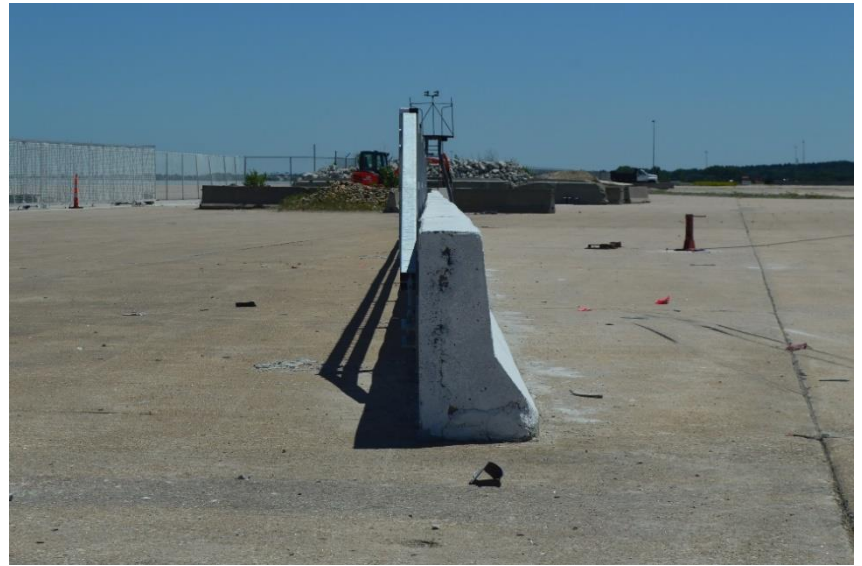
Figure 49. System Damage, Test No. MNPD-3

Damage to the barrier was minimal, as shown in Figures 49 through 58. Barrier damage largely consisted of contact marks, scraping, and gouging of the concrete barrier. The length of vehicle contact along the barrier extended downstream approximately 13 ft – 11 in., starting 14½ in. upstream from the impact point.

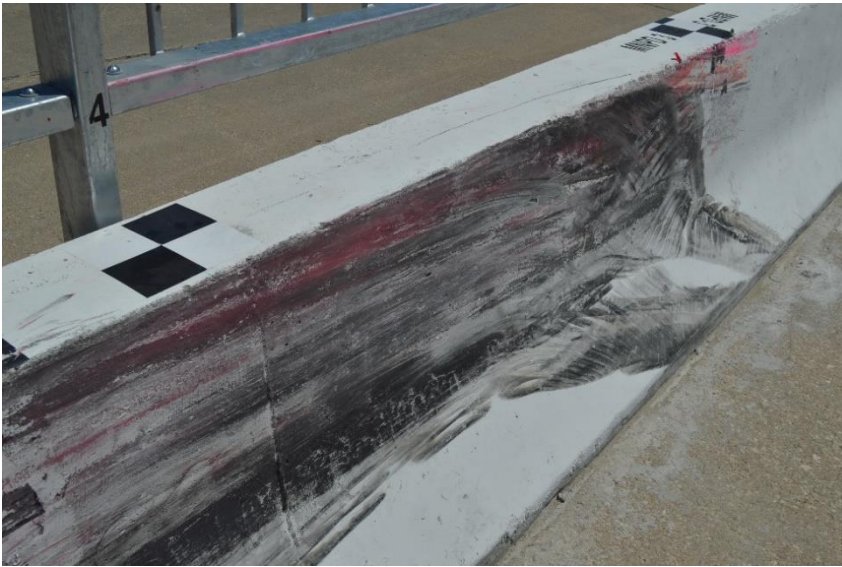
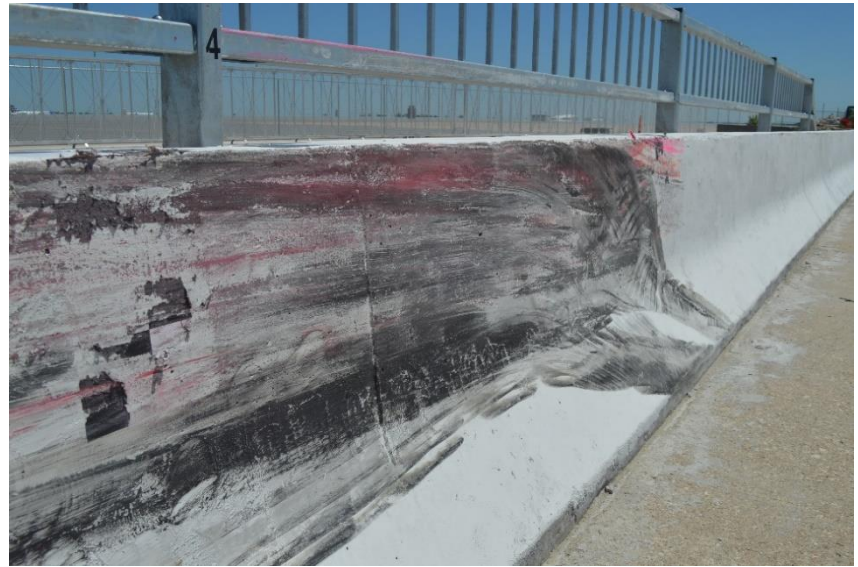
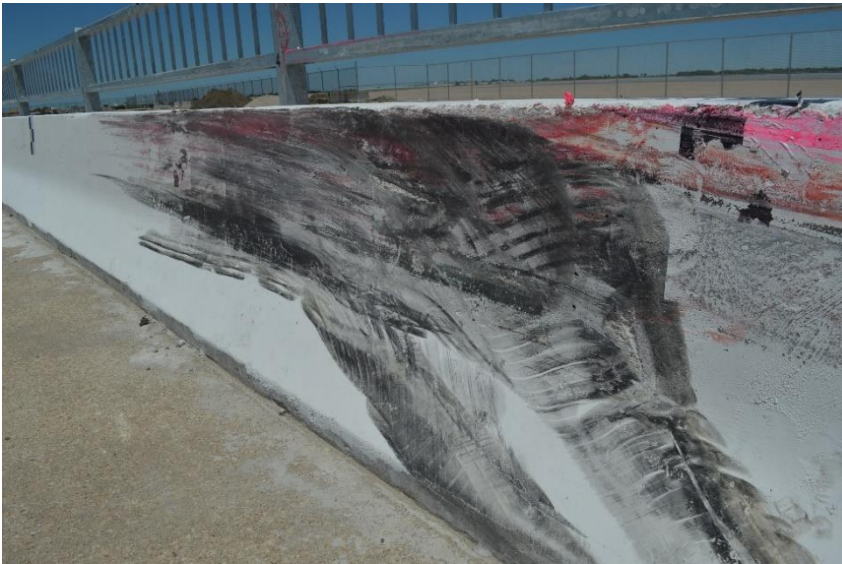
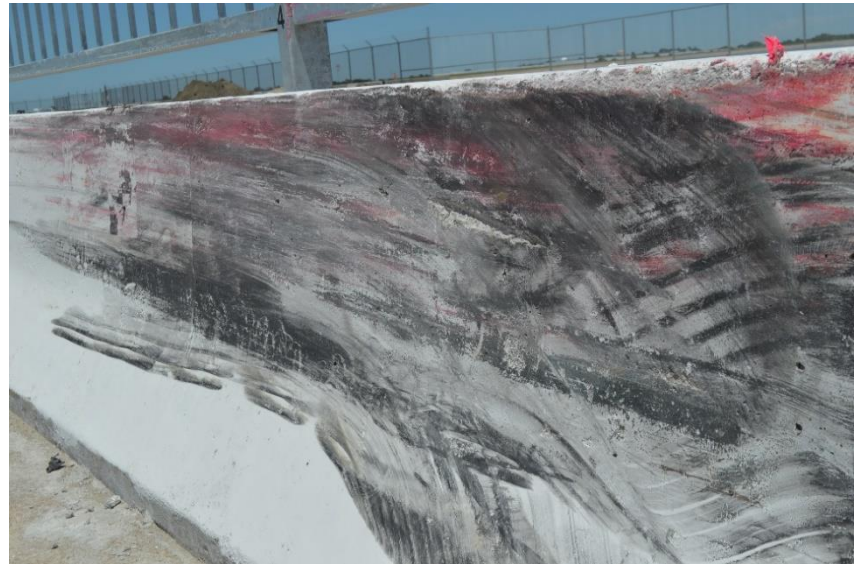
Tire marks were visible on the front face of the J-shape concrete barrier, starting 14½ in. upstream from impact and extending 167 in. downstream across the traffic side of the barrier. Scuff marks were also found along the length of vehicle contact. Gouging was found on the front face of the barrier measuring 4½ in. long and located 15 in. from the top edge and extending 5½ in. downstream from the impact point with a height of 4 in. and a width of ¼ in. Scraping measuring 10 in. long was located 31 in. downstream from the impact point and 7 in. from the top front corner of the concrete barrier with a width of ½ in. Chipping, measuring 2½ in. long, was located 17 in. downstream from the impact point and 13¼ in. below the top front corner of the concrete barrier with a width of ¾ in. Additional chipping, measuring 11¼ in. long, was located on the top traffic-side corner of the concrete barrier 24½ in. downstream from post no. 4 with a height of ¾ in.

Figure 51. Tire Marks and Concrete Gouging, Test No. MNPD-3

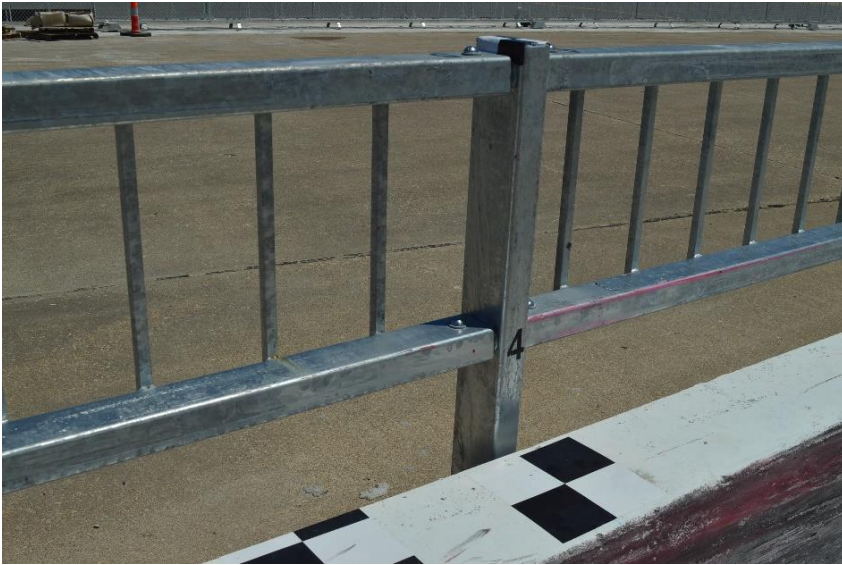
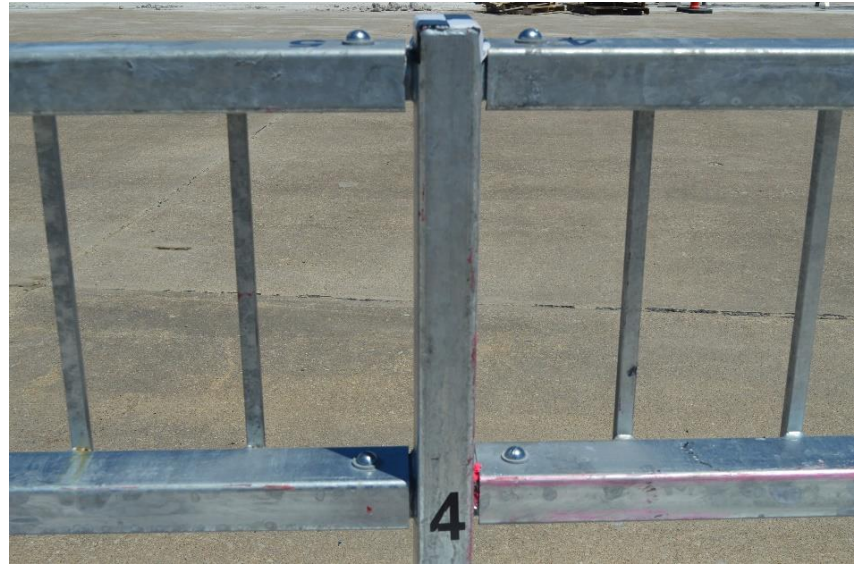
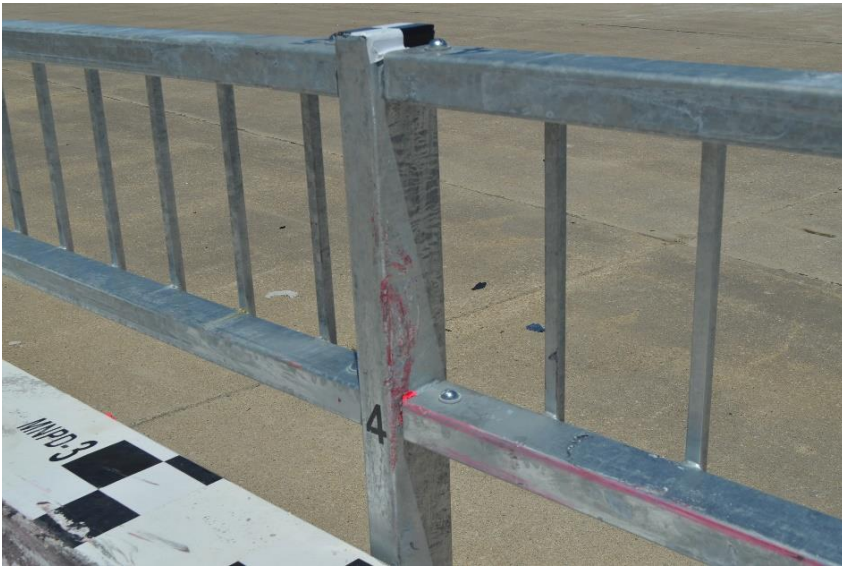
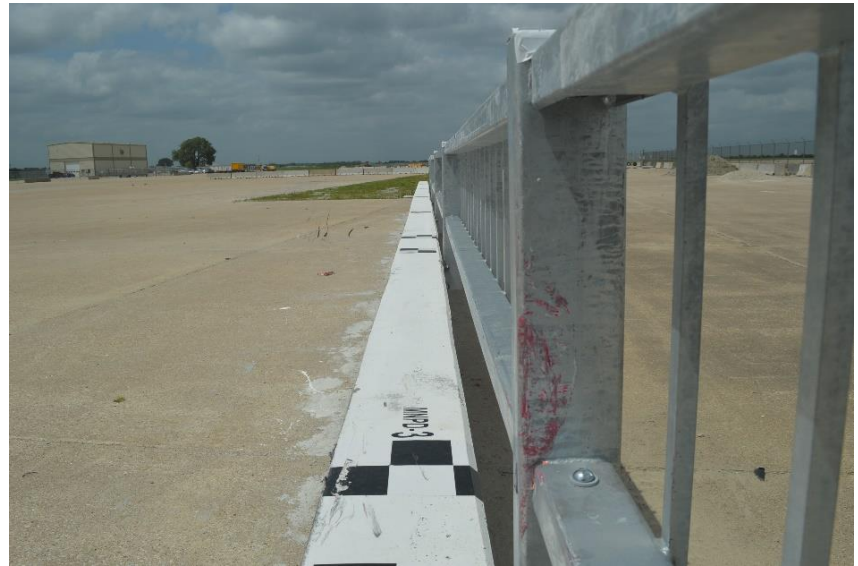
Figure 53. Rail and Post No. 4 Damage, Test No. MNPD-3

Contact marks measuring ¼ in. wide were found on the top corner of the lower rail, starting 23¼ in. upstream from post no. 4 and extending 31¾ in. downstream to the end of the rail. Contact marks ½ in. wide were found on the bottom corner of the lower rail, starting 10½ in. upstream from post no. 4 and extending 8½ in. downstream. Contact marks were found on the front face, near the top corner of the lower rail, starting 5¼ in. downstream from post no. 4 and extending 12 in. downstream. Minor vehicle contact occurred with the first vertical spindle located upstream from post no. 4, as shown in Figures 54 and 55. A small amount of vehicle debris remained on the spindle. Contact marks on the front face of the first spindle upstream from post no. 4 extended upward 7½ in. from the top face of the lower rail, as shown in Figure 53. Contact marks on the upstream face of post no. 4 began 7½ in. from the top and extended 11½ in. downward. A separate contact mark was observed on the downstream face of post no. 4, starting 4¾ in. from the top and extending 1¼ in. downward.

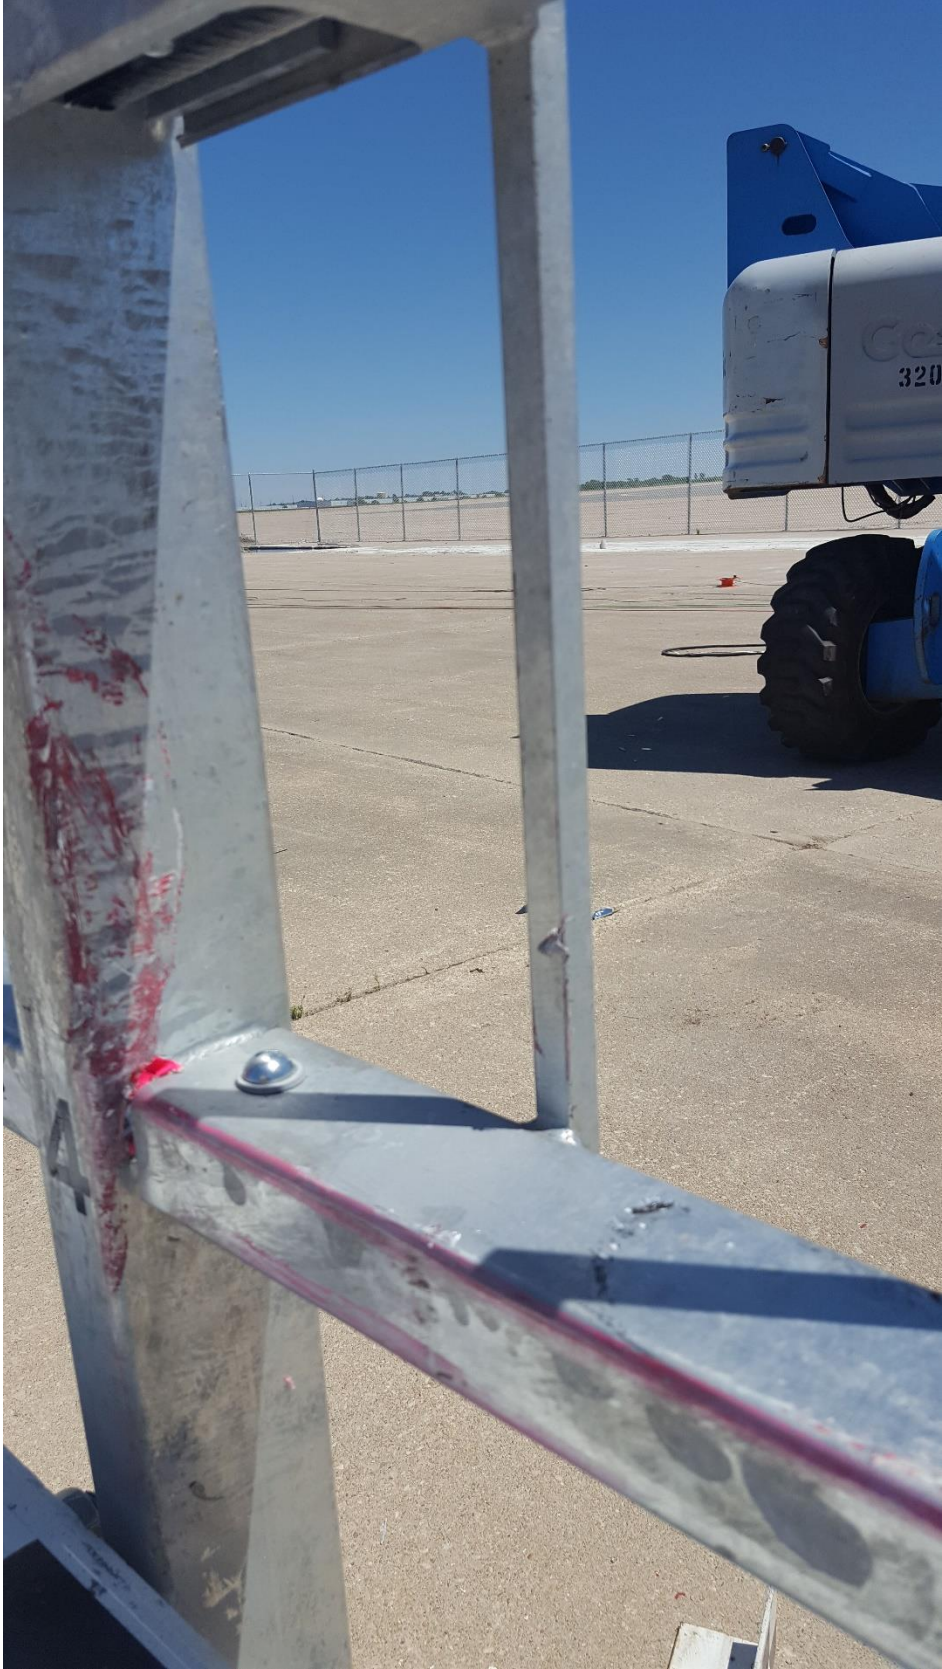
Figure 55. Spindle Contact and Debris, Test No. MNPD-3

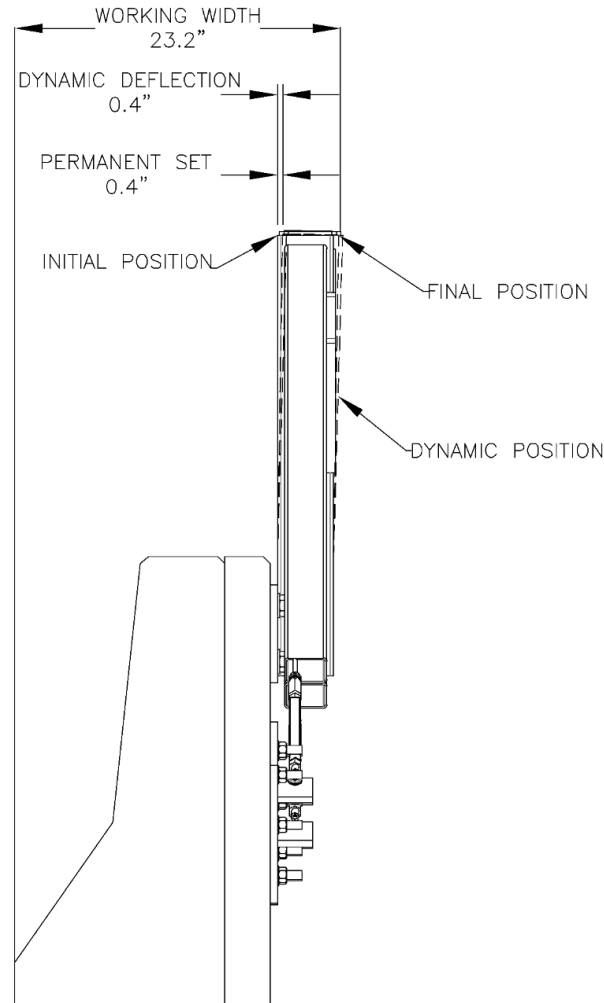
The maximum lateral permanent set of the barrier system was 0.4 in. between post nos. 5 and 6, as measured in the field. The maximum lateral dynamic barrier deflection, including rotation of the metal railing, was 0.6 in. on the upper rail at post no. 6, as determined from high-speed digital video analysis. The working width of the system was found to be 23.2 in., also determined from high-speed digital video analysis. The ZOI was 12¾ in. Barrier deflections are shown schematically in Figure 59.

Figure 59. Permanent Set Deflection, Dynamic Deflection, and Working Width, Test No. MNPD-3

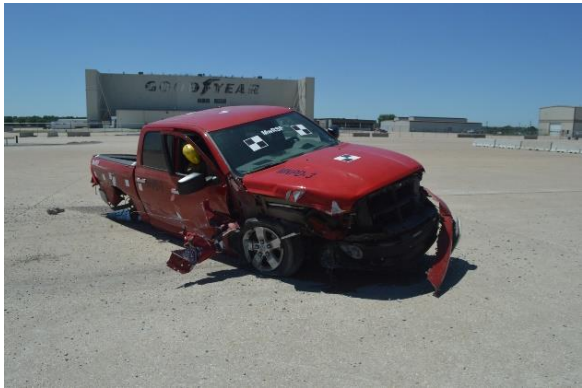
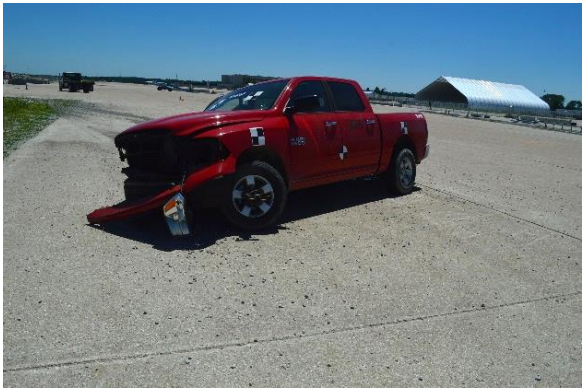
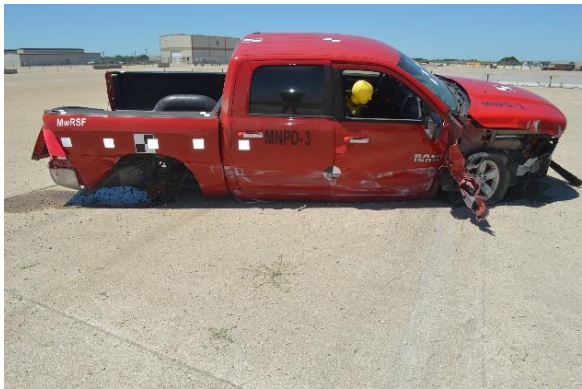
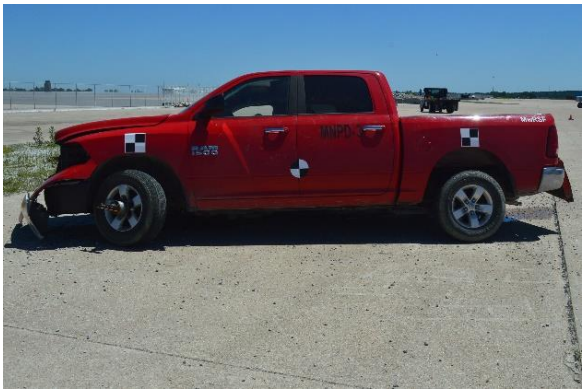
Figure 60. Vehicle Damage, Test No. MNPD-3

The majority of the damage was concentrated on the right-front corner and right side of the vehicle, where impact had occurred, as shown in Figure 60. The vehicle's steel engine hood was deformed across its entirety, and the right edge was deformed inward, as shown in Figures 60, 61, and 62. The left side of the front bumper was pushed downward. The right side of the bumper was crushed inward. The right-front fender was dented, torn front to back, and pushed upward near the

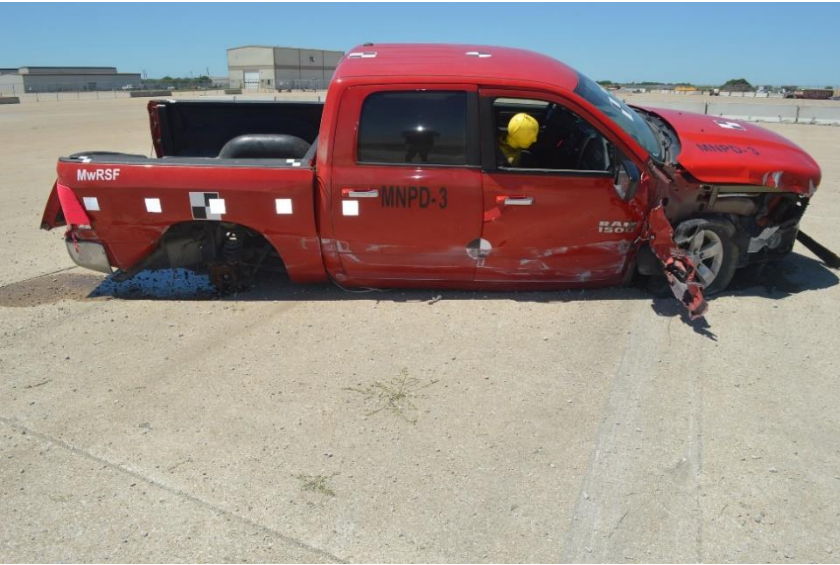
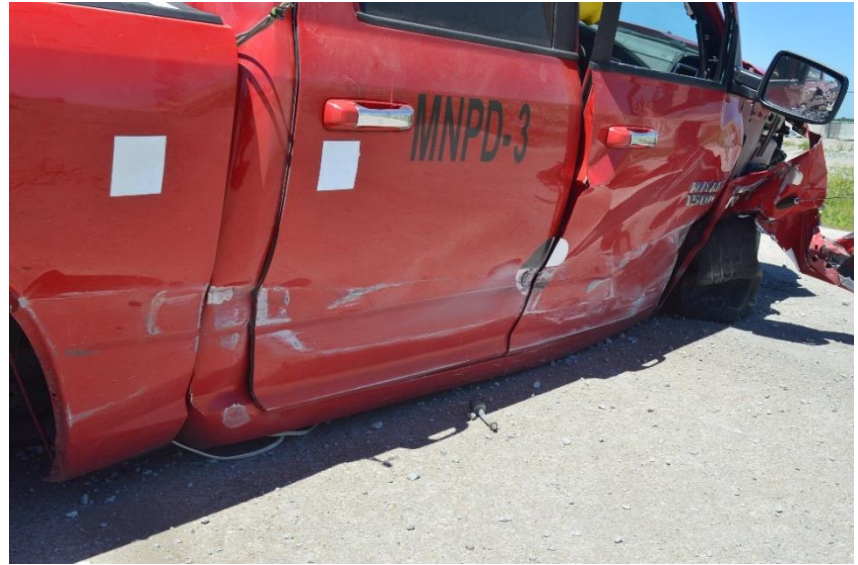
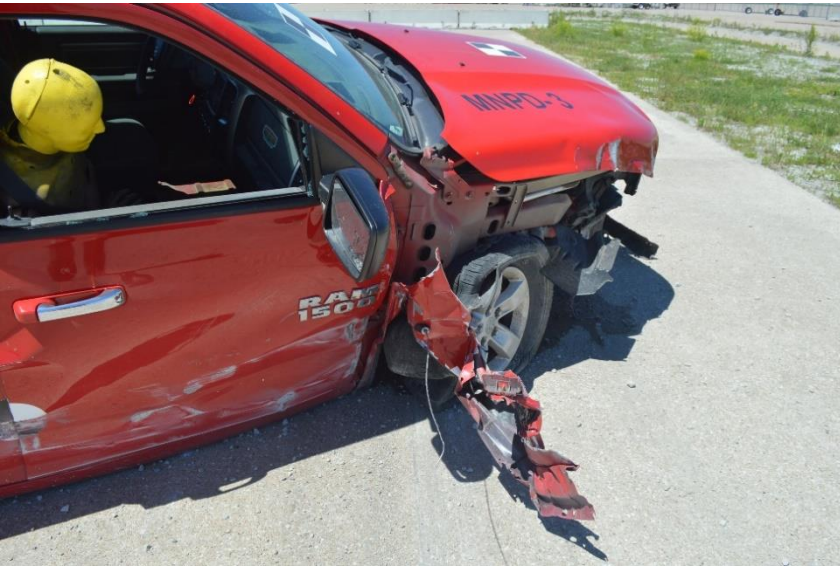
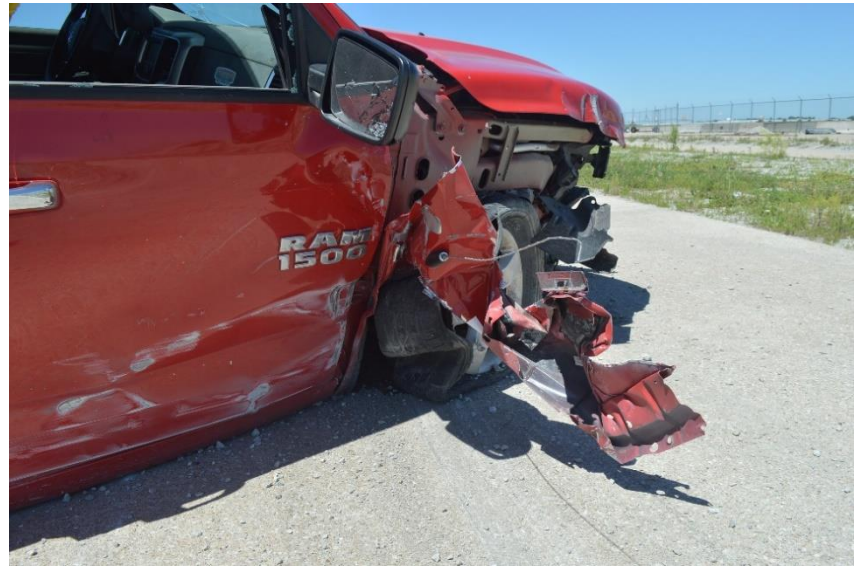
Figure 61. Vehicle Damage, Test No. MNP-3

right-front door, as shown in Figures 61 and 62. The right-front cast aluminum rim was severely deformed, fractured, and crushed, as shown in Figure 62. The grille was pushed backward and fractured around the right-side headlight assembly. The right-side headlight was disengaged from the vehicle, as shown in Figure 62. The right-side, upper control arm was fractured. The right side of the radiator was pushed backward. Denting and scraping were observed across the entire right side. The right-front door was slightly ajar, and creases were found in the door's sheet metal. The right-side window glass shattered, as shown in Figures 61, 62, and 63. The right-rear door was dented and ajar. The right side of the truck bed was dented, and the fuel hatch was ajar. The right-rear wheel detached, as shown in Figure 63. The right side of the rear bumper was torn and pushed downward. The right side of the windshield had a hairline crack, as shown in Figure 67. The roof and remaining window glass remained undamaged.

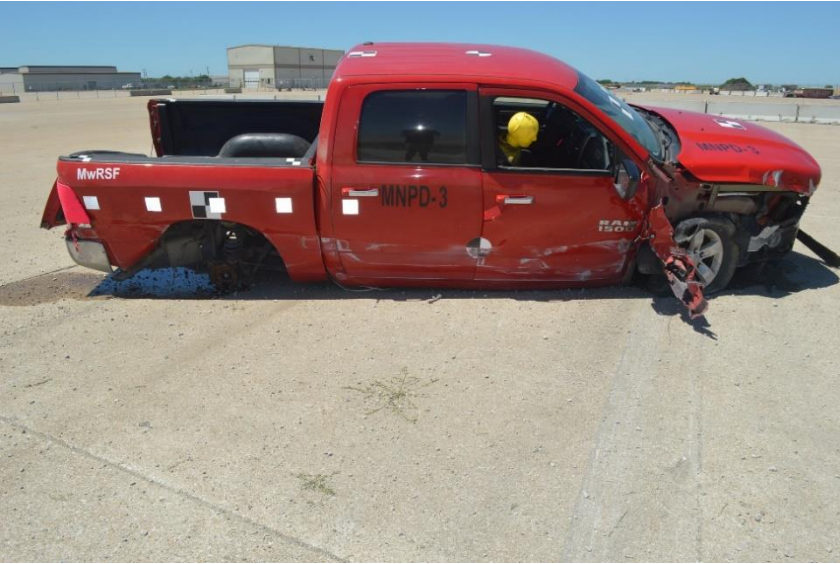
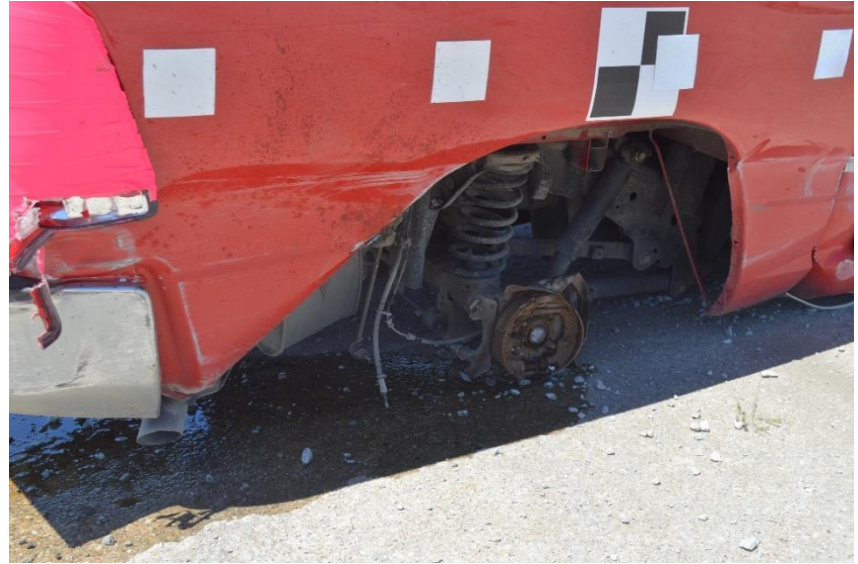
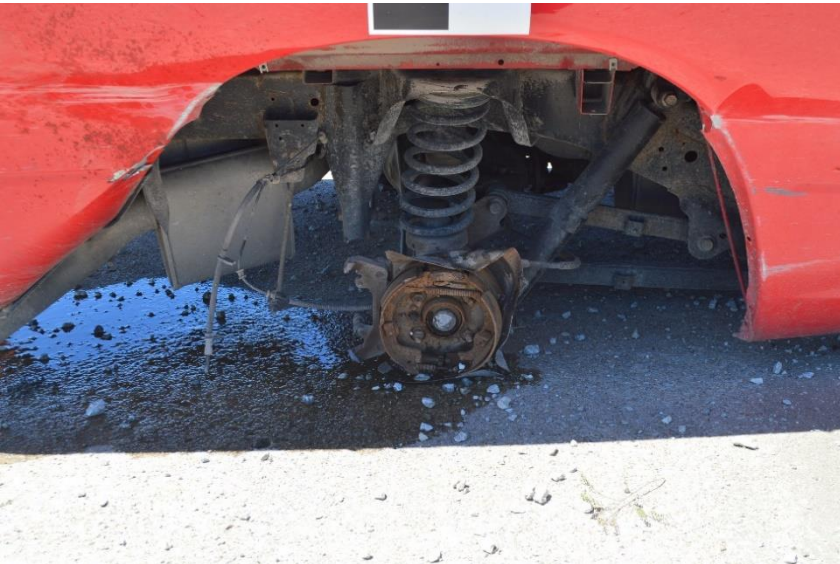
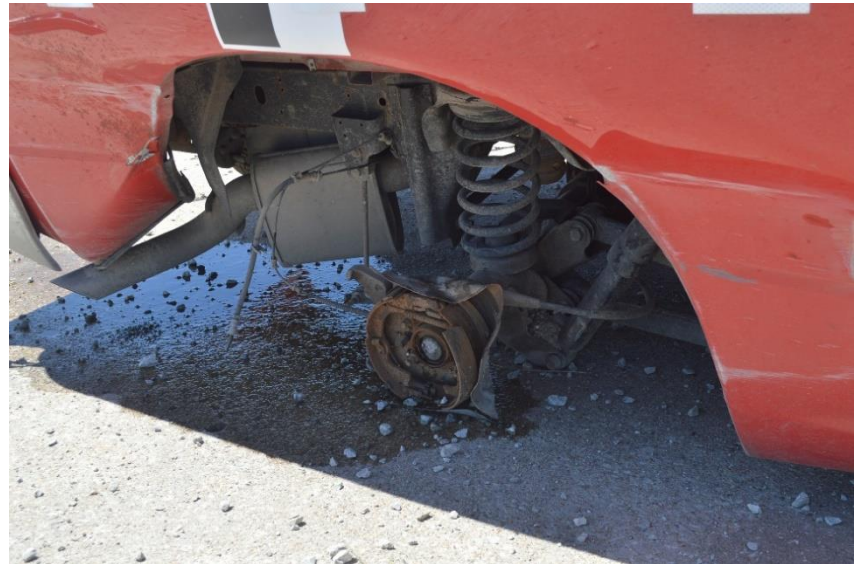
Figure 63. Vehicle Damage, Test No. MNP-3

The damage to the vehicle was moderate, as shown in Figures 60 through 67. The maximum occupant compartment deformations are listed in Table 5 along with the intrusion limits established in MASH 2016 for various areas of the occupant compartment. MASH 2016 defines intrusion or deformation as the occupant compartment being deformed and reduced in size with no observed penetration. There were no penetrations into the occupant compartment, and none of the established MASH 2016 deformation limits were violated. Occupant compartment deformations along with the corresponding locations are provided in Appendix C.

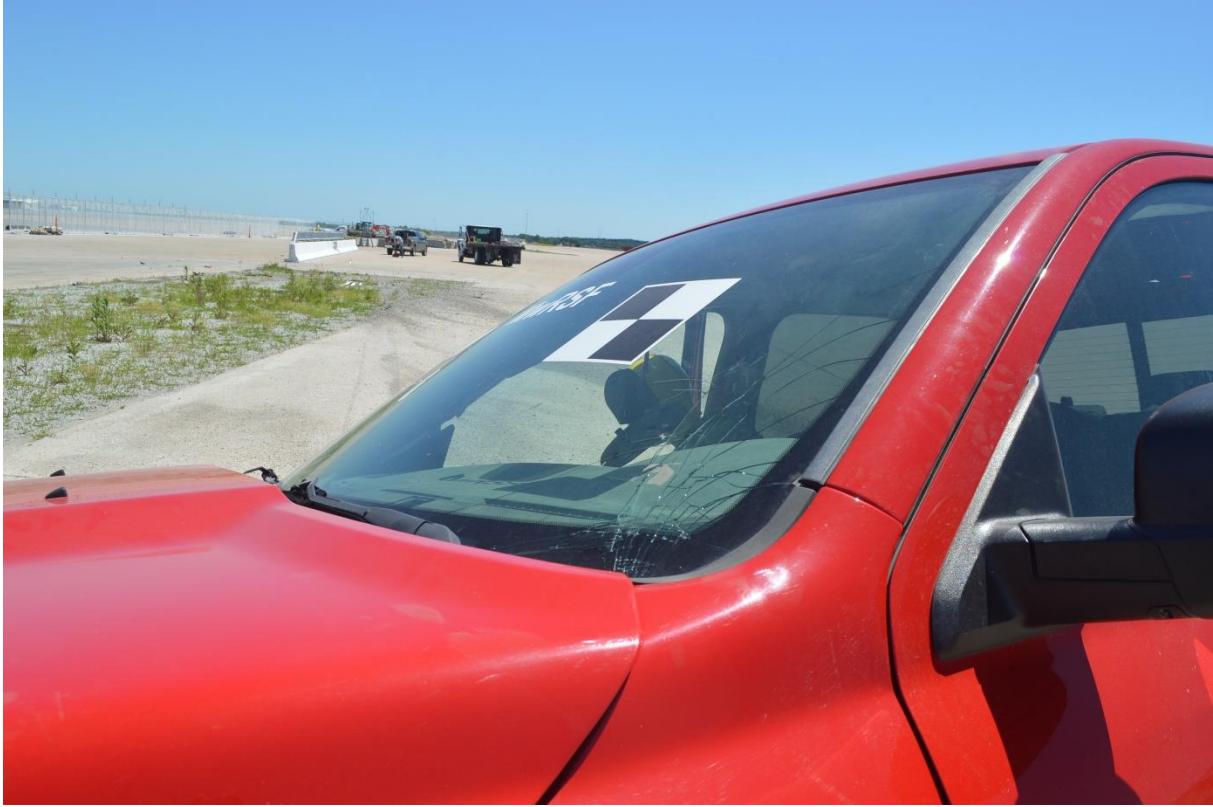
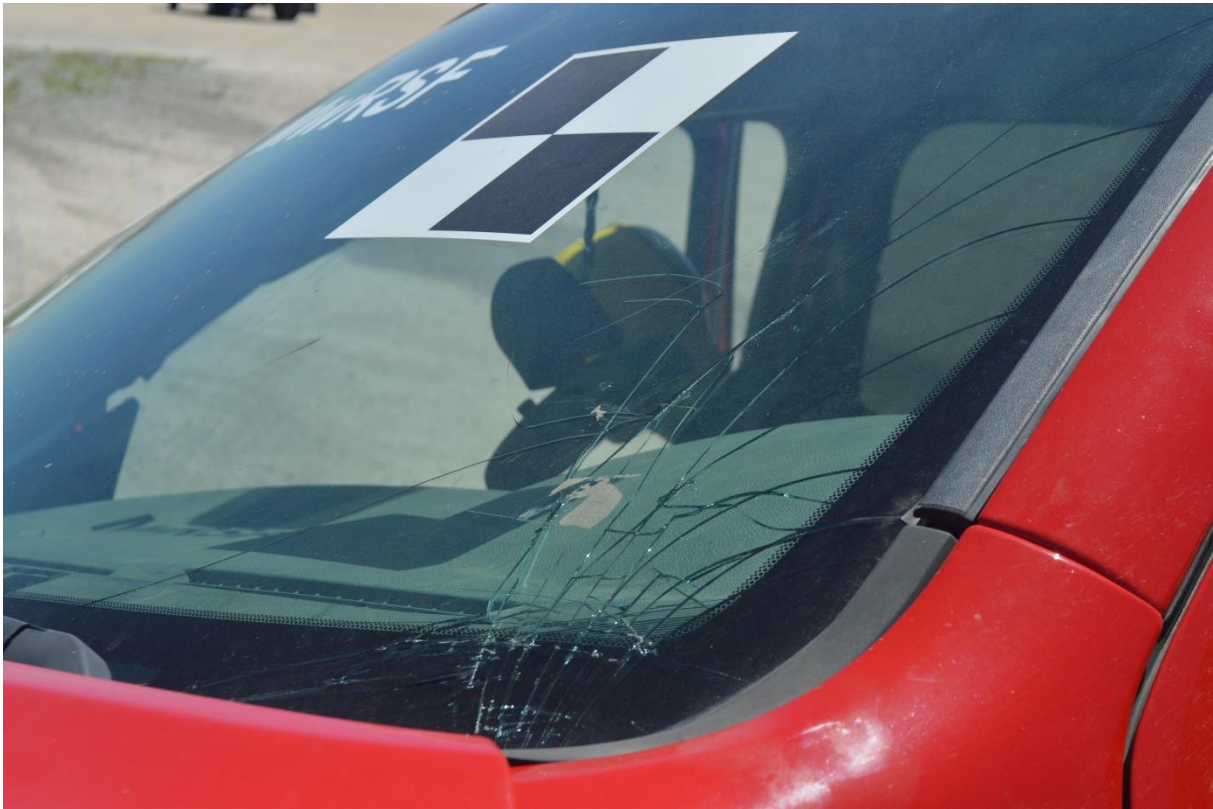
Figure 67. Windshield Damage (Post-Test), Test No. MNPD-3
