*Midwest Pooled Fund Research Program  
Fiscal Years 2017-2019 (Years 27 through 29)  
Research Project Number TPF-5 (193) Supplement #106  
NDOT Sponsoring Agency Code RFPF-17-MGS-2*

## **EVALUATION OF THE MGS PLACED 6 IN. BEHIND A 6-IN. TALL AASHTO TYPE-B CURB TO MASH TL-3**

MWRSF Research Report No. TRP-03-390-20

August 27, 2020

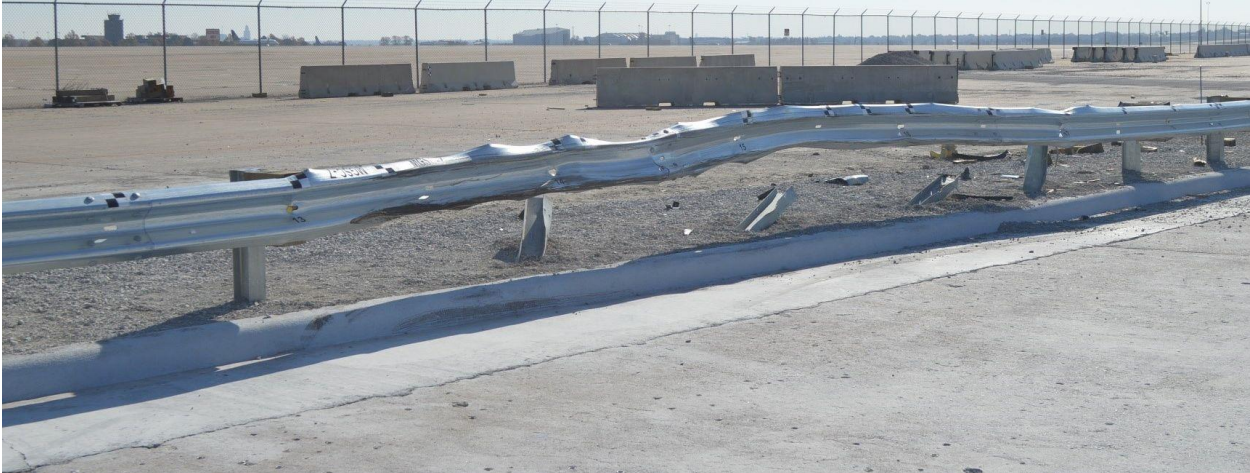
Figure 49. System Damage, Test No. MGSC-7

Damage to the W-beam guardrail with curb system was moderate, as shown in Figures 49 through 57. Damage consisted of contact marks on various MGS components, as well as bending, kinking, tearing, and twisting of the posts and guardrail. The length of vehicle contact along the barrier was approximately 25 ft – 7 in., which spanned from 12 in. downstream from post no. 13 to 19 in. downstream from post no. 17.

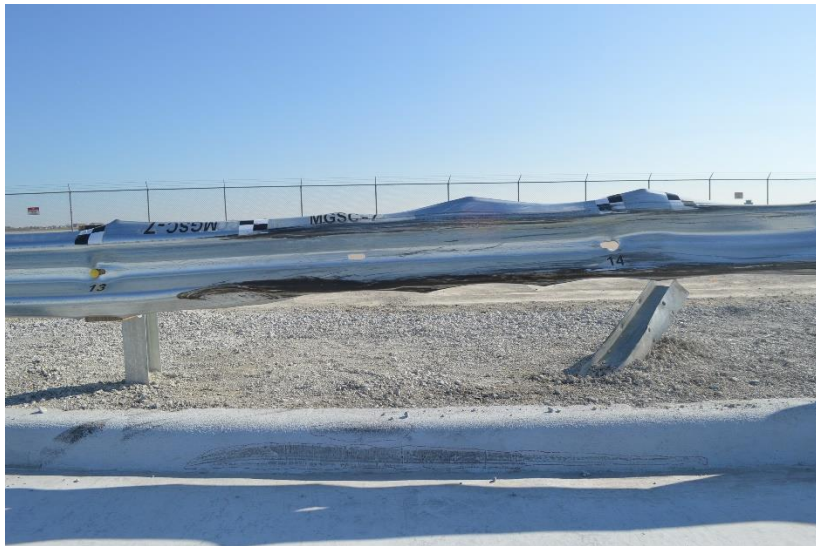
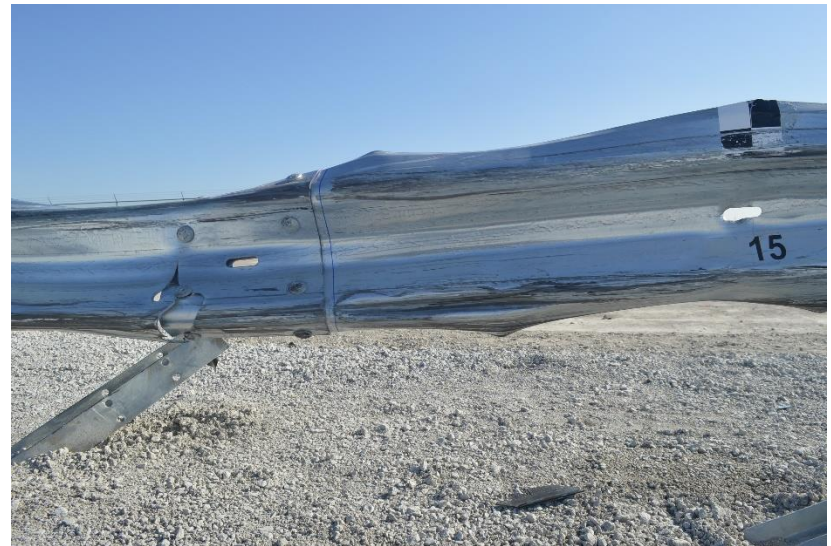
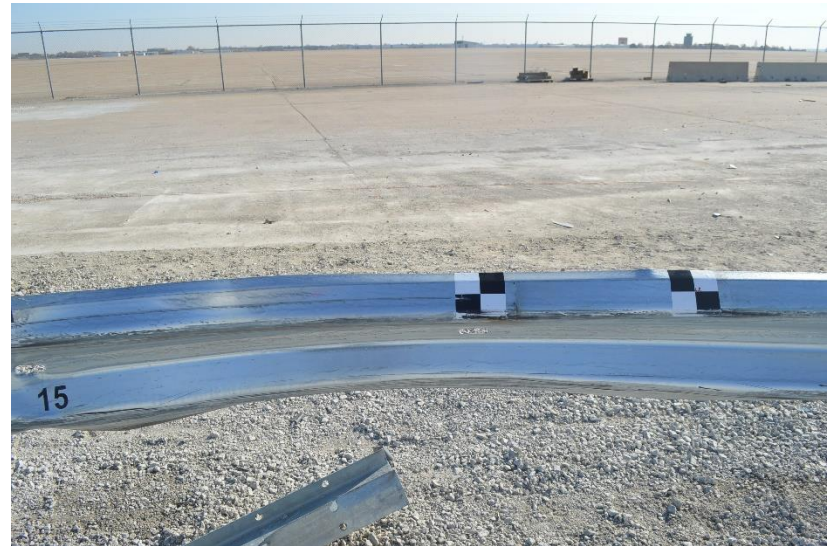
Figure 50. Guardrail Damage, Post Nos. 13 through 15, Test No. MGSC-7

The W-beam guardrail was laterally displaced between post nos. 13 and 17 and was disengaged from post nos. 14 through 17. Rail kinking and flattening was observed at multiple locations along the rail between post nos. 13 and 17. The bottom of the rail was bent upward from post no. 14 to post no. 17. The rail was partially torn at the splice location between post nos. 14 and 15. The tear extended from the bottom edge of the rail, through the lower-upstream bolt holes, and stopped near the middle of the W-beam valley.

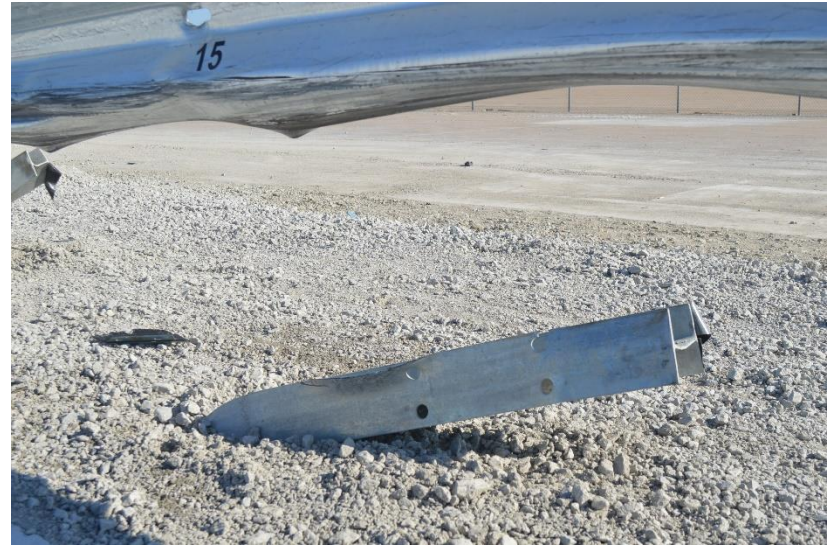
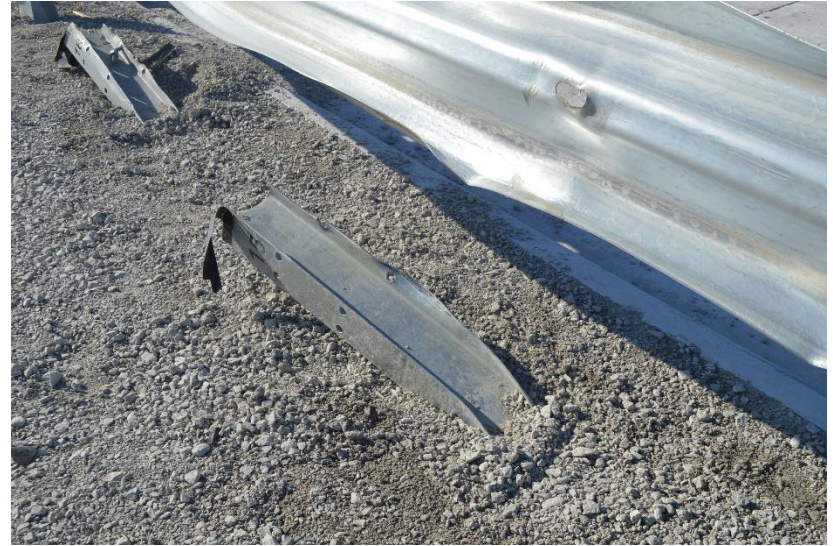
Figure 54. Post Nos. 14 and 15 Damage, Test No. MGSC-7

Post nos. 14 through 16 were bent back and downstream at ground line. Post no. 17 was bent slightly downstream and twisted to face downstream. Soil heaves and craters formed at the bases of post nos. 14 through 17. Contact marks were found on the upstream edge of post nos. 14 through 17. Post nos. 3 through 14, 16, and 17 were twisted to face downstream. Post nos. 1, 2, and 19 through 29 did not deflect and were not damaged.

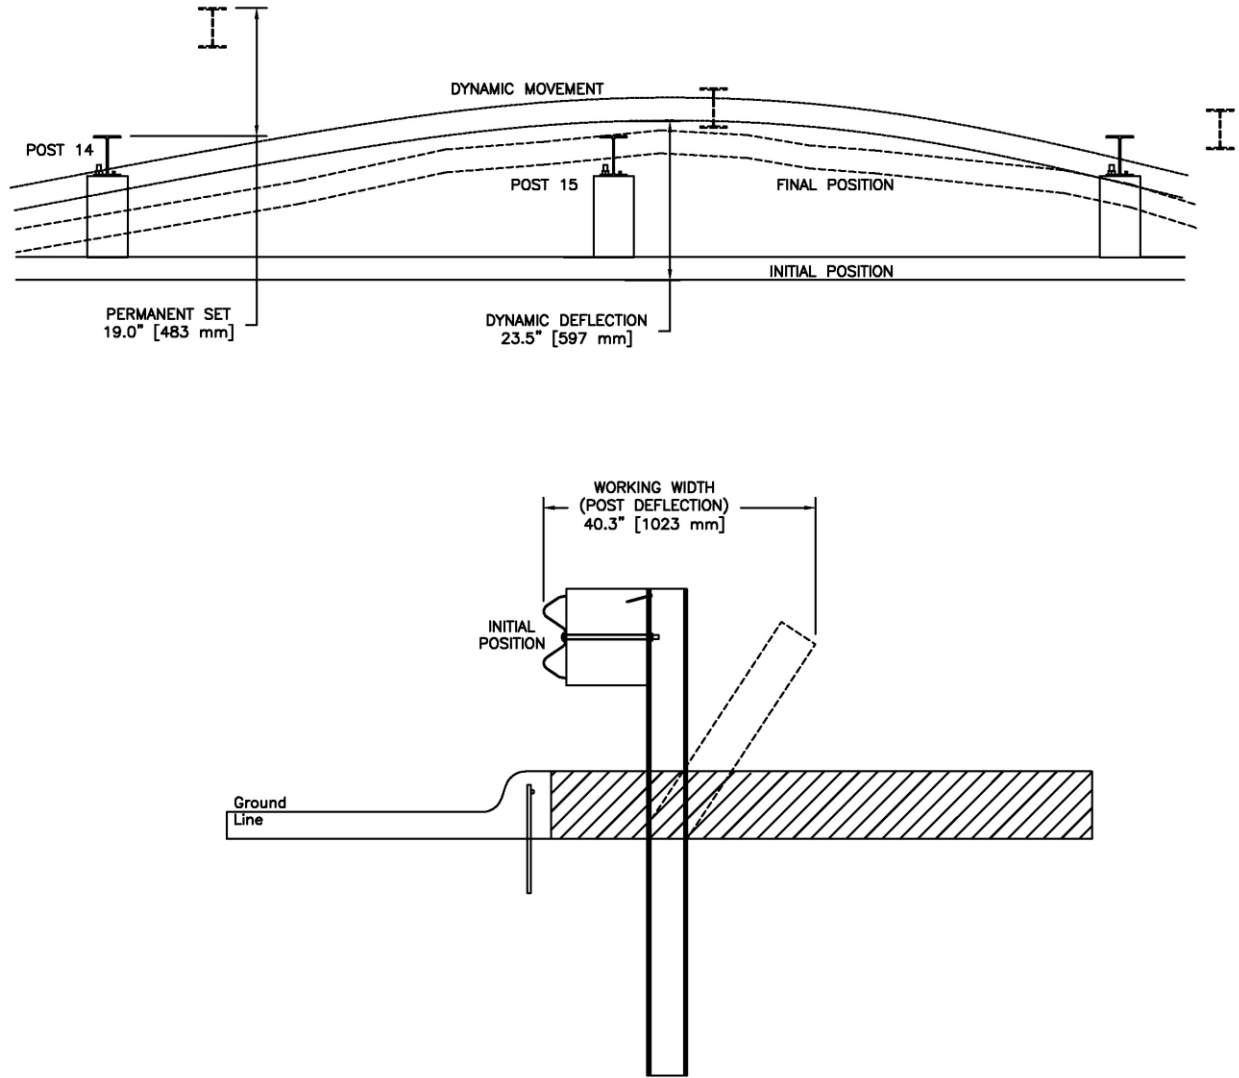
Figure 58. Permanent Deflection, Dynamic Deflection, and Working Width, Test No. MGSC-7

The maximum lateral permanent set of the barrier system was 19.0 in. which occurred at post no. 14, as measured in the field. The maximum lateral dynamic barrier deflection, including deformation of the guardrail along the top surface, was 23.5 in. of the rail at post no. 15, as determined from high-speed digital video analysis. The working width of the system was found to be 40.3 in., determined from video and measurements in the field. A schematic of the permanent set deflection, dynamic deflection, and working width is shown in Figure 58.

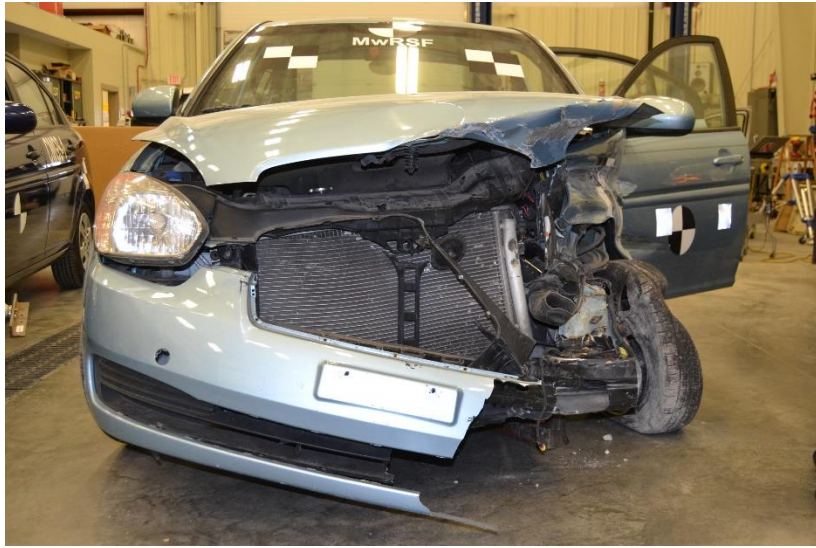
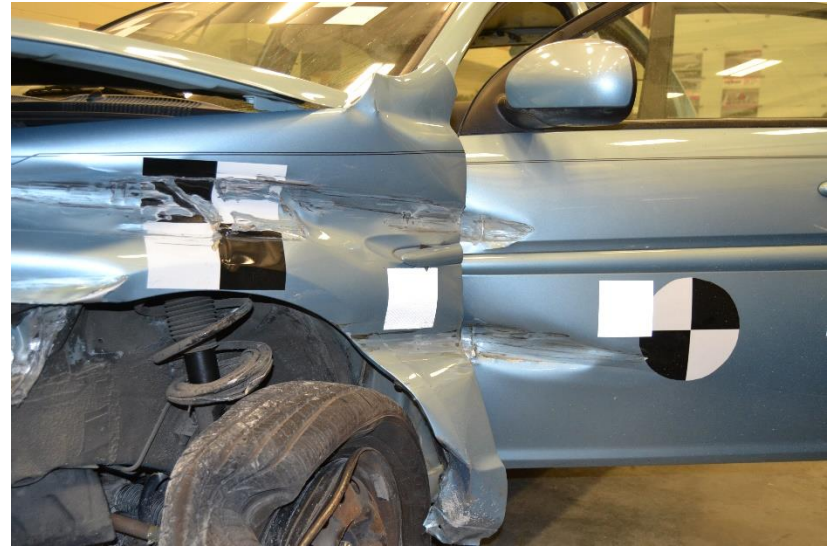
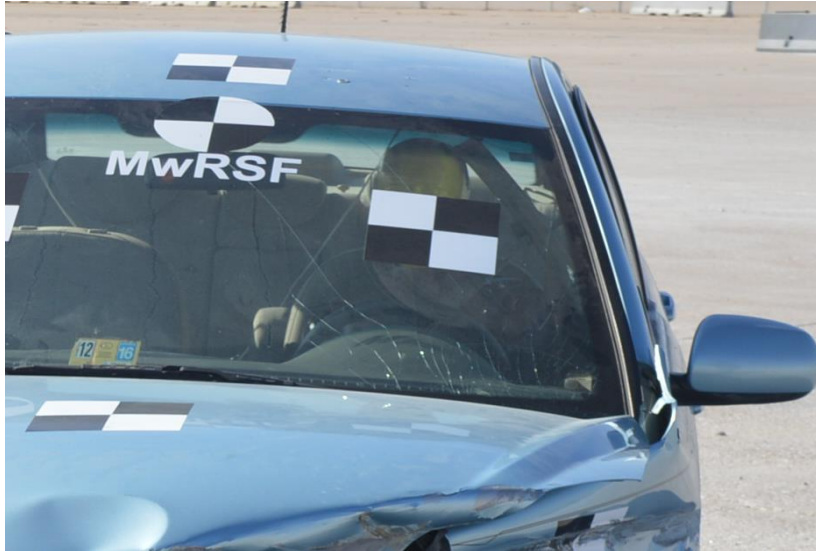
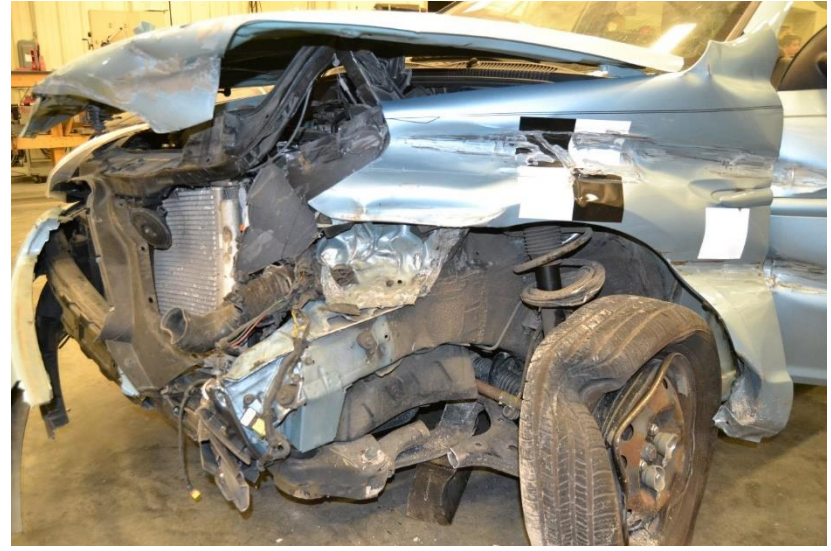
Figure 60. Vehicle Damage, Test No. MGSC-7

The majority of the damage was concentrated at the left-front corner and front end of the vehicle where the impact had occurred. The left-side of the bumper cover was ripped and detached starting 8 in. left of bumper center. The left-front bumper corner was crushed inward and down. The left-side of the radiator core support was displaced. The left-front hood was folded under and pushed in. The left-front fender was bent inward 10 in., and the bottom of the fender protruded outward 5 in. The left-front frame rail was split and crushed backward. The left-front tire was torn, and the wheel rim was bent at three locations. The left-front door was dented near the front and the latch was damaged. The windshield was cracked at the bottom left-front corner, but the roof and remaining window glass were undamaged.

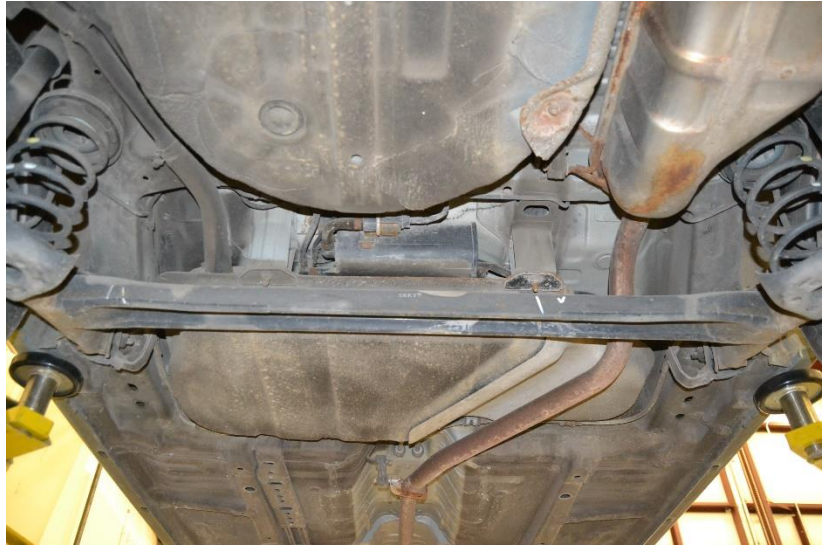
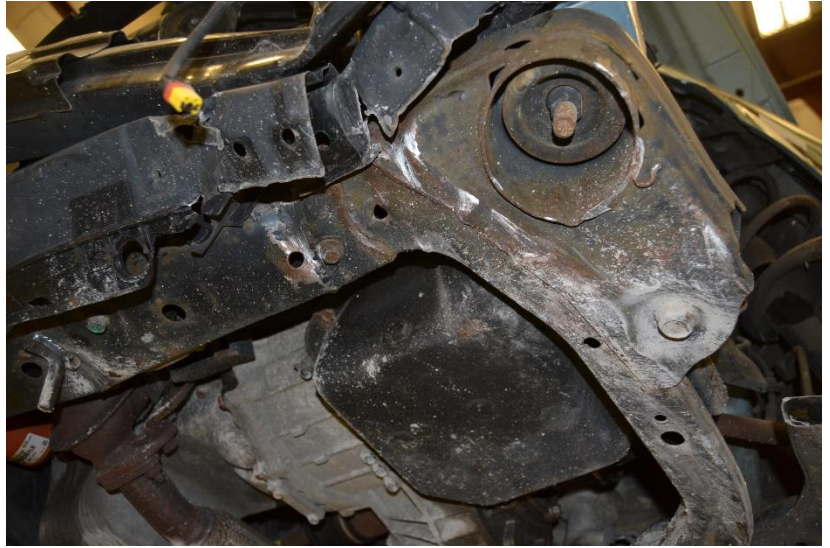
Figure 62. Vehicle Undercarriage Damage, Test No. MGSC-7

The left-front sway bar was bent upward approximately 2 in. and was in contact with the lower control arm. The left lower control arm was torn 6 in. from the center of the king pin and pulled outward 3 in. The left tie-rod was in contact with the left-front tire rim. A 2¾-in. by 6-in. scrape was found on the oil pan. Scrapes were found at multiple locations on the engine and transmission cross members. The left frame horn was crushed inward 6 in. and pushed down.

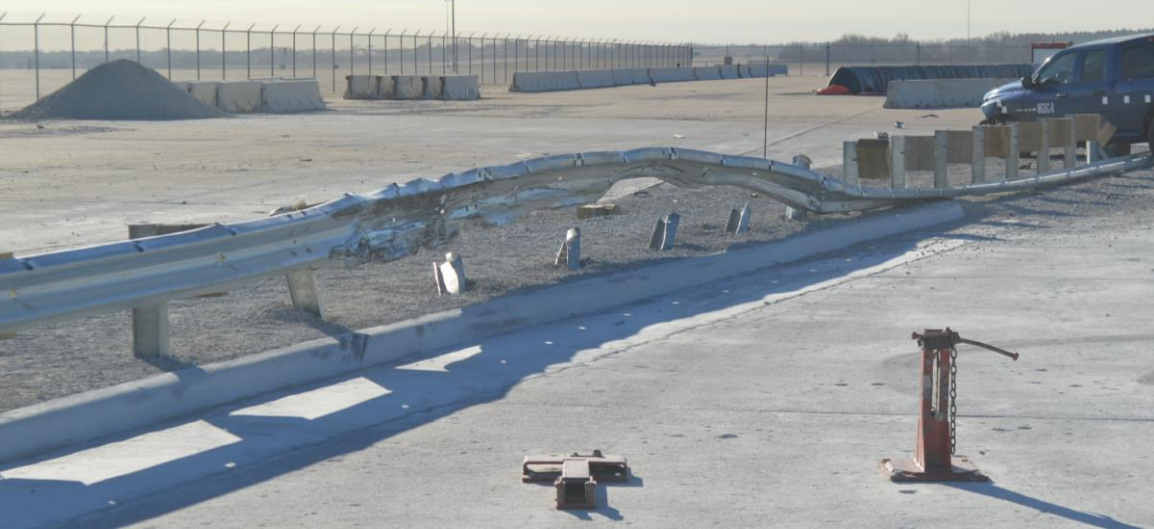
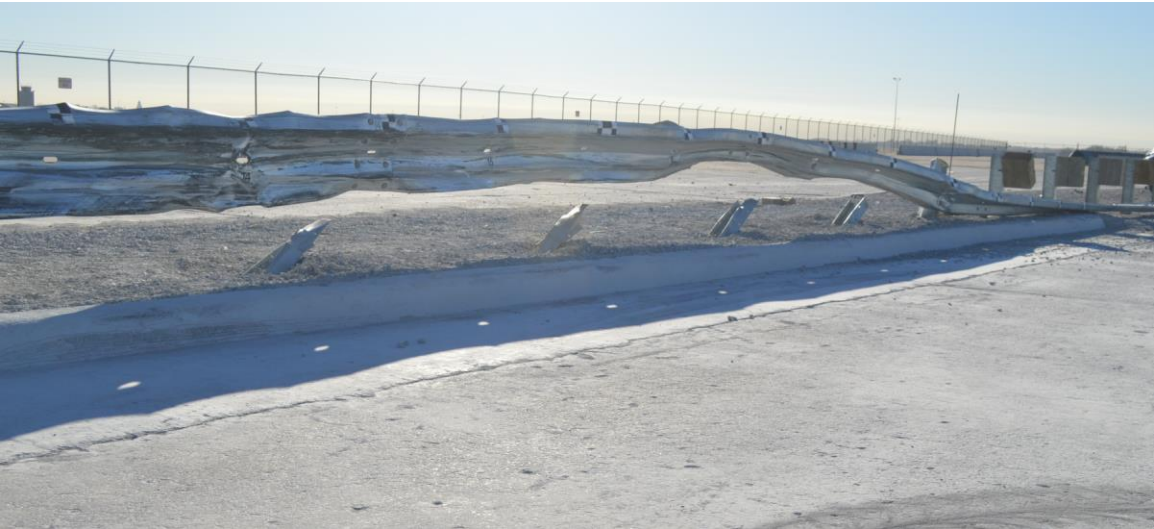
Figure 71. System Damage, Test No. MGSC-8

The most significant post displacements and deformations spanned from post no. 13 to post no. 18. Soil gaps formed at the bases of post nos. 6 through 8, 10, 12, and 22. Soil heaves and craters formed at the bases of post nos. 14 through 19, and additional soil heaves were found at post nos. 26 and 27. Post no. 13 was bent backward and twisted downstream. Blockouts disengaged from post nos. 14 through 17. Each post in this range was bent backward and downstream in addition to being twisted to face upstream. Post no. 18 was bent backward and downstream while being twisted to face downstream. The blockouts of post nos. 18 through 23 had rotated about the attachment bolt. Post nos. 26 and 17 were bent backward and downstream, and post no. 28, which was a BCT post within the downstream anchorage, fractured off at ground level.

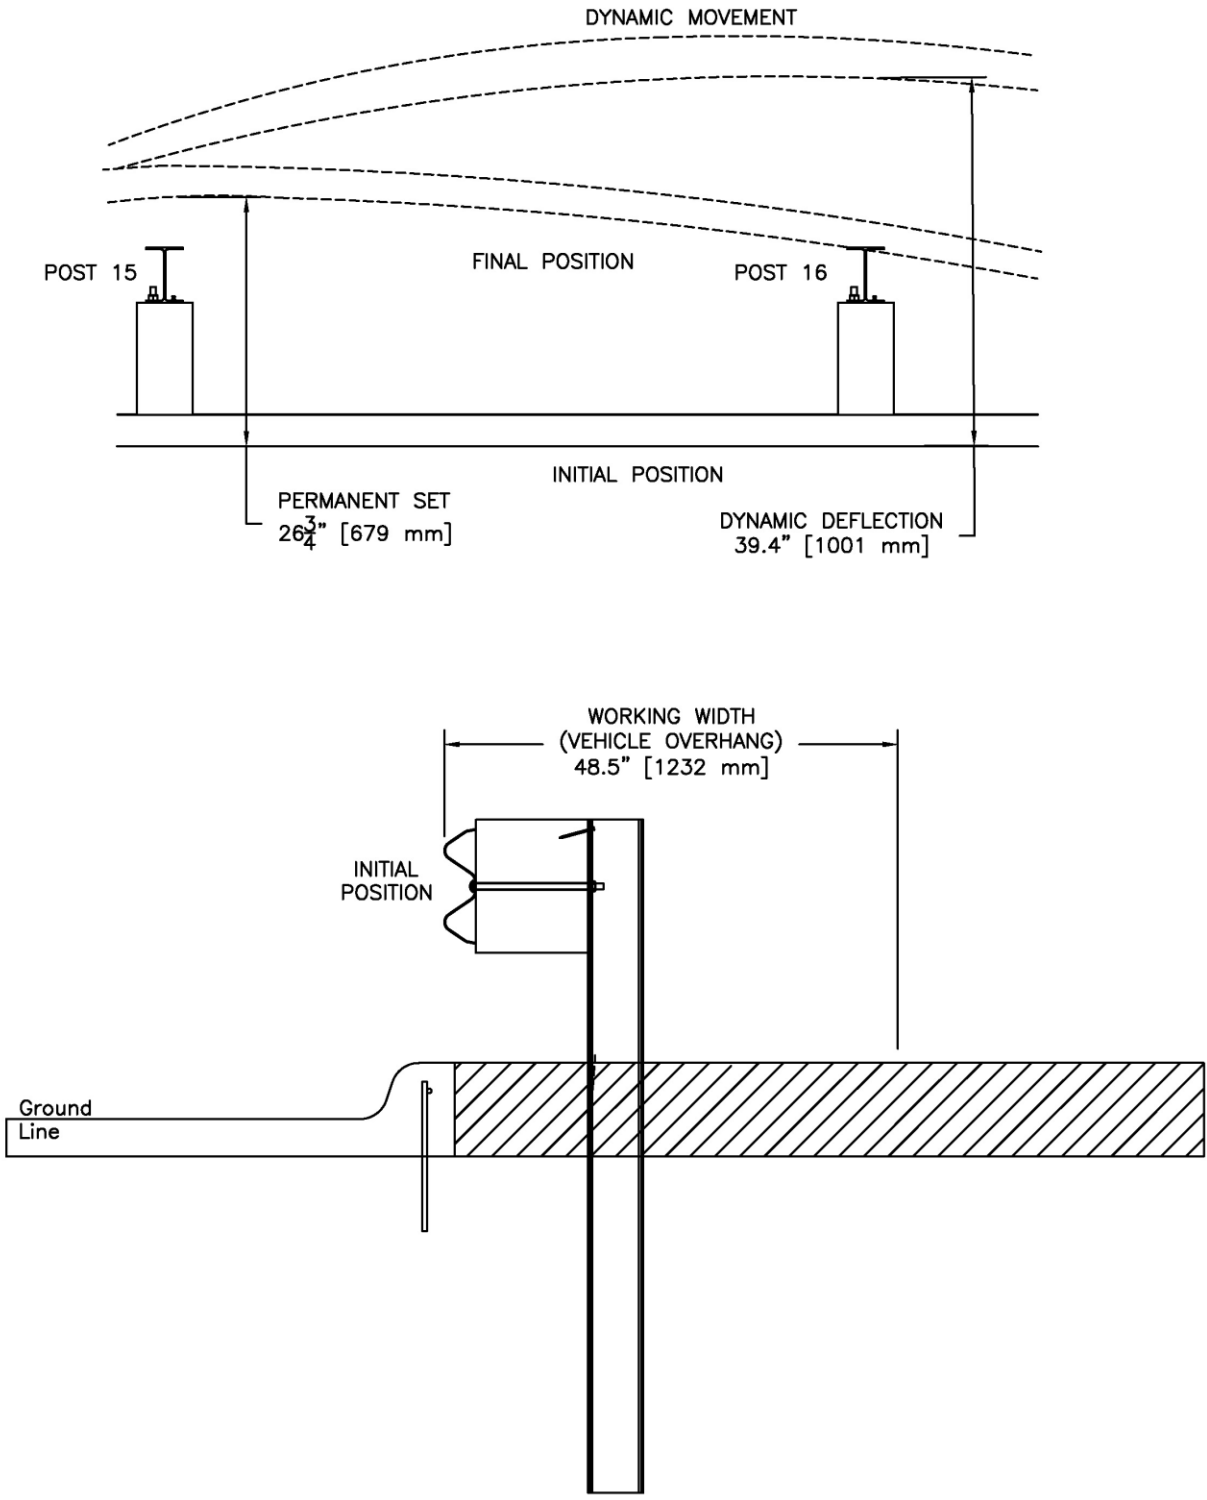
Figure 80. Permanent Deflection, Dynamic Deflection, and Working Width, Test No. MGSC-8

The maximum lateral permanent set of the barrier system was 26¾ in., which occurred on the guardrail located at post no. 15, as measured in the field. The maximum lateral dynamic barrier deflection was 39.4 in. measured on the guardrail at post no. 16, as determined from high-speed digital video analysis. The working width of the system was found to be 48.5 in., also determined from high-speed digital video analysis. A schematic of the permanent set deflection, dynamic deflection, and working width is shown in Figure 80.

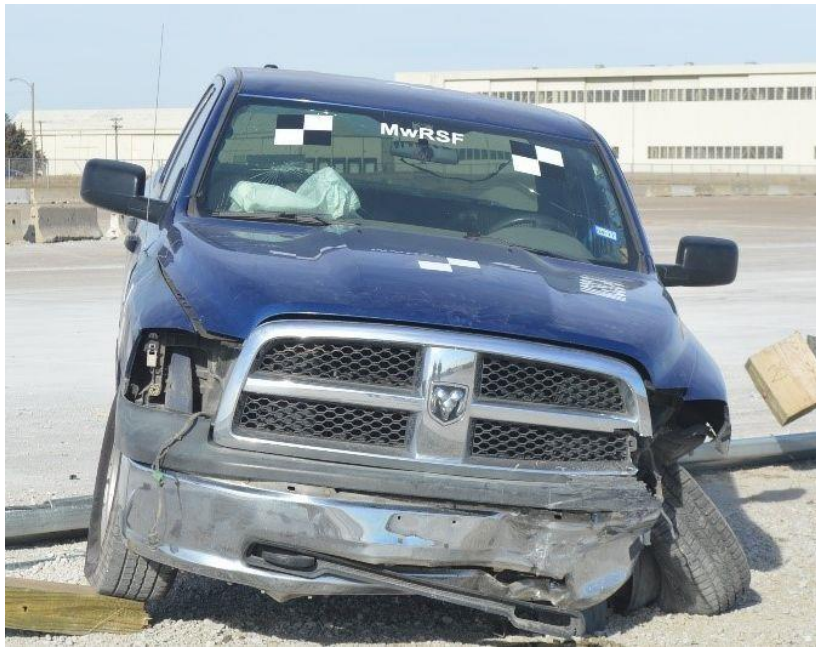
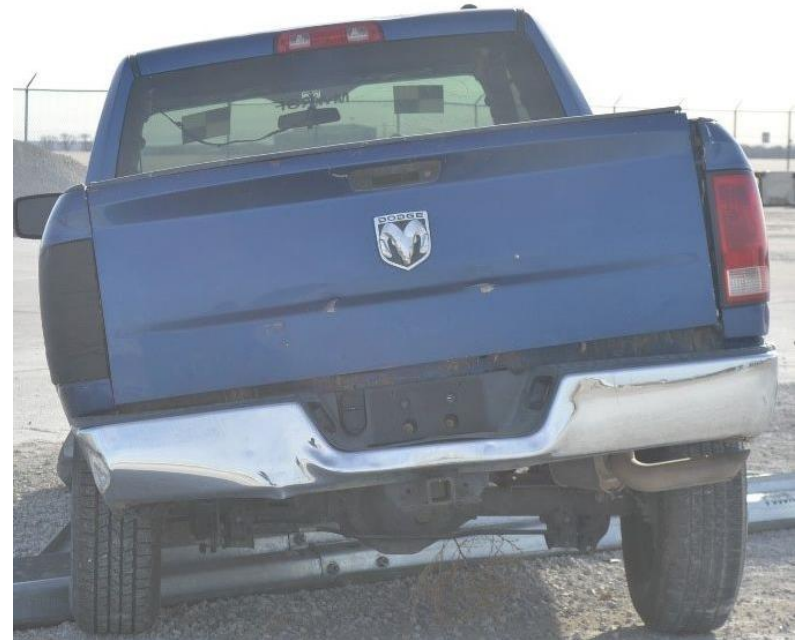
Figure 81. Vehicle Damage, Test No. MGSC-8

The majority of the damage was concentrated at the left-front corner of the vehicle where impact occurred. The left-front bumper was deformed inward toward the engine, and the grille was partially fractured and disengaged from the vehicle. Both front headlights were disengaged. The left-front fender was bent and torn, and the left-front tire sidewall was torn. The wheel rim was bent at several locations. Several minor dents were found on both the left-front and left-rear vehicle doors. Scrapes extended from the left-front fender to the rear bumper along the left side of the vehicle. The left-rear bumper was dented inward. The windshield was cracked at mid-height on the right side due to contact from the vehicle airbag. Additional cracks in the windshield extended outward from the bottom left corner of the windshield. The roof and remaining windows were undamaged.
