**MARYLAND DEPARTMENT OF TRANSPORTATION
STATE HIGHWAY ADMINISTRATION**

**Highway Rock Cut Inventory and Failure Potential,
Allegany County, Maryland**

FINAL REPORT

May 2020

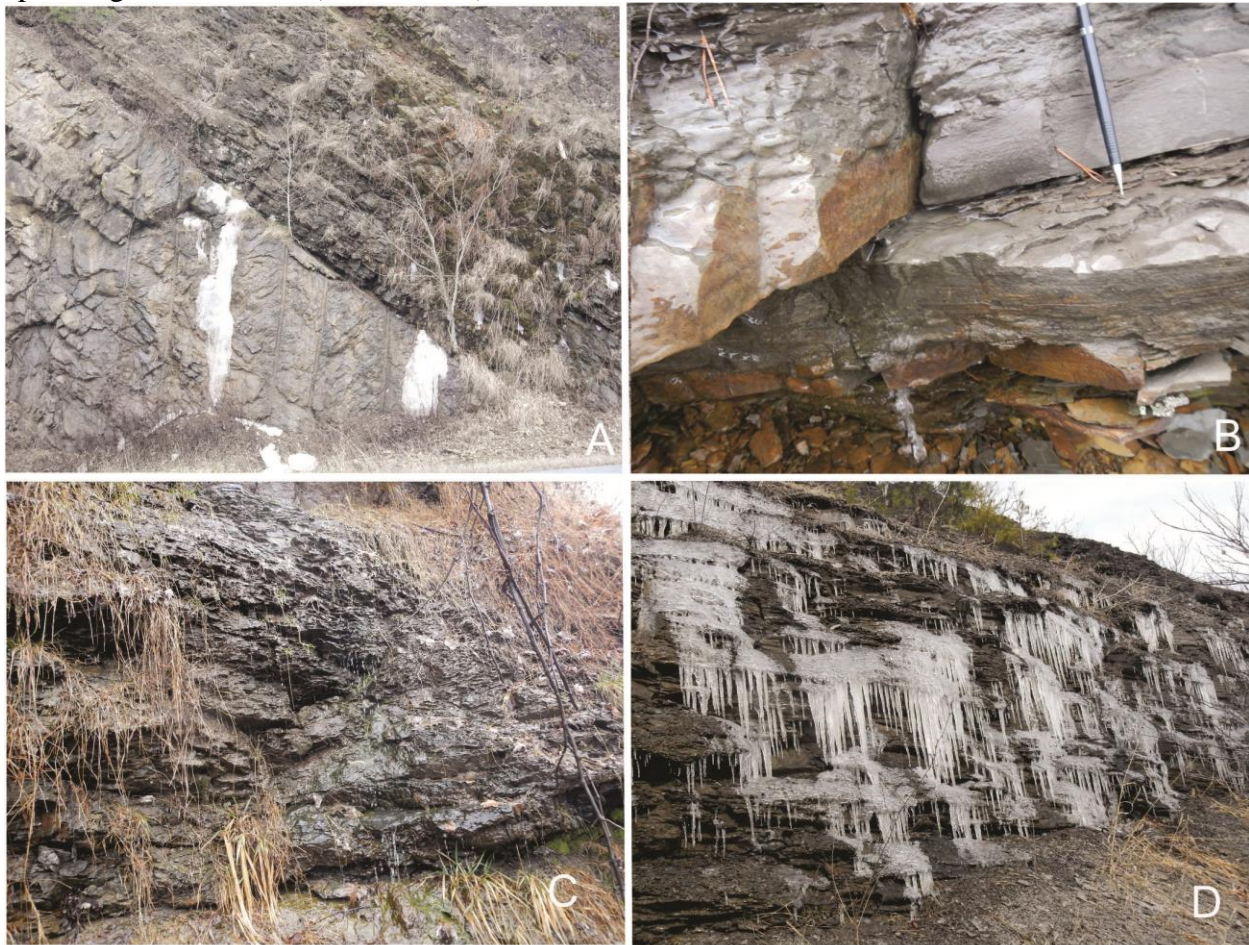
Water seeping from or running on rock slopes constitutes a significant secondary contributing factor to roadside slope failure potential for several reasons (Figure 7). Most importantly, water can serve as a lubricant that reduces friction between rock layers and along fractures and parting surfaces. This reduced friction, especially where failure planes are steeply inclined, can contribute to the triggering of slope failure events. Where subvertical, fractures can increase the conductivity of the water downward into subsurface stratification planes and reduce friction along those surfaces.

Figure 7. Degrees of variation in the amount and distribution of water on roadside slopes. A, Water seeps along stratification. B, Water seeping along joints and fractures. C, D, Water covering the surface of outcrops.

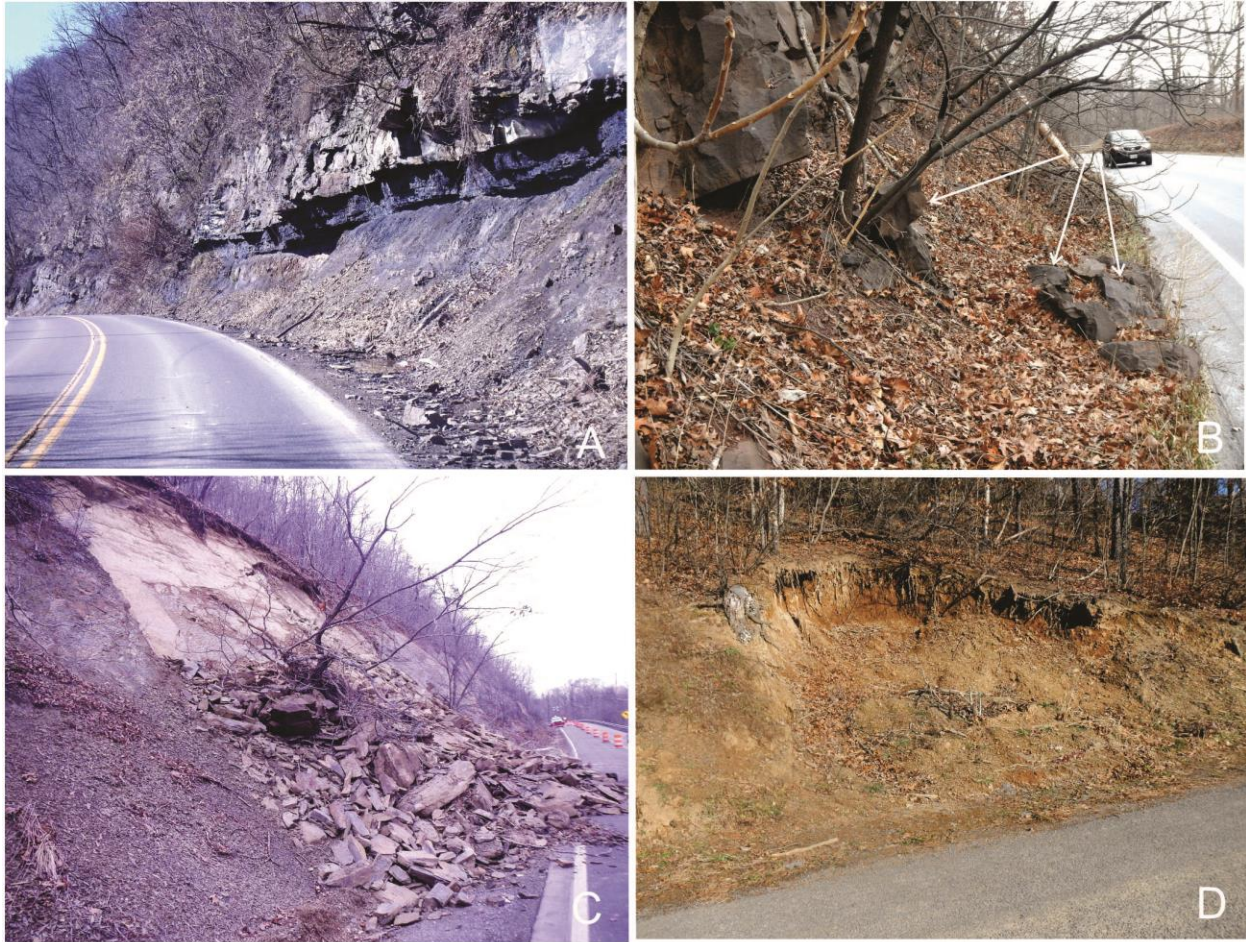
Figure 10. Type of slope failures and resulting hazards identified during this study. A, Rockfall. B, Rock roll. C, Rock slide. D, Slump (rotation) scar.

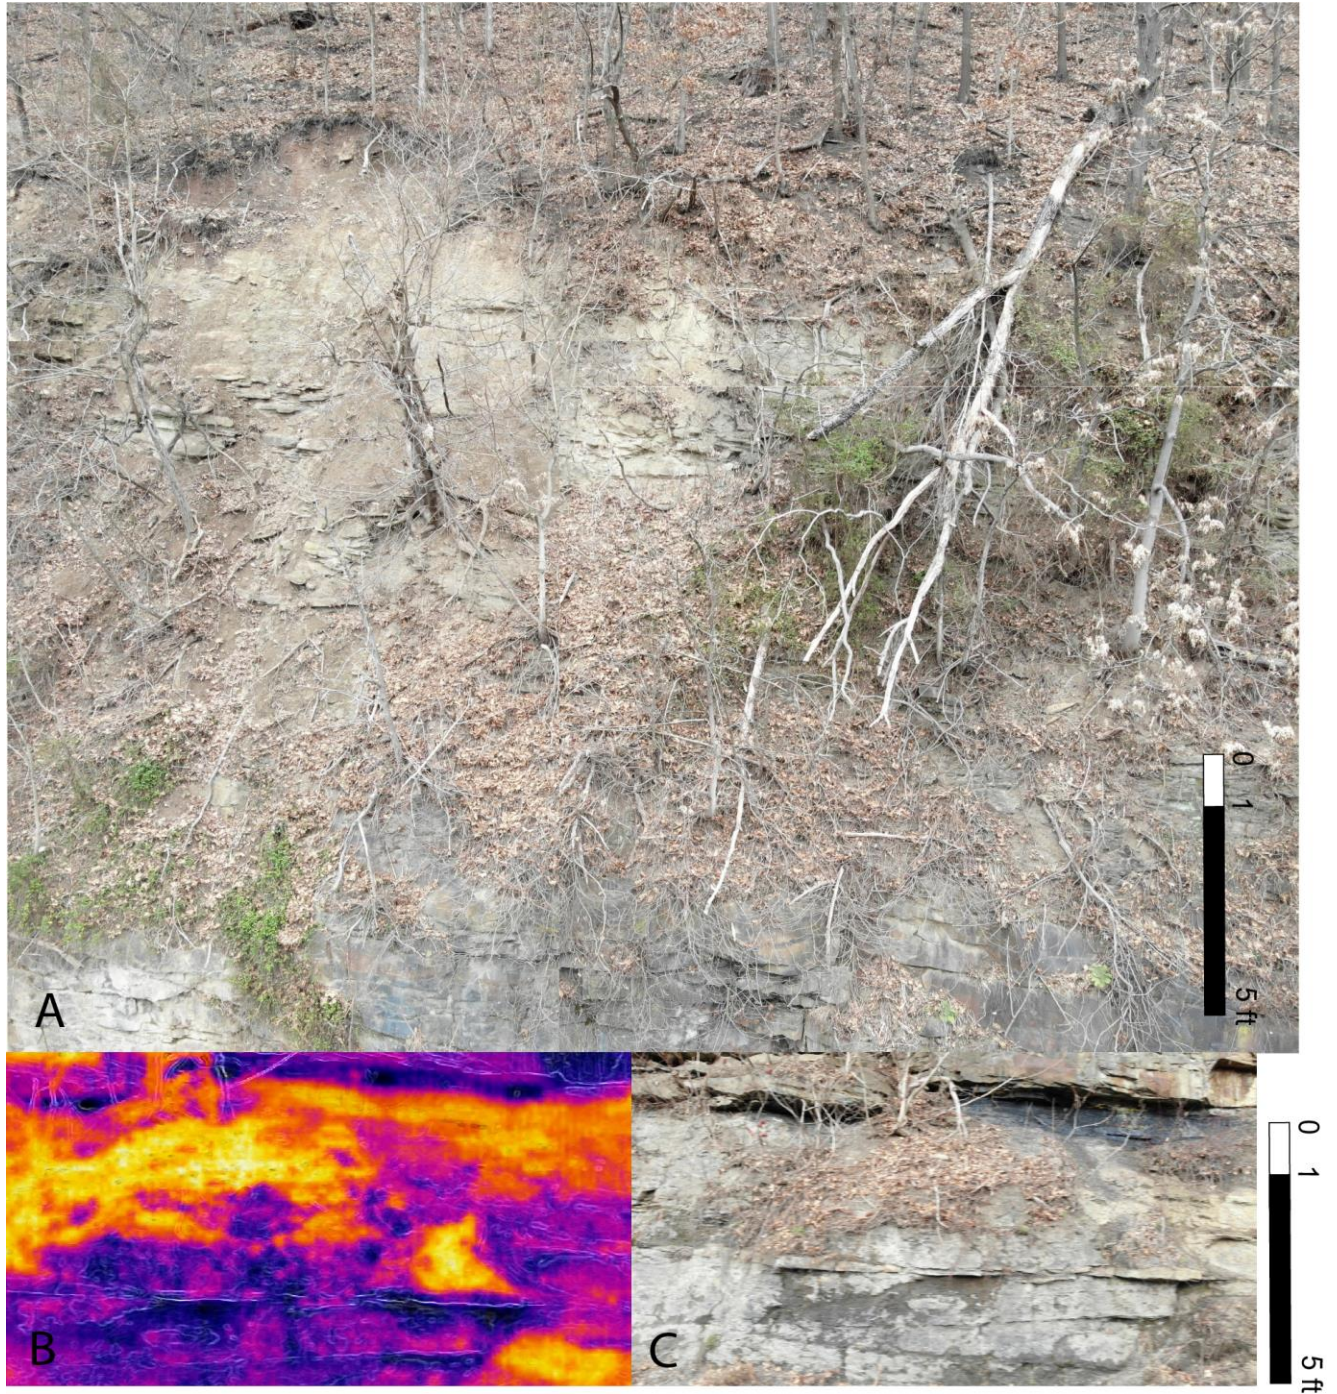
Figure 17. Drone imagery. See Figure 18A for location. A, Slide scarp approximately 50 feet above road, on hillside above two massive sandstone layers. Not visible from road level. B, Infrared drone imagery (orange/red = warm, purple/black = cold) of bedrock layers (purple) with water (black) exiting along stratification in the Allegheny Formation. C, Visible drone imagery, same area as B.

Examination of drone video footage, in visible light and side-by-side with infrared light, emphasizes the importance of groundwater exiting along bedrock stratification, and delineates a slope failure above the height visible from the roadside on MD 135, both east and west of Westernport. The groundwater seepage and slope failure are likely related; both features may be

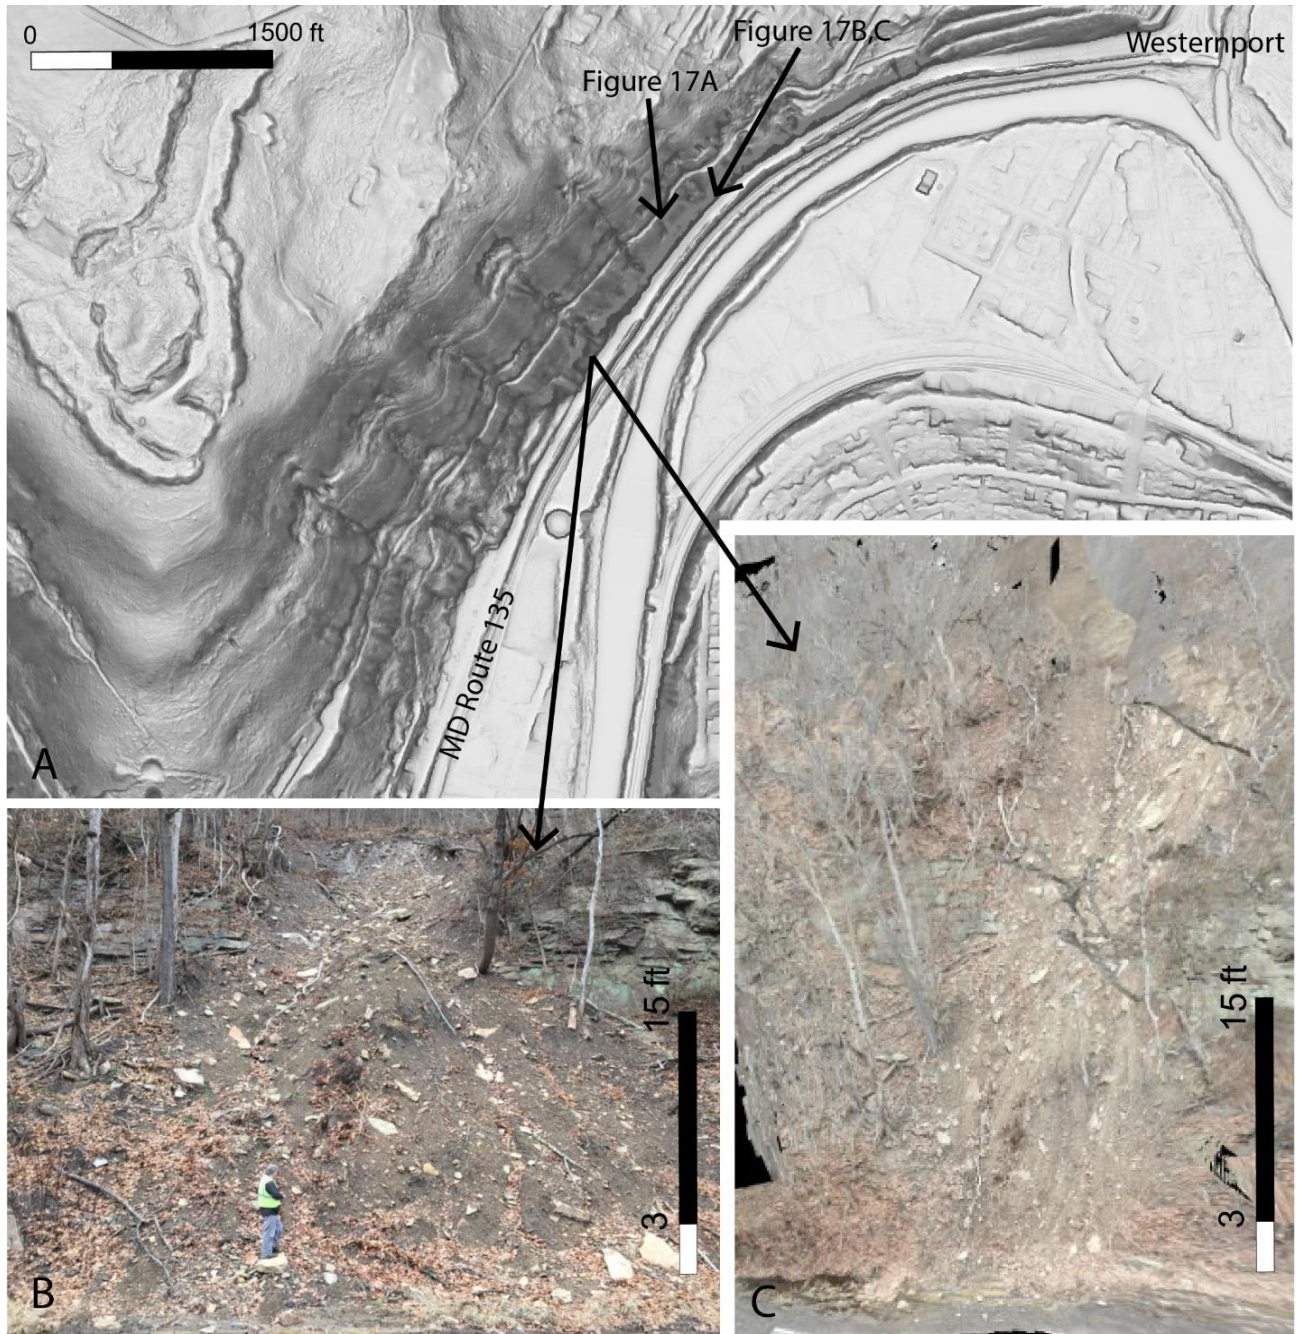
However, there were challenges to drone imagery collection. Safety of the drone survey crew and passing drivers was the first concern. Even with one lane of traffic control in place, the drone crew did not have abundant room to maneuver themselves and keep the UAV a safe distance from passing vehicles. Second, there were obstructions to the drone flight path, such as overhanging power lines and trees, and it was easy to lose sight of the drone when flying high enough (>100 feet) to capture images of the upper portion of the hillslope. Third, images produced by stitching drone photos together were somewhat distorted. Furthermore, processing was time-intensive without a super-computer or cloud processing features. For example, a stitched image of 850 photos for a 25-foot-wide slide area west of Westernport took approximately 15 hours to process (Figure 18C). Fourth, due to low resolution of infrared video capture, infrared images did not produce a coherent stitched image. Additionally, when the UAV was not flown far enough away from the outcrop, or was rotated while flying, the resulting stitched image was distorted (Figures 18B, C).

Figure 18. Slope failures. A, LiDAR image showing channel visible on hillslope above MD Route 135 that leads to slide area in photos B and C. Similar channels nearby also visible. B, Standard photo of slide area. C, Stitched image of drone photography, same location as B.
