Proper Overlay Type and Designs for PCC Pavement

Pangil Choi, Hoonill Won, Fei Yu, and Moon C. Won

Research Project 0-6910
Research Report 0-6910-R1
<http://www.techmrt.ttu.edu/reports.php>

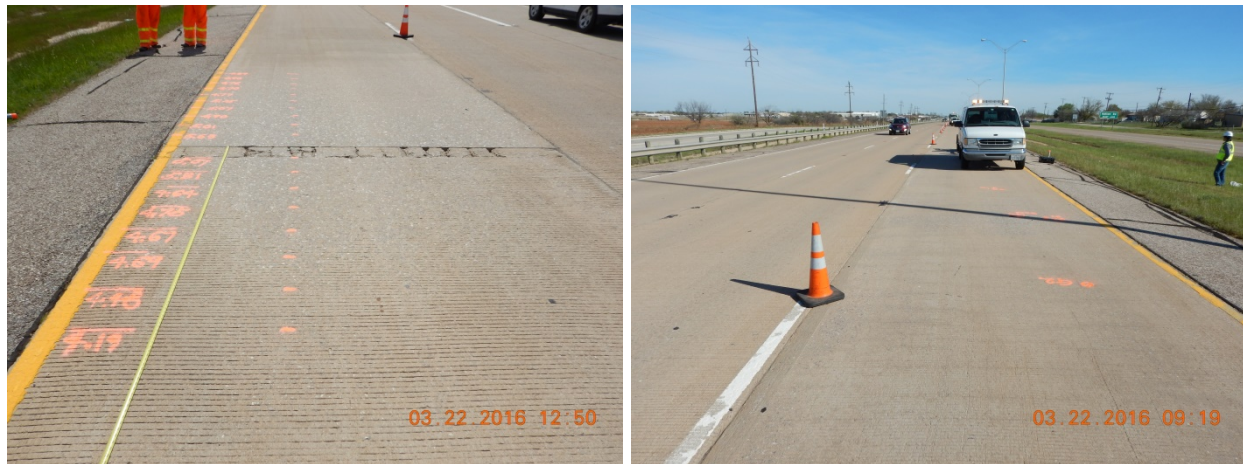
Figure 3.12 Overall pavement condition at poor and good sections

The overall BCO condition on US 281 was good, without any distresses except at a transverse construction joint (TCJ) area. Based on the visual survey results, two sections were selected as good and poor sections, as with the US-287 test section in Bowie. **Figure 3.12-(a)** shows a distress near a TCJ at the poor section and **Figure 3.12-(b)** provides an overall view of the good section selected. **Figure 3.13** shows the testing location on US 281 in Wichita Falls.

(a) Distress at construction joint (poor section)

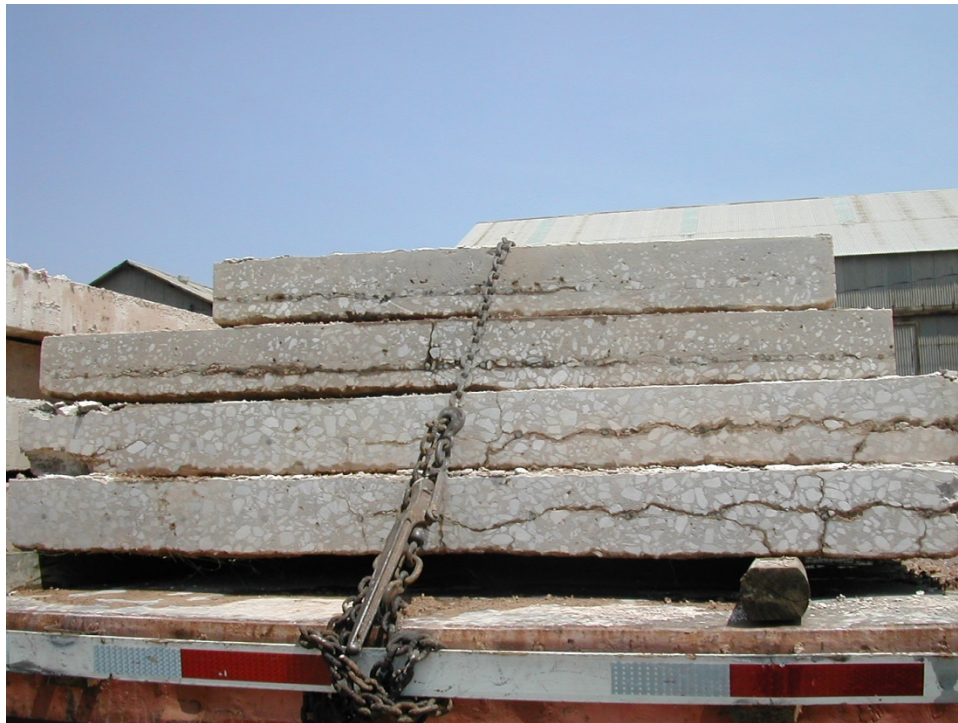
Figure 3.19 Horizontal cracks at the depth of longitudinal steel

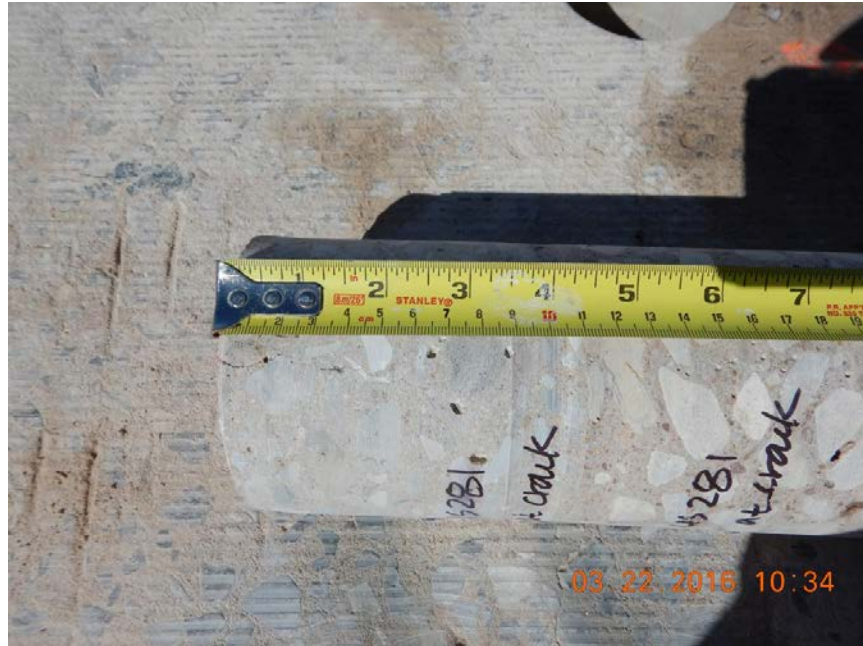
Figure 3.25 Close-up view of G3 core taken at transverse crack

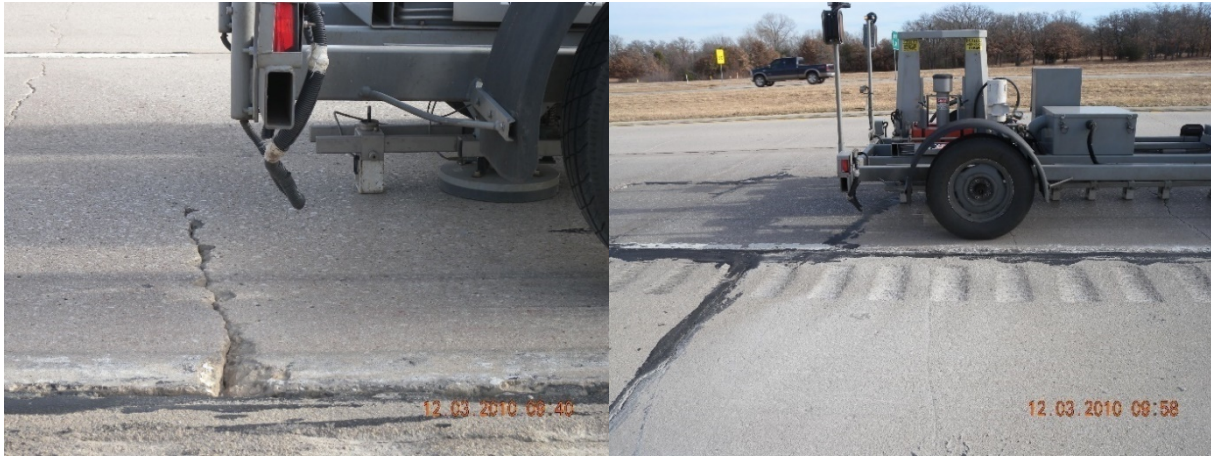
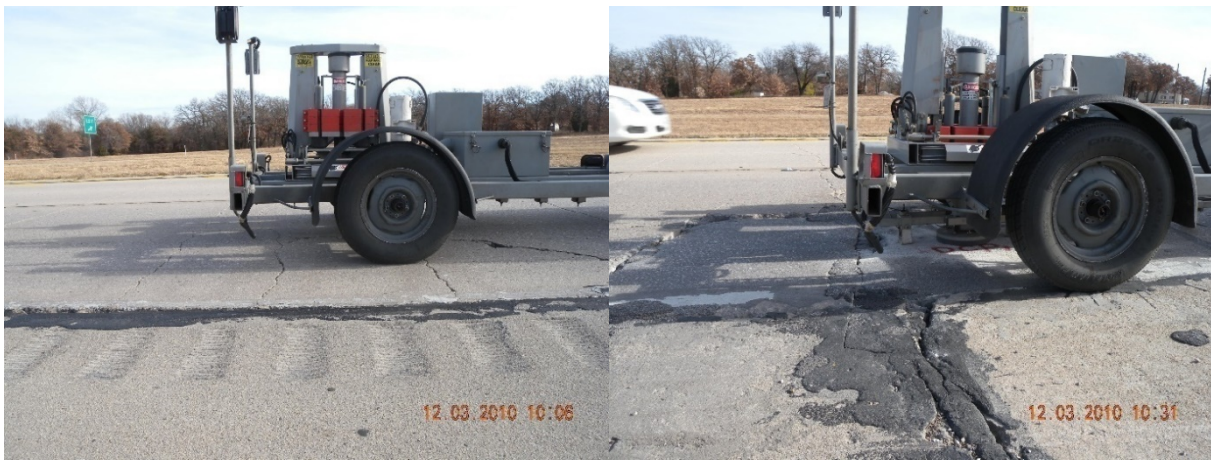
Figure 4.2 Representative distresses on old CRCP

On US 287 in Bowie, distresses appeared in existing CRCP at several locations, in the form of punchouts and half-moon-shaped longitudinal cracks. Also evident were transverse cracks with large crack widths and concrete chipping. FWD deflections in these locations were much higher than at other locations. It would be of great importance to identify whether these distresses with high deflections will reflect through to BCO and cause distresses in BCO. **Figure 4.2** shows typical distresses in the existing CRCP, and the FWD deflections near those distress locations are shown in **Figure 4.3**.

a. Chipping at transverse crack in old CRCP

b. FDR in old CRCP

c. Diagonal cracking in old CRCP

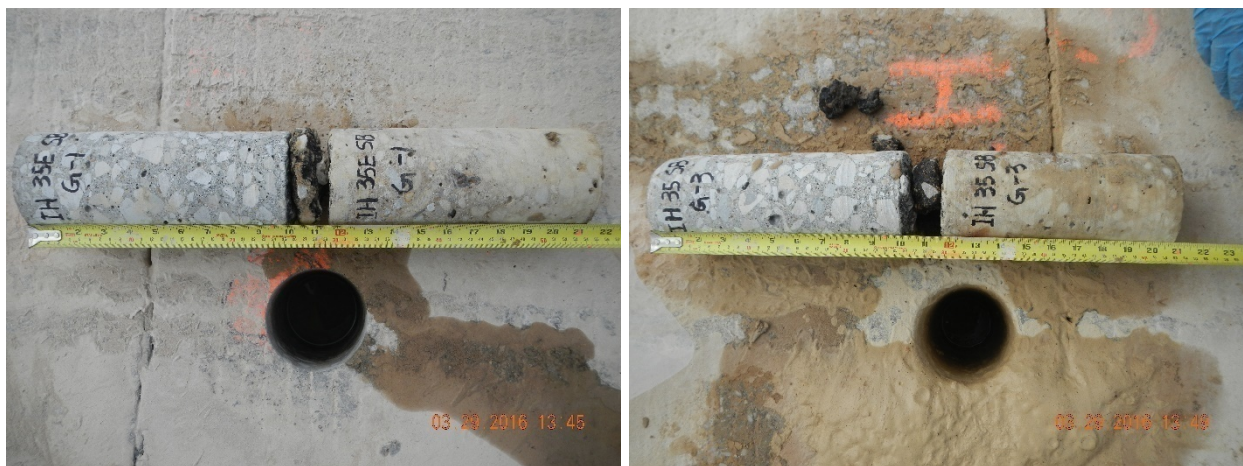
Figure 4.35 Deteriorated AC interlayer in a good section of IH 35E

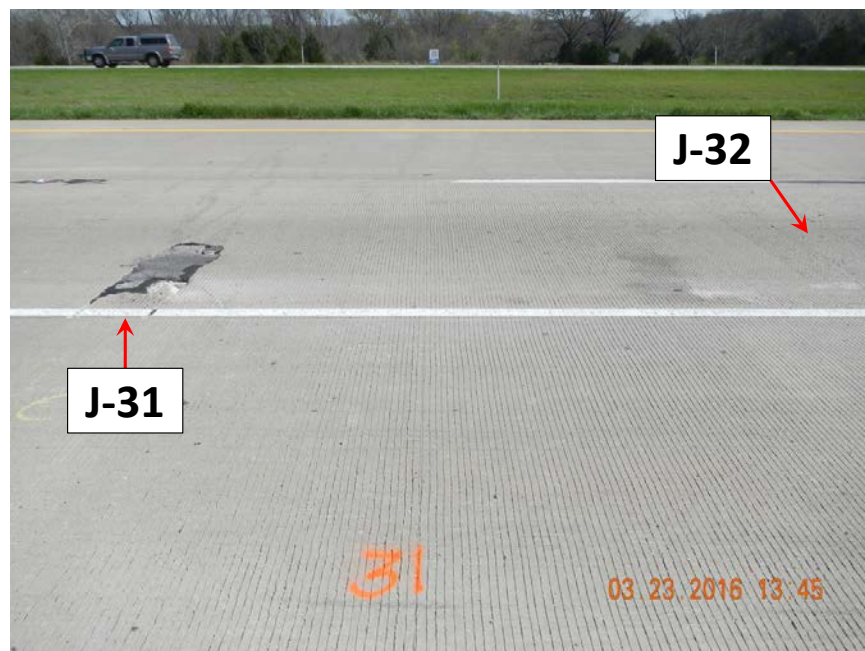
Figure 5.4 Distress in CRCP BCO on CPCD (US 75 in Sherman #1)

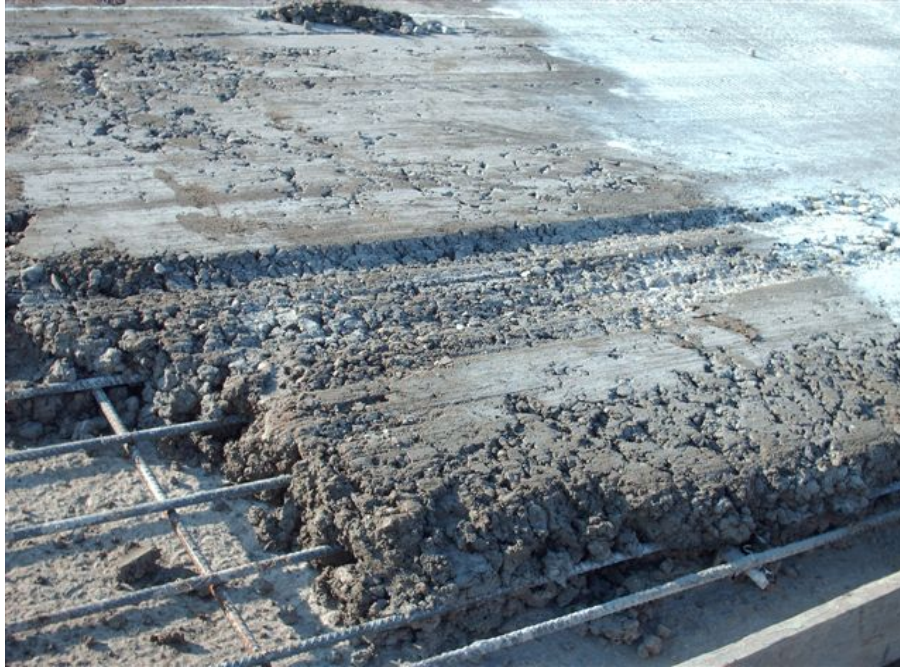
Figure 5.9 Dry concrete in BCO that was removed and replaced

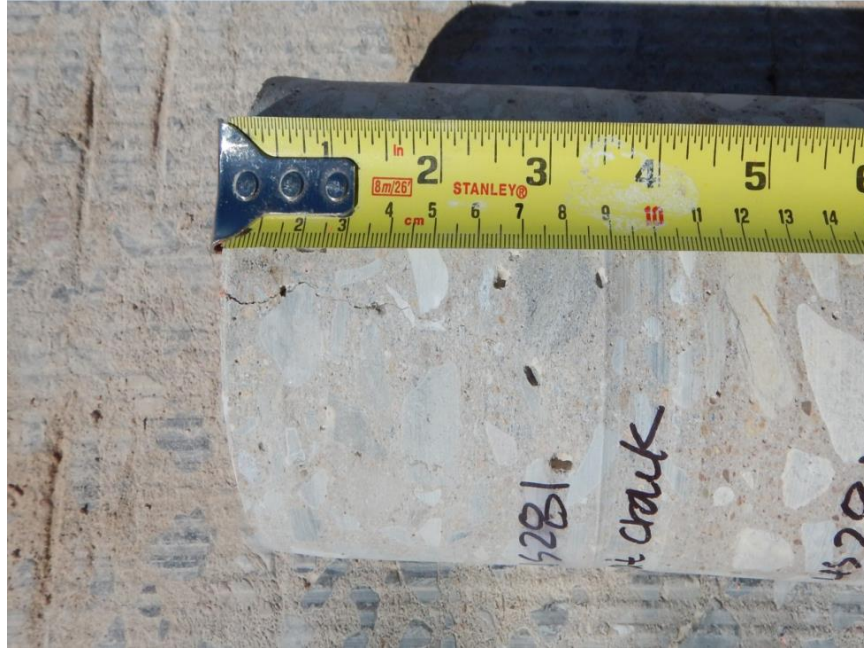
Figure 6.4 Close-up view of concrete core taken at transverse crack

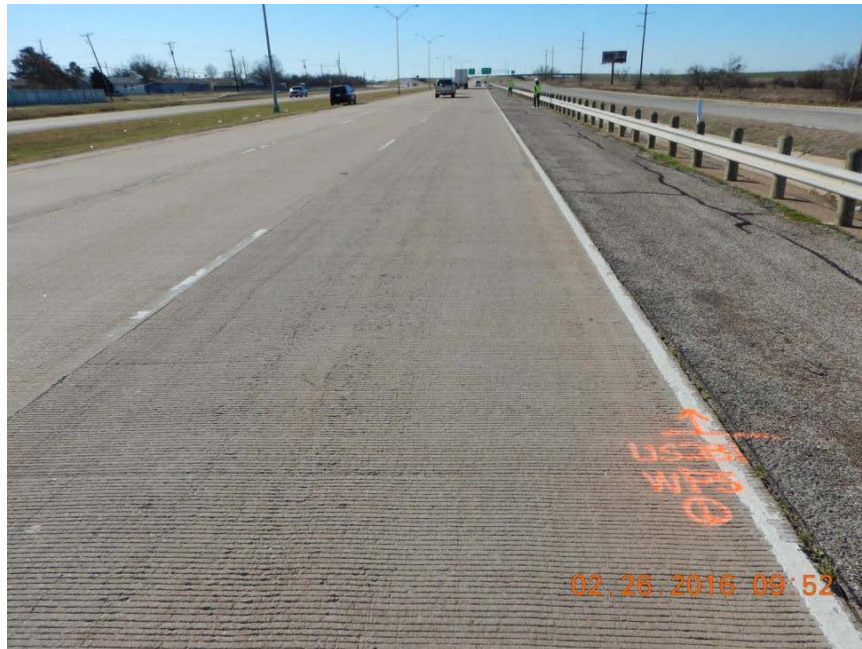
Figure 6.5 Overall BCO condition on US 281 in Wichita Falls

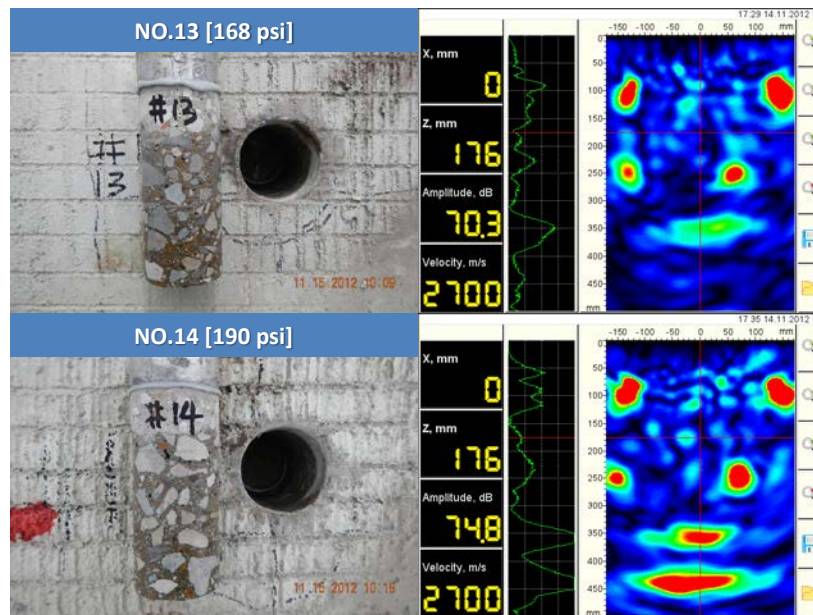
Figure 6.7 Bond strength and MIRA testing (interface failure)

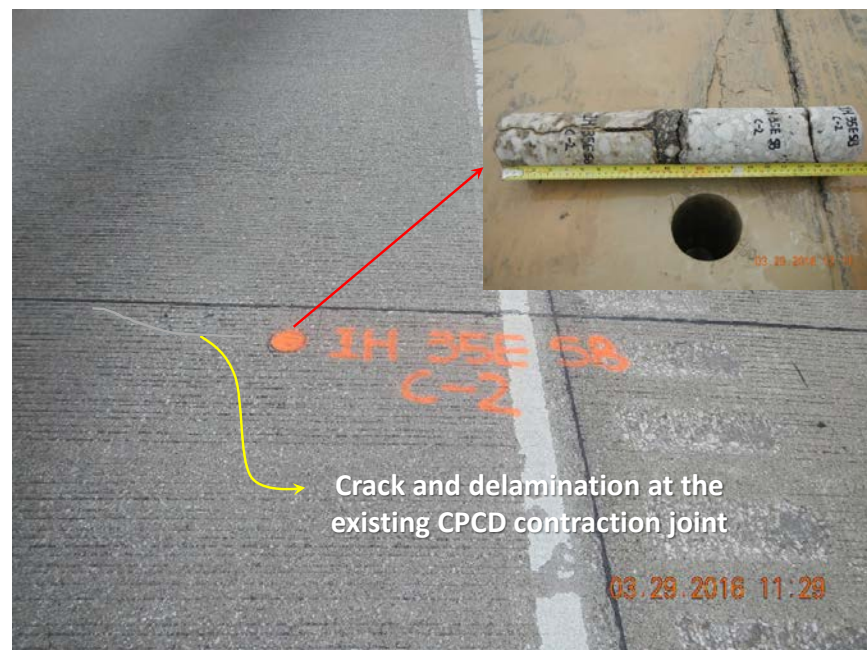
Figure 6.12 Delamination and crack due to joint mismatch between existing CPCD and overlaid CPCD
