MASH TEST 3-11 EVALUATION OF TxDOT W-BEAM GUARDRAIL WITH 7½-INCH DIAMETER ROUND WOOD POSTS IN CONCRETE MOW STRIP

Test Report 0-6968-R2

TEXAS A&M TRANSPORTATION INSTITUTE

TEXAS DEPARTMENT OF TRANSPORTATION

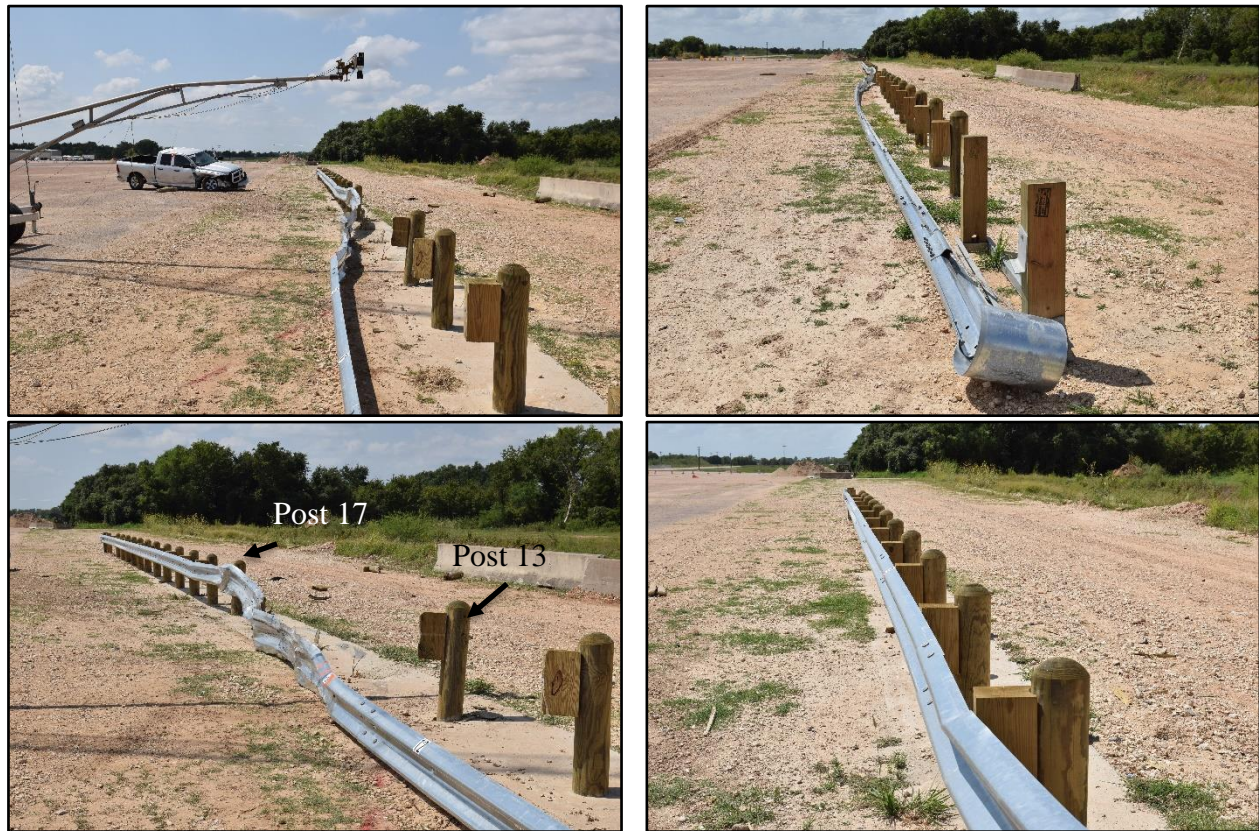
Figure 5.3. TxDOT W-Beam Guardrail with 7½-inch Diameter Round Wood Posts in Concrete Mow Strip after Test No. 469689-4-1.

Figures 5.3 and 5.4 show the damage to the TxDOT W-beam guardrail with 7½-inch diameter round wood posts in concrete mow strip. The rail released from posts 1 through 16, and 18. There was a ¾-inch gap in the soil on the upstream side of post 1, and ½-inch gaps on the downstream side of posts 1 and 2. The blockouts rotated clockwise at posts 3 through 11. The blockout rotated clockwise and cracked at post 12. Post 13 had 1½-inch gaps in the grout on the traffic side and ½-inch on the field side, and it was leaning toward the field side at 86°. Post 14 broke off at grade, and the grout cracked near the post. Post 15 also broke off at grade, and had a 2½-inch gap in the grout on the traffic and field sides. Post 16 fractured and broke off at 6 inches above grade, and had a 2-inch gap in the grout on the traffic side and a 4-inch gap on the field side. There was a 1-inch gap in the grout on the traffic side and a 2-inch gap on the field side of post 17, it was leaning back at 83°, and the blockout was broken and detached. There was no apparent damage or post movement from posts 19 through 30. Working width* was 50.9 inches, and height of working width was 54.4 inches. Maximum dynamic deflection during the test was 43.4 inches.

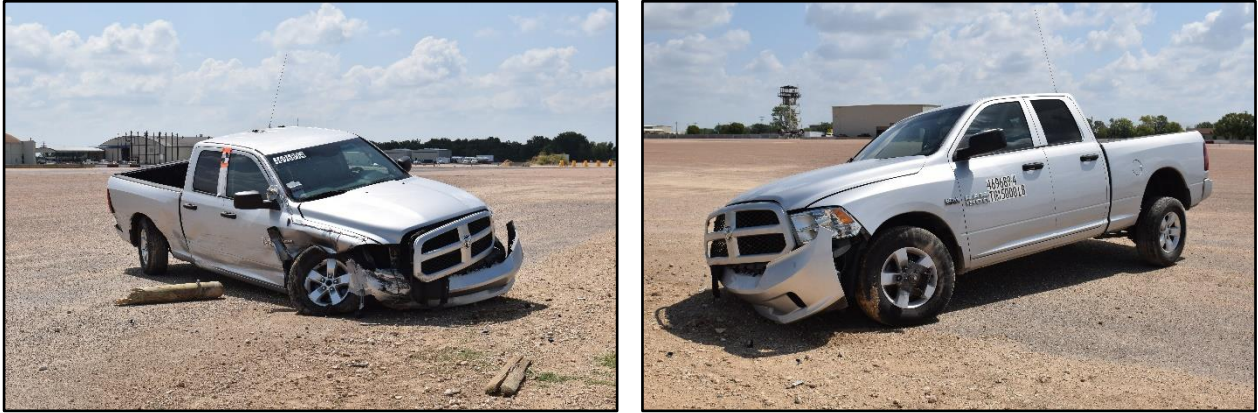
Figure 5.5. Test Vehicle after Test No. 469689-4-1.

Figure 5.5 shows the damage sustained by the vehicle. The front bumper, grill, radiator support, right front fender, right frame rail, right upper and lower A-arms, right front tire and rim, right front and rear doors, right cab corner, right rear exterior bed, right rear spring and trailing arm, and rear bumper were damaged. Maximum exterior crush to the vehicle was 10.0 inches in the front plane at the right front corner at bumper height. Maximum occupant compartment deformation was 1.5 inches in the right front floor pan. Figure 5.6 shows the

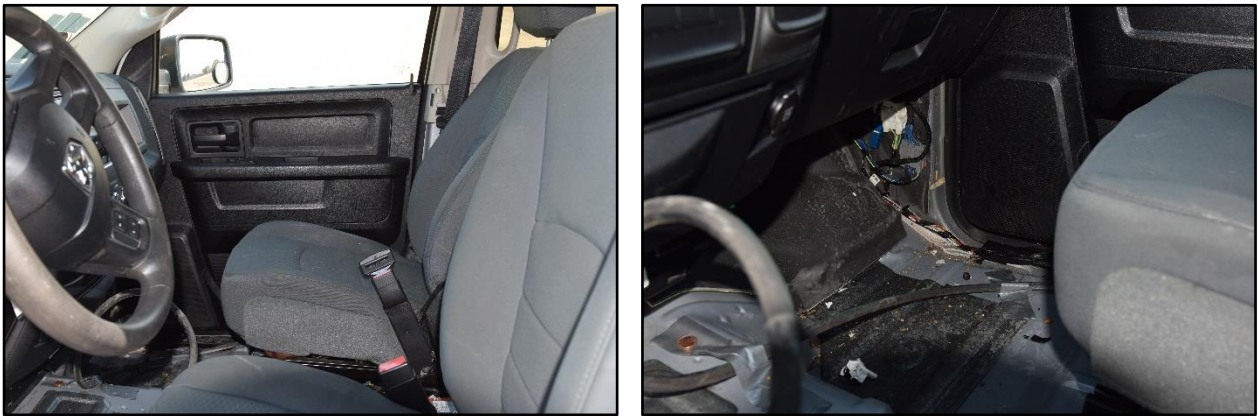
Figure 5.6. Interior of Test Vehicle after Test No. 469689-4-1.

interior of the vehicle. Tables D.3 and D.4 in Appendix D1 provide exterior crush and occupant compartment measurements.
