Asset Management for Retaining Walls

Final report

Michigan Department of Transportation
ORBP Number OR15-114

March 2020

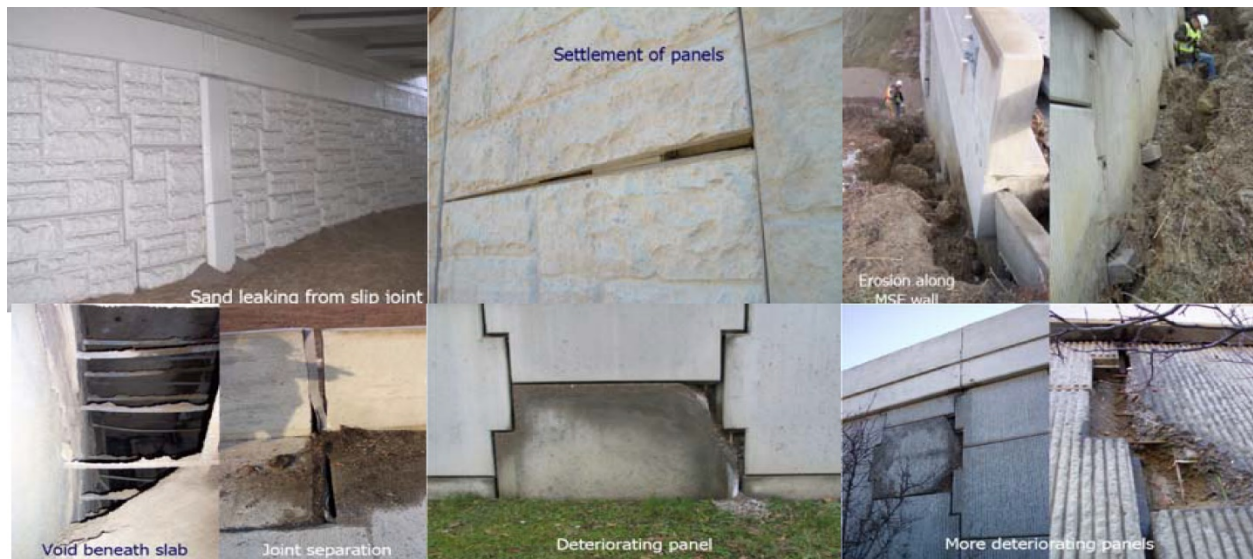
Figure 1.9. Observed problems in MSE walls (Narsavage 2006)

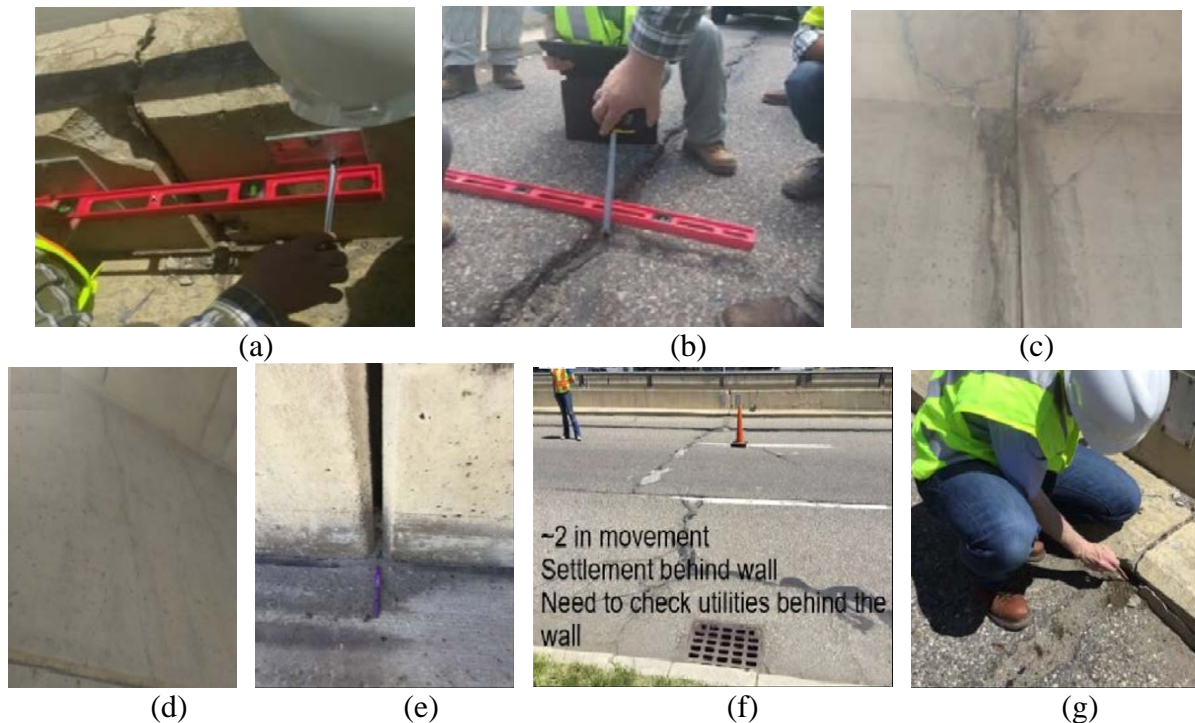
Figure 2.2. M-10 retaining wall system distress (June 2017): (a) wall tilting observed at the wall top; (b) severe lateral cracking of the service road pavement; (c) leakage stains on the wall face at the top of the wall; (d) vertical cracking of the wall face; (e) joint movement between wall panels; (f) distress of storm water pipe behind the wall; and (g) backfill soil evident at the wall joints.

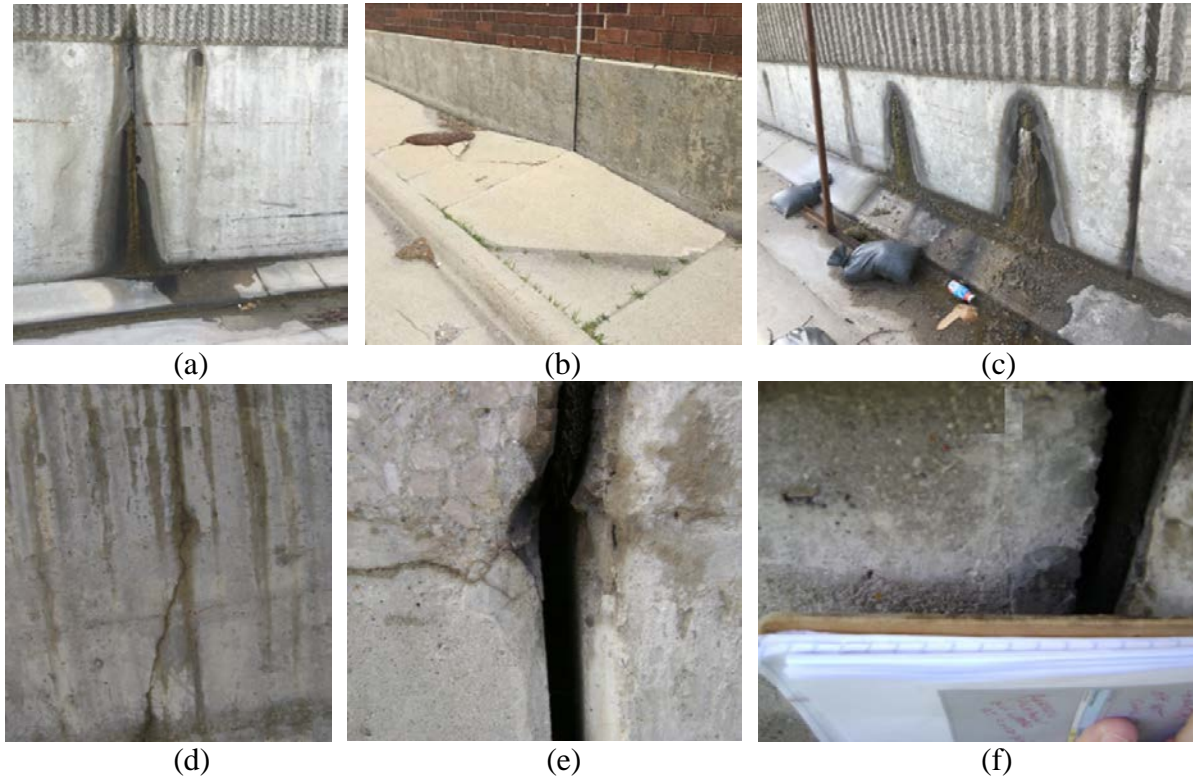
Figure 2.3. Issues observed on I-696 wall panels (June 2017): (a) water leakage via the lower portion of the wall expansion joint; (b) walkway failure on the top of the wall back fill; (c) prolonged and severe weeping through drainage holes; (d) moderate levels of vertical cracking; (e) excessive wall expansion at panel joints; (f) differential tilt of adjacent panels.

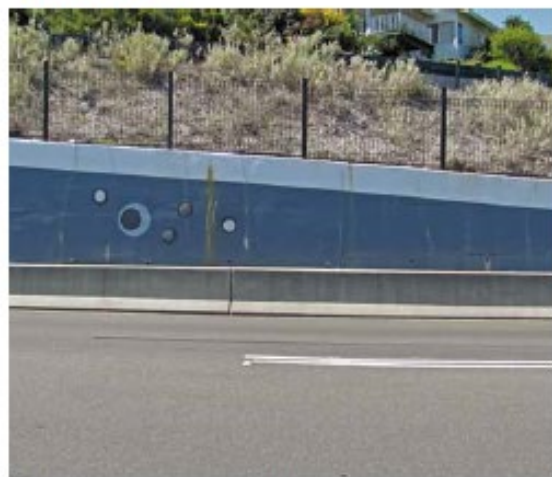
Shrinkage cracks obvious and early signs of corrosion of reinforcement.

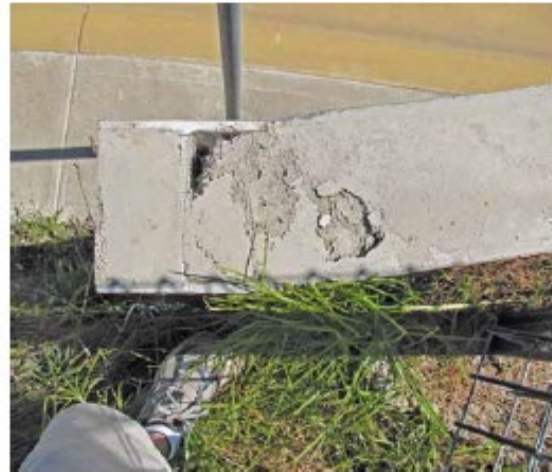
Incomplete filling of concrete around supporting steel posts with potential for water penetration and corrosion

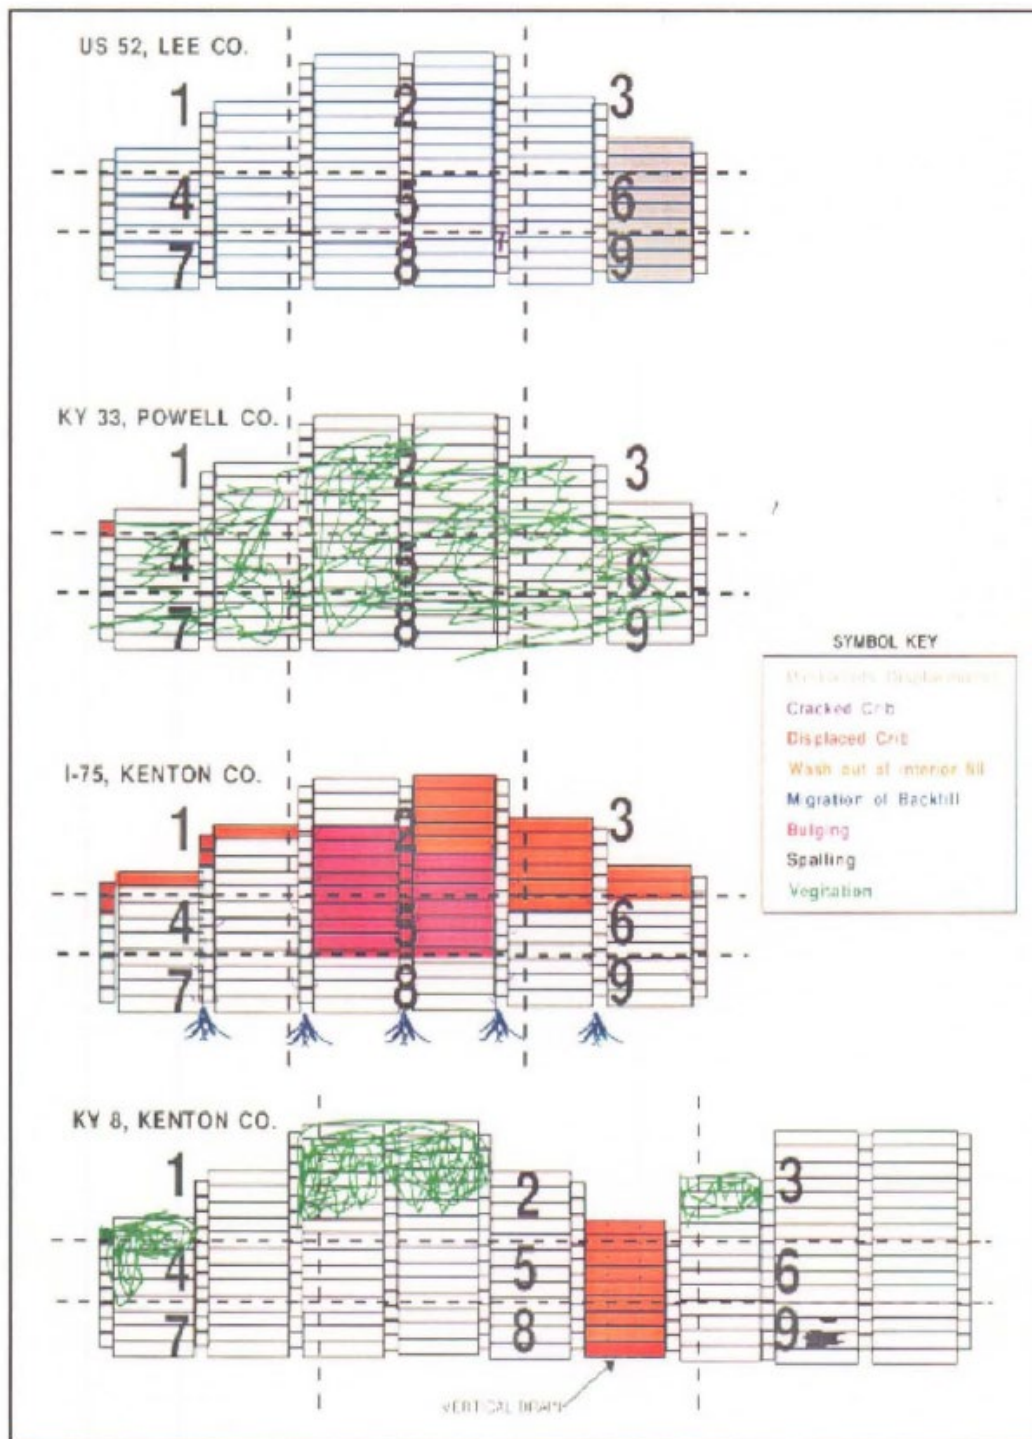
Figure 12: Distress Observed on Concrete Crib Walls

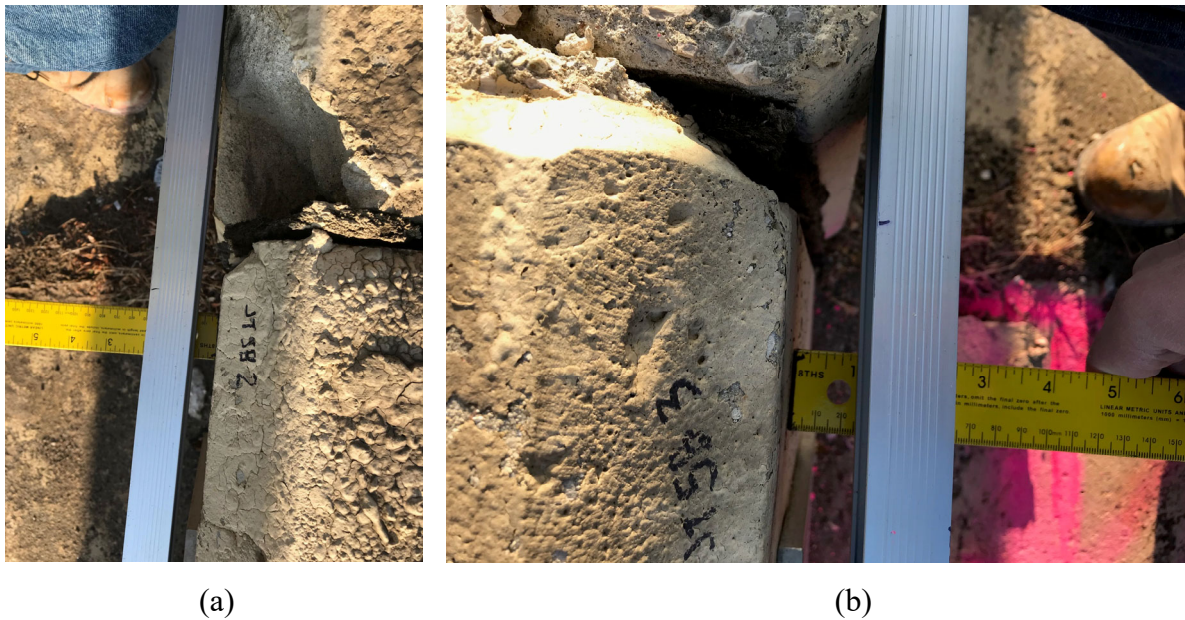
Figure B.1. Manually measured movement of the M-10 wall panel at the top wall parapet in January 2020.

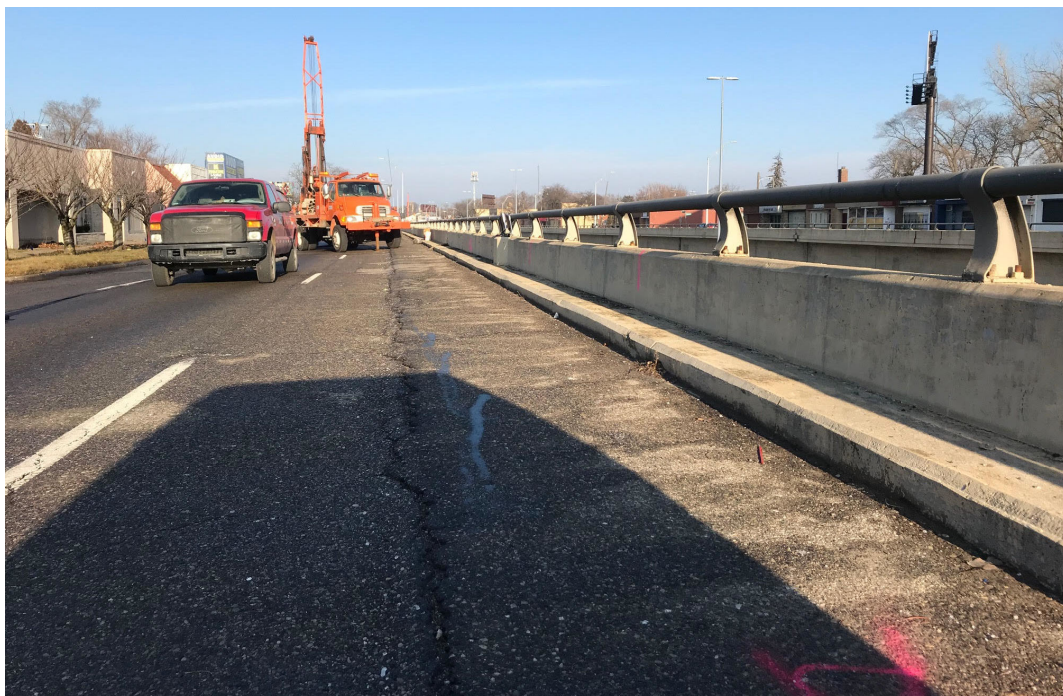
Figure B.2. Top road surface at the top of the suspected failed M-10 wall panel (January 2020); major tensile crack in asphalt surface evident parallel to wall face.

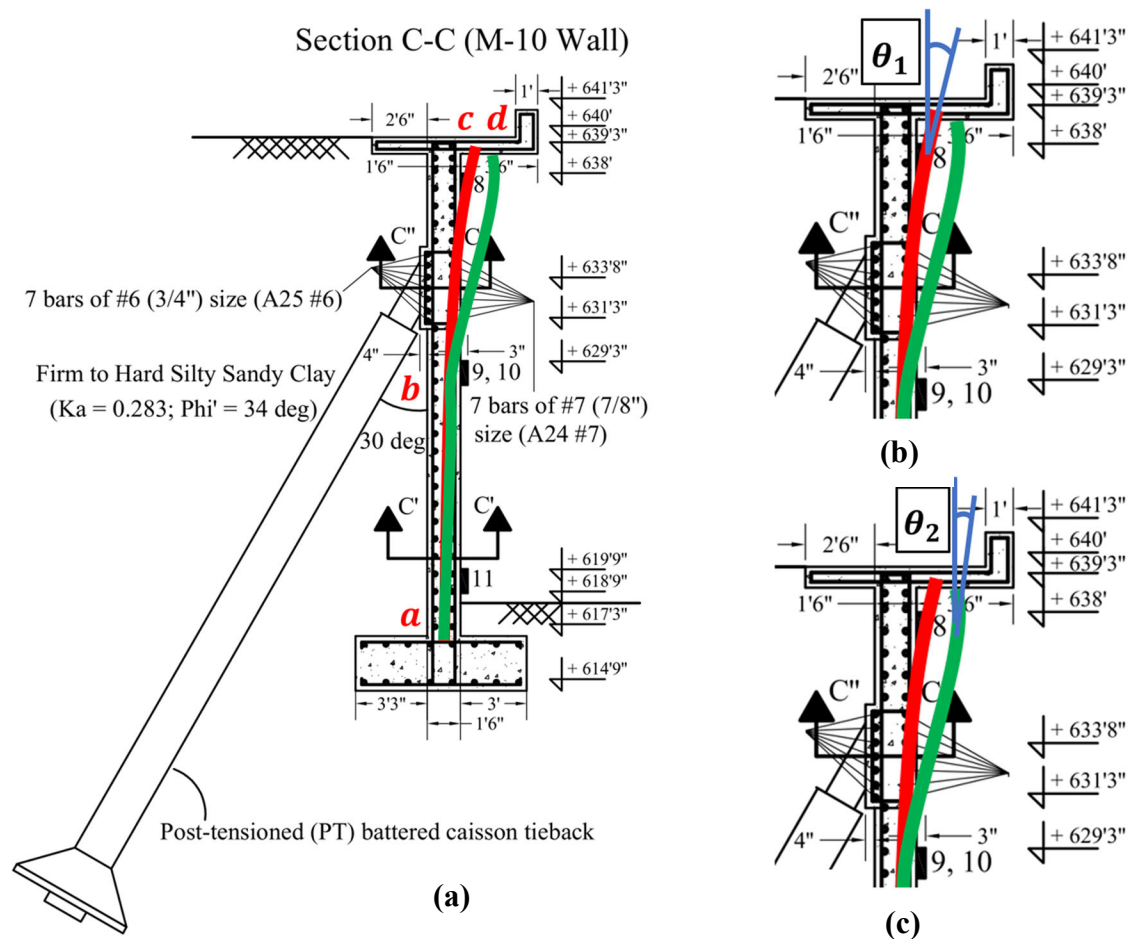
Figure B.7. Deformation curves of the drifted M-10 retaining wall system with the tieback caissons shown: (a) hypothesize deflection curve of the wall panel before the major rain event (a-b-c) and during high hydrostatic pressures immediately following the rain (a-b-d); (b) top-level rotation of retaining wall panel before movement showing a large tilt toward the freeway; (c) top-level rotation of retaining wall panel after the buildup of hydrostatic pressures resulting in displacement and reduced top tilt of the panel. The wall returns to deflected shape (a-b-c) after hydrostatic pressure is relieved.

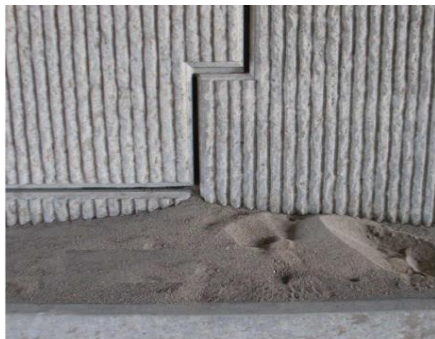
Loss of Backfill

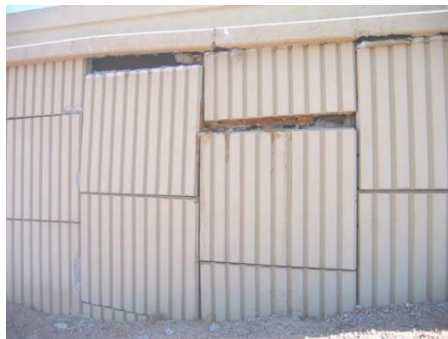
Joint Spacing

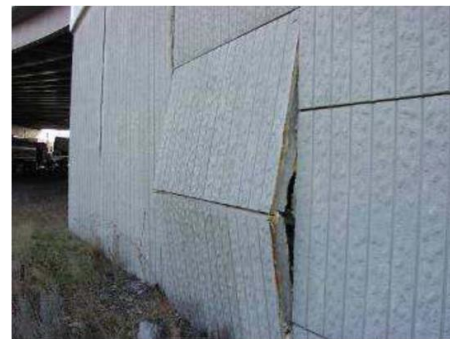
Panel Bowing
