# JOINT TRANSPORTATION RESEARCH PROGRAM

## Post-Fire Assessment of Prestressed Concrete Bridges in Indiana

**Amit H. Varma, Jan Olek, Christopher S. Williams,  
Tzu-Chun Tseng, Sijia Wang, Dan Huang, Tom Bradt**

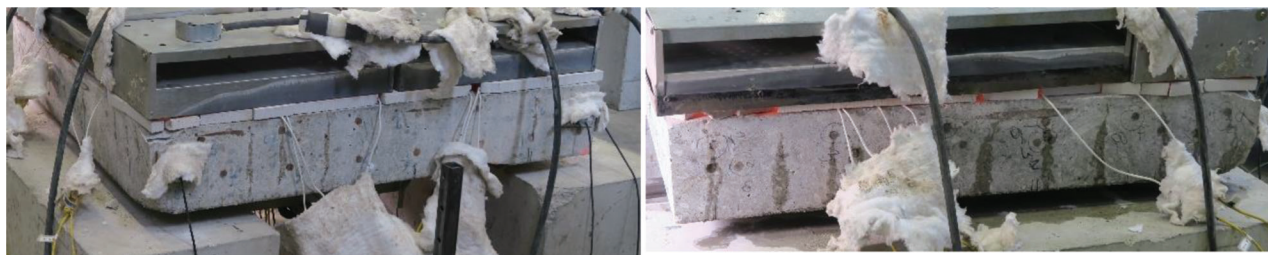
**Figure 4.3** Observation of moisture from D-40-1100 during test.

(a) At 16 Minutes–Surface Temperature: 620°F

(b) At 36 Minutes–Surface Temperature: 1,041°F

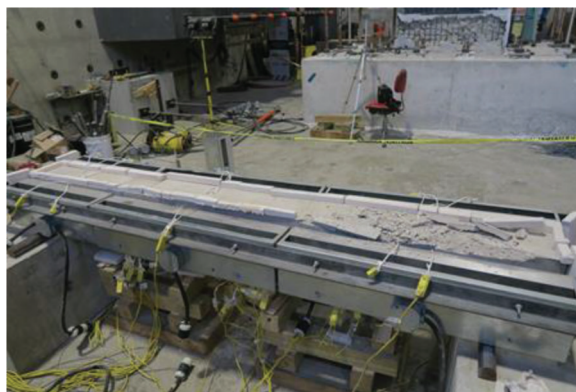
**Figure 6.13** Spalling during the test at Specimen PS4.

Figure 6.3 presents the surface temperature-time history for the specimen PS4, since the severe spalling happened during the test, the heaters were shut down at 29 minutes from the start of test. The maximum surface temperature of concrete reached 899°F (482°C) when the heating test was stopped. The through-depth
