# Minnesota Drive Ramps Microsurfacing Experimental Feature

## Post-Construction Report

**October 2020**

**FHWA-AK-RD-4000(181)**

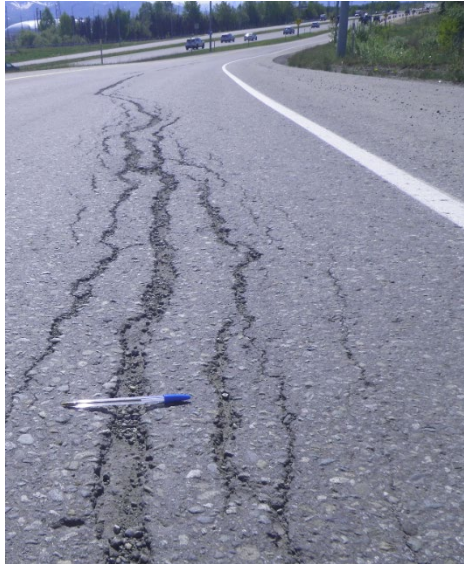
*Photo 1 – Ramp 1 Prior to Surface Preparation*

The primary distresses is high severity longitudinal cracking down the center and right of the lane starting near International Airport Road. There is low raveling, and studded tire wear that deepens near the bottom of the ramp near Minnesota, which received rut fill using hot mix. At the end of the guardrail, pattern cracking has formed around the cracks. The cracks are near 1.5" at the widest and received crackseal and HMA to fill. The photo on the left is prior to surface preparation, and the right is after, with the larger crack being filled with both crackseal and hot mix.

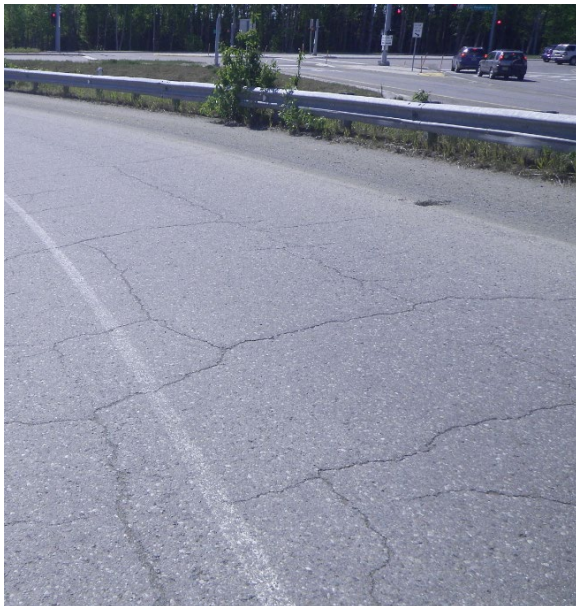
*Photo 3 - Ramp 8 General Condition*

This cloverleaf ramp has block cracks of moderate severity for nearly the entire length along with a wide joint crack. Fatigue based cracking is beginning to appear in the wheel paths in addition to the block cracking. See photo below to the left that shows the general ramp condition.

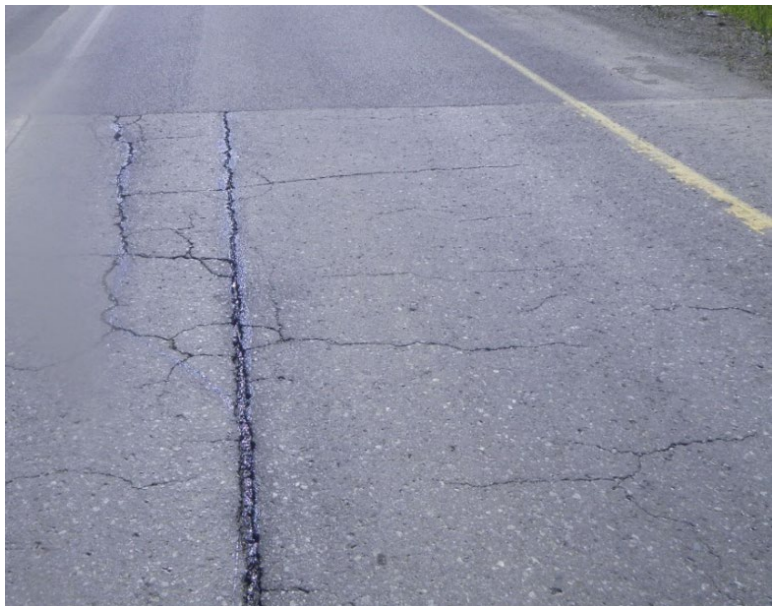
*Photo 4 - Ramp 9 General Condition*

A longitudinal joint crack is present for the majority of the ramp, along with block cracking that has developed into alligator cracking in the right wheel-path that extends to near the end of the ramp at the International Airport sign. From then on, faint block cracking is beginning to develop along with moderate severity transverse cracks. See the photo above and to the right.

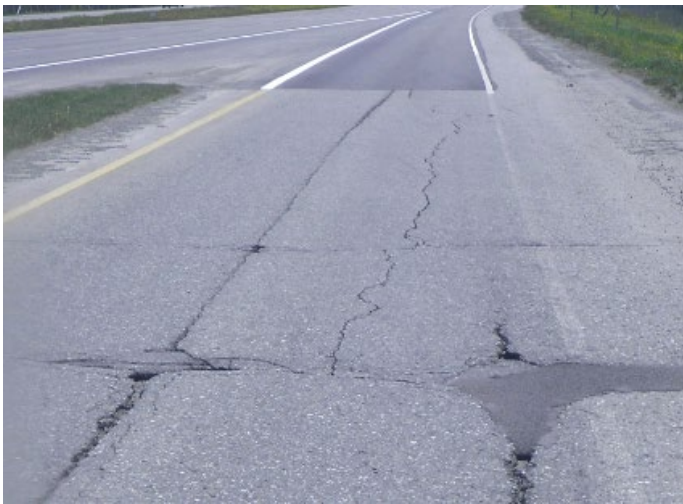
*Photo 5 - Ramp 11 Prior to Surface Preparation*

The predominant distresses are low to moderate severity thermal cracking and a low density joint that is raveling and losing aggregate. Potholes have been forming at the transverse cracks, with two major potholes approximately 50' from the end of the microsurfacing near Minnesota. There is intermittent longitudinal cracking on the ramp. See the photo below and to the left.

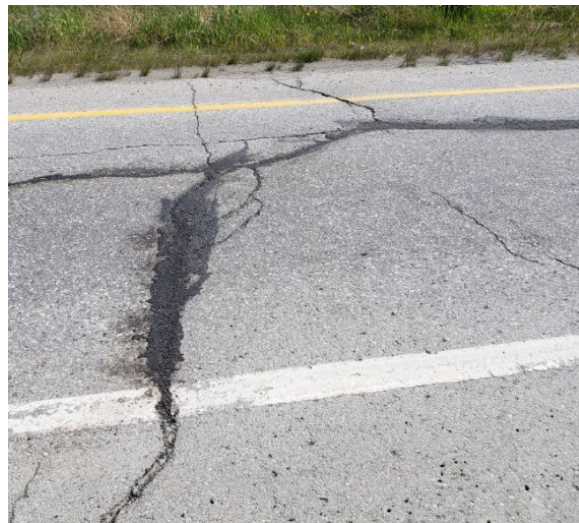
*Photo 6 - Ramp 12 - Cracks after Surface Preparation*

There is high severity longitudinal cracking and potholing beginning approximately halfway down the ramp. Transverse cracking varies between low to high severity throughout the ramp. See the above right photo.

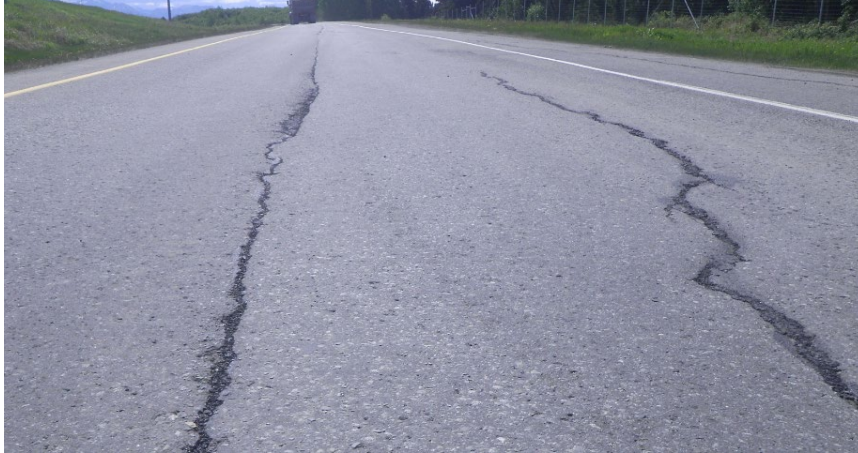
*Photo 7 - Ramp 15 After Surface Preparation*

There is high severity longitudinal cracking for the first 200' of the ramp near 100<sup>th</sup> Avenue. There is also moderate to high severity joint raveling consistently along the ramp that has opened up to near ¾" in width. High severity transverse cracking is present where the ramp ties into Minnesota.

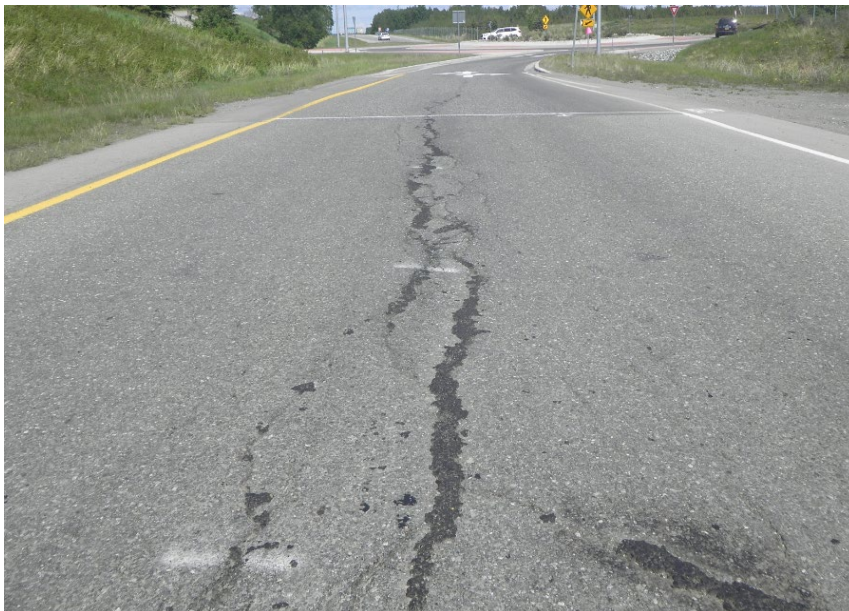
*Photo 8 - Ramp 16 After Surface Preparation*

There is high severity longitudinal cracking near 100<sup>th</sup> Avenue. The rut depths are low and raveling is low severity and isolated to joints. High severity transverse cracking is located near the Minnesota end of the ramp.

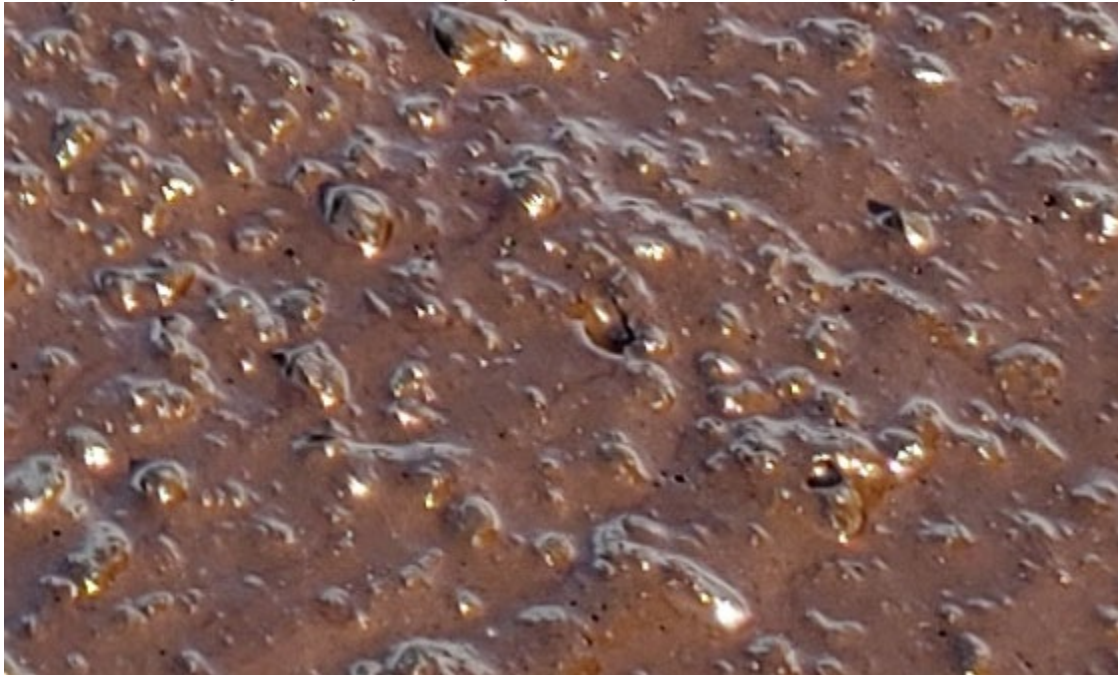
After the microsurfacing was placed on the test strip, small holes/bubbles were observed on the surface which were not seen with the previous formulation using lime. This indicates water is escaping the system as it sets and, while difficult to see, can be observed in the photo below.

*Photo 13 - Bubbles from Slurry on Test Strip*

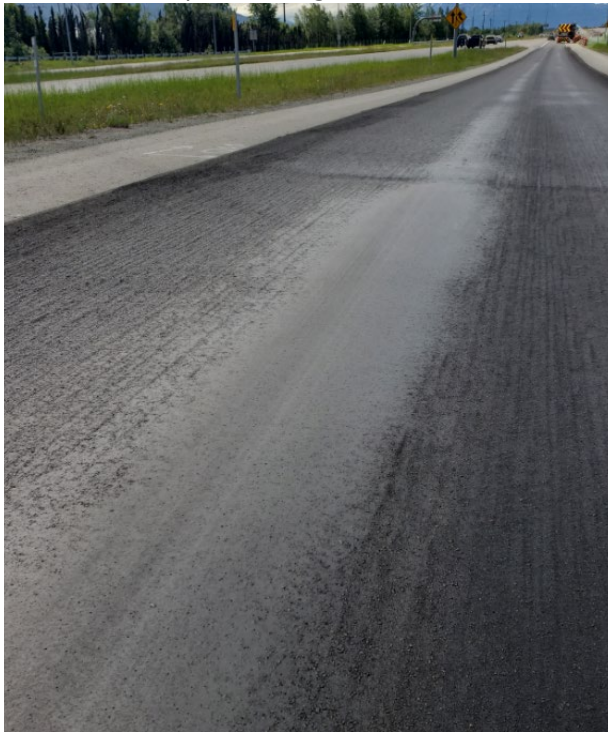
Comment was received from construction that Ramps 1 and 2 were not performing well. On Ramp 1, the photo below on the left, flushing was observed over the majority of the ramp in the wheelpaths. While no deformation or rutting in the wheelpaths was visible, it appeared that the course aggregate had been depressed and the fines were flushed to the surface. On Ramp 2, photo below on the right, the center left hand turn lane had severe flushing and also deformation/shoving of the microsurfacing material.

*Photo 14 - Ramp 1 Flushing Distress*

Construction had noted Ramps 1 and 2 were being used on a haul route for borrow material being transported to Anchorage International Airport for construction work. On Ramp 2 the damage occurred directly in front of a signalized intersection within a few days of application. It is likely the trucks coming to a stop and then accelerating into the turn onto International Airport Road that caused significant damage on the fresh microsurfacing, including flushing and material pickup.

It was observed the trucks returning to the pit from Anchorage International Airport used Ramp 1 onto Minnesota and then took Ramp 10 onto Raspberry and likely caused flushing damage to the recently placed microsurfacing on both of those ramps.

The final list of ramps determined to have sufficient loss of friction to warrant friction testing and removal were Ramps 1, 2, 5, 10 and 13. The area for 2020 removal due to a loss of friction from bleeding flushing/bleeding is 8,960 SY. This removal is anticipated to take place in September and be replaced with 1.5" of hot mix asphalt.

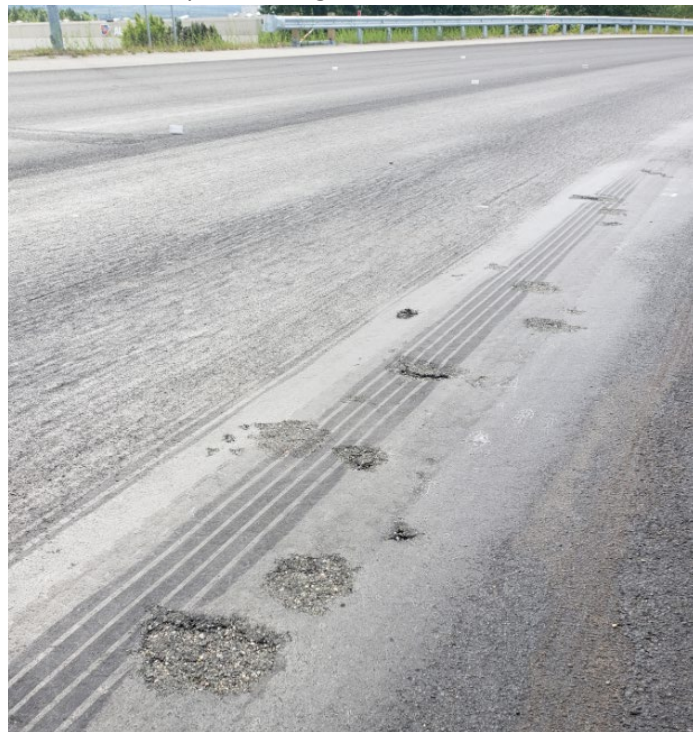
*Photo 15 - Ramp 2 Flushing Distress*

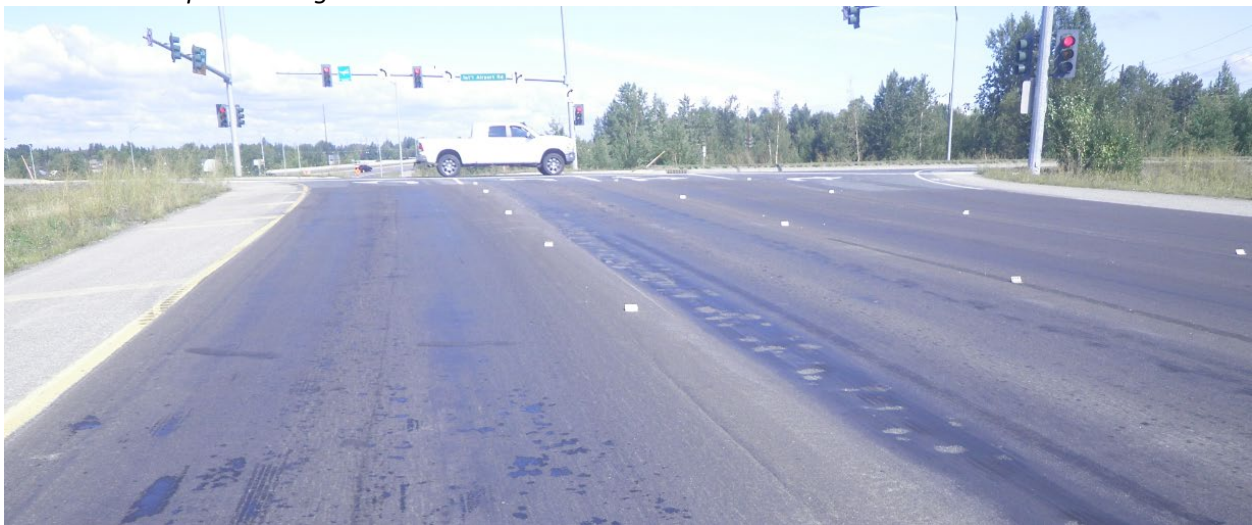
The photo below is from August 13<sup>th</sup> where severe flushing and shoving occurred at the signalized intersection on Ramp 2. The resulting surface was not sticky and tracking was not observed at any locations, but there was a loss of friction and the fines were visible at the surface.

*Photo 16 - Ramp 2 Flushing Distress*
