Appendix A
Preconstruction Documentation

Minnesota Drive Seward Highway to Tudor Road Microsurfacing Locations

Appendix B
Construction Photolog

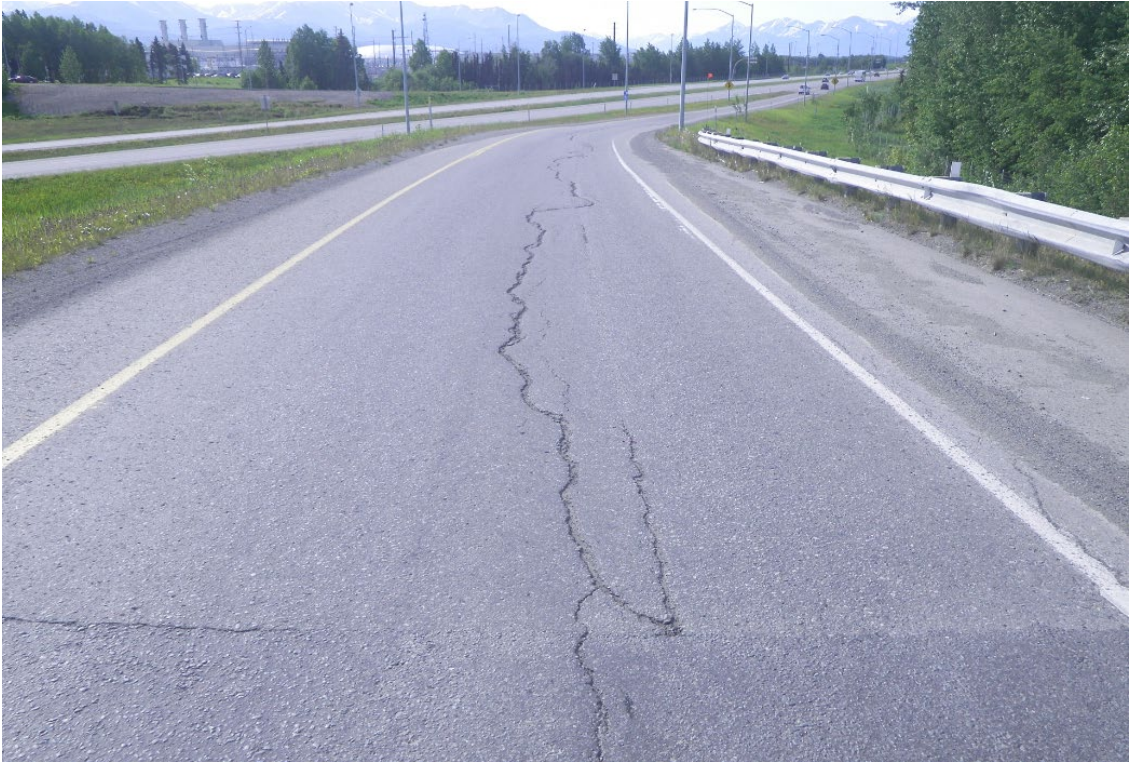
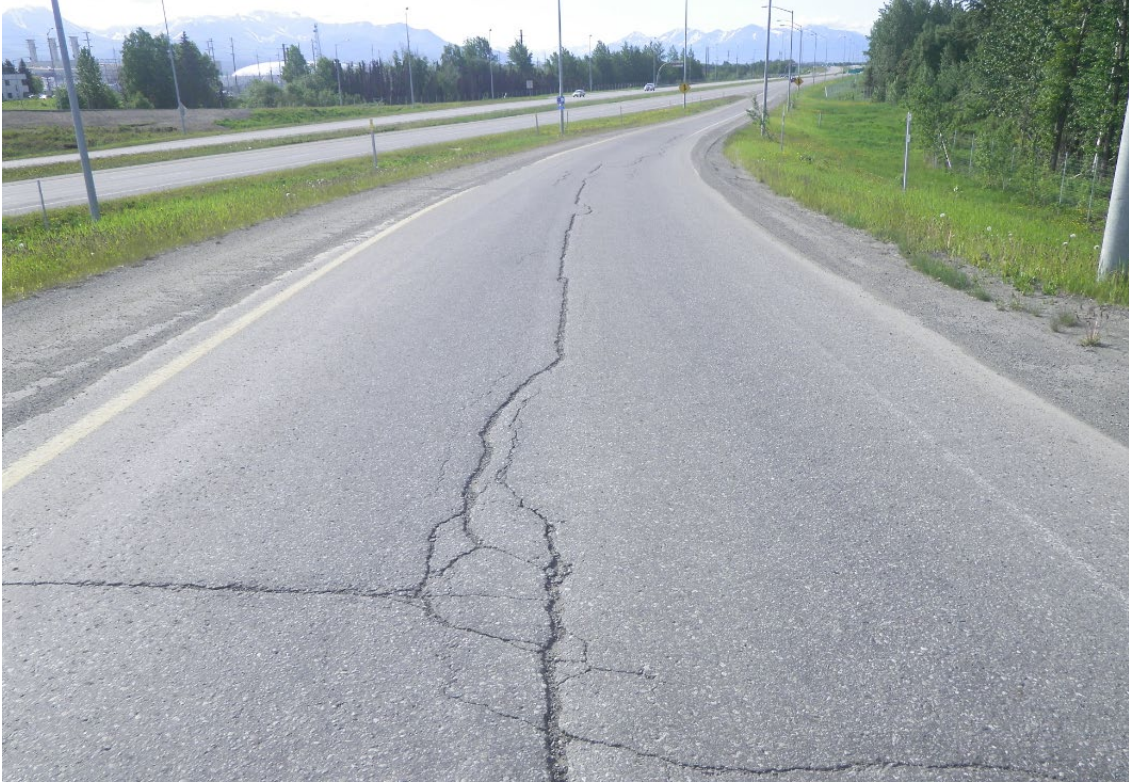
Ramp 1 – International Airport EB - Minnesota WB On Ramp

Ramp contained significant longitudinal cracking as well as moderate to high rut depths.

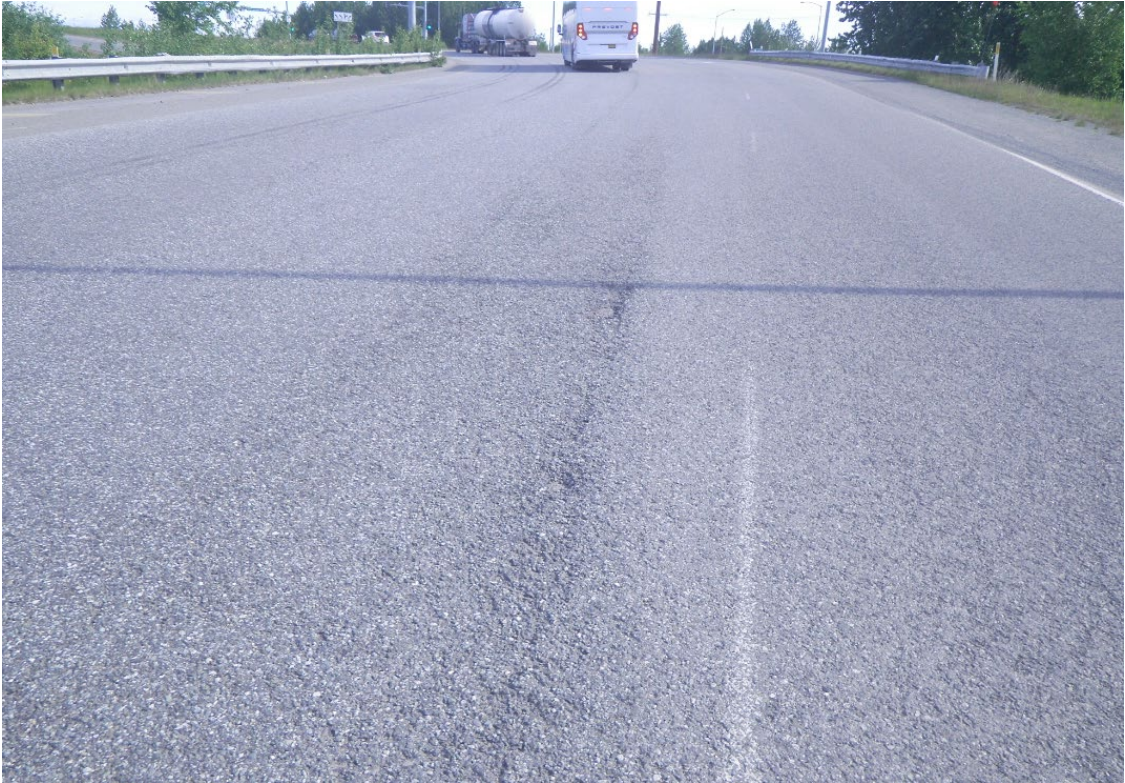
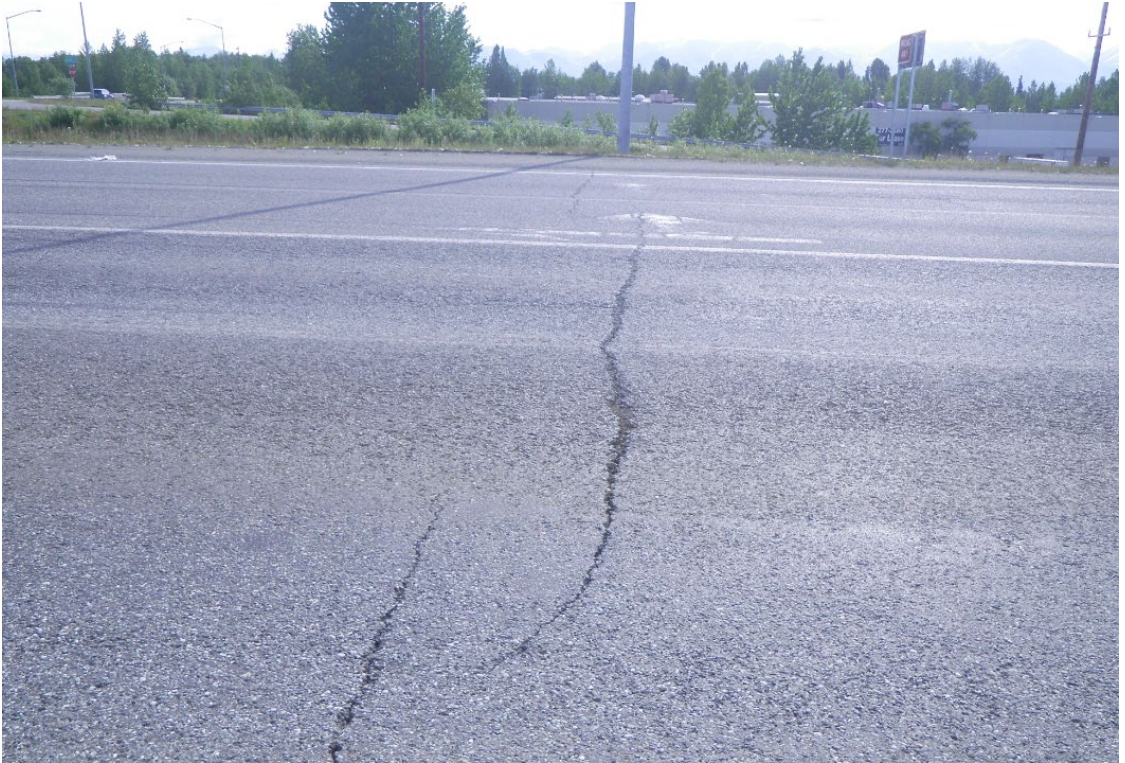
Ramp 2 – Minnesota NB - International Airport Ramp

Ramp had moderate rut depths at the intersection with International Airport Road, and moderate raveling and isolated high severity transverse cracking.

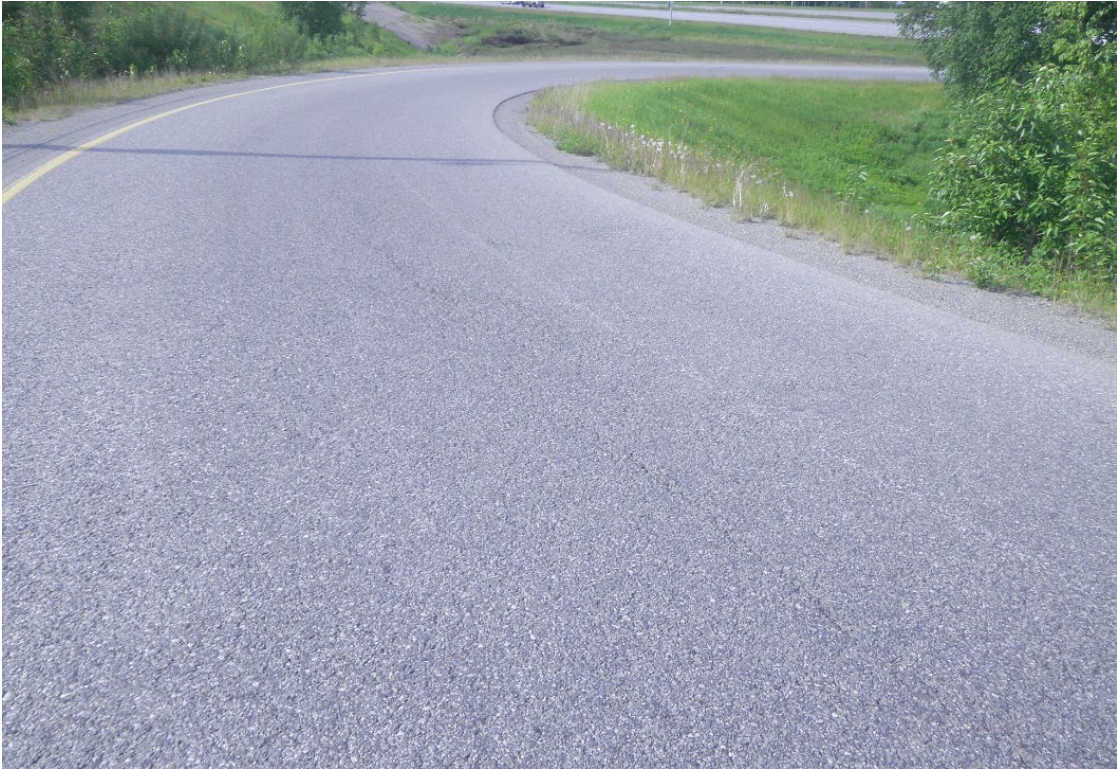
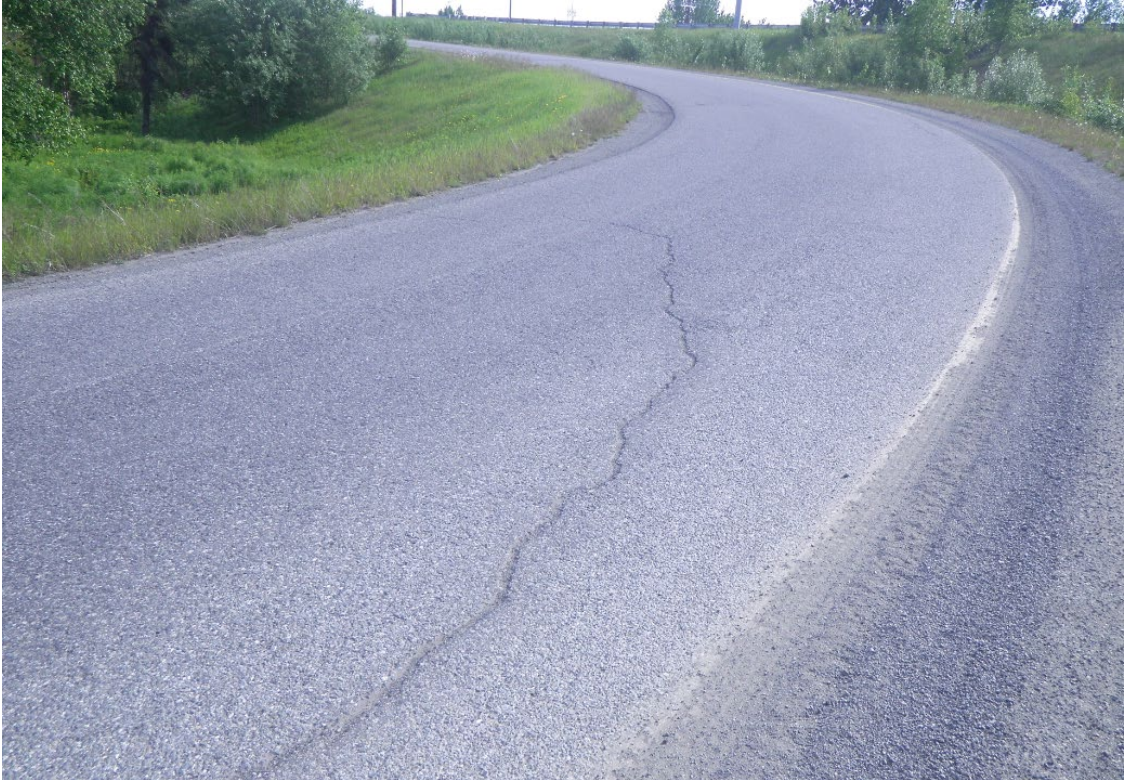
Ramp 3 – International Airport EB - Minnesota NB Loop

This ramp is a cloverleaf with minimal rutting, minor raveling and isolated moderate severity cracking.

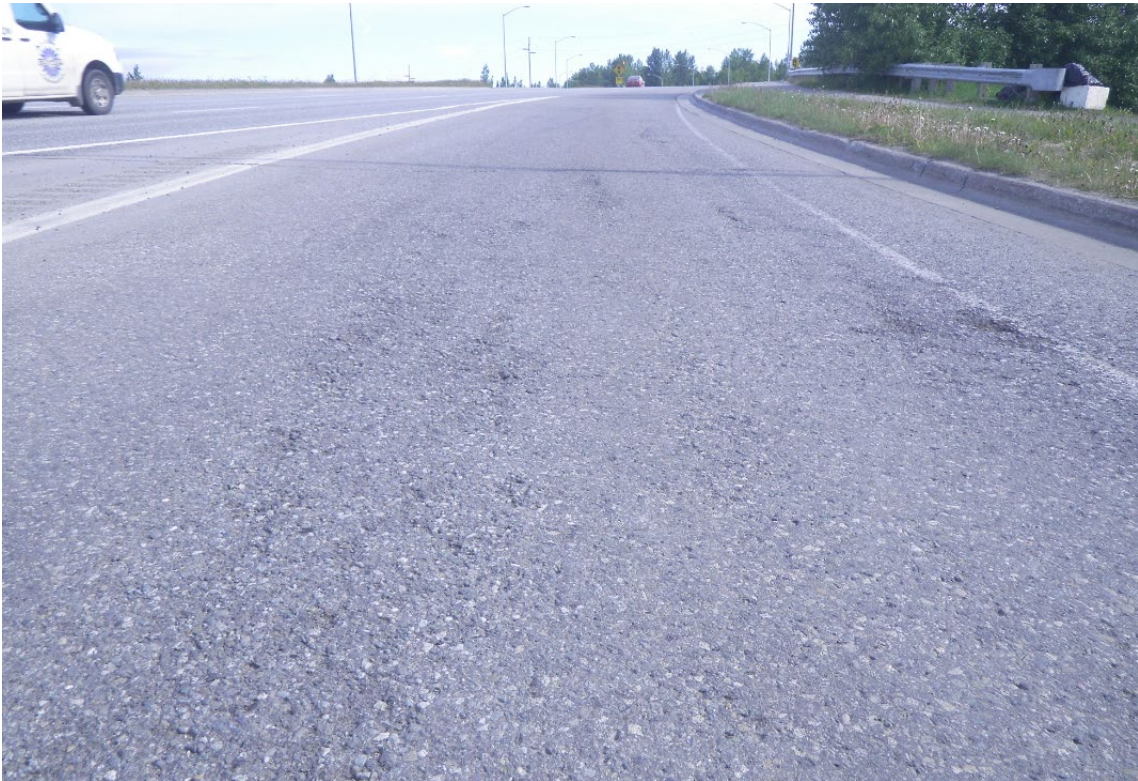
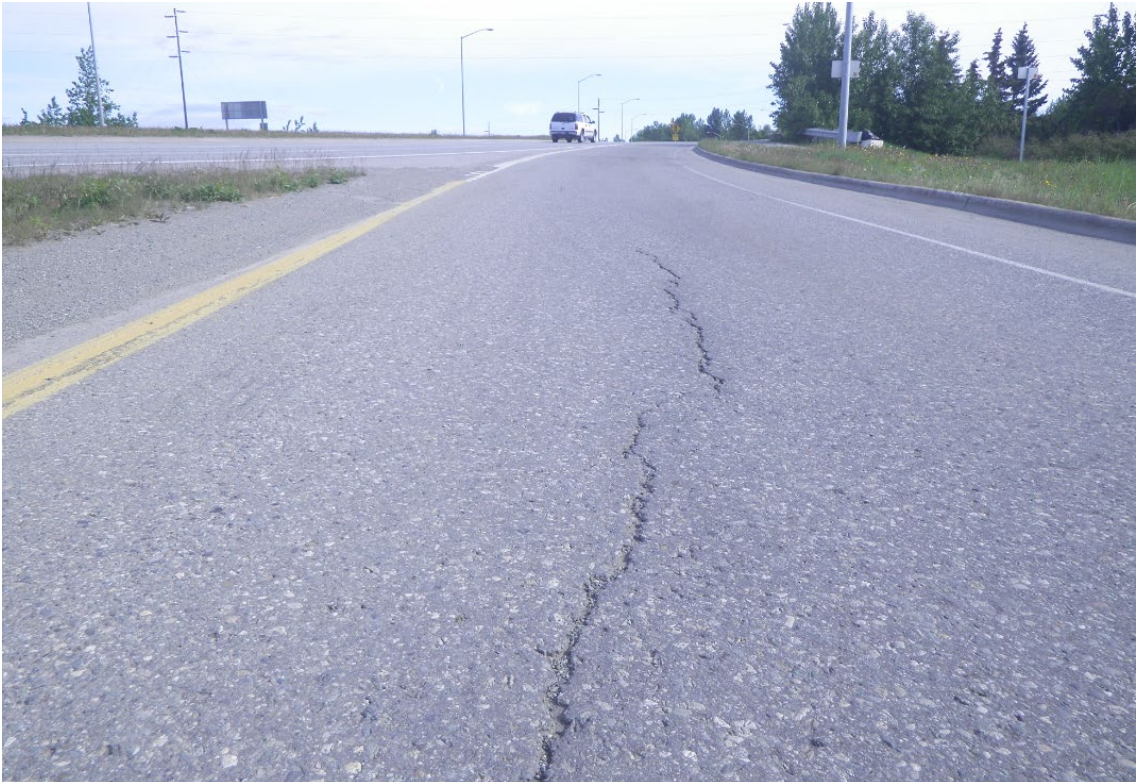
Ramp 4 – International Airport - Minnesota NB Ramp

Microsurfacing was applied over a small portion of this ramp to cover an area of raveling and cracking.

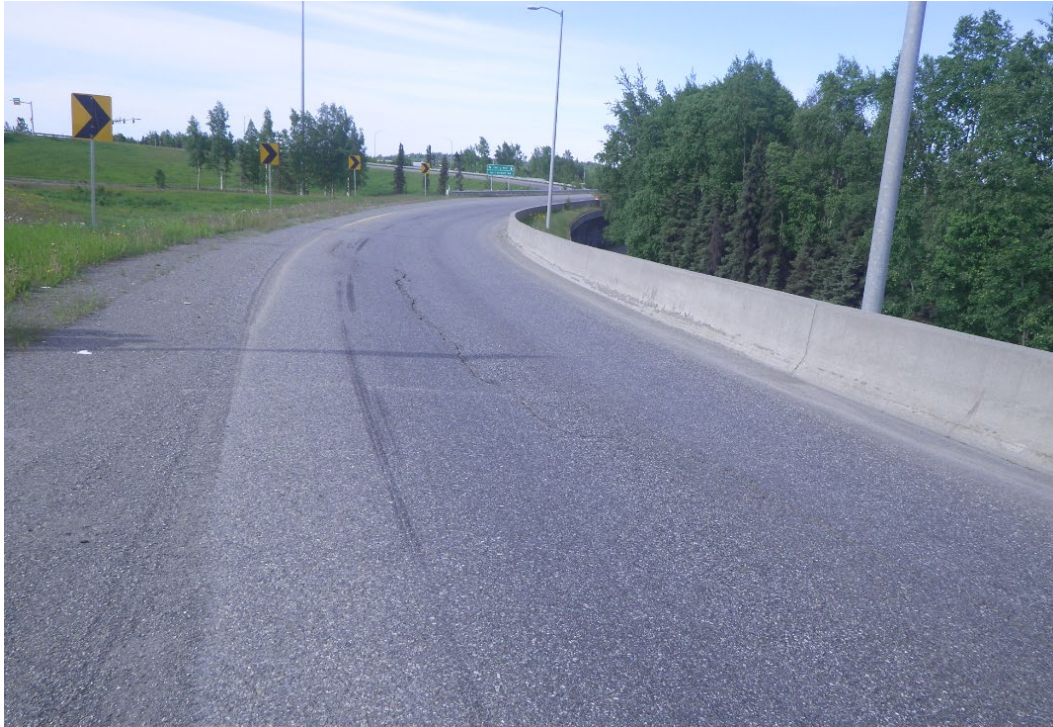
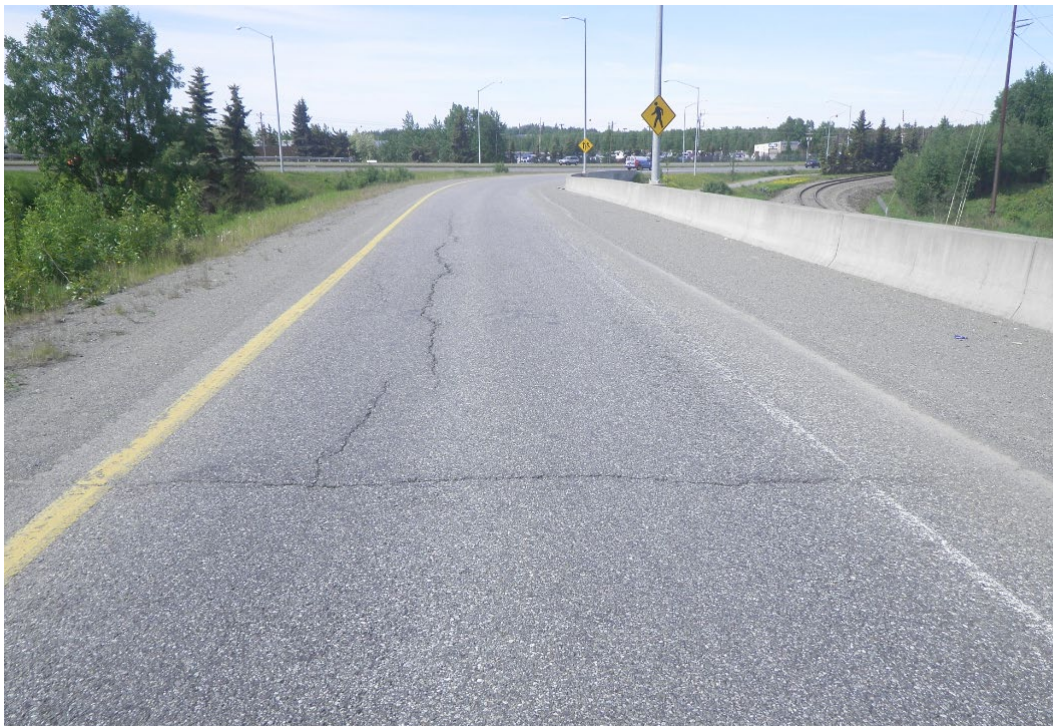
Ramp 5 – Minnesota SB - International Airport Ramp

The initial part of this ramp has high severity longitudinal cracking. The worst of this was fixed as part of the earthquake repair portion of the project and did not receive microsurfacing. The rest of the cracking received crackseal and hot mix tamped in place. The later part of the ramp had moderate severity transverse and longitudinal cracking and minor raveling.

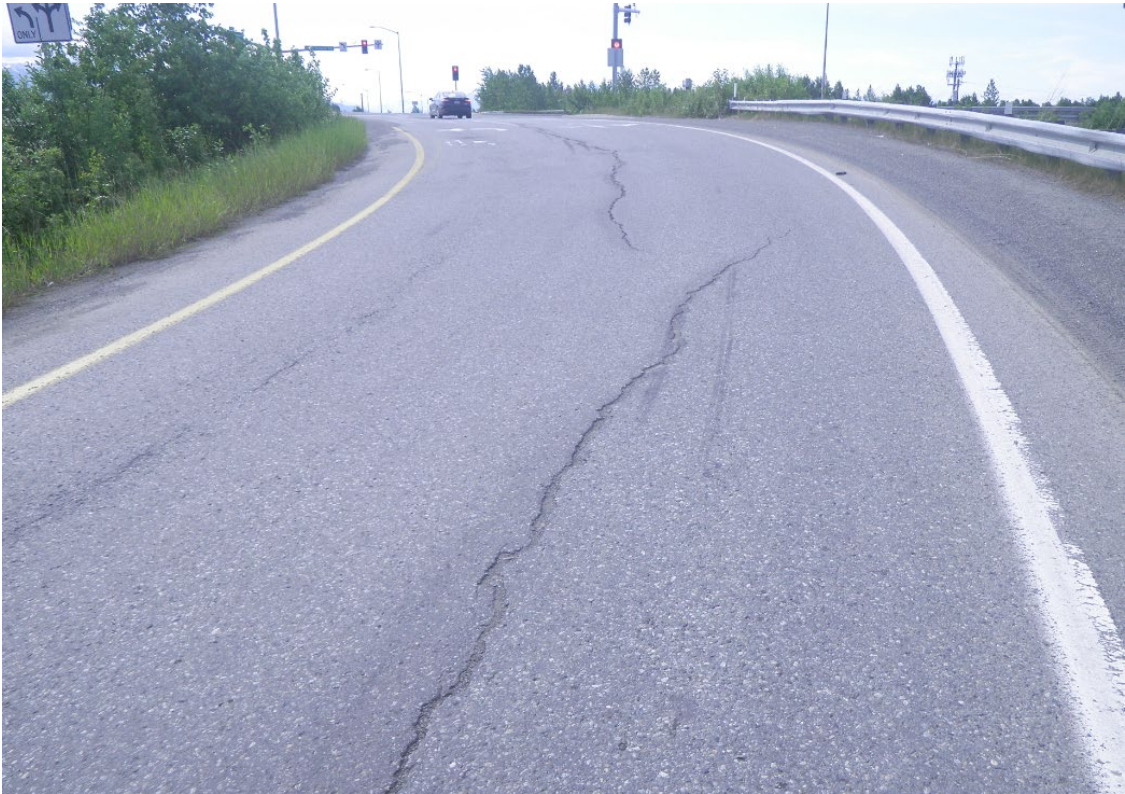
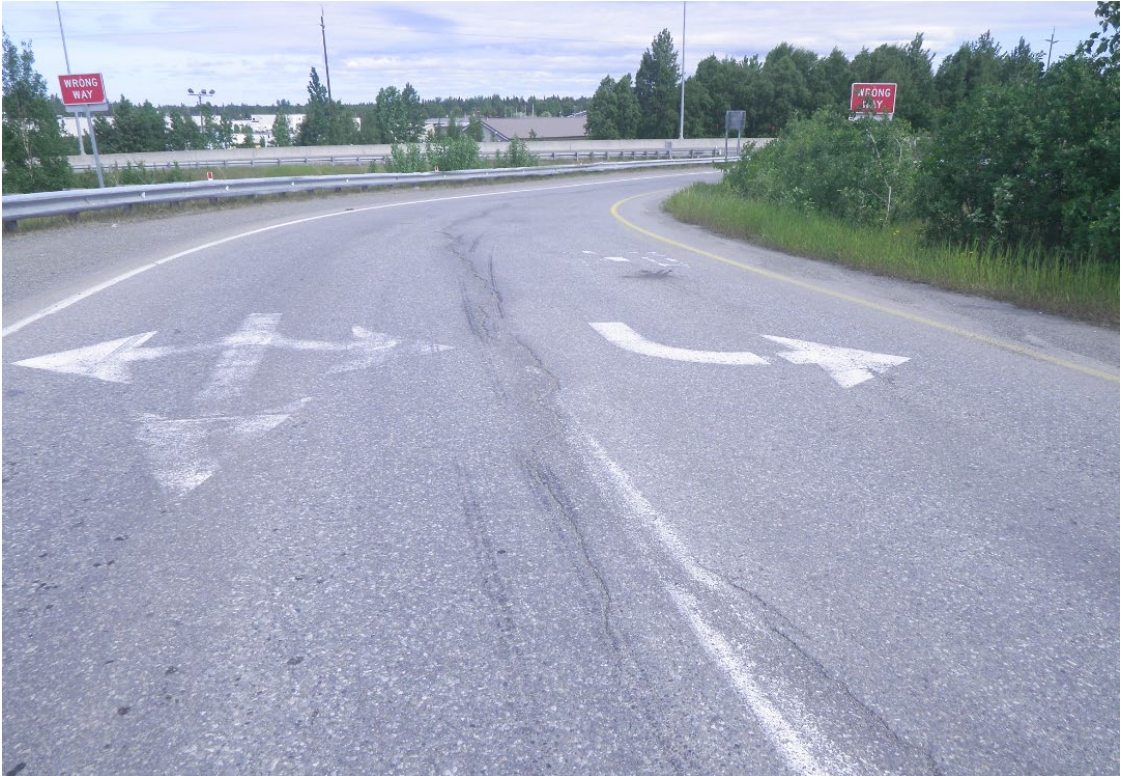
Ramp 6 – Minnesota SB - International Airport Ramp

This ramp had minor rut depths but moderate to high severity longitudinal cracking.

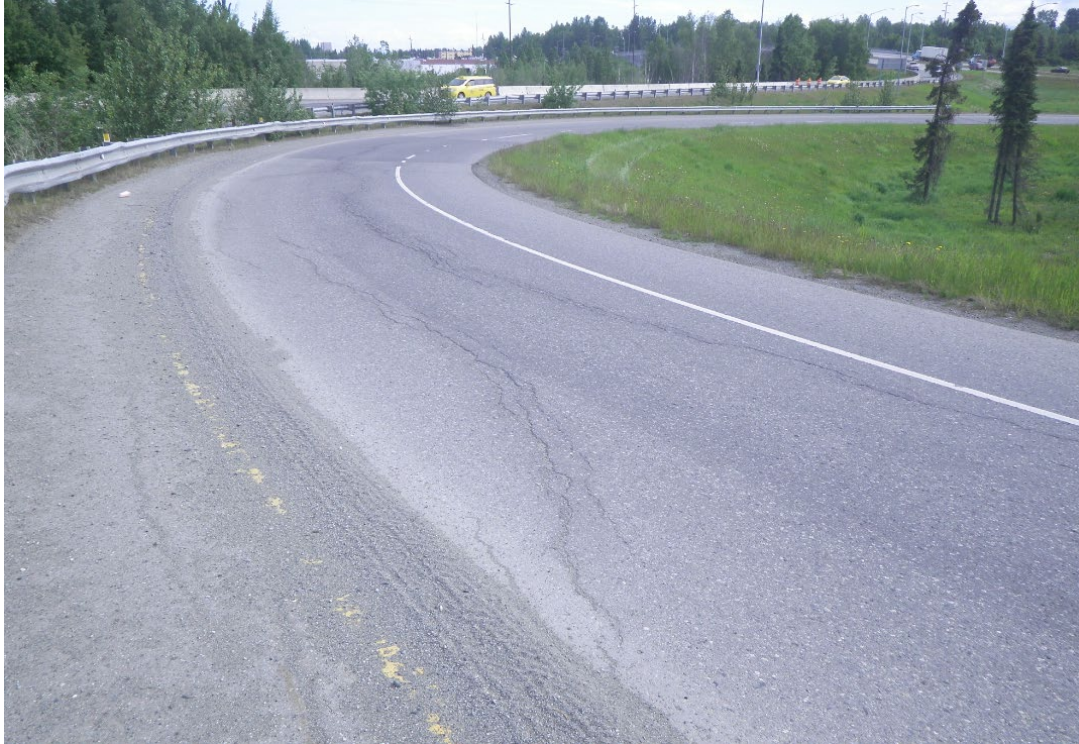
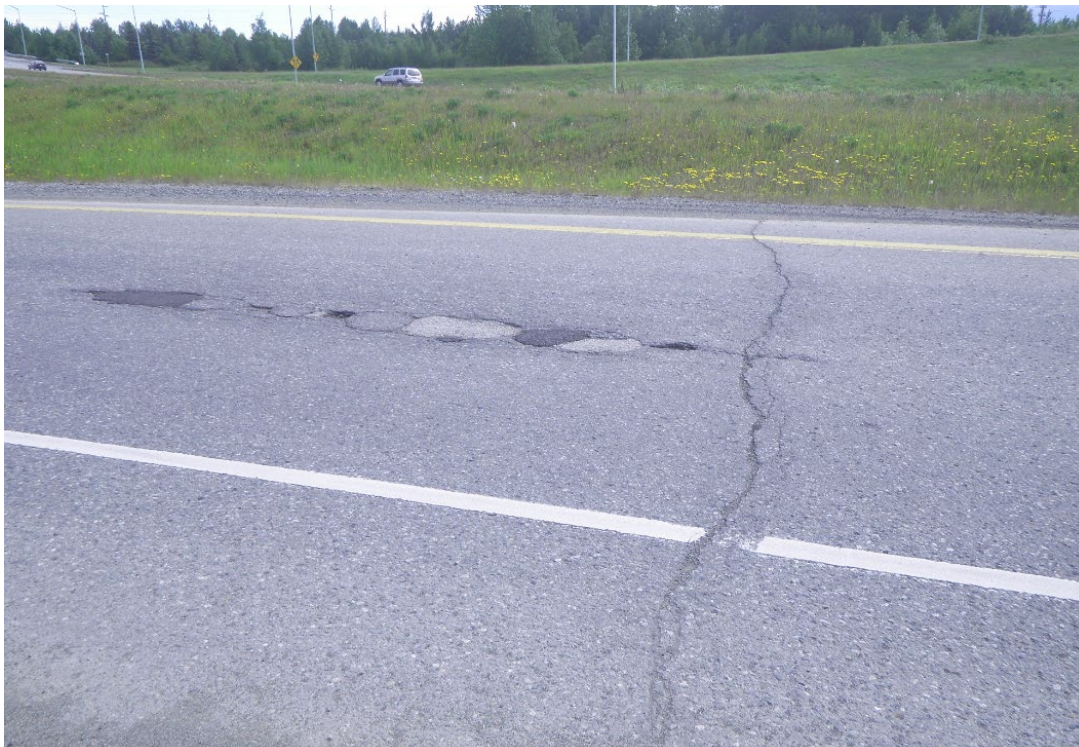
Ramp 7 – International Airport WB - Minnesota SB Loop

There are low rut depths but high severity longitudinal cracking is present in the middle of the ramp that may be related to embankment movement as well as underlying frost susceptible soils. At the base of the ramp there is transverse cracking with potholing.

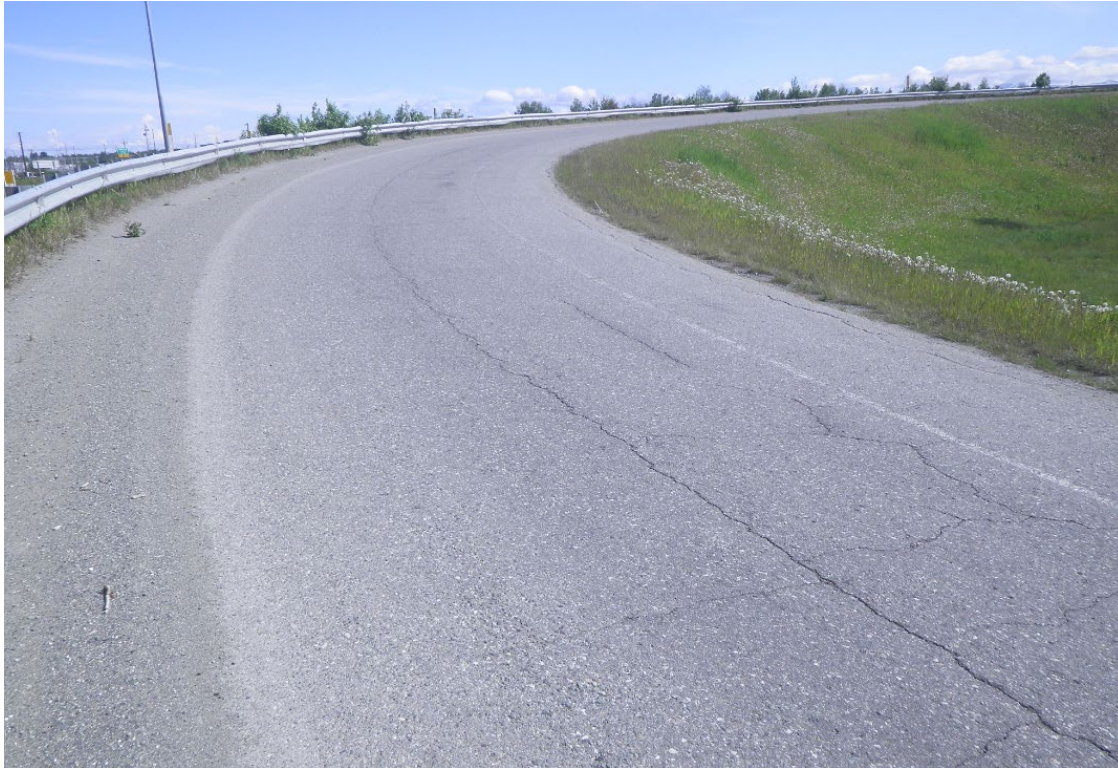
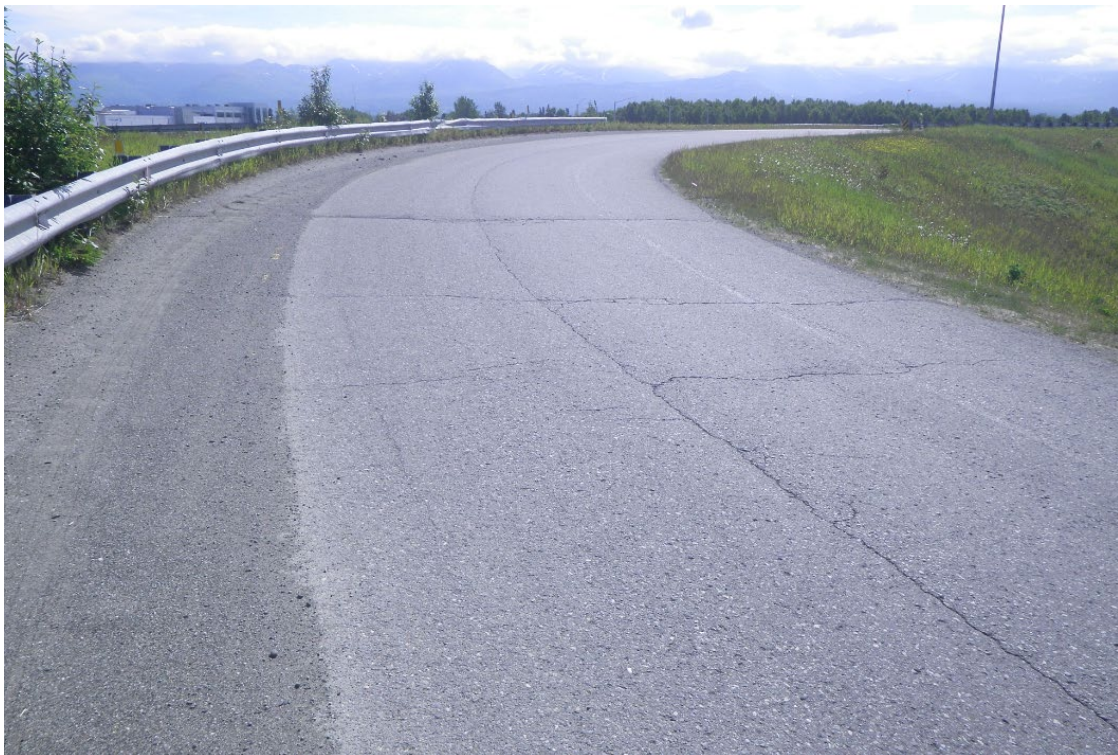
Ramp 8 – Raspberry WB - Minnesota SB Ramp

The entire ramp is blocked cracked with a centerline crack present for the entire length. Fatigue cracking is beginning to develop in the inside wheelpath.

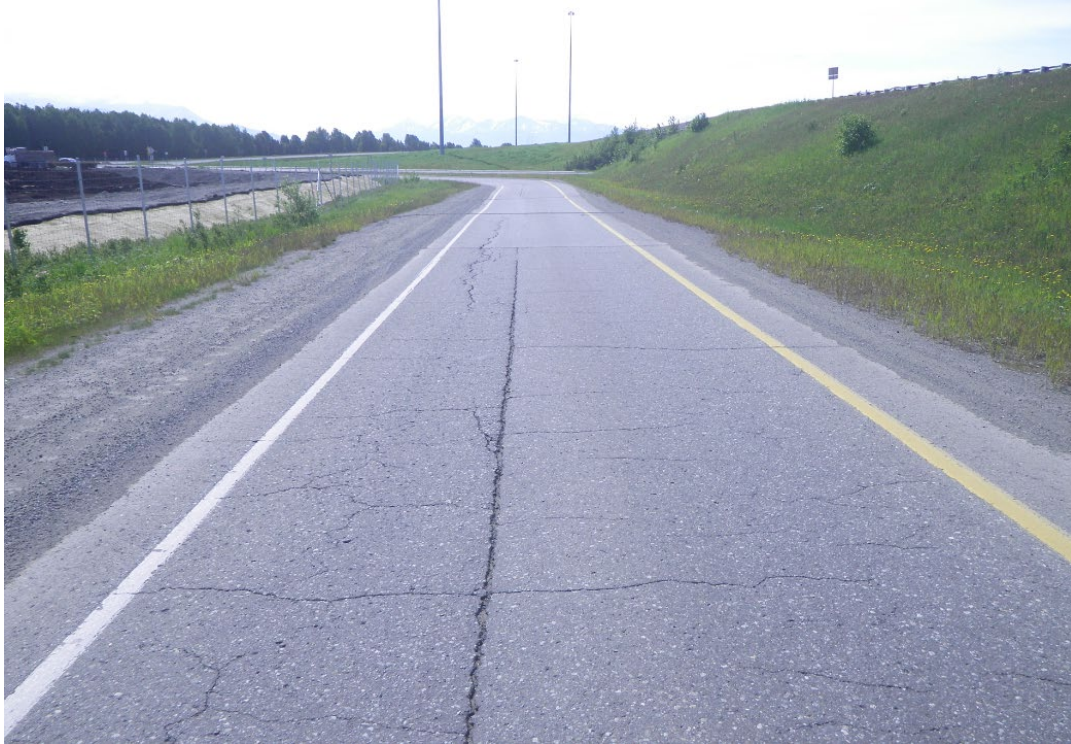
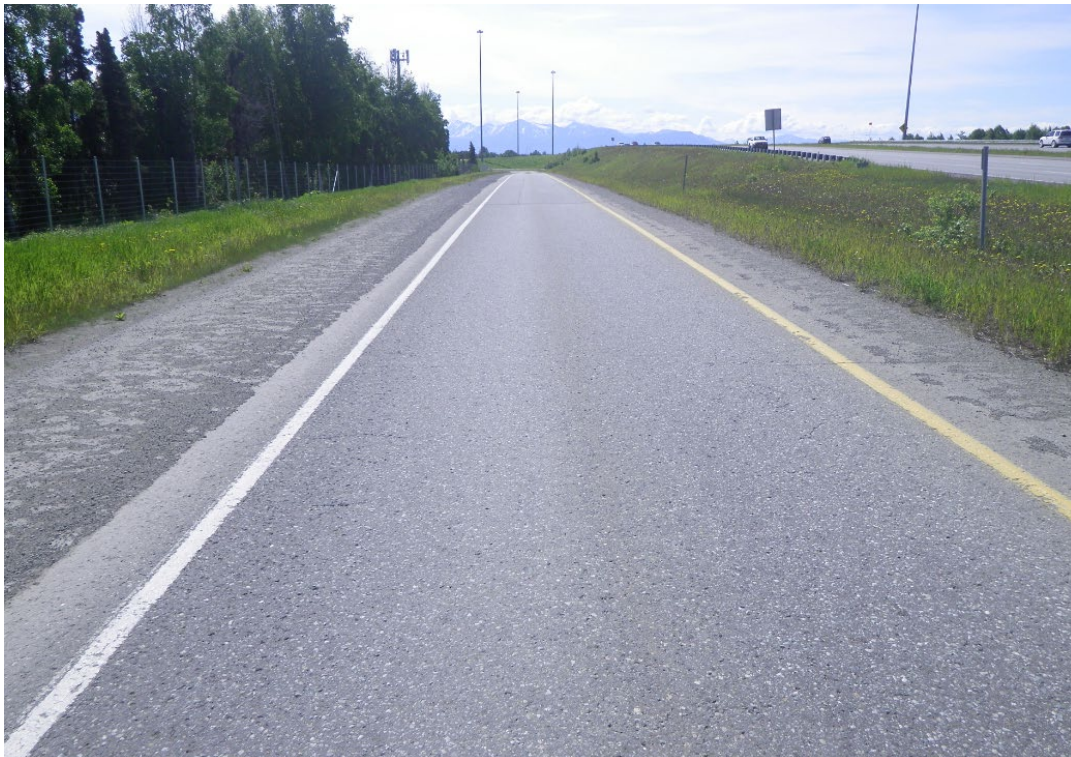
Ramp 9 – Raspberry WB - Minnesota NB Ramp

At the beginning of this ramp there is a high severity center crack with fatigue cracking forming in the right wheelpath. The conditions improve at the International Airport sign, although faint wheelpath cracking is beginning to form in areas.

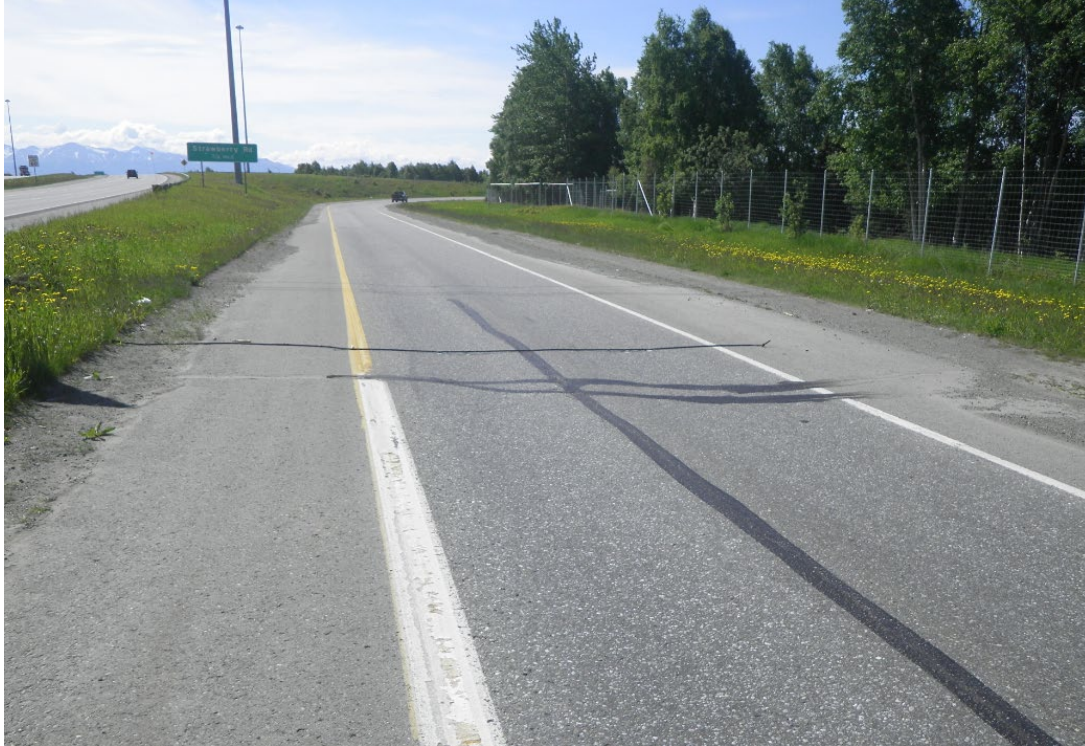
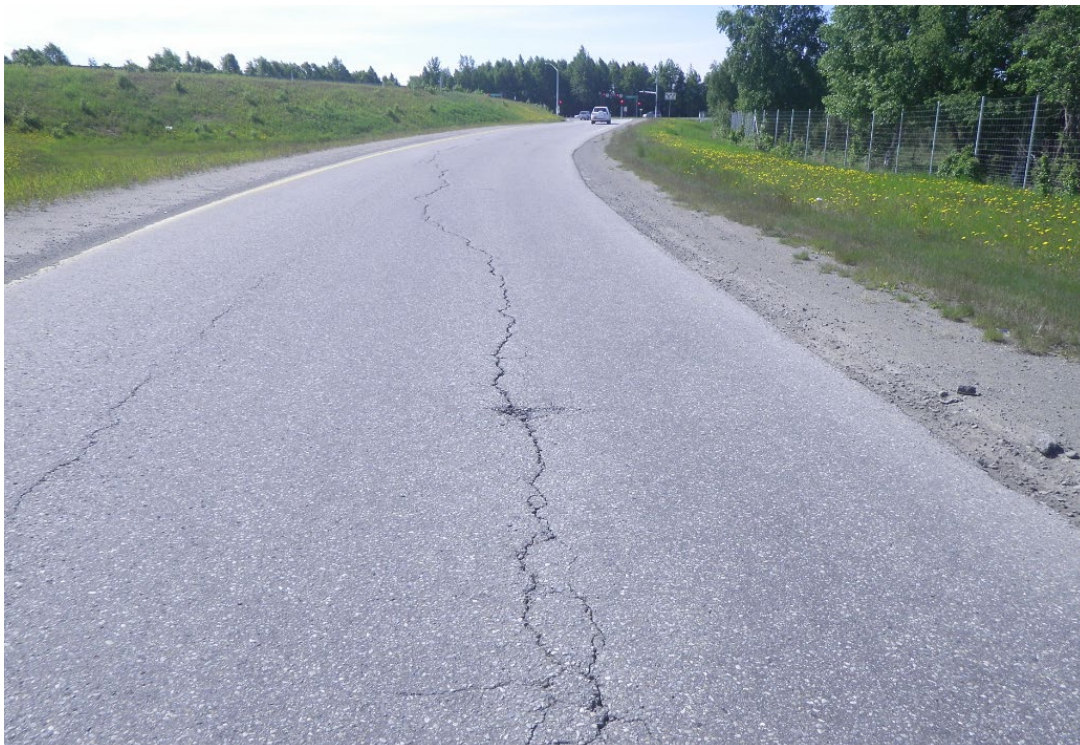
Ramp 10 – Minnesota SB - Raspberry WB Ramp

The beginning of this ramp had high rut depths that received hot mix for rut fill prior to the micorsurfacing application. Farther down the ramp there was moderate to high severity longitudinal and transverse cracking with less severe rut depths.

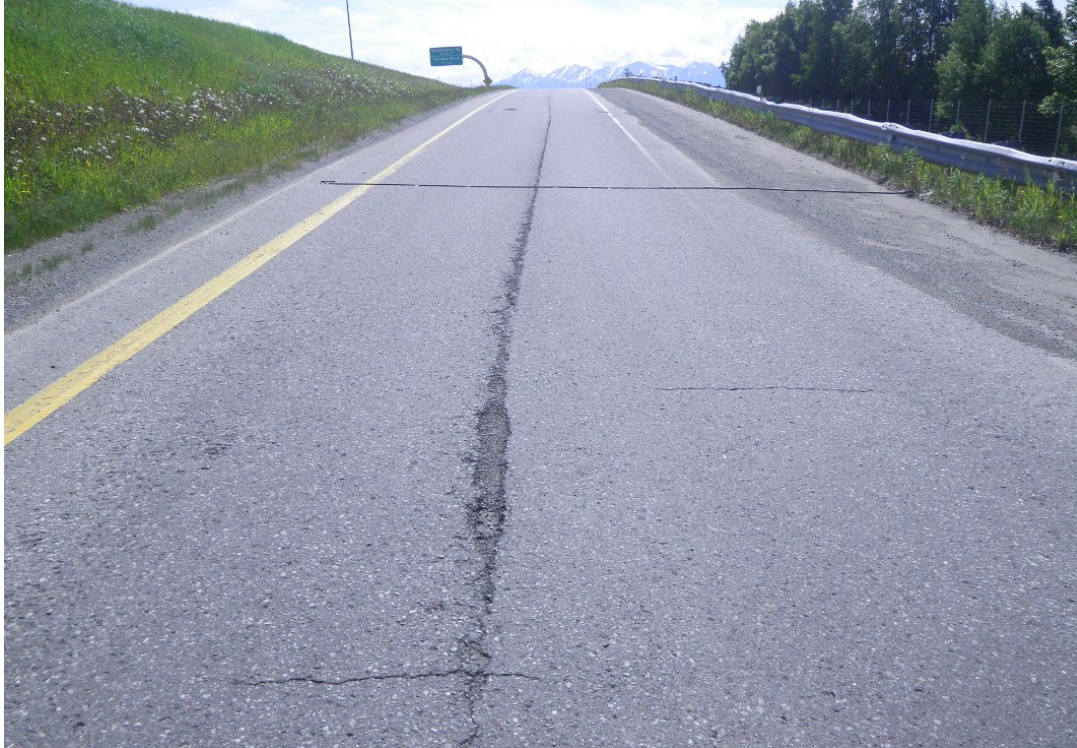
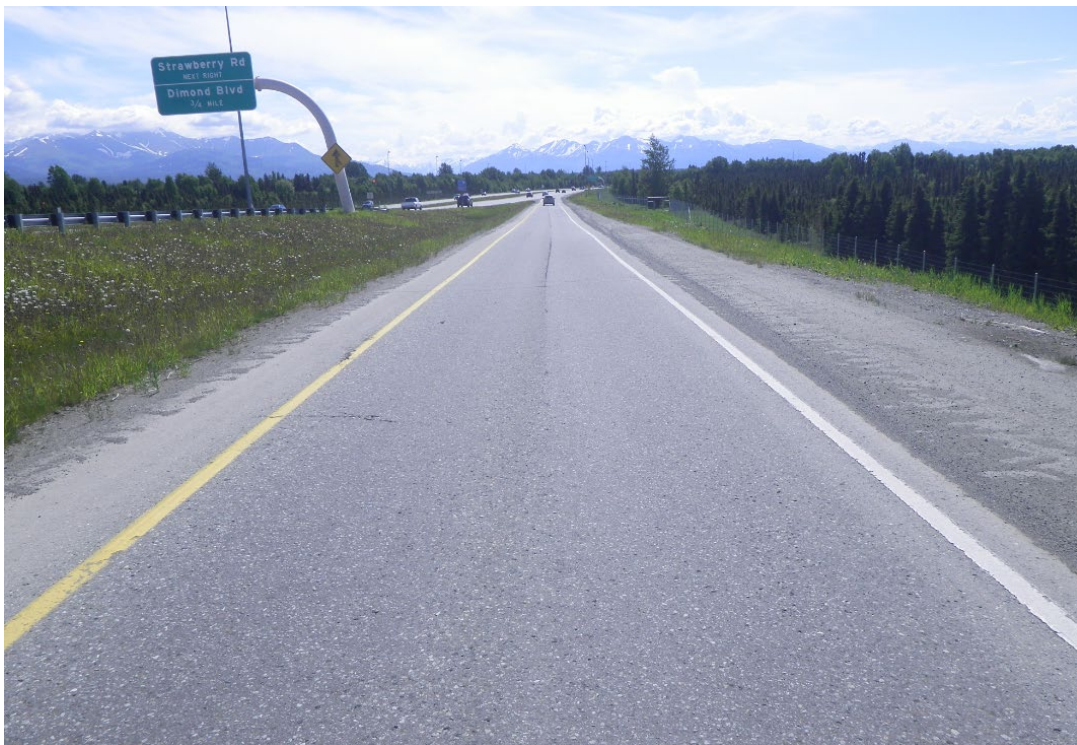
Ramp 11 – Raspberry EB - Minnesota SB Ramp

The primary distresses on this ramp are a longitudinal joint crack and intermittent transverse cracks with associated potholes. The rut depths are minor with the exception of the southern end where traffic accelerates to begin merging with Minnesota where it nears ½" on average.

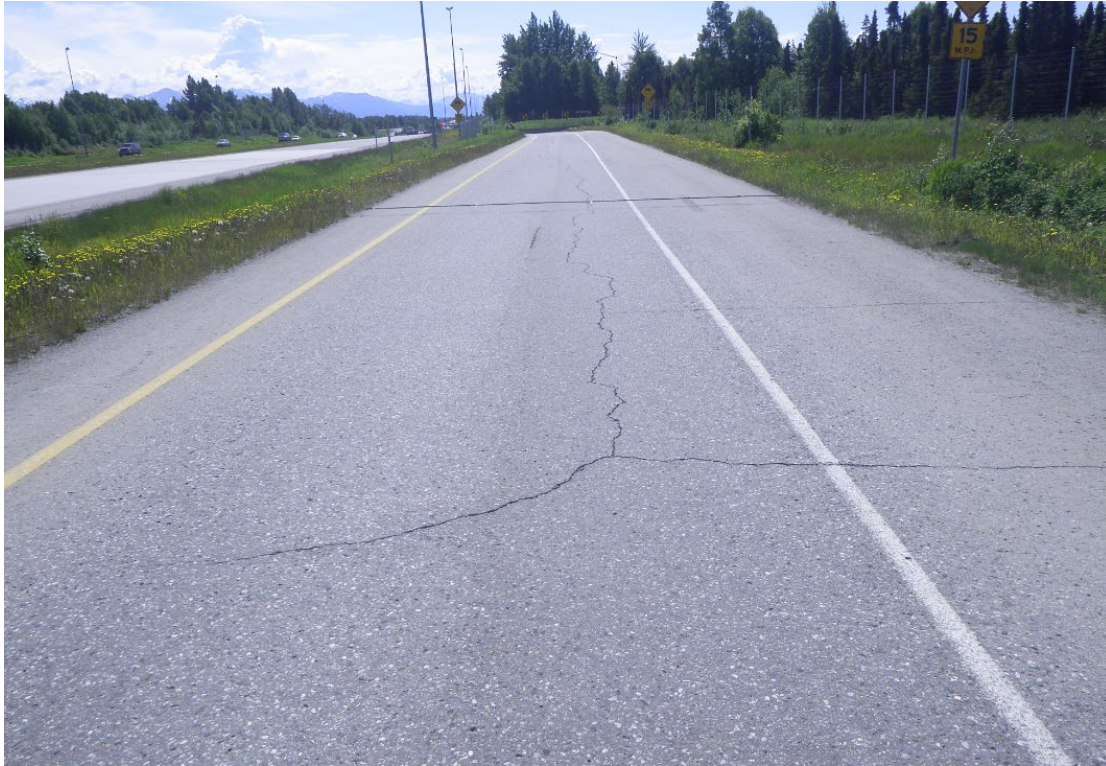
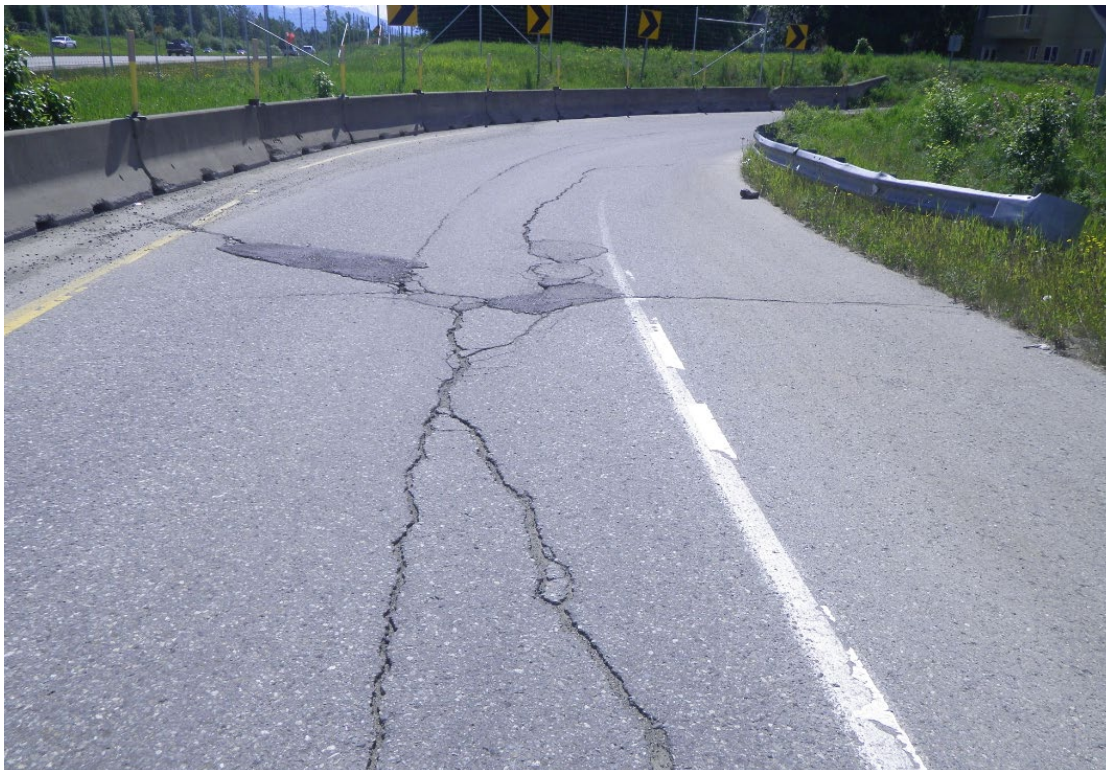
Ramp 12 – Minnesota SB - Strawberry Ramp

There are low rut depths on this ramp, but it does have high severity longitudinal cracking, transverse cracking and potholing that worsen towards the end of the ramp.

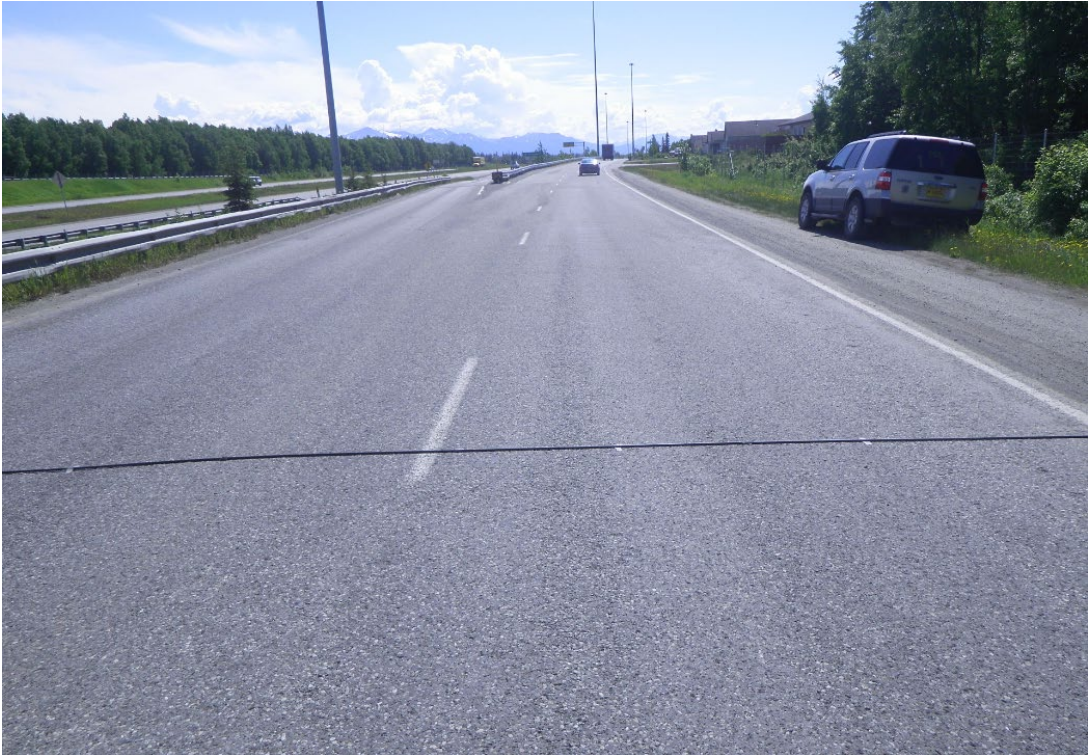
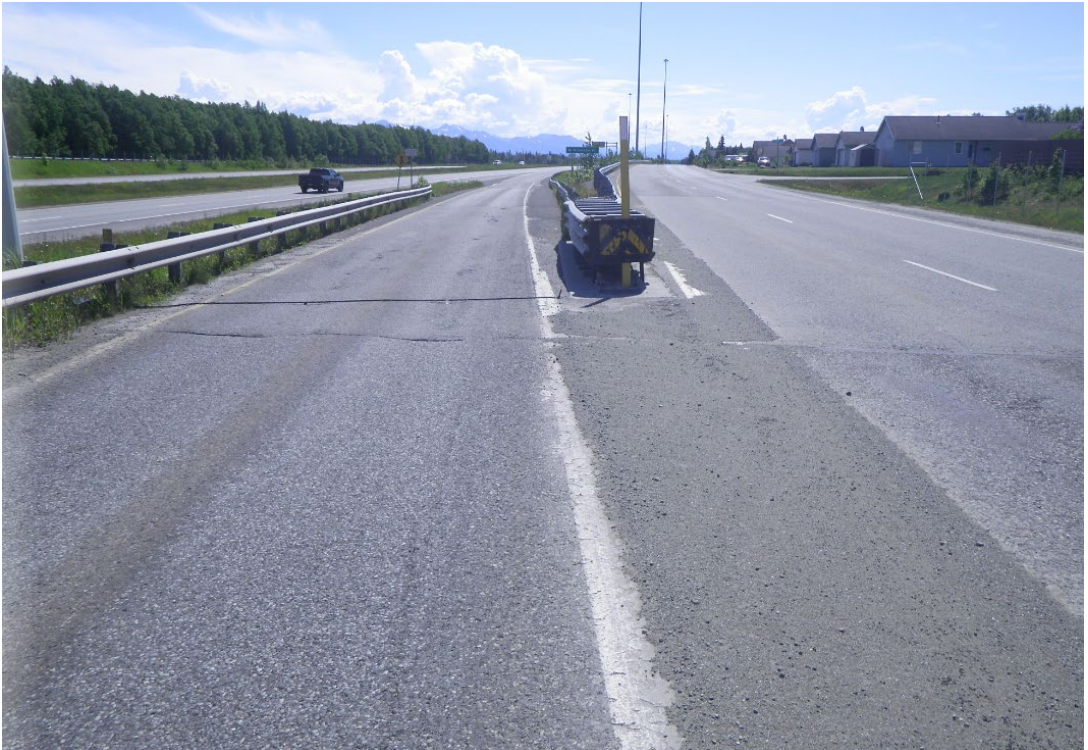
Ramp 13 – Dimond - Minnesota SB Ramp

There are moderate rut depths on the left portion of the ramp that accelerates and merges onto Minnesota, which received pre-level prior to the microsurfacing application. The rest of the ramp is in good condition with ruts less than half an inch and low severity raveling.
