Appendix A
Preconstruction Documentation

Minnesota Drive Seward Highway to Tudor Road Microsurfacing Locations

Appendix B
Construction Photolog

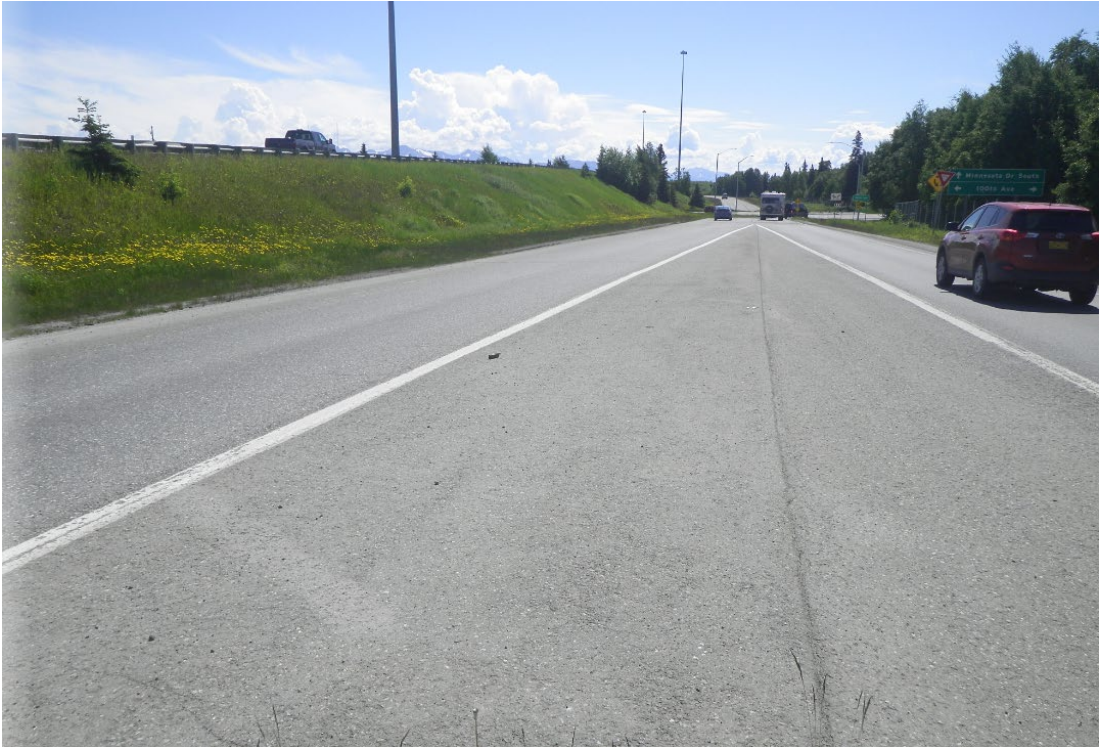
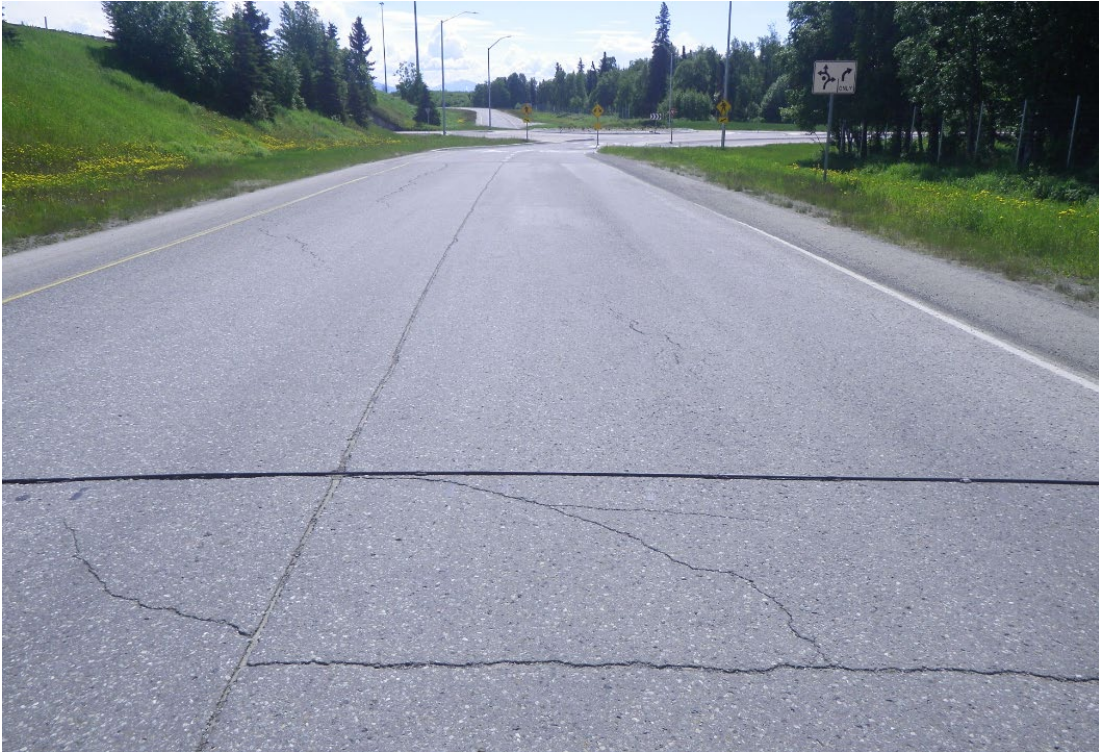
Ramp 14 – Minnesota SB - 100th Ramp

The ramp has isolated potholes, low rut depths but longitudinal and transverse cracking near 100th Avenue.

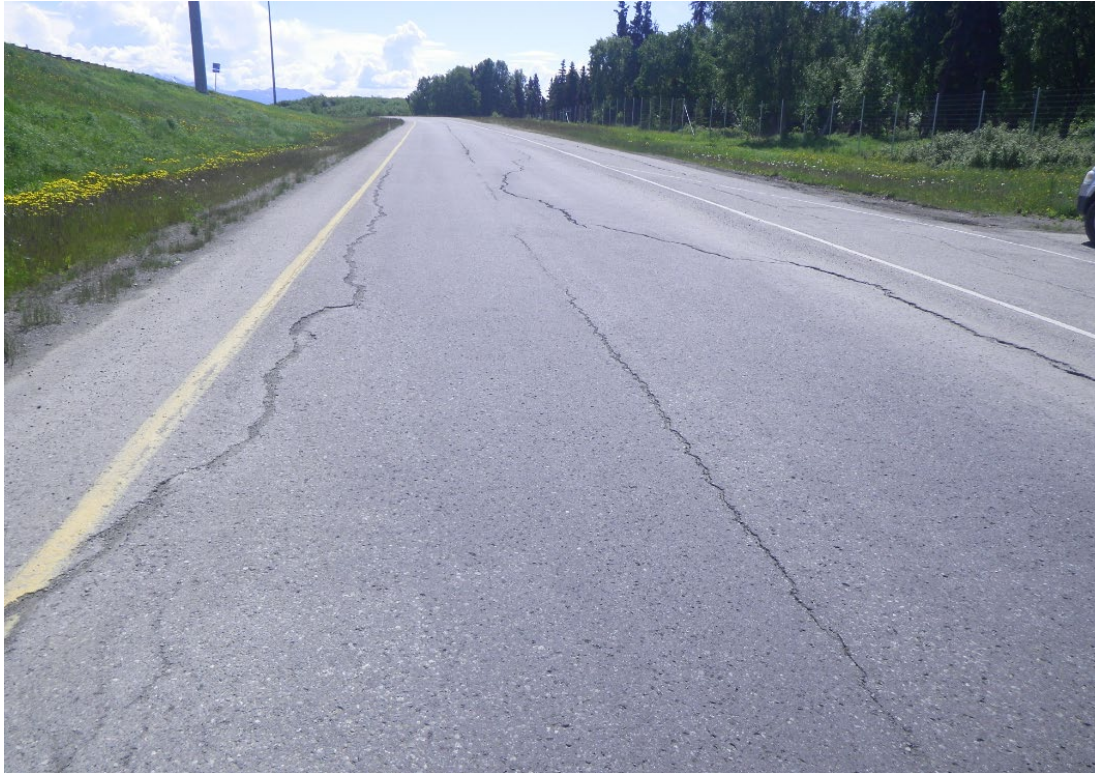
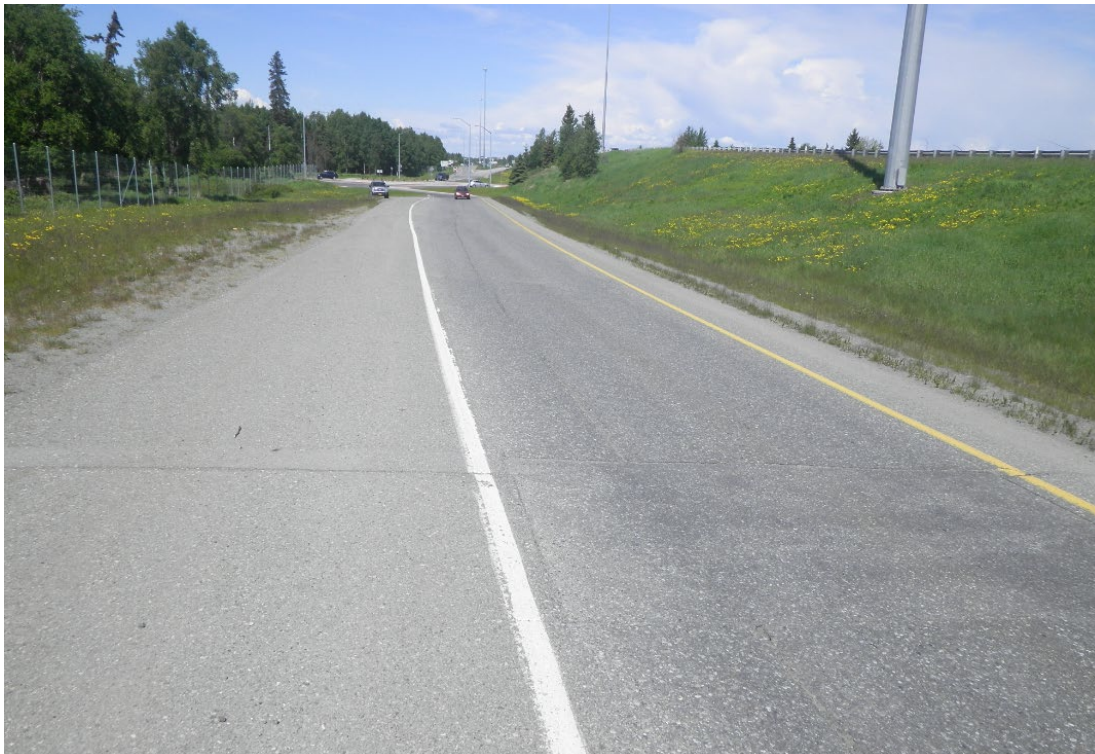
Ramp 15 – 100th Avenue Minnesota SB Ramp

There is high severity longitudinal cracking and joint cracking near 100th Avenue that improves farther down the ramp

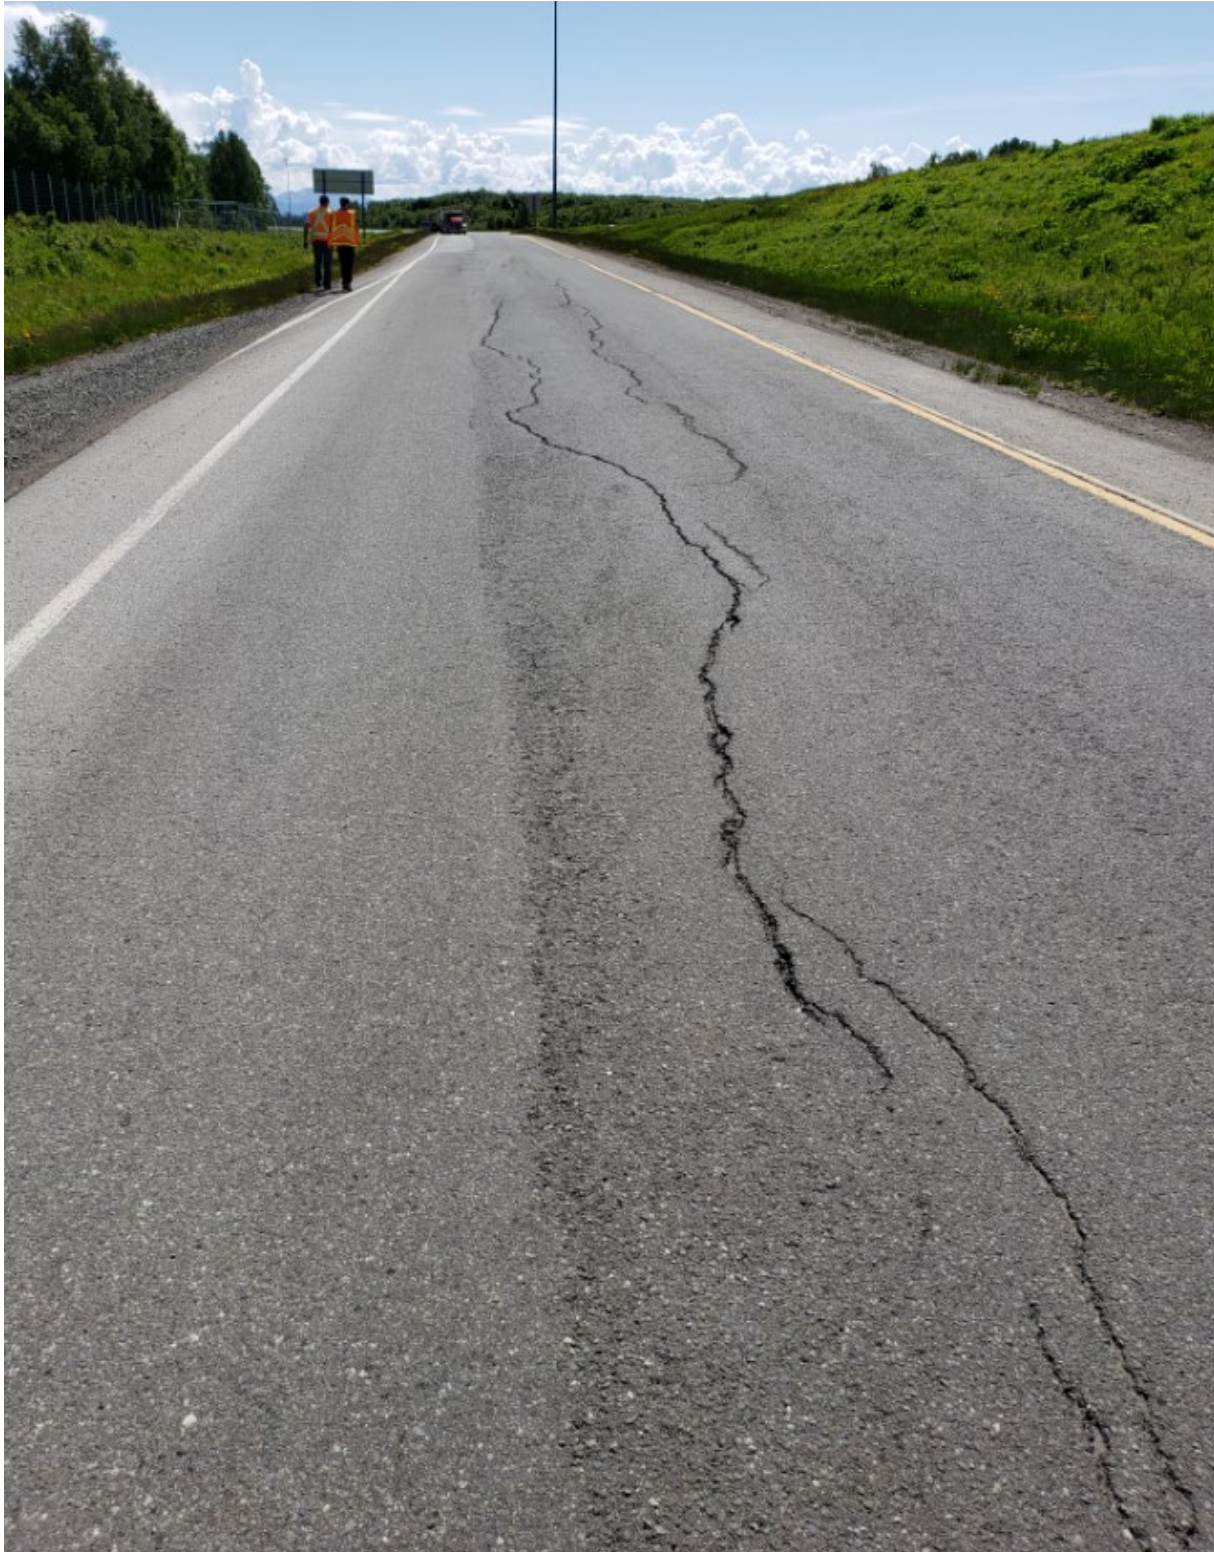
Ramp 16 – Minnesota NB - 100th Ramp

Near the beginning of the ramp there is low severity transverse cracking and raveling, but closer to 100th Avenue there is high severity longitudinal cracking.

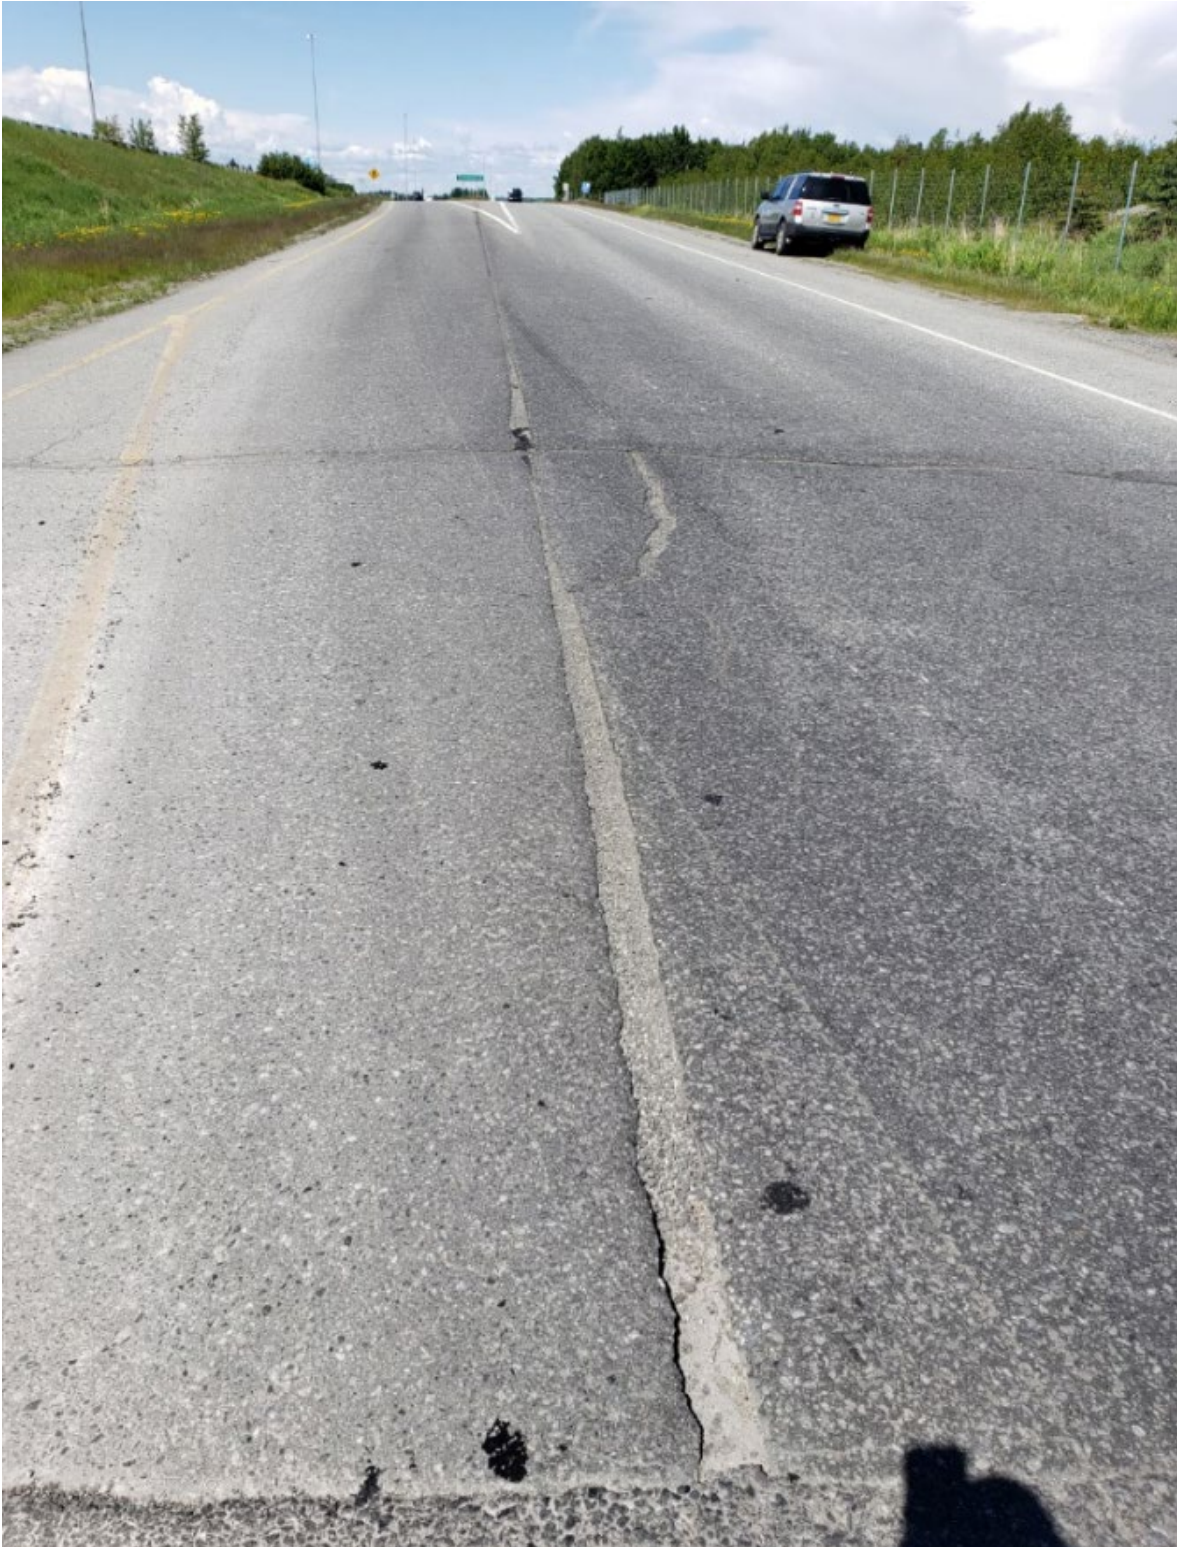
Ramp 17 – 100th Avenue - Minnesota NB Ramp

There is moderate longitudinal and transverse cracking near 100th Avenue with isolated potholes and some high severity transverse cracking where the ramp merges into Minnesota Drive.

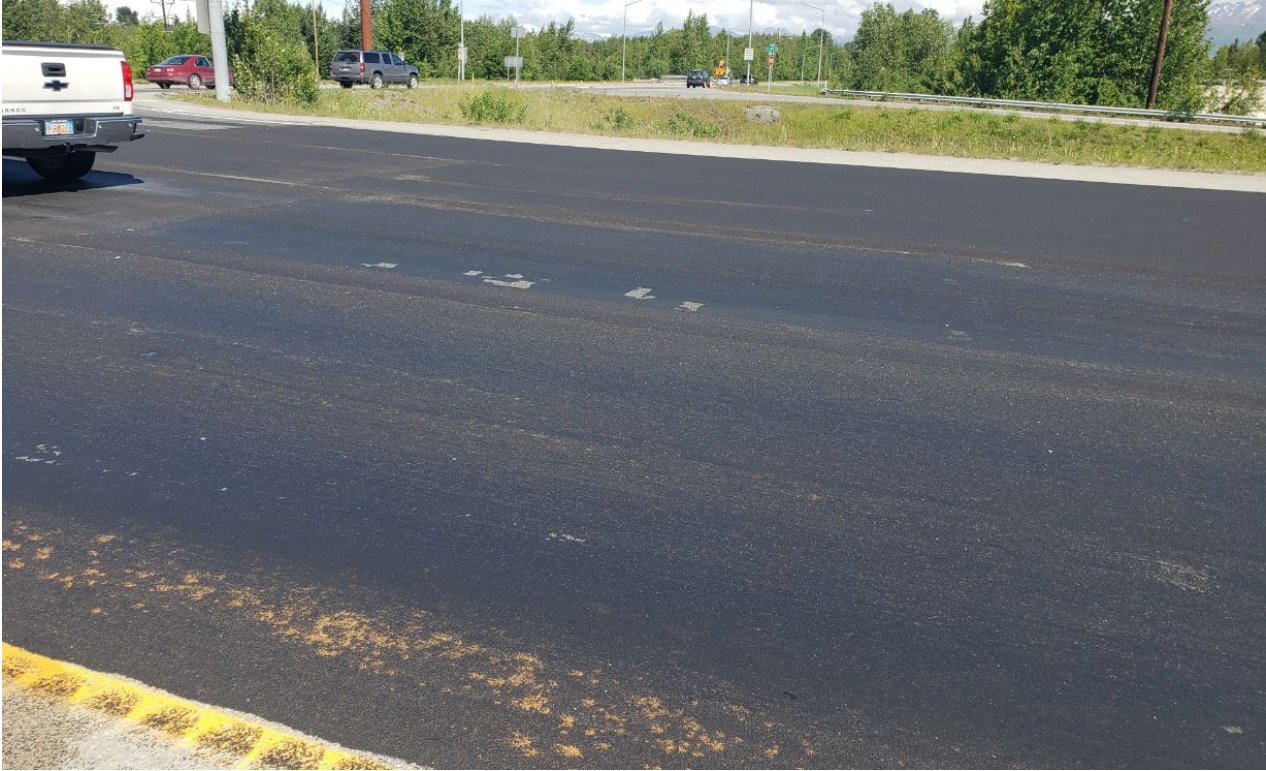
There was some pickup by traffic on the scratch course on Ramp 2 on the fourth day of production. This is at the signalized intersection that the major pickup and deformation occurred on the surface course.

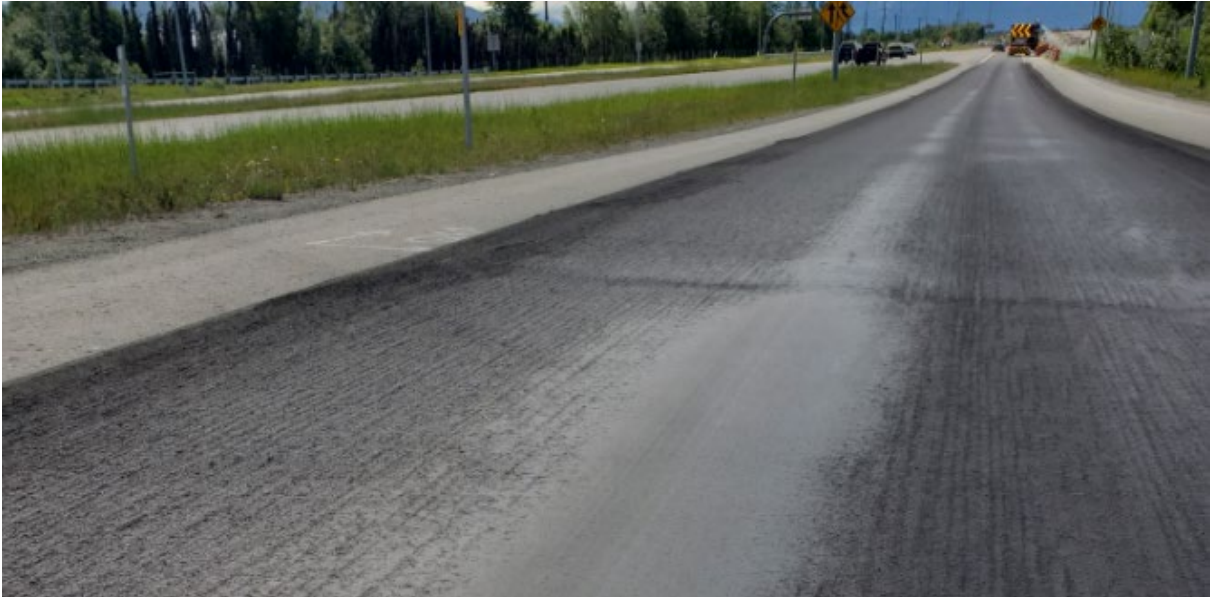
Construction continued on the surface course without issue until Saturday, June 13th when distress was reported on the surface course of Ramps 1 and 2 at International Airport Road. The flushing distress on Ramp 1 at the transition of the rut fill that extends down the ramp as indicated by QAP mark on the left.

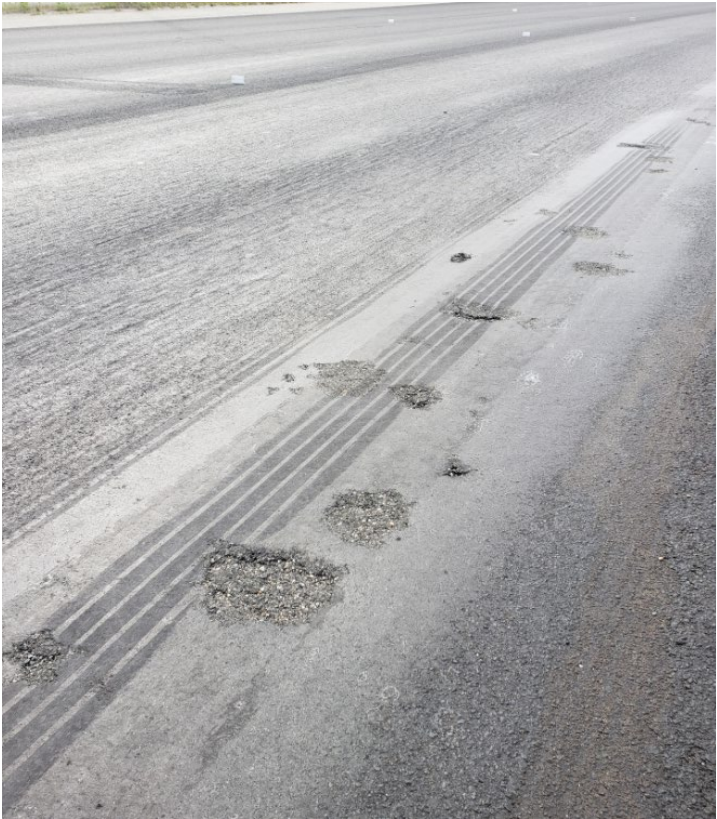
Ramp 2, shown below, had extreme flushing and pickup, caused by the static loading and turning motion of trucks hauling material to the Anchorage International Airport.

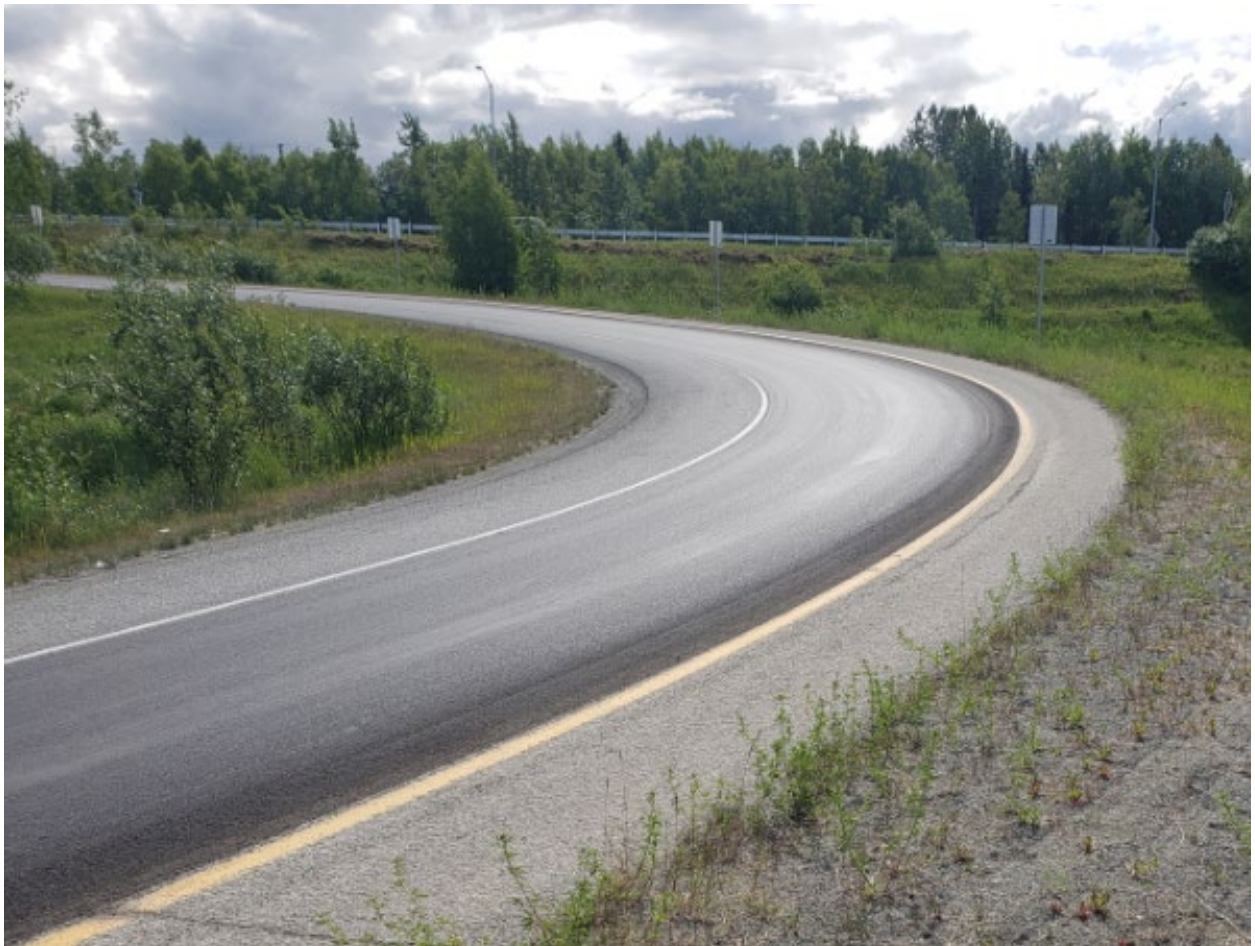
Ramp 3 was reviewed while out looking at Ramps 1 and 2 and no flushing, bleeding or other distresses were present on the ramp. This is the same location that was hand worked in the previous photos.

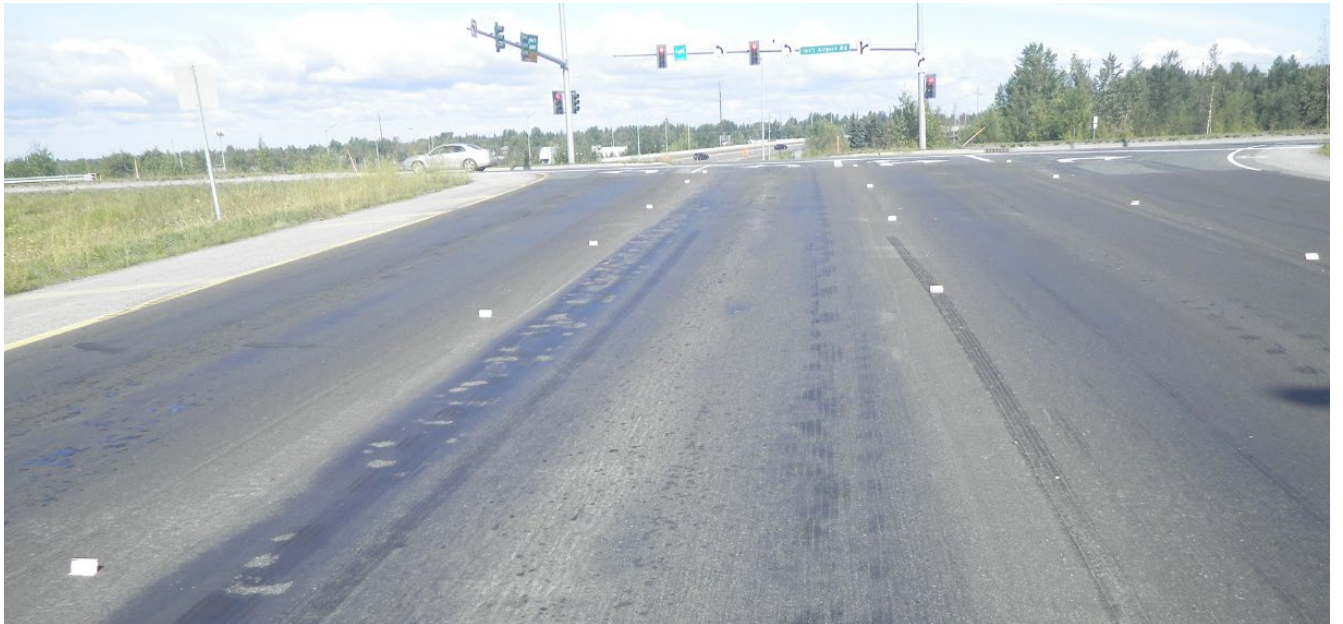
The flushing distress and pickup by traffic can be observed on Ramp 2

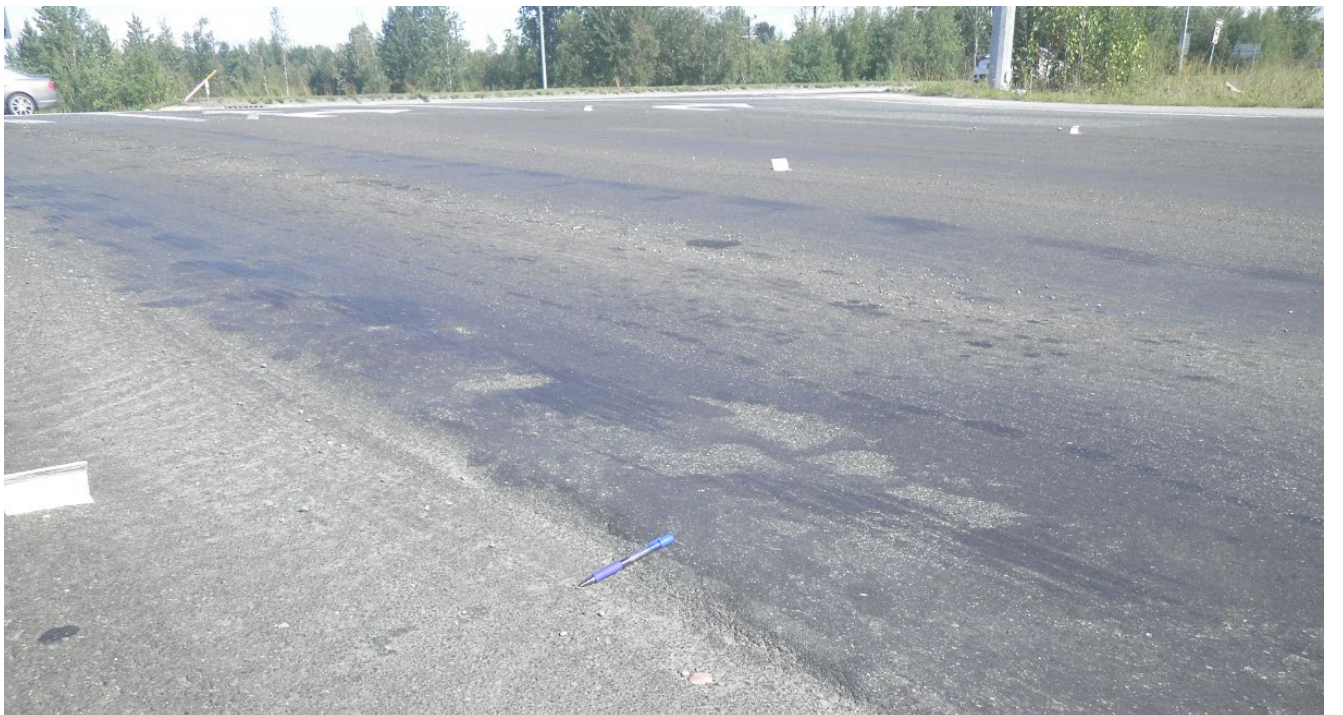
The deformation of the micorsurfacing created a hump where the pen is placed in the photo below. This deformation was not observed on any other ramps where flushing was present, likely because Ramp 2 is the only ramp that has static loading on the micorsurfacing.

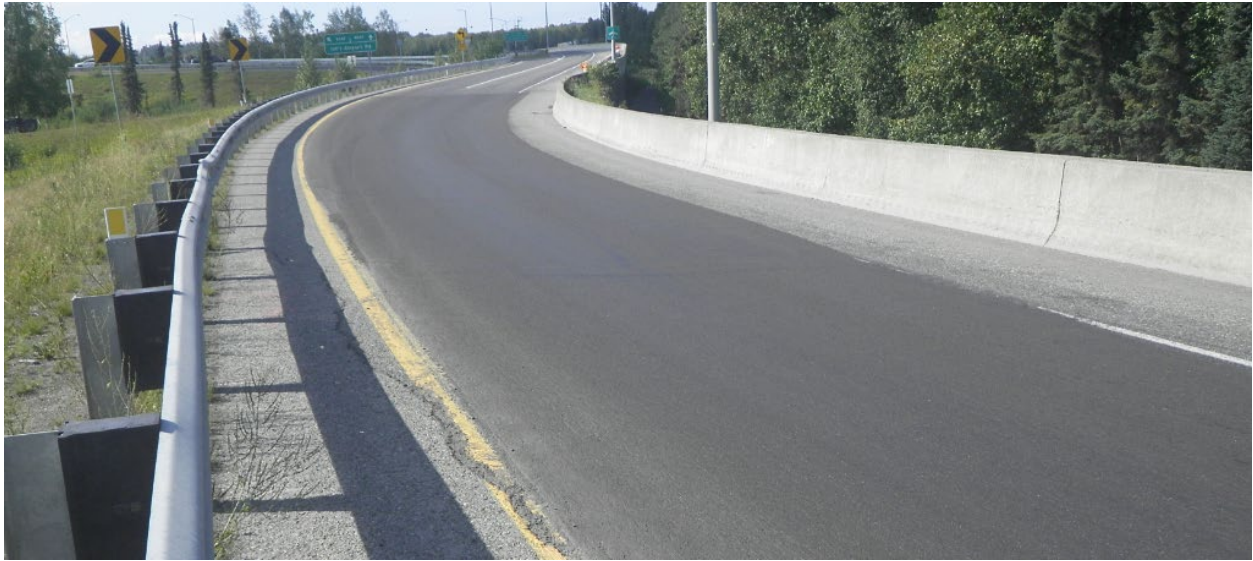
Ramp 5 had some minor flushing on the portion closest to Minnesota shown in the first photo below that was placed over moderate to major severity longitudinal cracks.

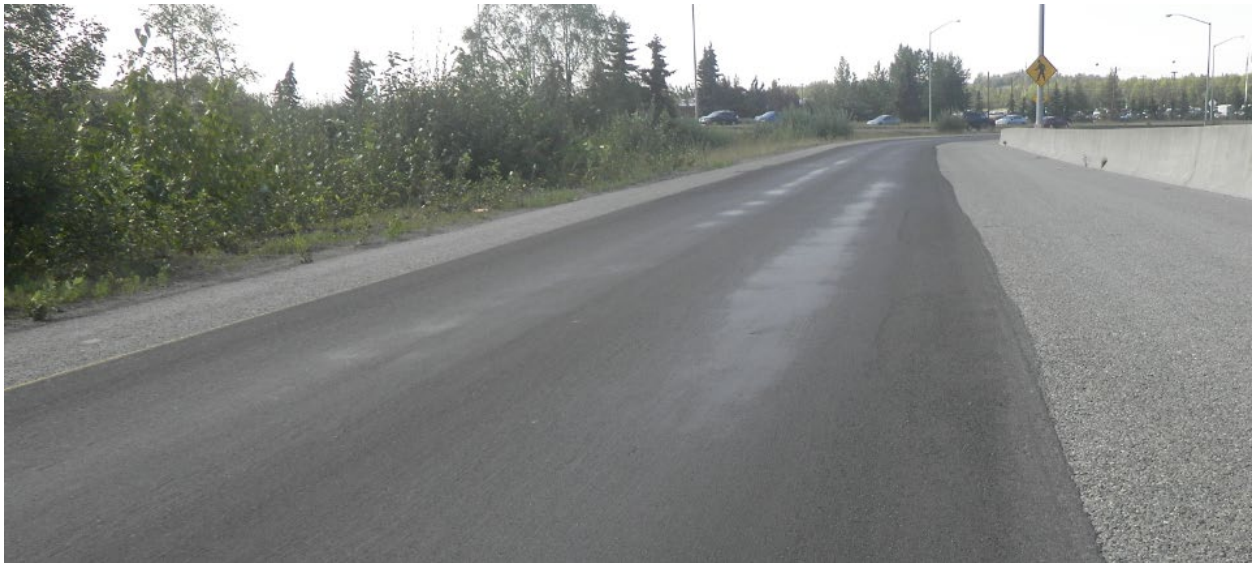
More severe flushing was visible in the area closer to merging onto International.

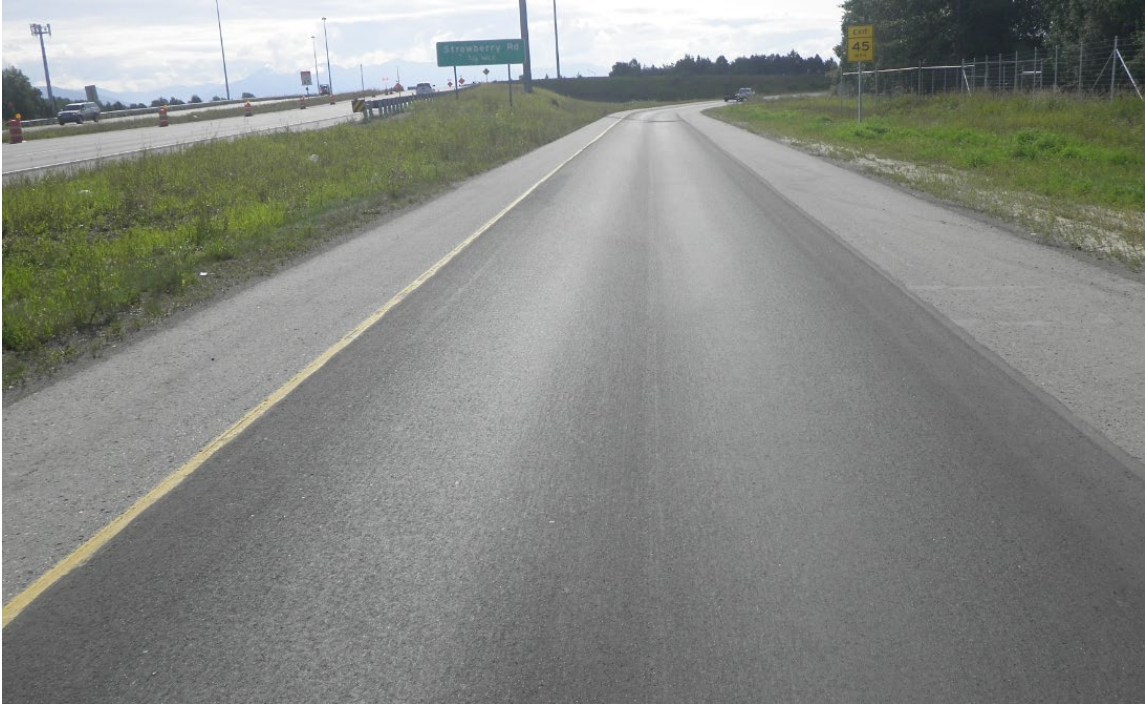
Ramp 10 had been noted to be a part of a haul route, as Ramps 1 and 2 were, so it was investigated as well. There was minimal flushing over the initial part of the ramp that received rut fill.

This turned into more severe flushing after the rut-filled area going into the curve.
