U.S. Department of
Transportation
Federal Railroad
Administration

Retrofit and Full-Scale Testing of a State-of-the-Art End Structure on a Budd M1 Cab Car

1. AGENCY USE ONLY (Leave blank)		2. REPORT DATE August 2021		3. REPORT TYPE AND DATES COVERED Final Report July 2007 – July 2009
4. TITLE AND SUBTITLE Retrofit and Full-Scale Testing of a State-of-the-Art End Structure on a Budd M1 Cab Car			5. FUNDING NUMBERS DTRS57-04-D-30008

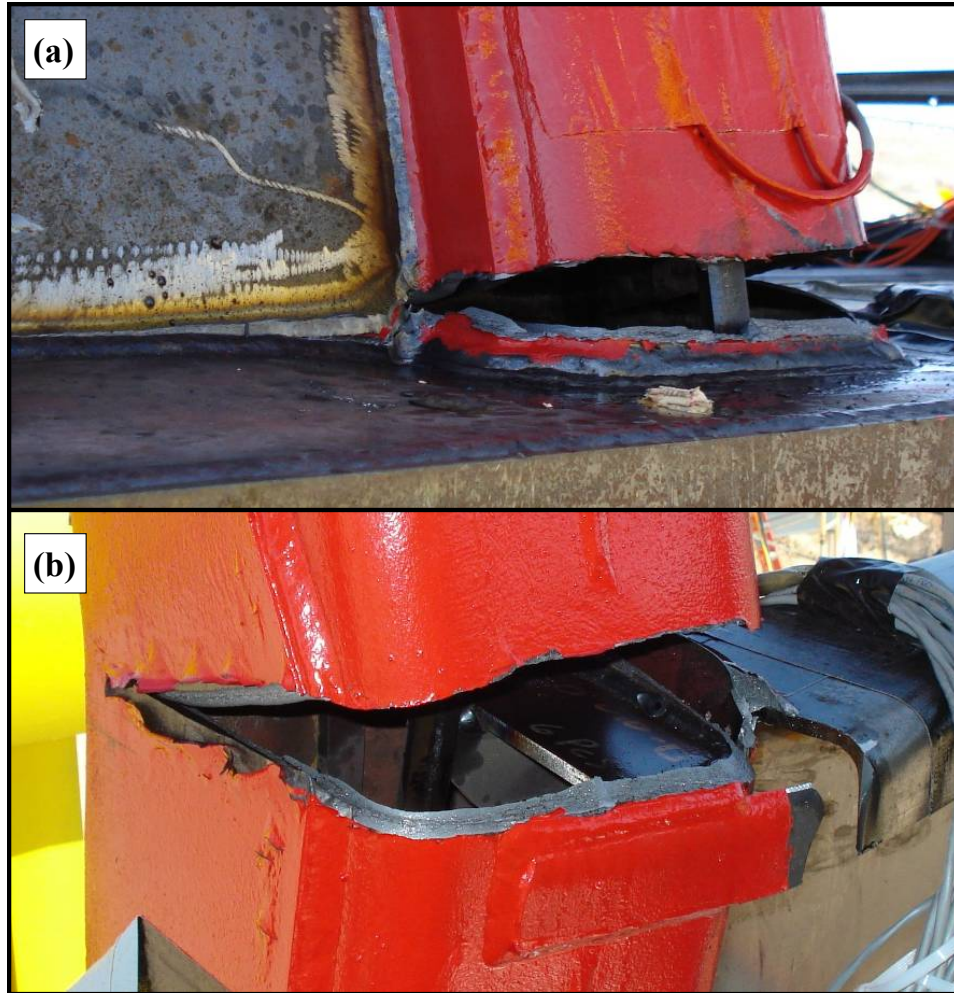
An inspection of the fracture at the back of the post following the test revealed that it occurred at a location where both an internal gusset and an external tab are welded to the post (see [Figure 31](#)). The fracture, in fact, occurred along the edge of one of the two welds. These details, which were not in the original model, were subsequently added and the analysis was run again. Material failure model parameters were adjusted so that the extent of fracture was more consistent with the test results.

Note that the material used to fabricate the collision posts was A572-50. This material exhibits ductility limits that are similar to, but not the same as, the A710 steel used in the corner post for the 2002 test. Strength data used in the material model were based on certifications provided with the A572-50 plates from which the collision posts were fabricated. It was necessary to extrapolate these data to form a complete stress-strain curve for this material. Based on the results of some supplemental calculations, it appeared likely that much of the difference between the values of the failure parameters found to be optimal for modeling A572-50 behavior in this test and those that were found to be optimal for modeling A710 behavior during the 2002 corner post impact test was attributable to differences in the hardening behavior assumed for the respective material models.

Figure 31. Post-test photographs showing fracture regions: (a) front base of the collision post and (b) in back of the collision post, opposite impact point

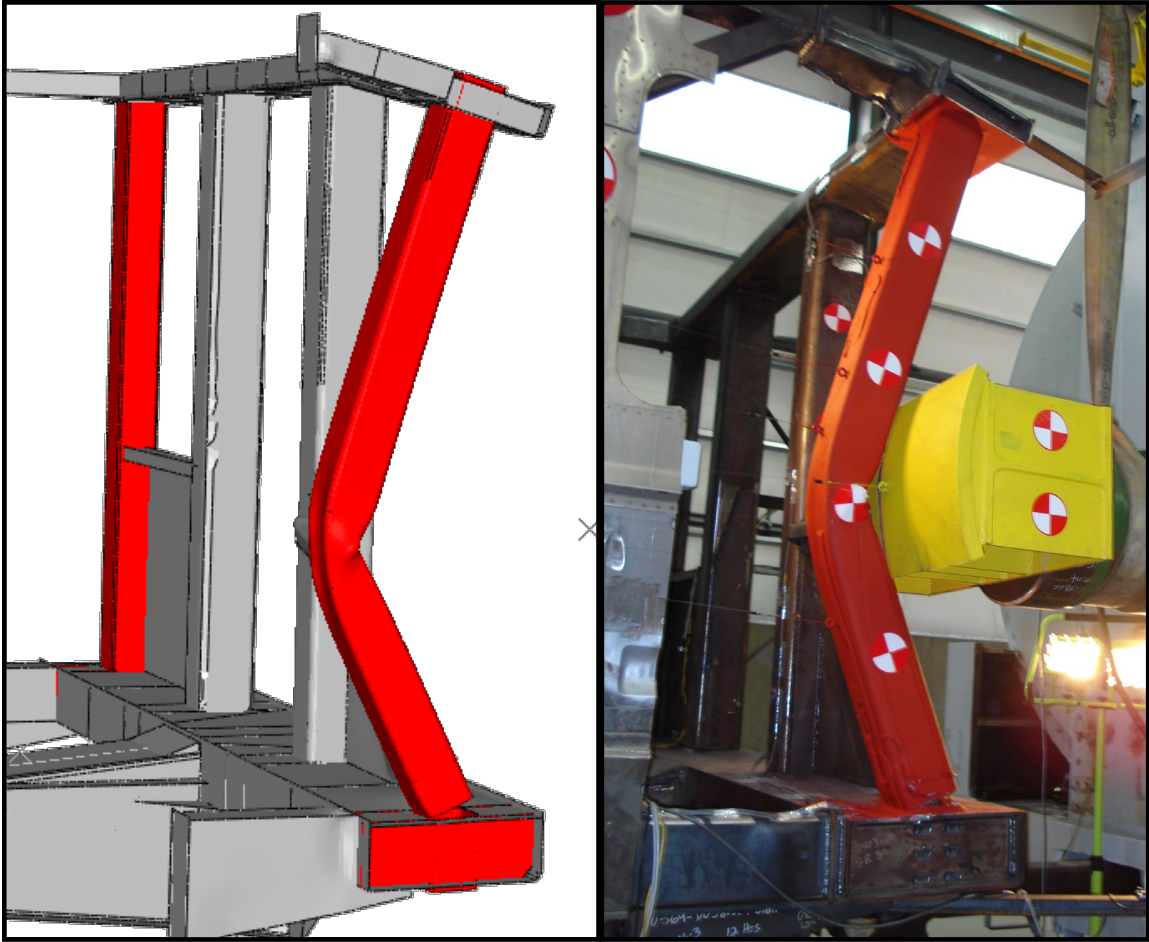
Figure 39. Comparison of predicted (left) and measured end frame deformation during corner post quasi-static crush test

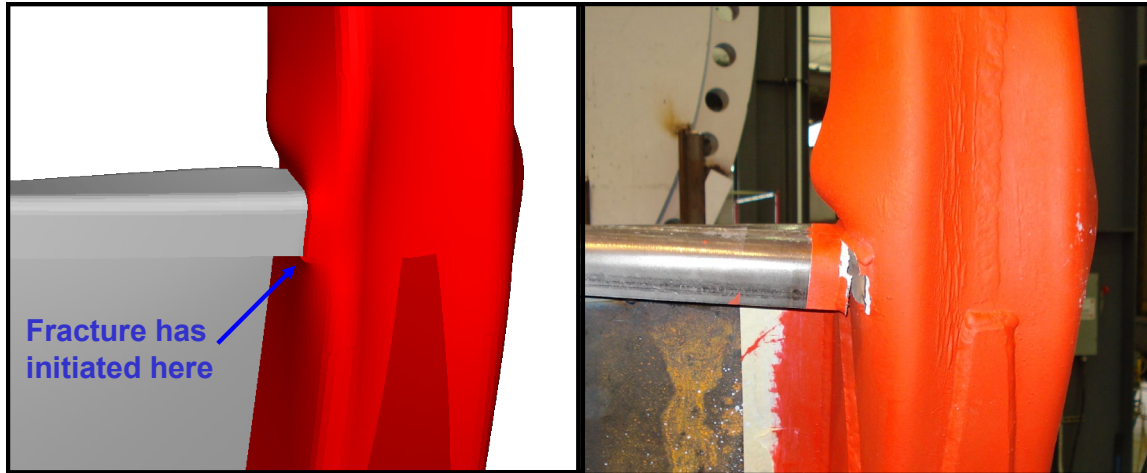
Figure 40. Comparison of predicted (left) and measured end frame deformation during corner post quasi-static crush test – detail showing back of corner post, opposite load application point

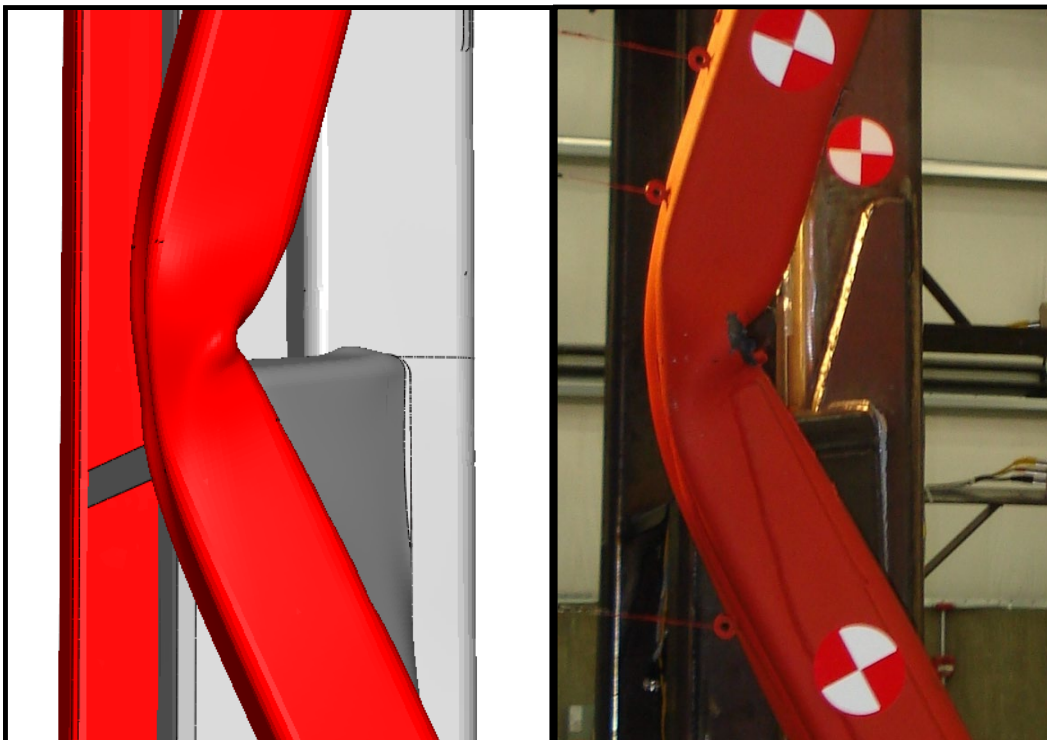
Figure 41. Comparison of predicted (left) and measured end frame deformation during corner post quasi-static crush test – detail showing back of connection of shelf/bulkhead to collision post

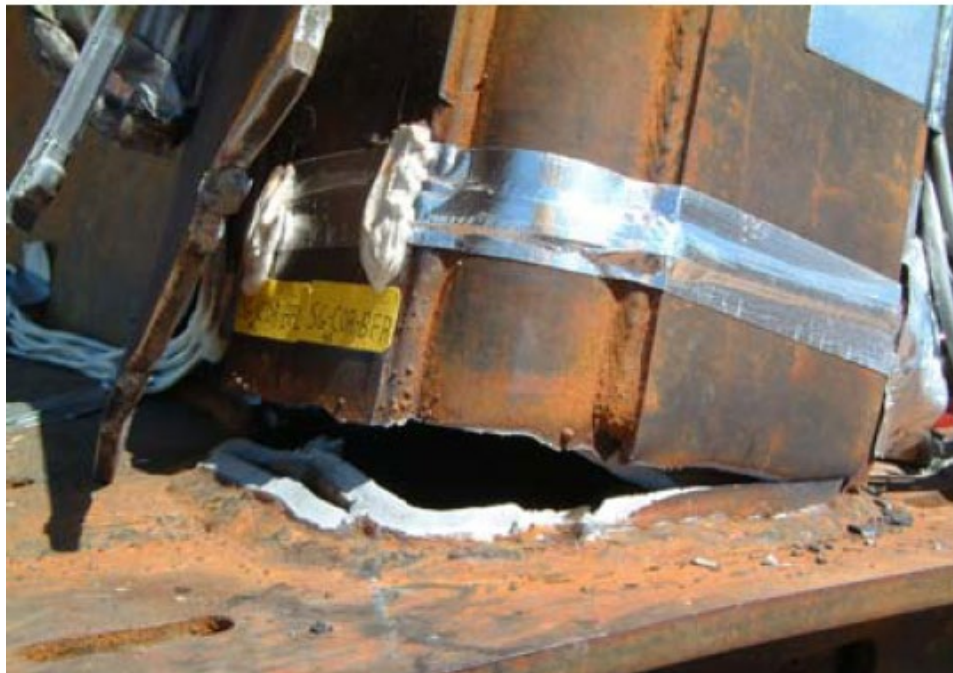
Figure D-10. Post-test photograph of base of corner post following coil impact
