# Case Studies of Two Non-Overlay Cathodic Protection Systems For Bridge Decks

RESEARCH REPORT 149

Research Report 149  
March 1990

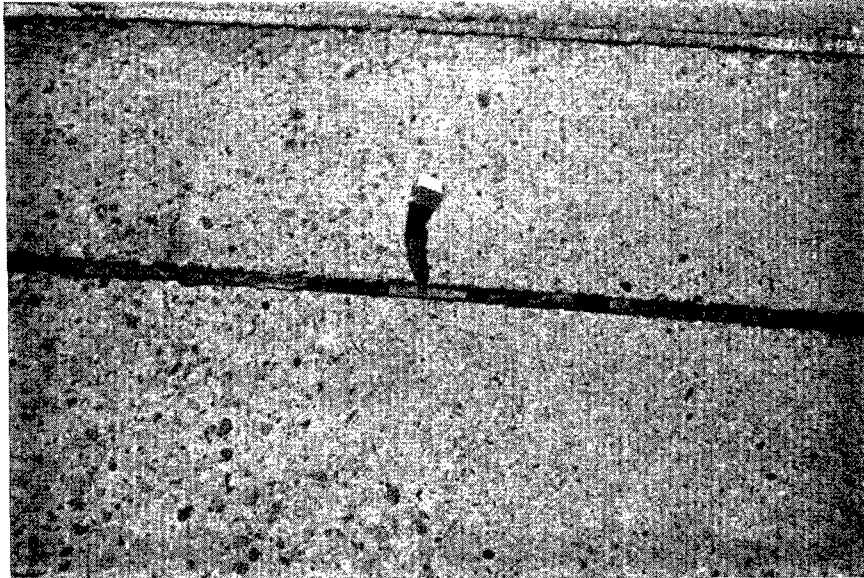
**Figure 1. Typical anode grout distress.**

Anode-grout debonding was first observed immediately after exposing the anodes to traffic. Small isolated areas of grout were repaired by the contractor in October 1983. After acceptance of the contract and one winter in service, larger areas of anode-grout distress appeared. By October 1984, about 200 lin ft had debonded or cracked (Fig. 1). Grout distress increased to 600 lin ft by the spring of 1985.

The anode-grout used here proved unsuitable for this task. Laboratory testing and field observations showed that grout shrinkage on setting usually caused it to crack along one vertical face of the sawcut slot. Traffic action, along with differential stresses between the grout and concrete substrate due to temperature changes, caused rapid deterioration of the anode matrix. In design of the system, close anode spacing was selected so that if minor breaks occurred in one anode, current from adjacent functioning anodes would help protect the steel near the broken anode.

Repair involved removing defective grout sections by air-chipping, and then hand-tooling the ends of each section of remaining sound grout so that about 1/2 in. of carbon filament conductor was exposed. The slots were cleaned by sand and air blasting. New carbon-filament conductors were then placed in the cleaned slots, overlapping the exposed existing carbon filaments. The slots were then backfilled with grout repair material and sprinkled with silica sand. About 3 cu ft of anode-grout and 1200 ft of carbon anode conductor were required to complete the repair work. By the beginning of October, all anodes were repaired and all zones were energized and fully operational. By the summer of 1986, a survey showed that though repaired anode-grout areas were still well bonded, an additional 150 lin ft of original anode-grout had debonded.

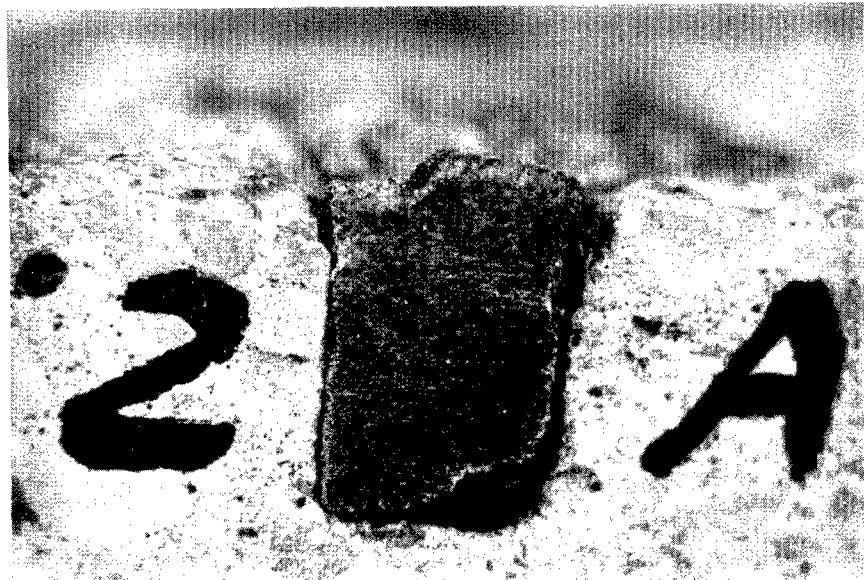
**Figure 2. Secondary anode cross-section.**

During anode repair operations at Whitney Point, carbon strands in the failed secondary anodes were often found not to be fully encapsulated by the conductive polymer grout (Fig. 2). These strands, supplied by Matcor, Inc., were in the form of flat ribbons that had to be twisted for insertion into the sawed slots before grout application. Bulking of these carbon strands prevented grout material from achieving full contact with the sawed slot bottom for bonding. Other problems included malfunction of panel meters and overloading of zone output circuits (which blew fuses). The meter problem was easily remedied by replacement and was not considered of major importance.

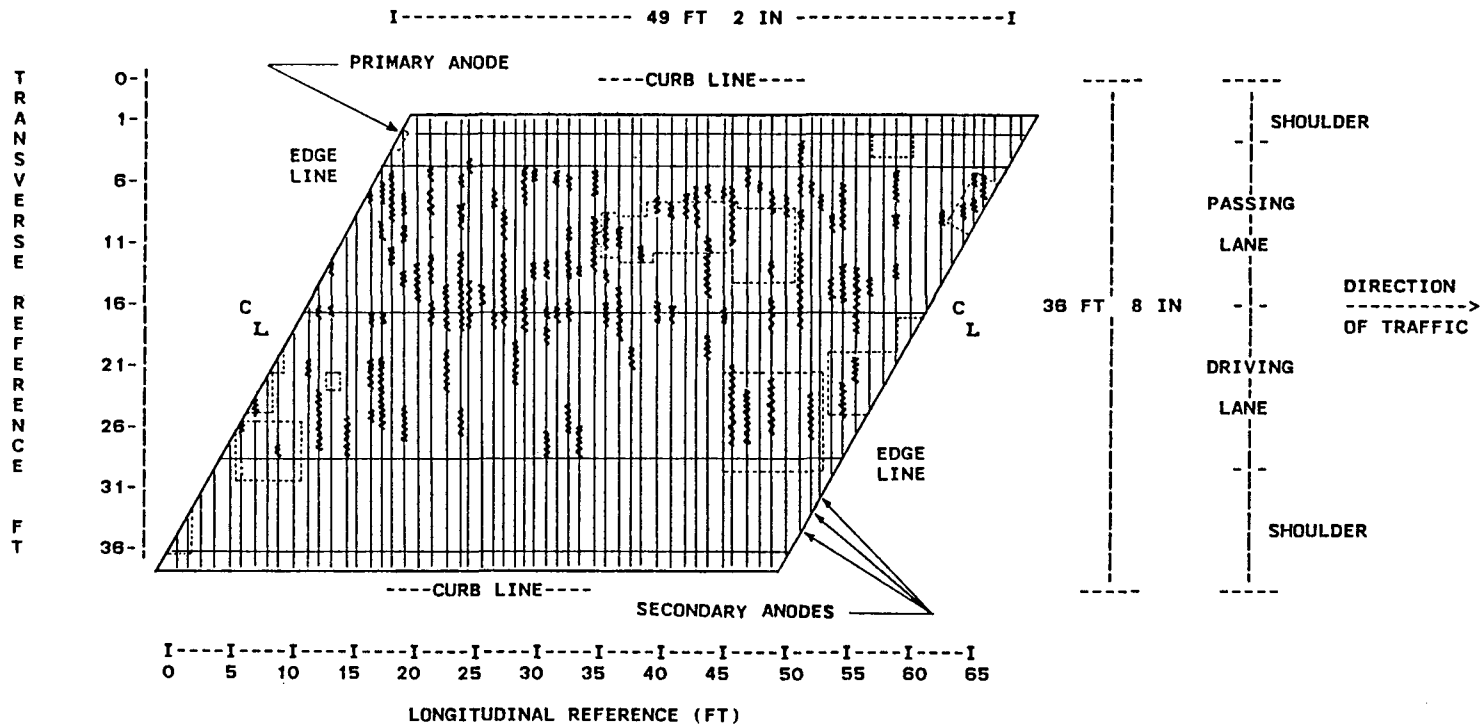
ANODE GROUT DISTRESS SURVEY  
MAY, 1986  
SPAN NO. 2 (ER&DB)

Anode-grout distress was described earlier. A total of 750 lin ft or about 12.5 percent of original grout failed by summer 1986, when it was last measured. As anode deterioration progressed, it was noted that a dark orange to brown discoloration was forming at the grout-concrete interface of the anodes. This is a characteristic stain caused by acid generation, which became pronounced as fewer and fewer anode paths were available to carry the zone current. The stain was noticeably absent from broken and isolated sections of anode-grout not energized.

After selecting the grout repair material, a major effort was made to repair the damaged anode matrix. A crew of seven worked for 10 days replacing damaged anodes. These repairs, in three sessions, began in May and ended in September 1985. Repair work was confined to the secondary-anode slots running perpendicular to the curbs and centerline. Damage was concentrated in or adjacent to the wheelpath areas. Grout repair areas are shown in Appendix C. The greatest damage was found on the southernmost span (Span 1). Primary anodes running parallel and close to the curbs were undamaged.

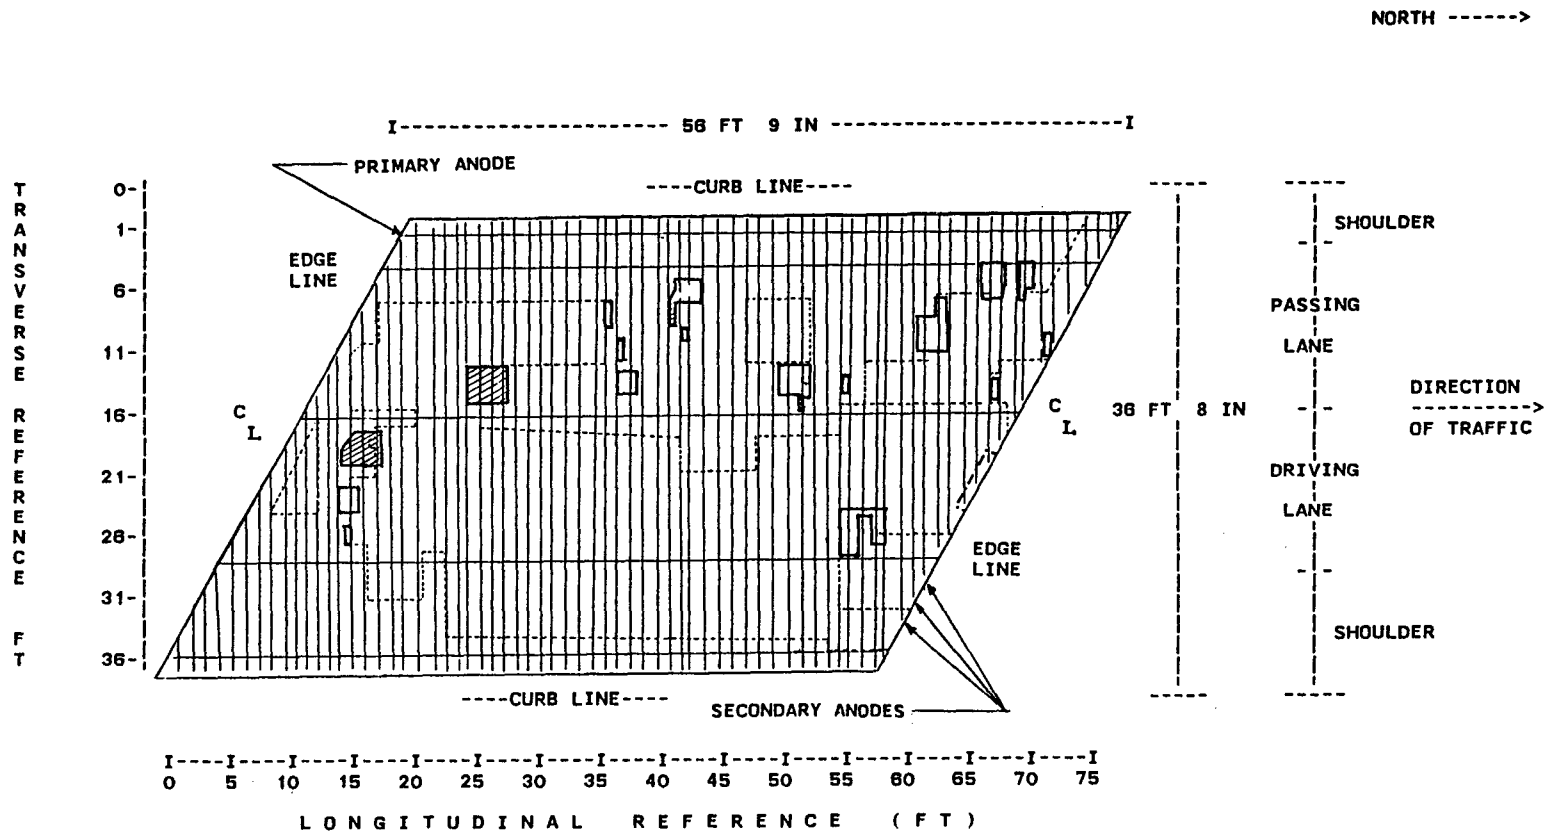
SPALL & DELAMINATION SURVEYS  
 MAY, 1987  
 SPAN NO. 1 (ER&DB)

In 1985, it became apparent that the bridge deck surface was experiencing surface distress in the form of spalling. Spalling and delamination were surveyed in May 1986 and again in May 1987. The pattern of distress was progressive and tended to occur in the travel lanes adjacent to concrete patch areas. Appendix D shows the spall and delamination survey results taken in May 1987. These data are summarized in Table 5.

Concrete deck distress at Whitney Point, first measured in May 1986, involved 1.2 percent of the deck area. Surveyed a year later, deck distress had doubled (Table 5). All spalls and delaminations detected were found in old concrete adjacent to deck surface areas patched before the system was installed. Since these areas previously seemed "sound" when the deck was surveyed for delaminations in 1983, distress formed either as a result of the rapid deterioration process described earlier, or existed before CP installation as corrosion-induced microcracks, not detectable using standard delamination-survey techniques.
