**DOT/FAA/TC-21/22**

# **Bond-Related Aircraft Accidents/Incidents: A Review**

April, 2021

Final report

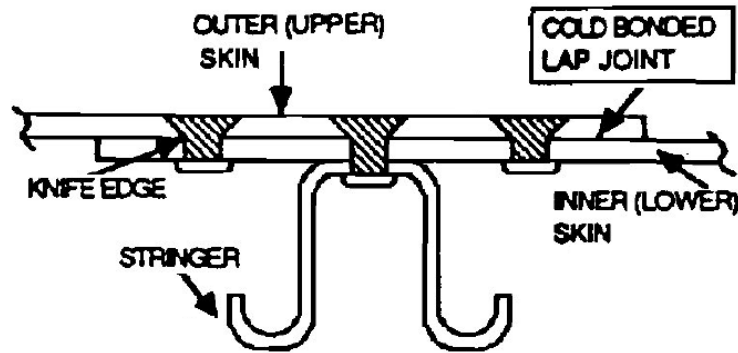
Figure 1. Typical fuselage skin lap joint [31] (modified)

One of the most well-known aircraft accidents is the Aloha Airlines flight 243 in 1988 (**TA01**). In this event, the single-aisle airliner experienced abrupt failure of about 5.5 meters of the main cabin fuselage upper lobe during cruise flight. Despite the substantial airframe damage, the crew managed to conduct a safe emergency landing. There was one fatality and several injuries among the 95 occupants. According to the investigators, the probable cause was that the maintenance program did not detect significant disbond and fatigue cracks in the fuselage skin lap joints. As illustrated in Figure 1, these joints were cold bonded and riveted (load path redundancy). Examination revealed a critical safety issue associated with improper surface preparation. This substandard bonding led to inadequate joint environmental durability [31,32].

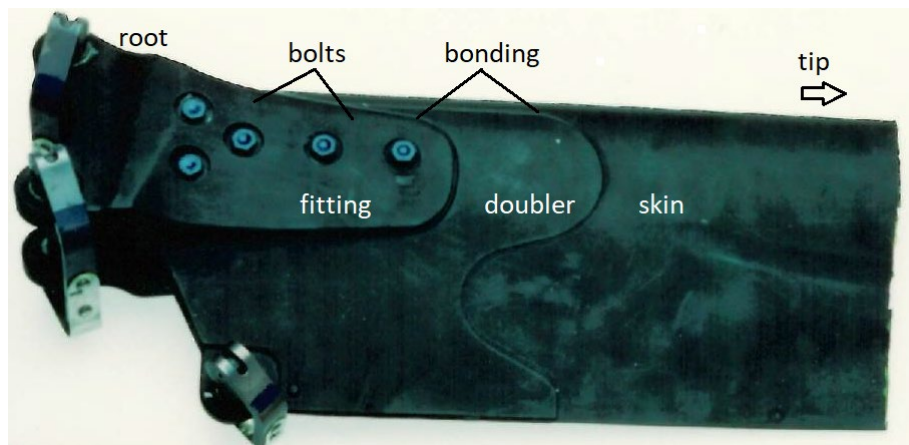
Figure 2. MRB root attachment [68] (modified)

- A similar event (**R02**) occurred in North America with another helicopter of the same model about two years after **R01**. One metallic MRB departed almost entirely from the rotorcraft while entering a hover. The resulting violent lateral vibration caused the tail boom to separate. The aircraft was destroyed, and the pilot was severely injured. Investigation revealed that the blade failure included disbonds and chordwise fatigue cracks triggered by production non-conformities. These discrepancies consisted of non-conforming doubler curvature relative to the blade skin (Figure 2). These discrepant components were initially rejected but subsequently accepted. Such defects likely led to

varying adhesive thickness, areas of improper bonding, and significant residual stresses in the blade skin, which eventually started the disbonds and fatigue cracks. Examination of the other four MRBs detected similar cracks and disbonds in the same location. This region had been inspected less than 50 flight hours before this event. After this event, the OEM established additional repetitive inspections in SBs. The FAA mandated these SBs [67,68].

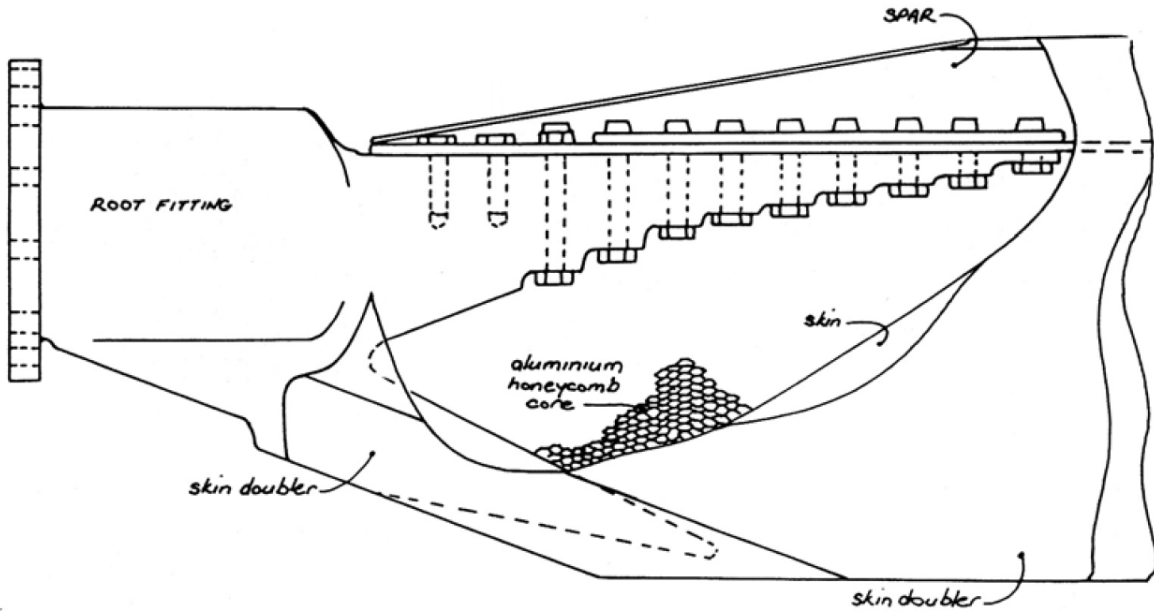
Figure 3. MRB spar root attachment [73] (modified)

In 2003, during a training flight, the two-seat piston-powered helicopter of event **R06** suffered an in-flight breakup and crashed. This crash fatally injured the flight instructor and student pilot. Wreckage inspections determined that one MRB failed in-flight at the root attachment. As illustrated in Figure 3, this attachment comprised bolted-bonded joints of metallic fitting, spar, skins, doubler, and core. Laboratory examination concluded that the MRB root attachment failed due to fatigue crack growth in the fitting and that disbond in that region was a contributing factor. The disbond increased bolt loads, prevented crack detection, and created a path for the ingress of water and other substances. These substances led to corrosion pits, fatigue crack nucleation, and ultimately the reduction in the time to fatigue failure. Two extensive surveys of retired MRBs (one including ten blades in Australia and another comprising 51 blades from different countries) with different times in-service and operational characteristics indicated that the disbonds were widespread [72–74]. Within the following 18 months, at least two similar accidents involving helicopters of the same model occurred: one (**R07**) during a powerline survey in the Middle East, leaving the two occupants dead [72,74], and another (**R08**) during an aerial agricultural operation in Oceania, resulting in severe injuries to the pilot [72]. These three events shared similarities regarding the disbond characteristics, fatigue crack patterns, and the fact that the failed MRBs had not reached the mandatory retirement life [72]. Reactions to these events included OEM SBs and ADs from different CAAs requiring either inspections in the MRB root attachment, MRBs removal from service, or reducing MRB retirement life.

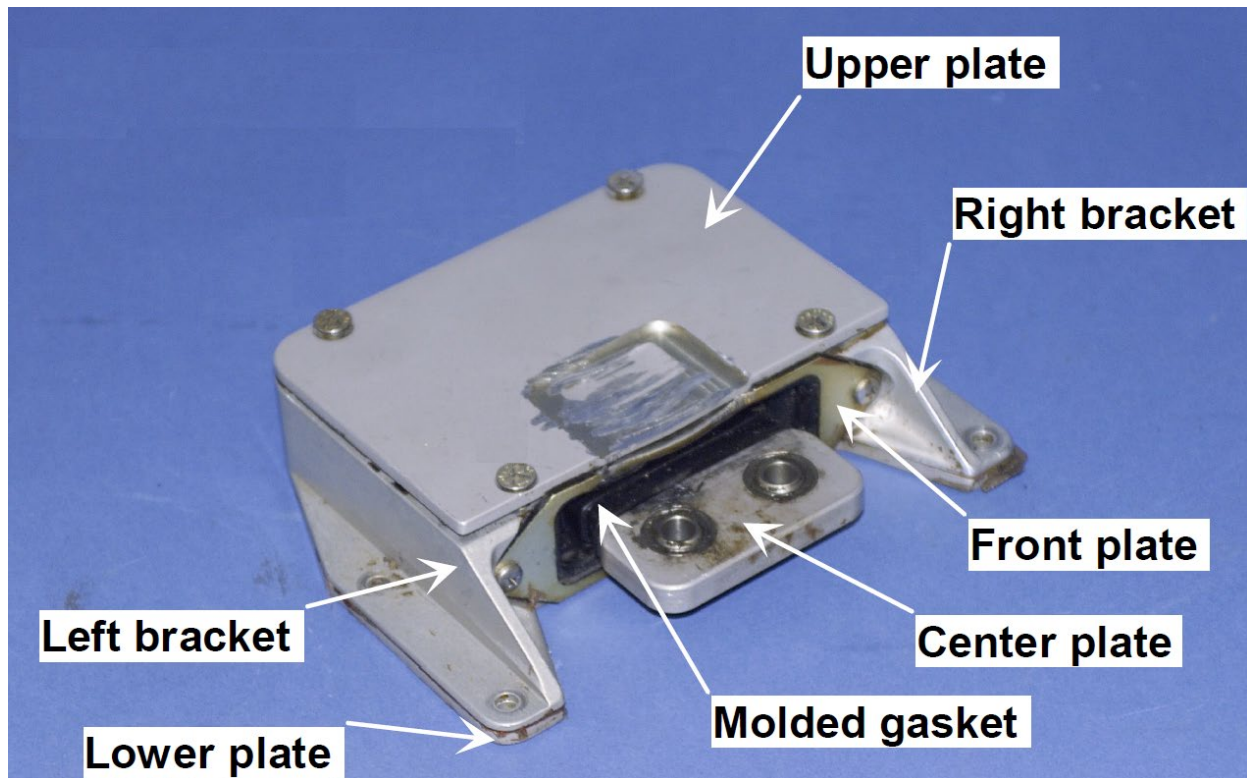
Figure 4. Pylon isolation mount [103] (modified)

In 1987, the five-seat turbine-powered rotorcraft of event **R29** suddenly experienced severe vibration while in cruise flight. This vibration prompted an autorotation to a road. This emergency landing rendered substantial aircraft damaged. All four occupants were unhurt. The vibration was caused by the joint's disbond between the upper plate and the rubber damper element (molded gasket) of a pylon isolation mount, as illustrated in Figure 4. Investigation revealed that the likely cause was bond degradation due to exposure to oil and grease. Despite the indications that the degradation occurred over a long time, periodic inspections had not detected this degradation [103]. About 13 years later, a similar event (**R30**) occurred with another helicopter of this model shortly after landing. The rotorcraft was also substantially damaged, but the pilot, the sole occupant, was unharmed. Examination concluded that inadequate surface preparation of the metallic center plate to the elastomeric blocks bond likely caused the pylon isolation mount interfacial disbond [104,105].

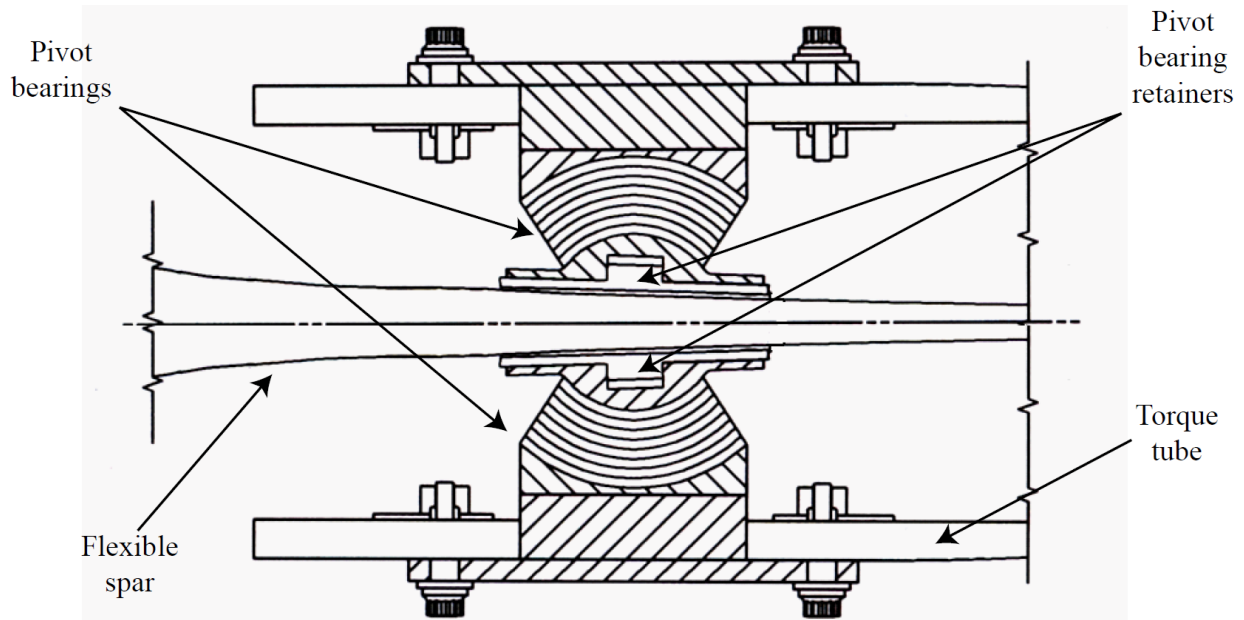
Figure 5. Longitudinal section through the tail rotor pivot bearing [106] (modified)

In 1993, the five-seat turbine-powered rotorcraft of event **R31** was approaching landing when it lost tail rotor control due to a tail rotor drive shaft failure. All four occupants were unscathed despite substantial aircraft damages. This helicopter had been previously involved in a tail strike accident. The same metallic shaft had been installed back in the aircraft after inspections for damage. For these inspections, an unapproved process (plastic medium blasting) for paint/coating stripping was employed. This process triggered irregular edges and induced stresses in some of the shaft bondlines. These discrepancies caused disbonds between the shaft and the couplings. Together with existing voids, these voids eventually led to shaft failure. Some shaft sections disbonded only when the rotorcraft impacted the ground during this accident [106]. Four years later, a helicopter of a similar model lost a metallic tail rotor drive shaft during an external load operation, reducing aircraft controllability (**R32**). The reduced controllability damaged the aircraft substantially. The pilot suffered no injury. Examining the joint's disbond between the shaft tube and the fitting flange showed adhesion failure and adhesive degradation. The use of an unapproved surface preparation process (blast media impingement) during a repair likely caused these defects. This unapproved process compromised the moisture barrier of the joint, allowing moist chloride ingress that eventually chemically attacked the joint [107].

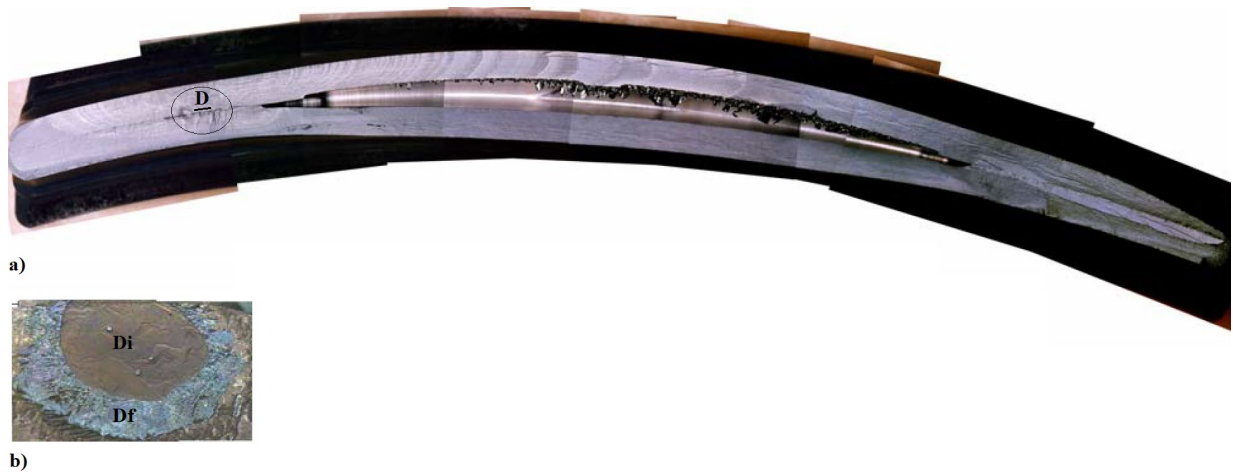
In 2002, the failure of one of the four engines caused severe vibration to the wide-body airliner of event **E01**. The airplane safely landed in the airport of origin, substantially damaged but with no harm to any of the 290 occupants. Post-flight inspections revealed that a sandwich blade—made of two titanium plates and a metallic honeycomb core—separated from the first-stage, low-pressure compressor in-flight. The blade separation led to secondary damage to the engine in which it was installed, the wing, the flaps, the fuselage, the horizontal stabilizer, and the adjacent engine. Fatigue cracks originating in a pre-existing disbond—depicted in Figure 7—led to the blade separation. The engine OEM had detected and 'concessionally' accepted this pre-existing disbond during manufacture. This approximately round disbond grew in service from 12 mm to about 22 mm in diameter. None of the three different required maintenance NDIs—established for spotting other probable defects in the blade—had detected the disbond growth or the fatigue cracks before becoming critical. After this accident, the engine OEM revised the 'concessional' acceptance system and reduced by half the related allowable damage. The engine OEM also

Figure 7. Failed blade: a) Cross-section showing the disbond (D); b) Initial (Di) and final disbond (Df) shape [124] (modified).

issued SBs applicable to the other aircraft models using a similar engine. These SBs recommended the removal from service of all blades with similar manufacturing defects [124].
