DOT/FAA/TC-15/47

Teardown Evaluation of a Composite Carbon/Epoxy Beechcraft Starship Aft Wing

September 2017

Final Report

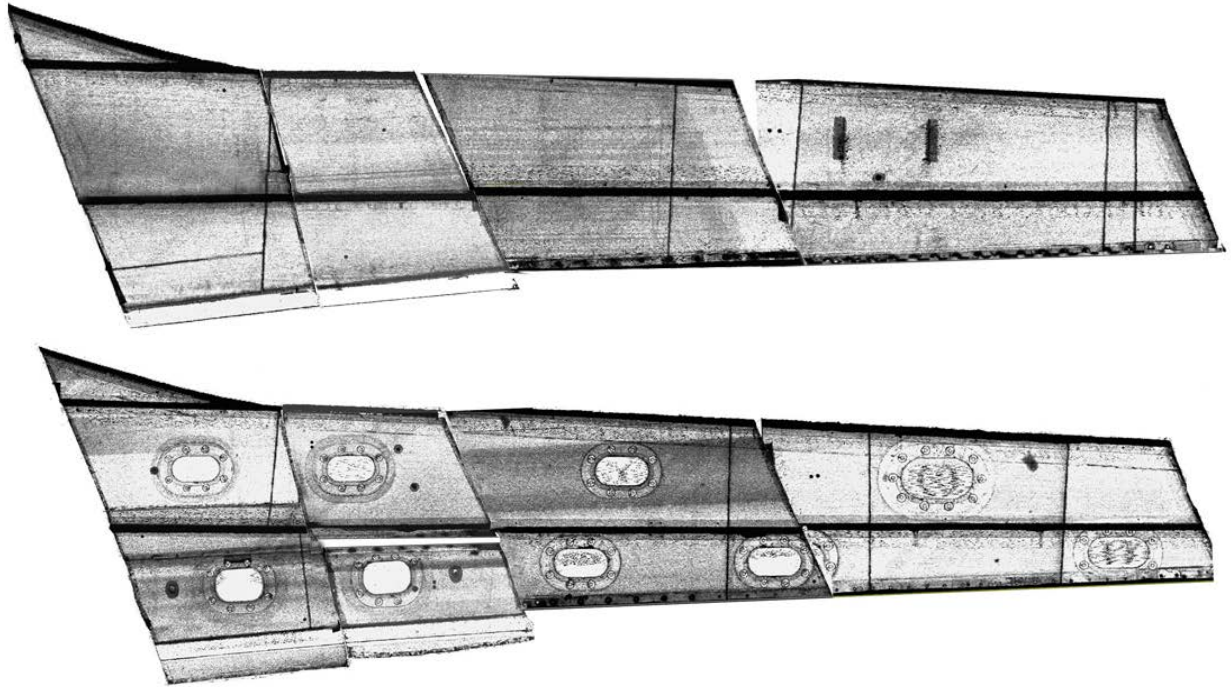
Figure 6. Beechcraft Starship aft wing TTU scans of the left upper- and lower-wing skins

Through-transmission ultrasonic (TTU) scans of the left upper- and lower-wing skins are shown in figure 6. TTU NDI showed no major flaws in the skins induced during manufacture or service. OEM records suggest that porosity levels in the upper skin (US) flanges exceed 2.5%.

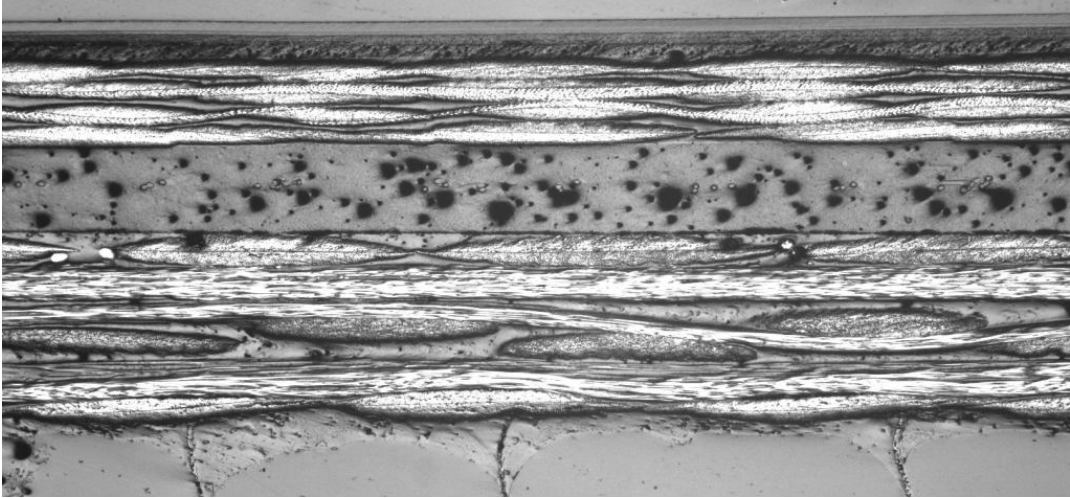
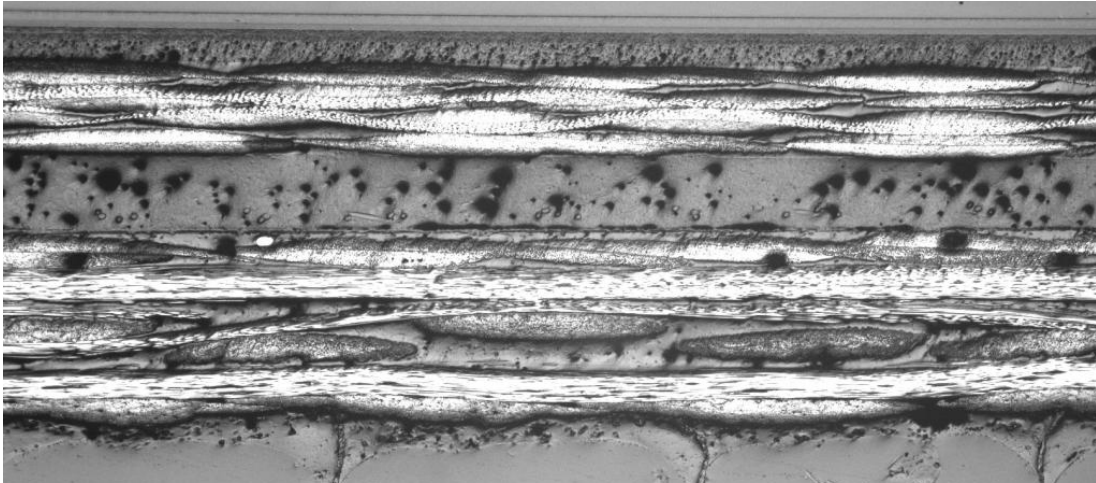
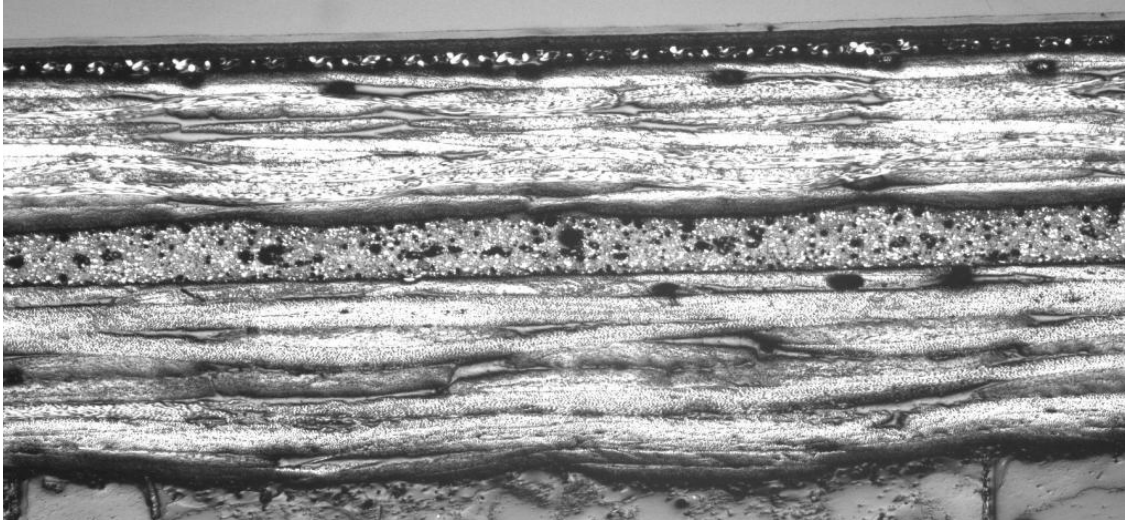
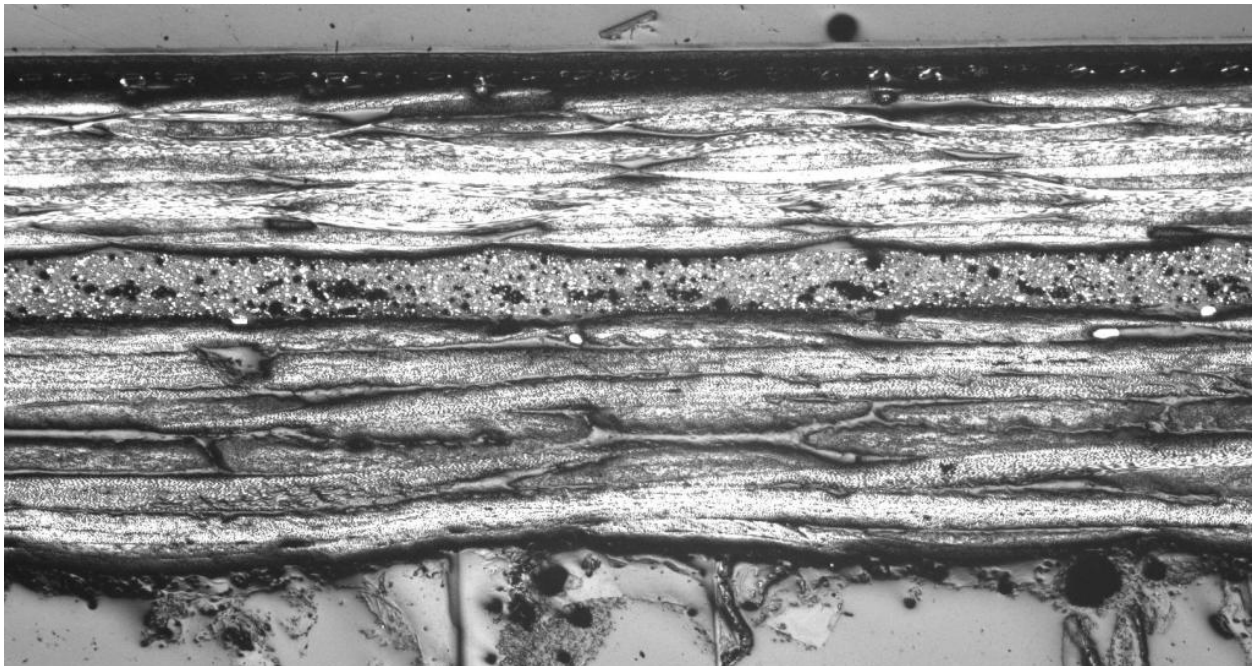
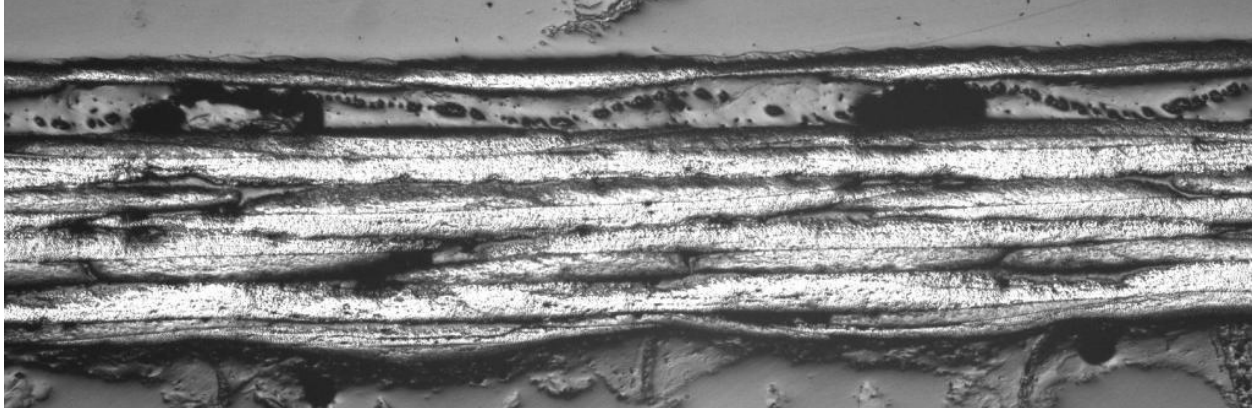
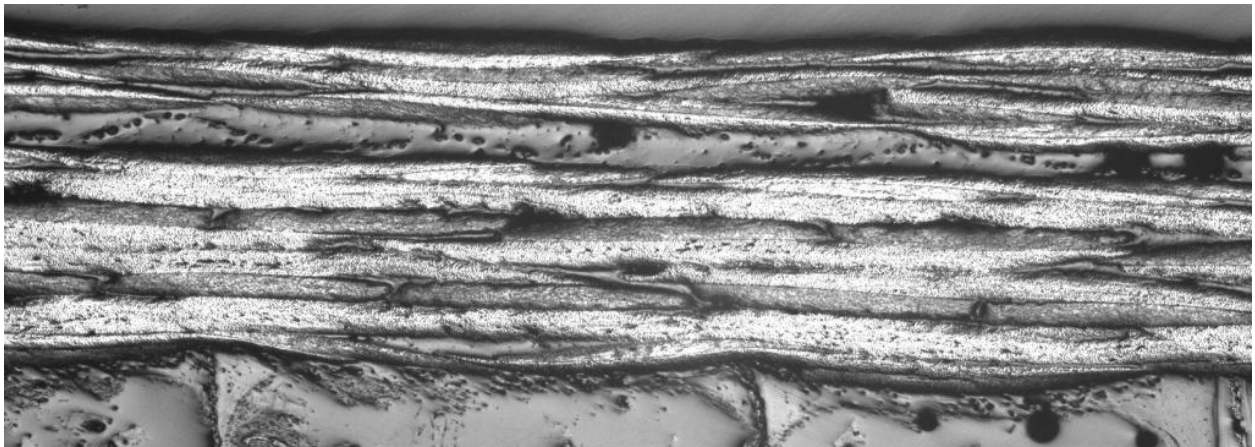
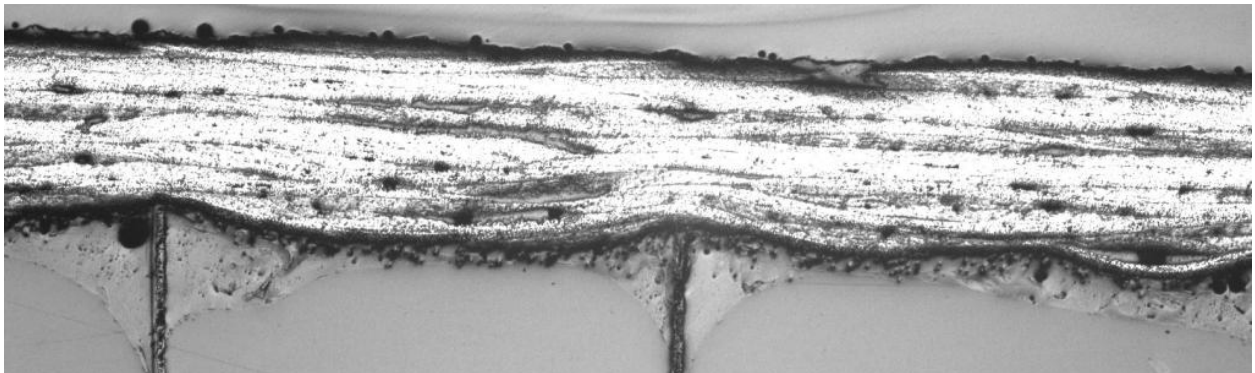
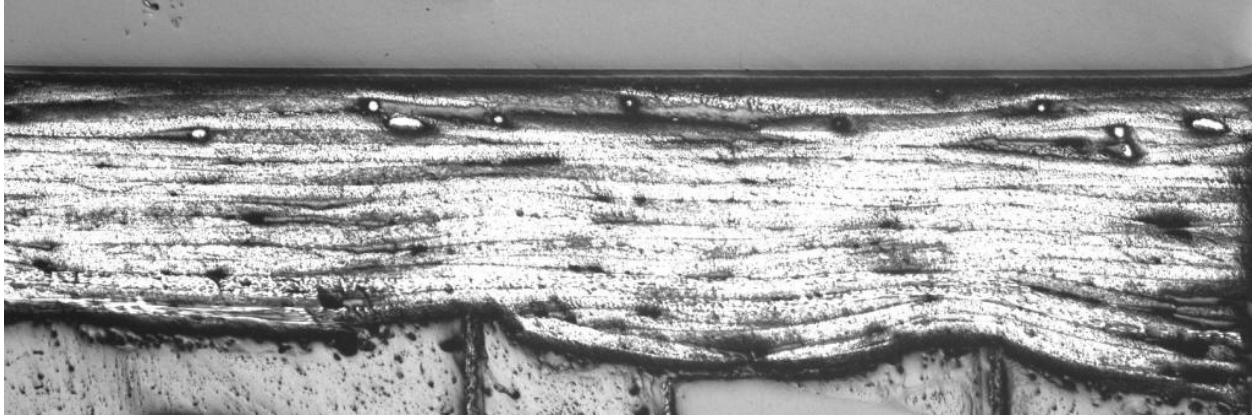
Image analysis was conducted on samples extracted from both the USs and LSs to inspect the structure microscopically for voids, microcracks, or any evidence of aging or material degradation. Extracted samples were potted, polished, and viewed under a microscope to detect any evidence of material aging. Various images showed scattered porosity in the adhesive layer between the plies, as shown in figures 22–29. Porosity, present in the adhesive plies of the US facesheets, was possibly caused by a combination of the resin and adhesive system (low flow) and the material form (fabric inherently entraps more air than tape).

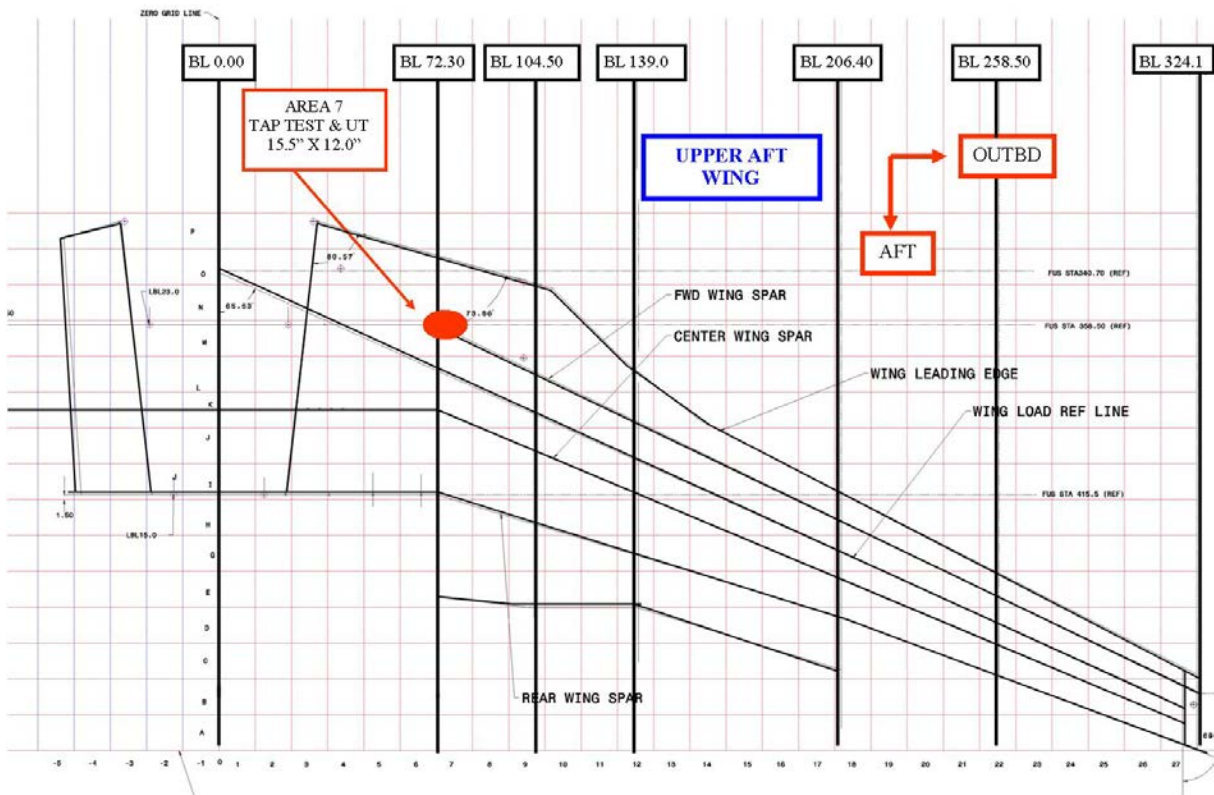
Figure 30. Overview of the right upper aft wing of the Starship

The initial TT examination of the upper aft wing skin did not reveal any damage or defects in the test section (RBL 100-RBL324), but revealed a potential disbond in one location. This area was inspected with the back-up UT procedure for verification. The UT confirmed the disbond in an area approximately 15.50" x 12.00". The disbond is believed to have been caused by the removal of the engine. Once the engine was pulled from the wing, it appeared that the skin may have been ripped away from the structure, which caused the disbonding. An overview of the disbond of the right upper aft wing is shown in figure 30. The damaged area was repaired using a wet lay-up bonded repair, according to the OEM specifications. During the repair, it was found that the area identified as a disbond was potted and that the UT and TT signals obtained were caused by sound attenuation through the potting material and not because of damage.

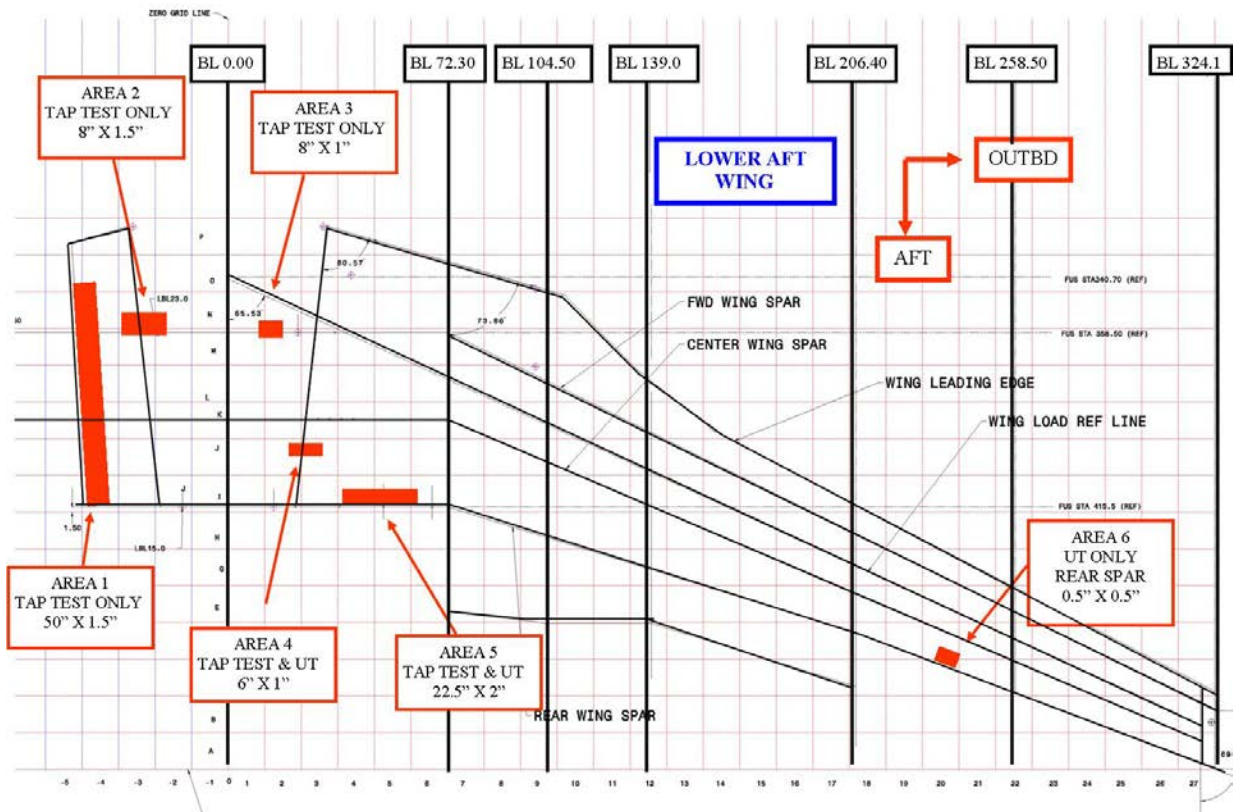
Figure 31. Overview of the right lower aft wing of the Starship

The initial TT examination of the lower aft wing skin revealed disbond in five locations. These areas were inspected with the backup UT procedure for verification. However, only three areas were confirmed with the UT inspection. All areas were re-inspected during the subsequent routine inspection. Another area was discovered during the UT inspection; however, because of its location, TT could not be performed effectively because of accessibility issues. An overview of all defected areas of the right lower aft wing is shown in figure 31. These delaminations were located in the area where the wing was cut away from the test section.
