DOT/FAA/TC-16/8

Federal Aviation Administration
William J. Hughes Technical Center
Aviation Research Division
Atlantic City International Airport
New Jersey 08405

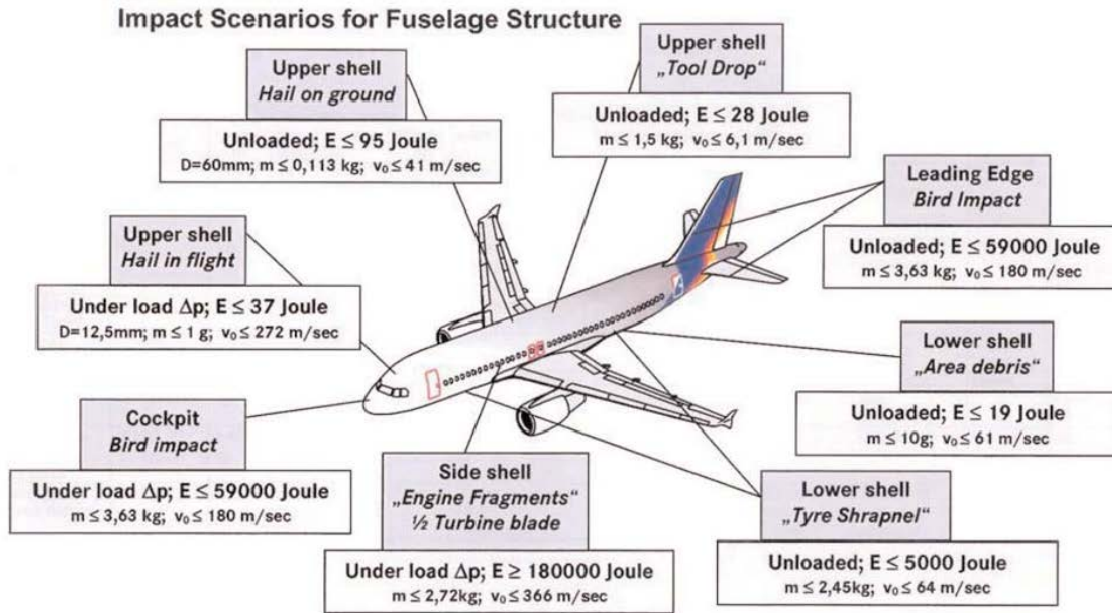
Figure 1. Impact scenarios and energy levels [8]

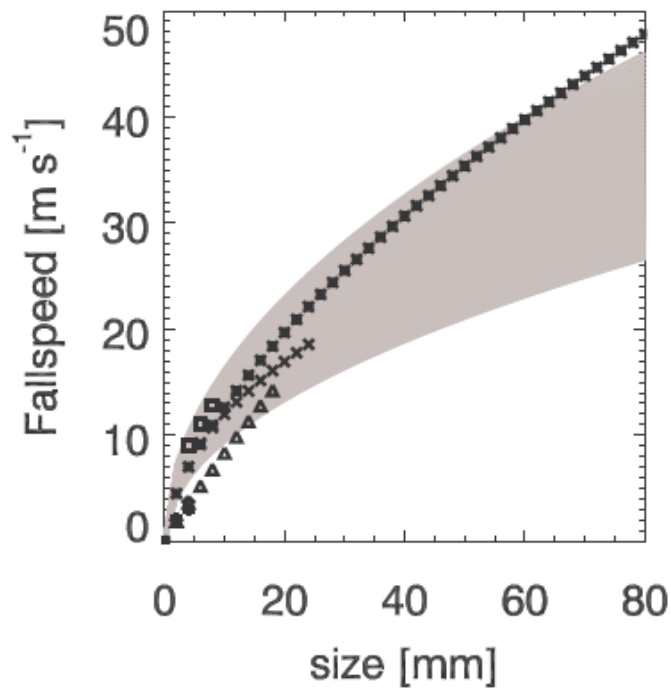
Figure 2. Terminal fall speed of hail

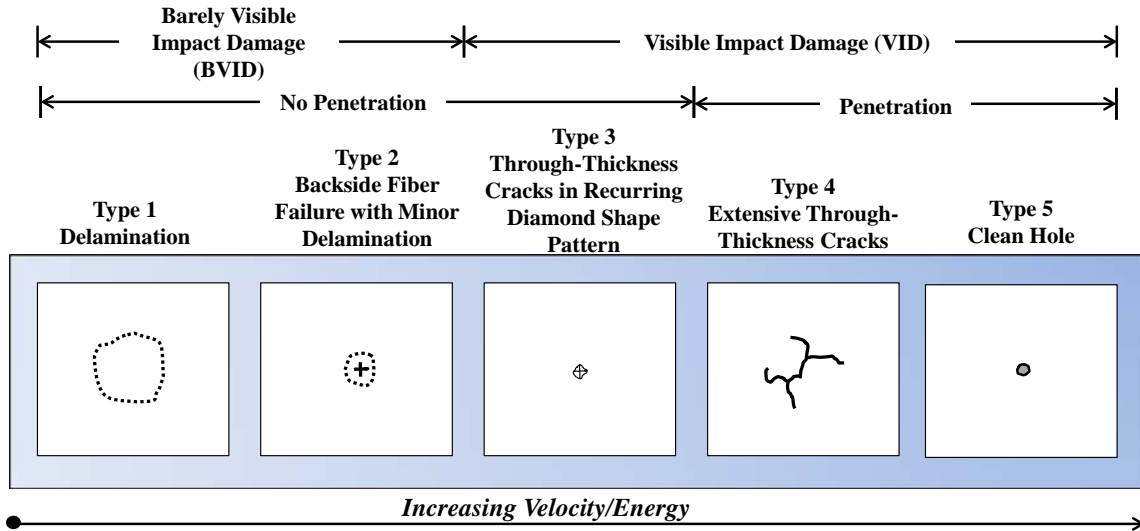
Figure 3. Damage mode progression for high-velocity ice impacts [15]

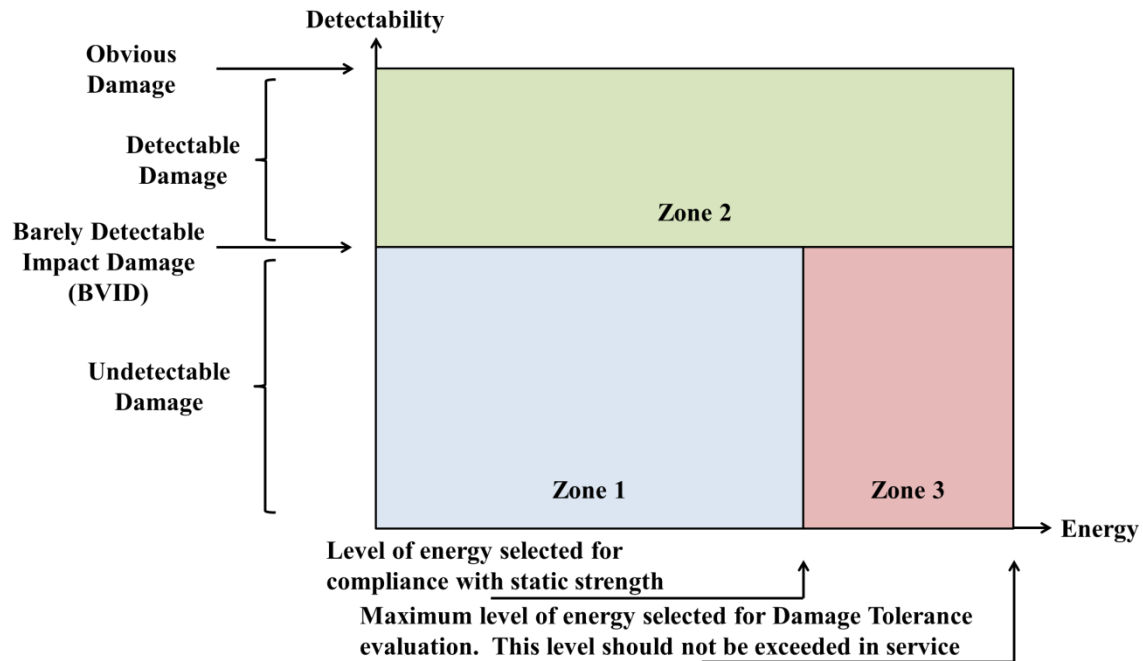
Figure 4. Damage-tolerant design [19]

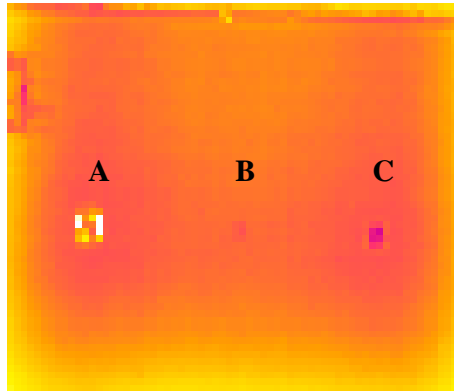
plot shows the magnitude of the phase and amplitude change at each location in an X-Y chart. The two C-scans at the top of the figure show the changes in the amplitude and phase.

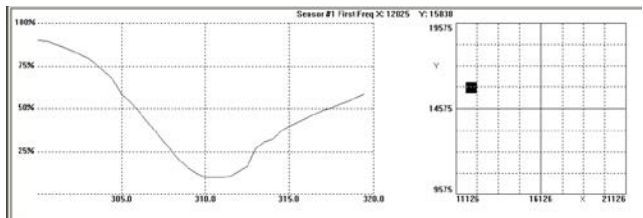
Impact Point A: Large Shift

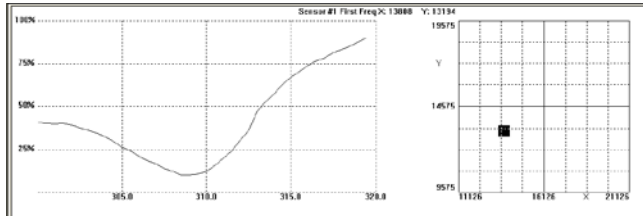
Impact Point C: Medium Shift

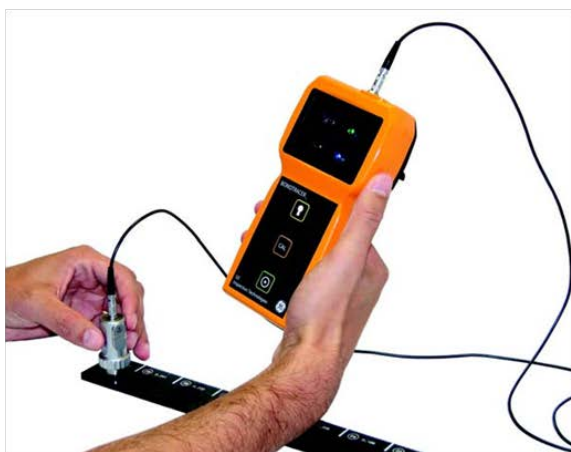
**General Electric –
“Bondtracer”**

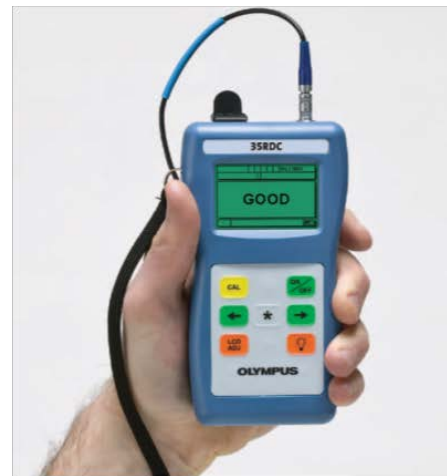
**Olympus –
“Ramp Damage Checker”**

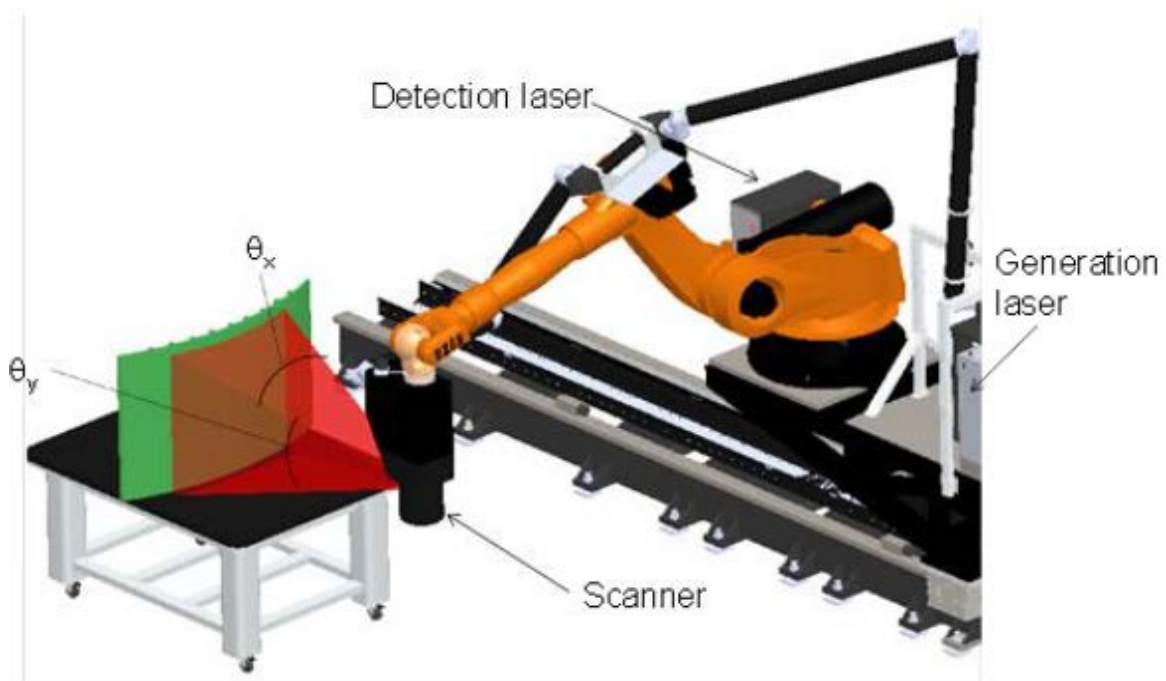
Figure 15. Inspection of a part using the iPLUS scan head and articulating robot

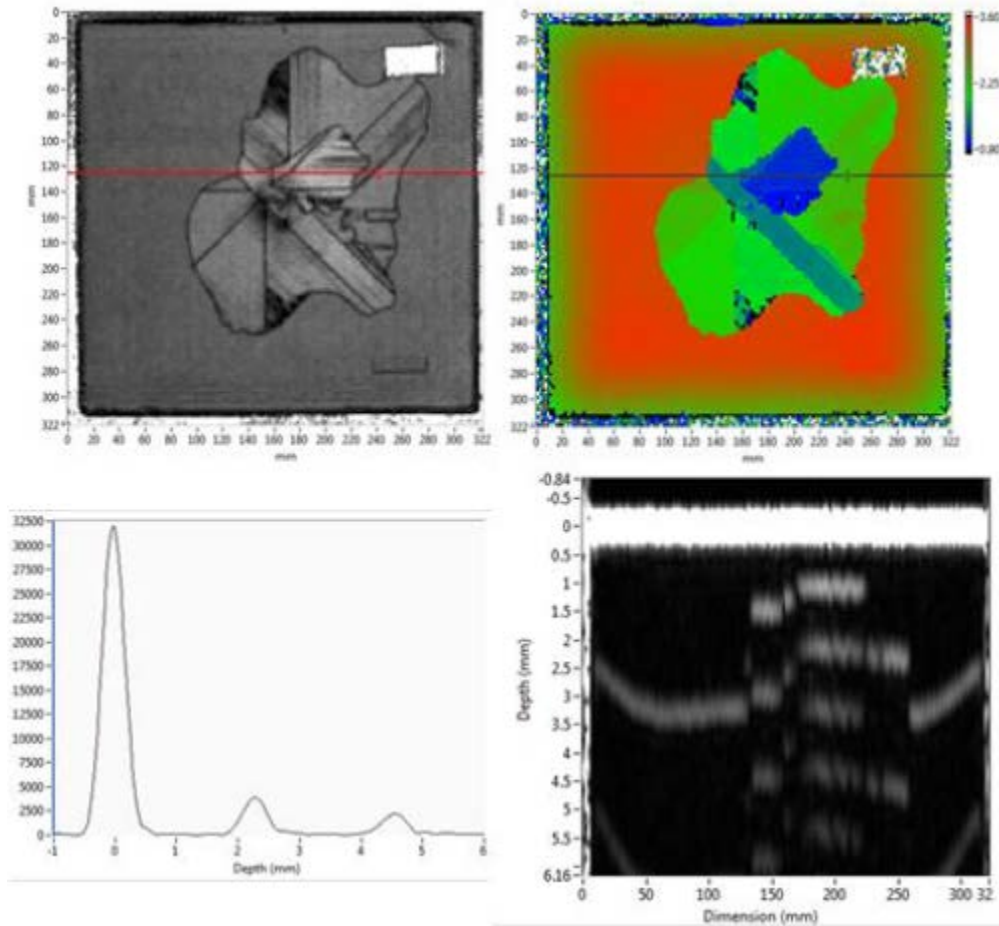
Figure 16. iPLUS laser UT scan of a 16-ply composite laminate with impact damage

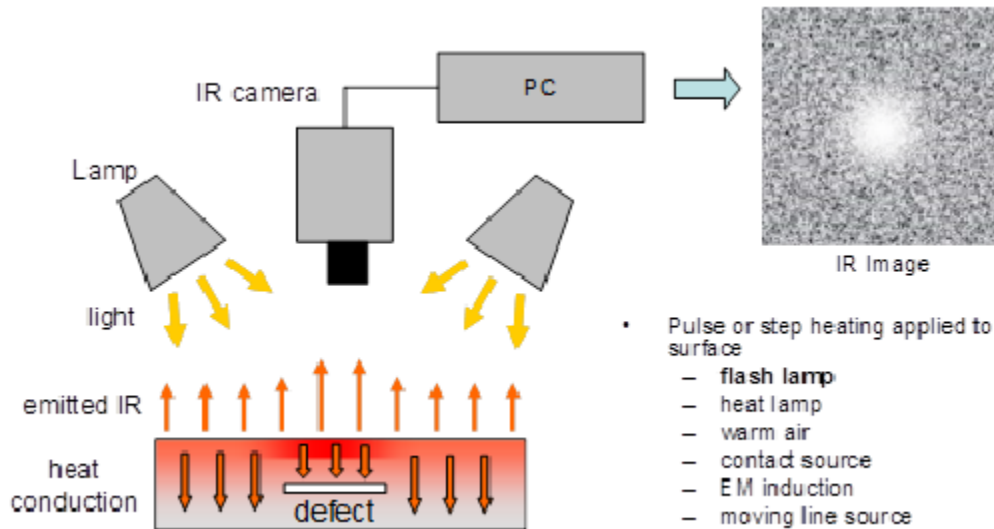
Figure 17. Principle of active pulsed thermography

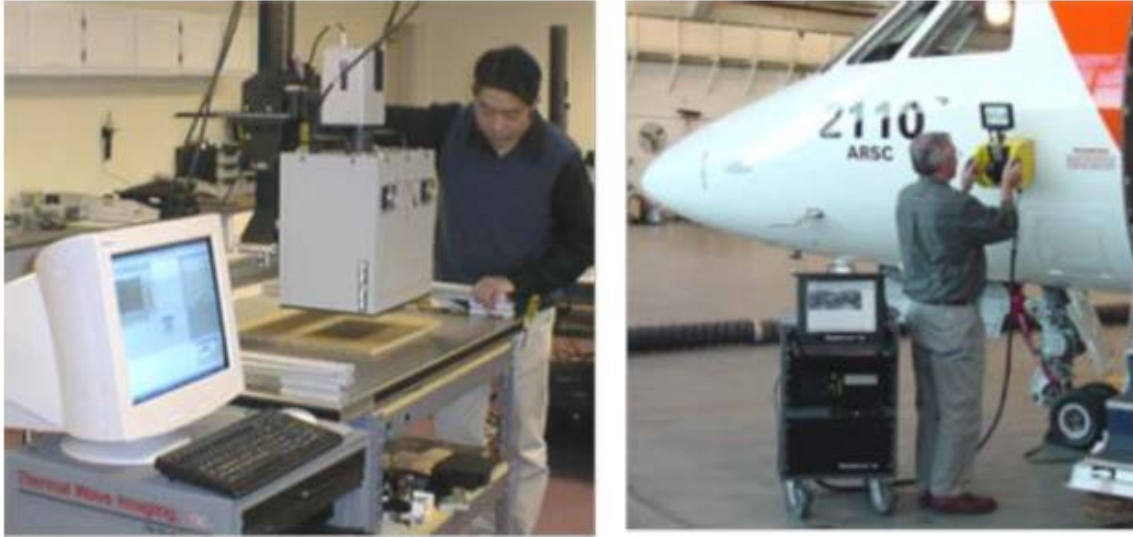
Figure 18. Laboratory thermal wave imaging system inspecting composite flaw-detection panels and portable field system inspecting an aircraft fuselage

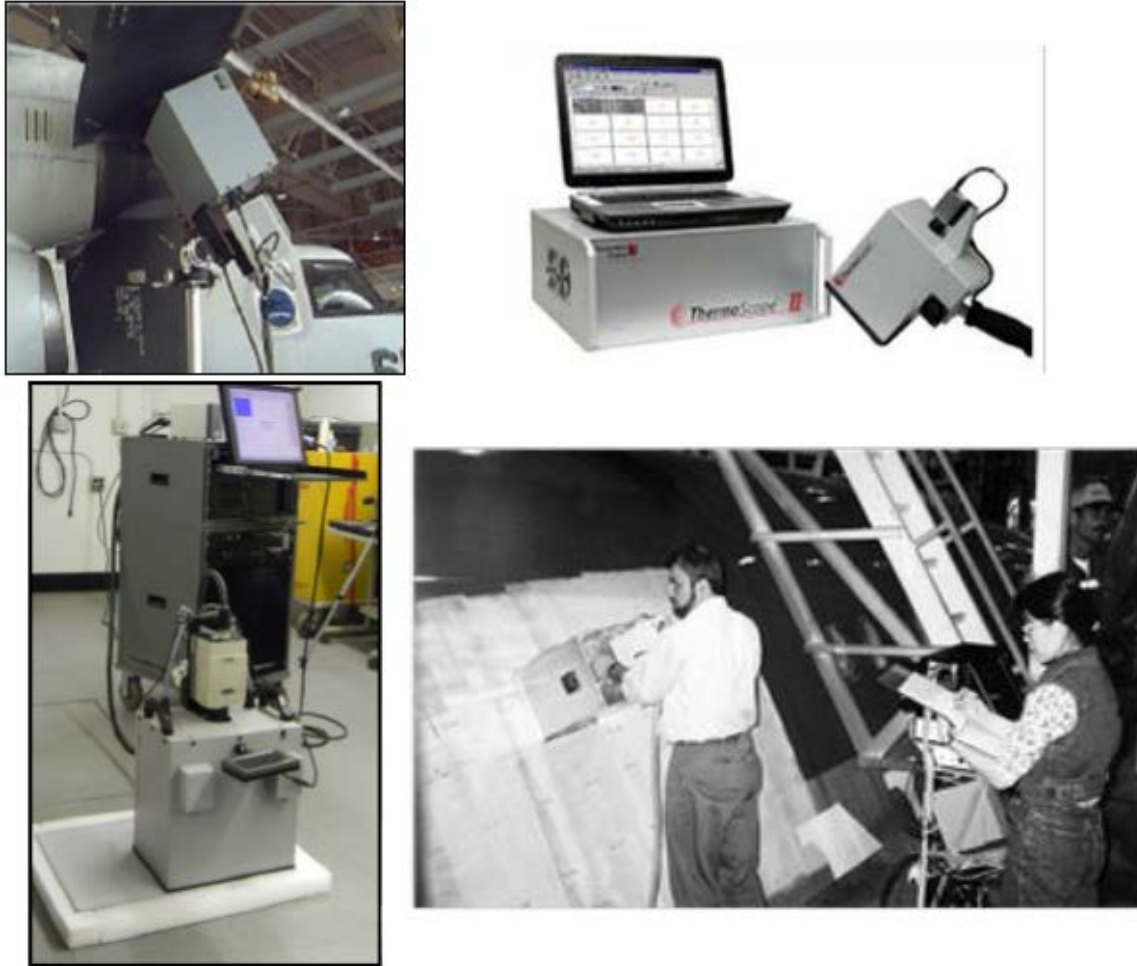
Figure 19. Thermal wave imaging system equipment and an inspection being conducted on an aircraft

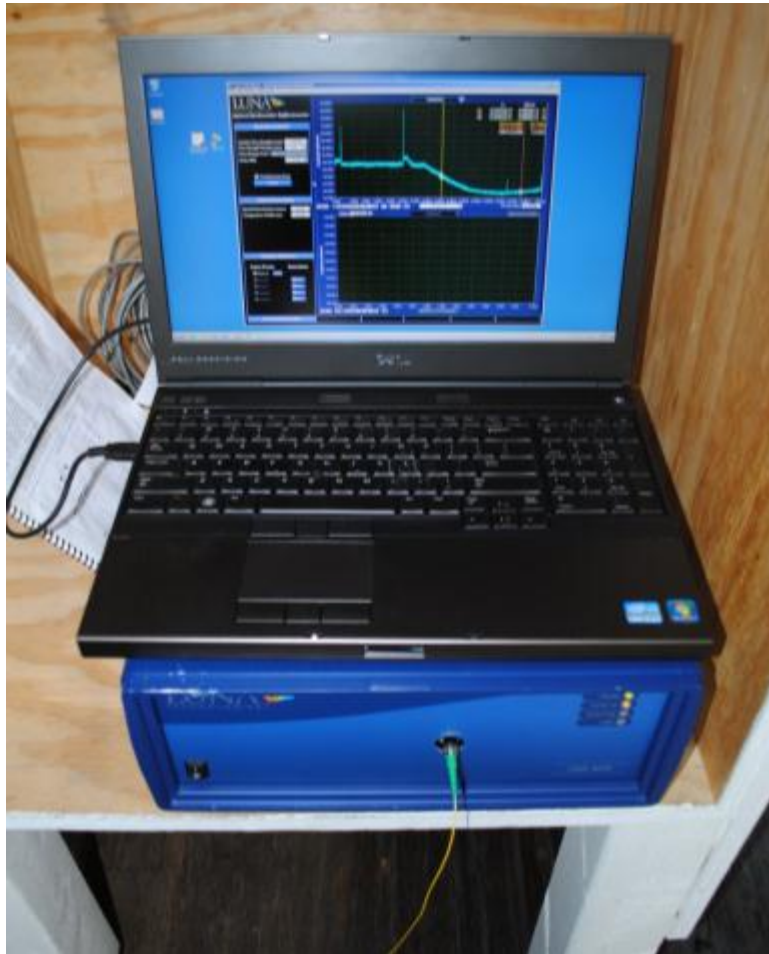
Figure 22. Luna Innovations' Optical Backscatter Reflectometer™

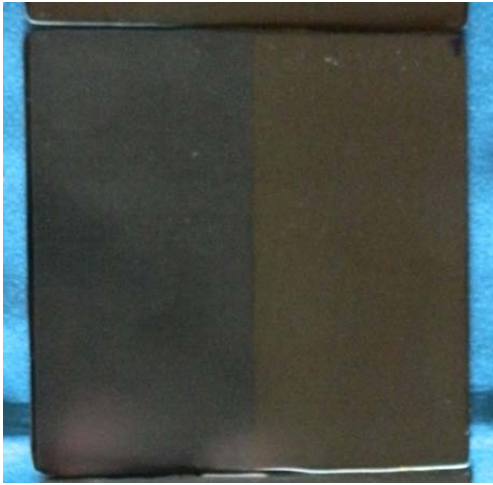
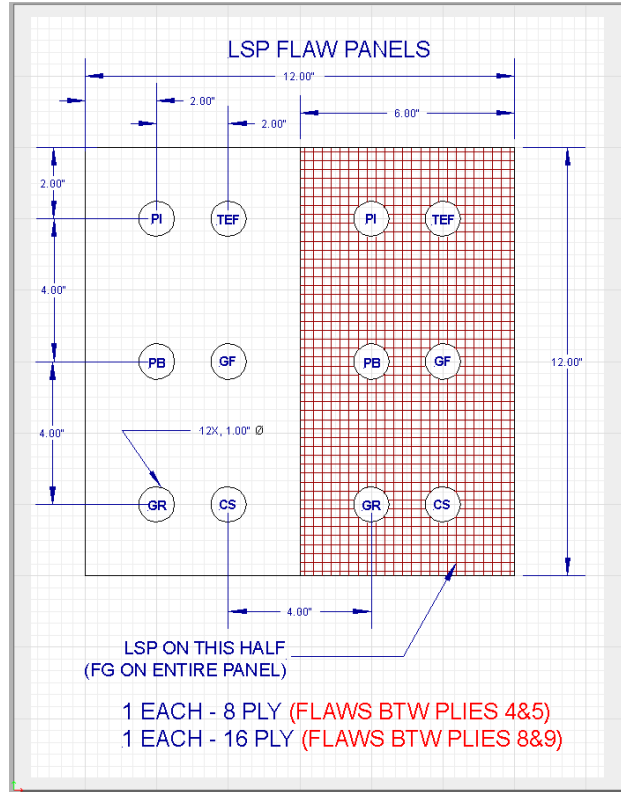
Figure 28. Lightning strike protection test panel design

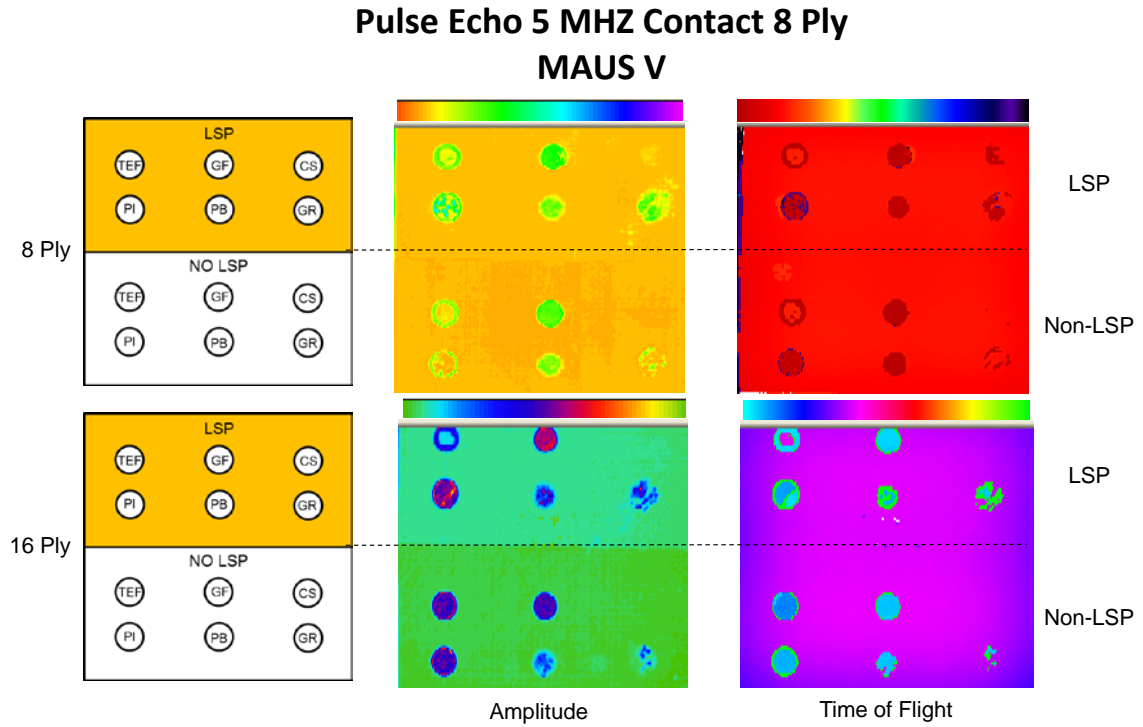
Figure 29. The UT C-scan inspection results of lightning strike protection test panels

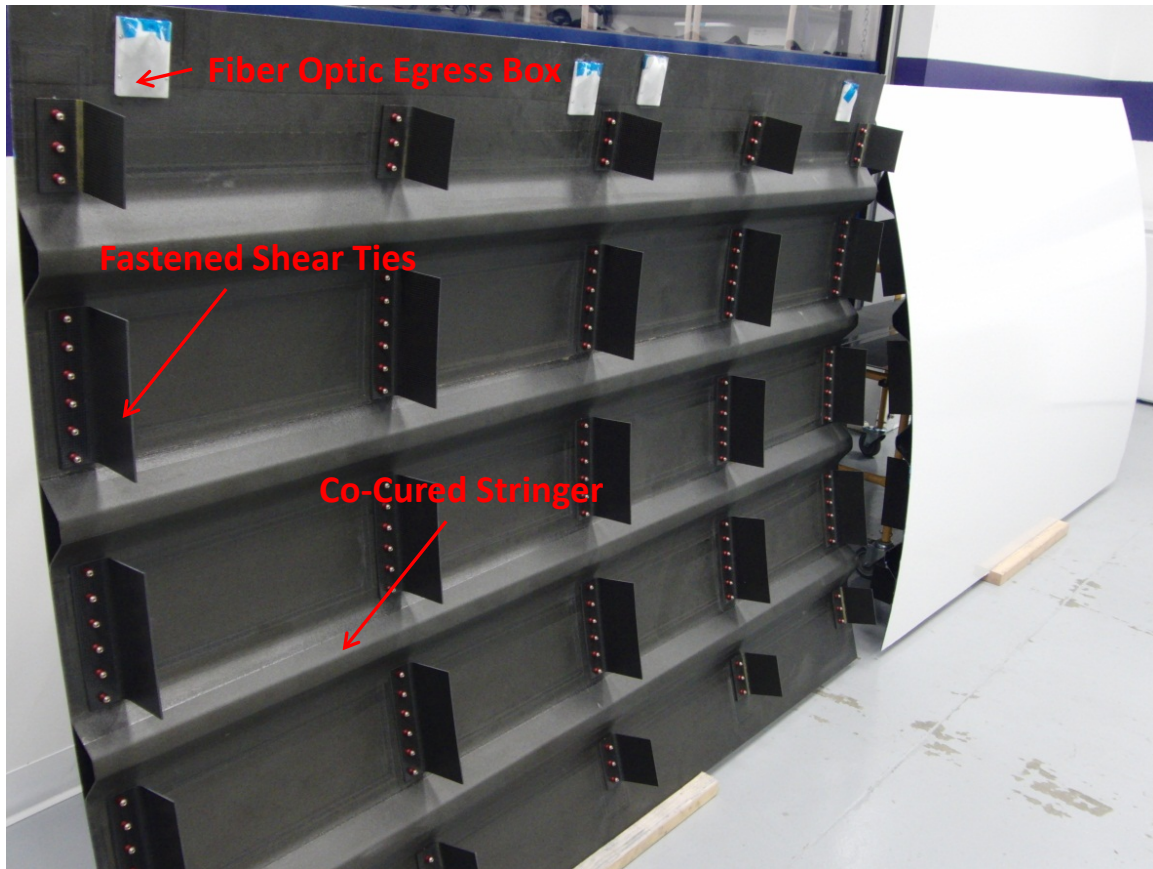
Figure 34. Backside and frontside views of carbon fiber fuselage sections

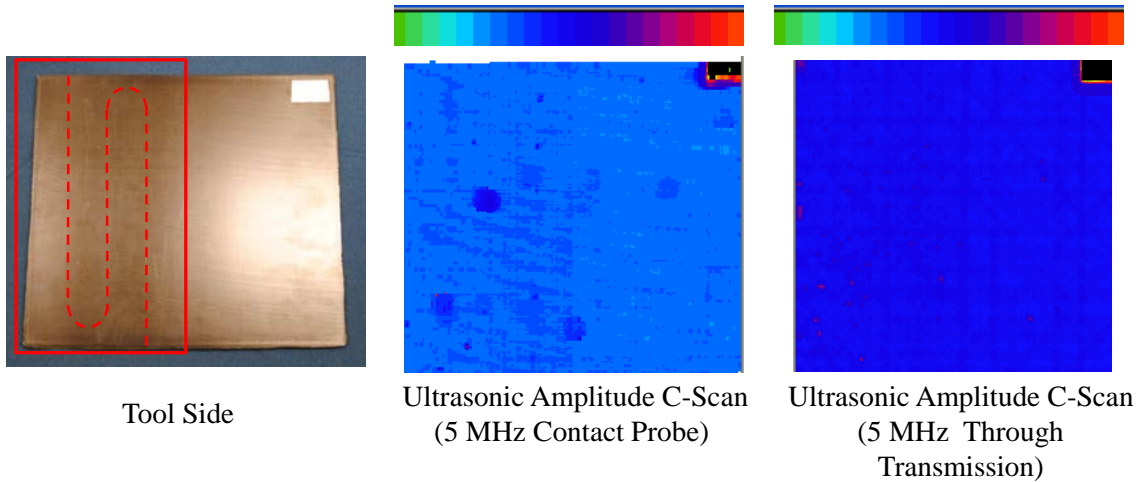
Figure 36. Embedded veil and FO NDI test panel with contact and through-transmission C-scans

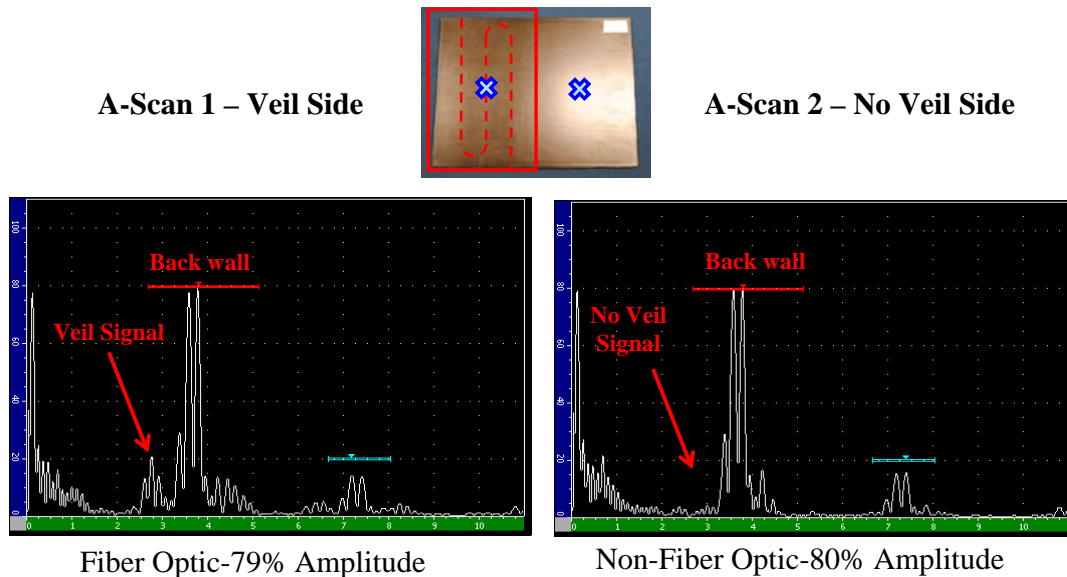
Figure 37. A-scan showing amplitude of veil and non-veil side of test panel

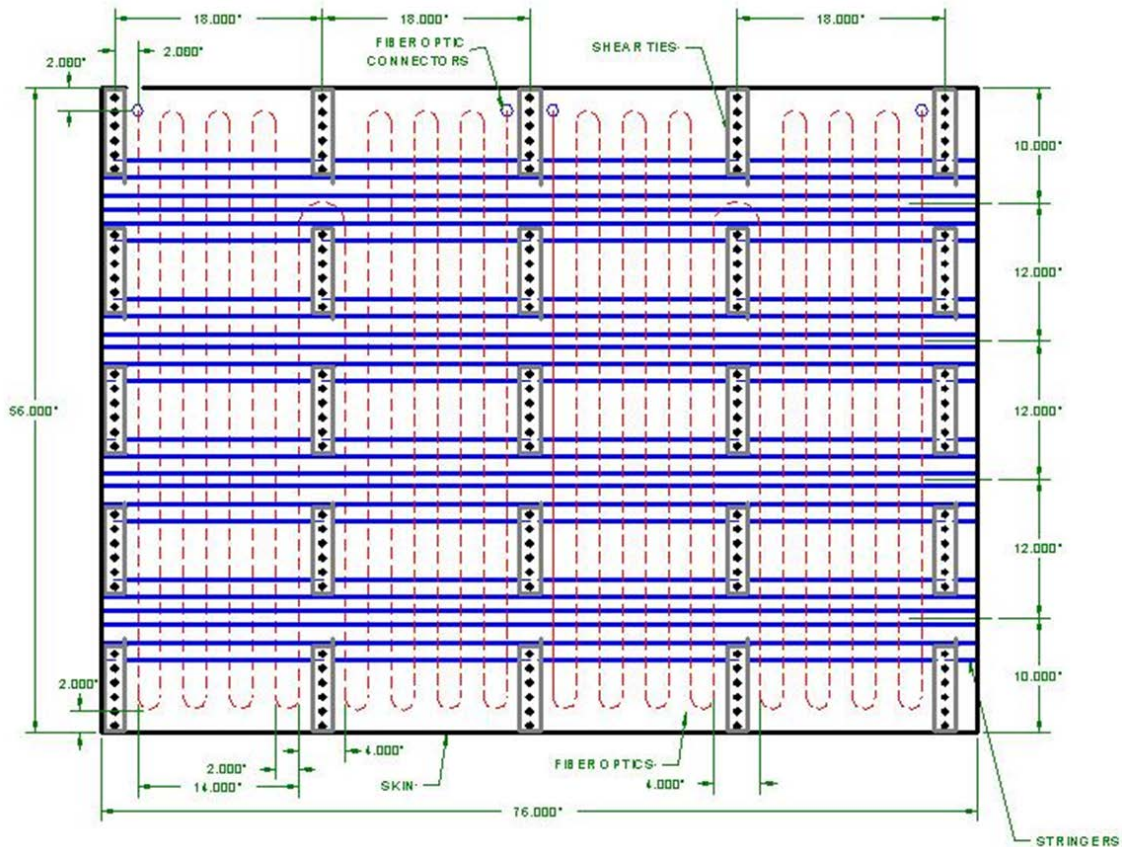
Figure 38. Embedded FO layout showing location of embedded fibers in panel A

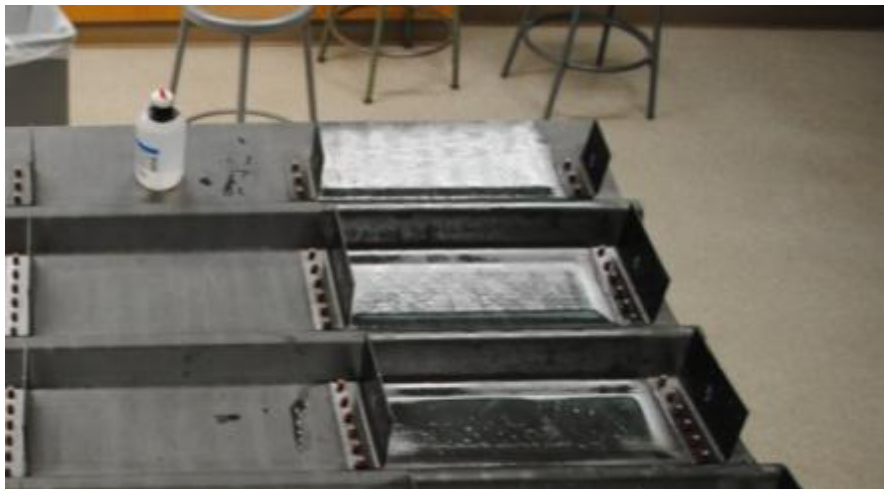
Figure 44. Conditioning and neutralizing the backside of the panel for bonding FO lines

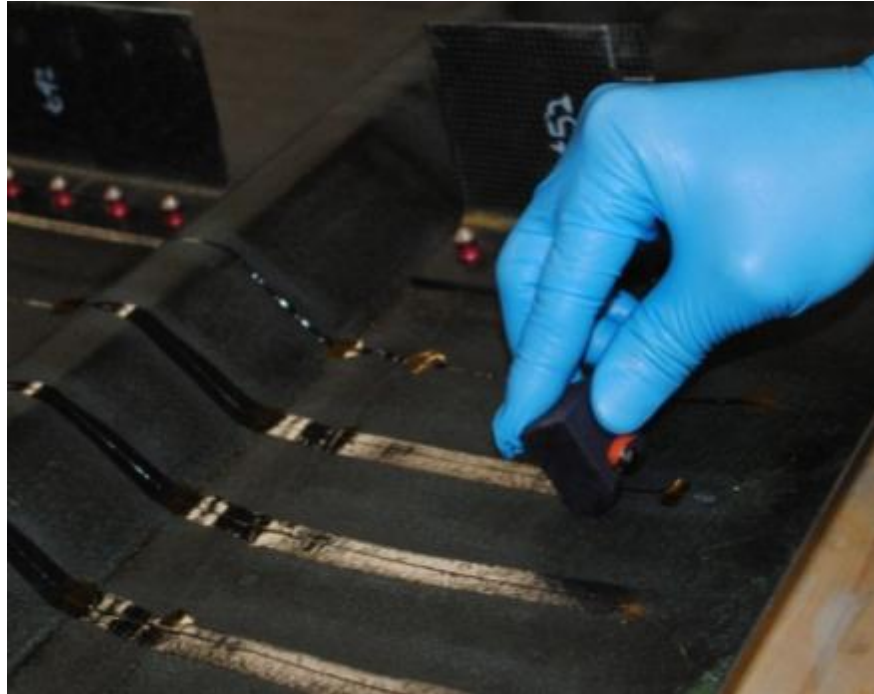
Figure 45. Thin line of M-bond GA-2 adhesive being squeezed smooth around FO

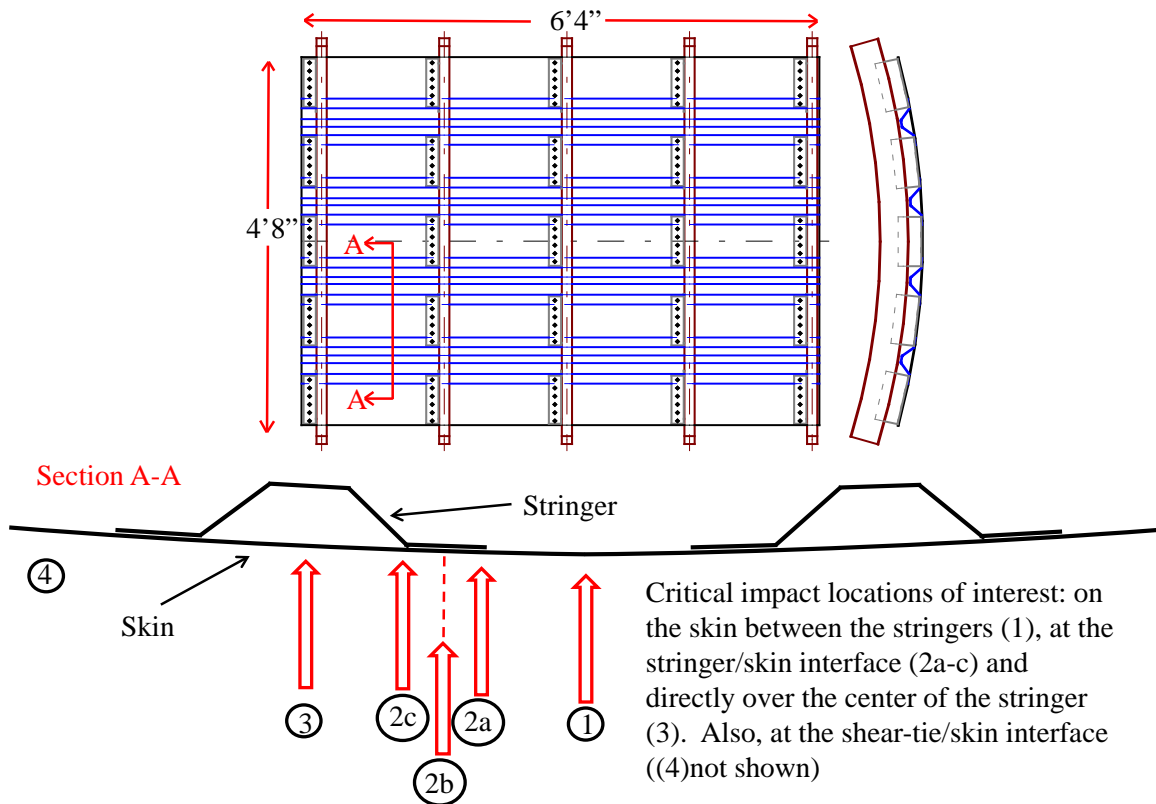
Figure 48. Panel showing impact areas of interest

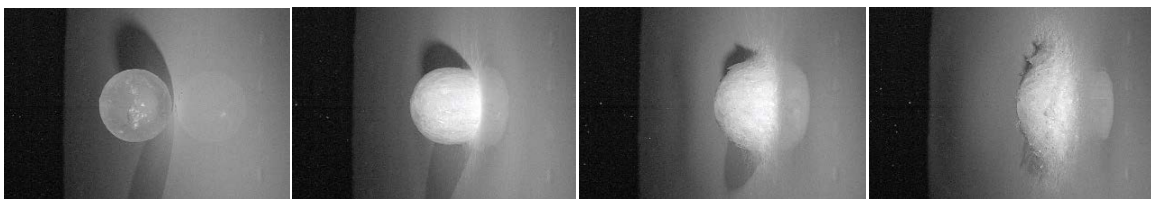
Figure 49. High-speed image of simulated hail impacting fuselage panel

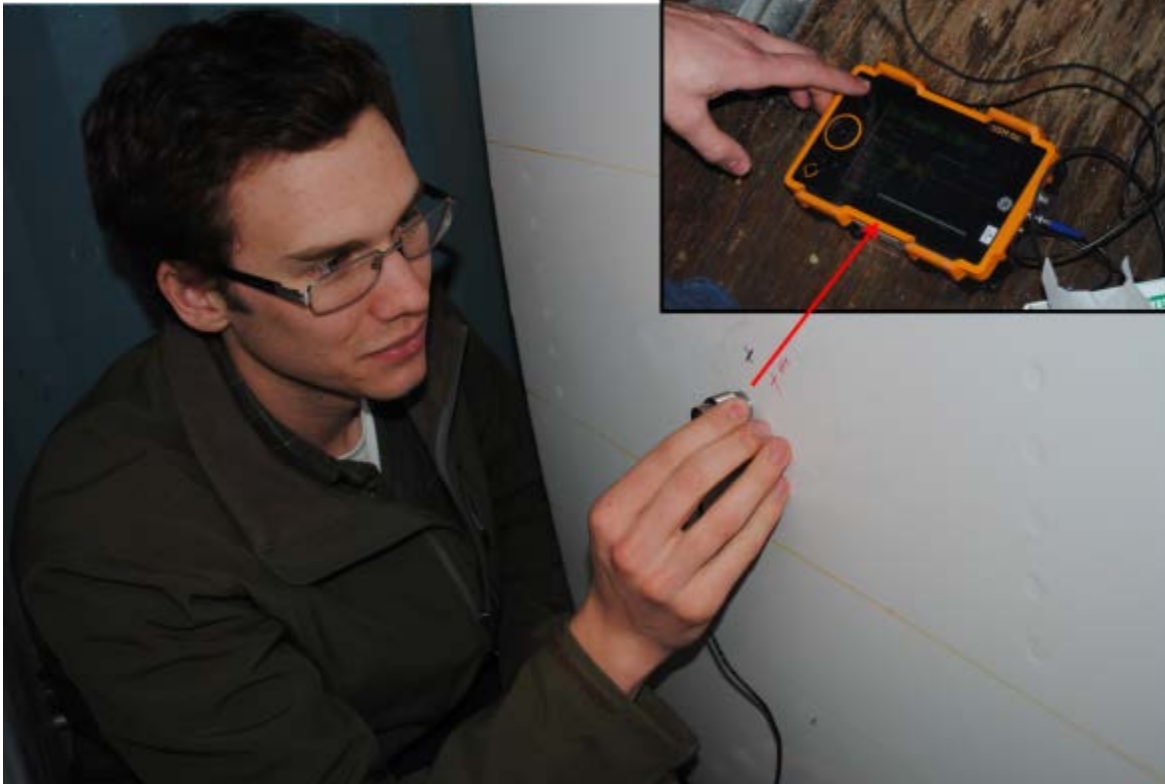
Figure 50. A manually deployed UT A-scan inspection being performed after impact to determine damage extent

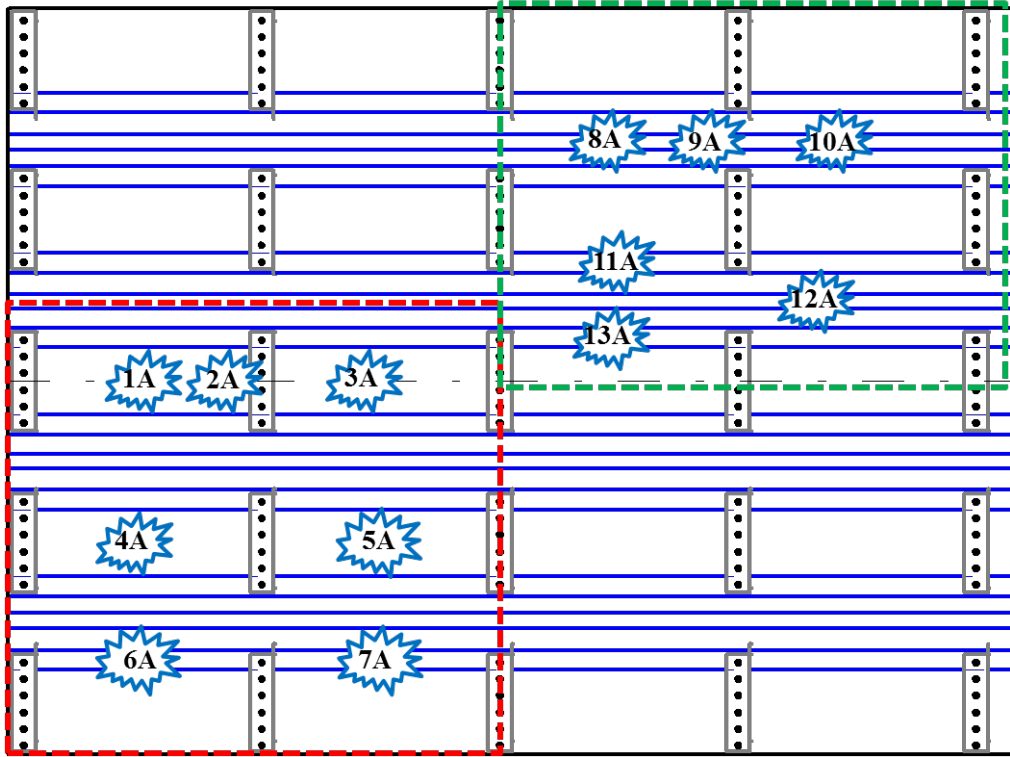
Bays 1&2 Ice Impacts

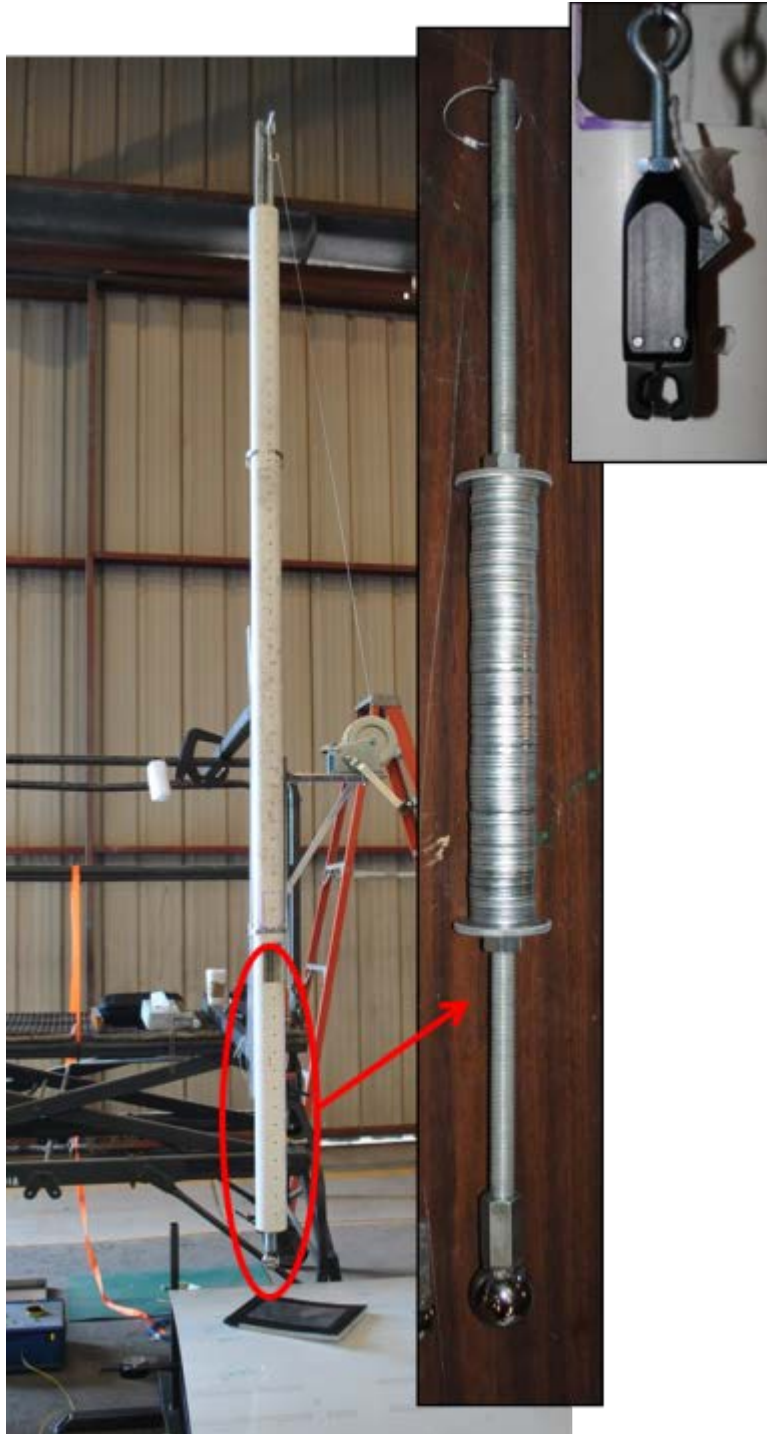
Figure 53. Guide tube, drop spear with 2" diameter impact tip, and quick release mechanism

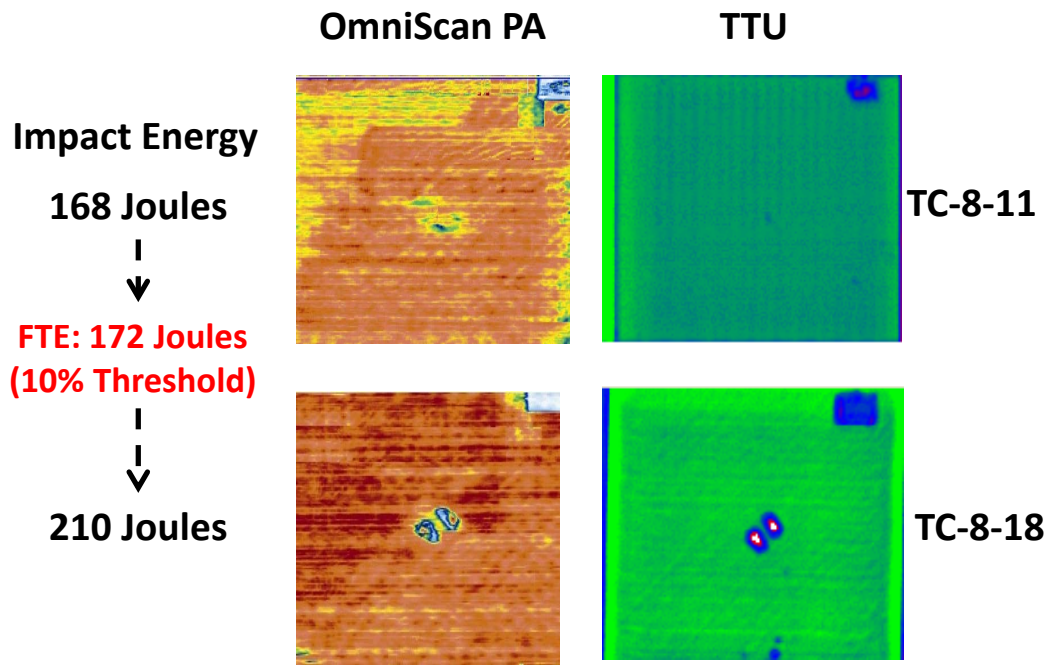
Figure 57. UT phased-array and through-transmission results of two 8-ply panels spanning the FTE for 38.1 mm simulated hail

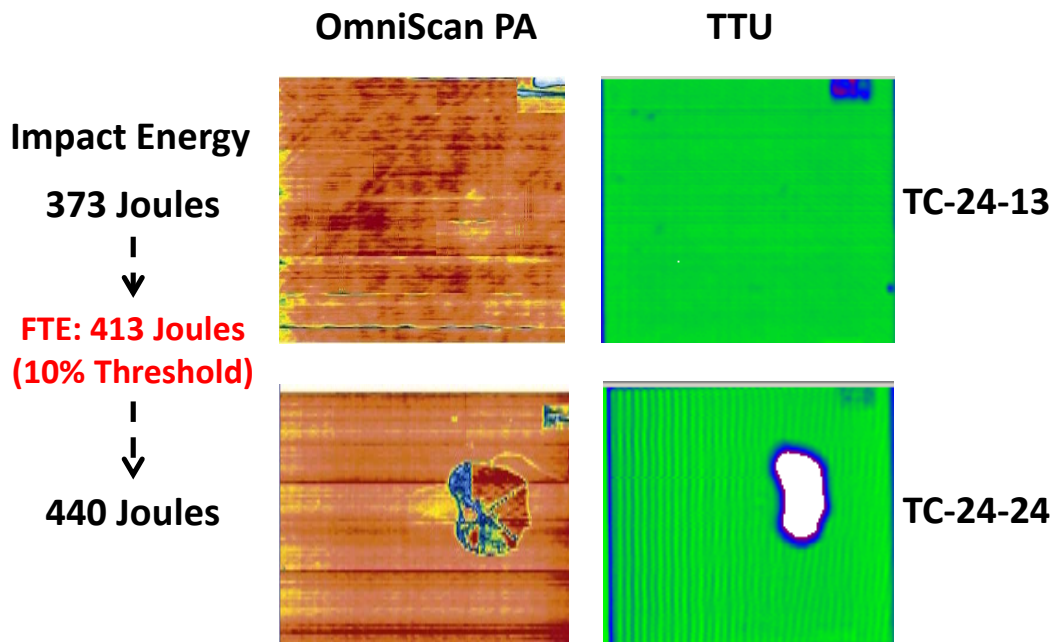
Figure 59. UT phased-array and through-transmission results of two 8-ply panels spanning the FTE for 38.1 mm simulated hail

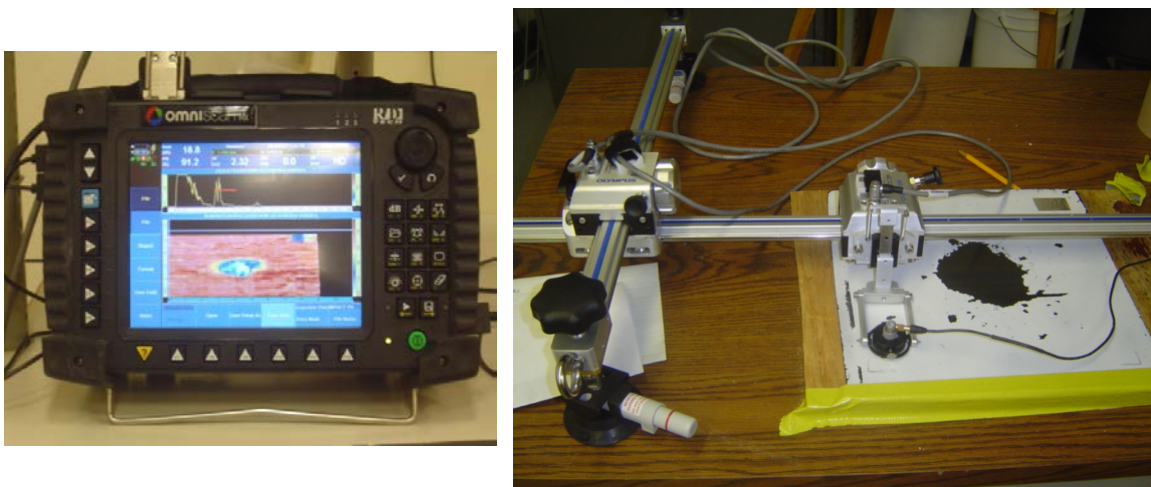
Figure 60. OmniScan 5 MHz single-element inspection setup

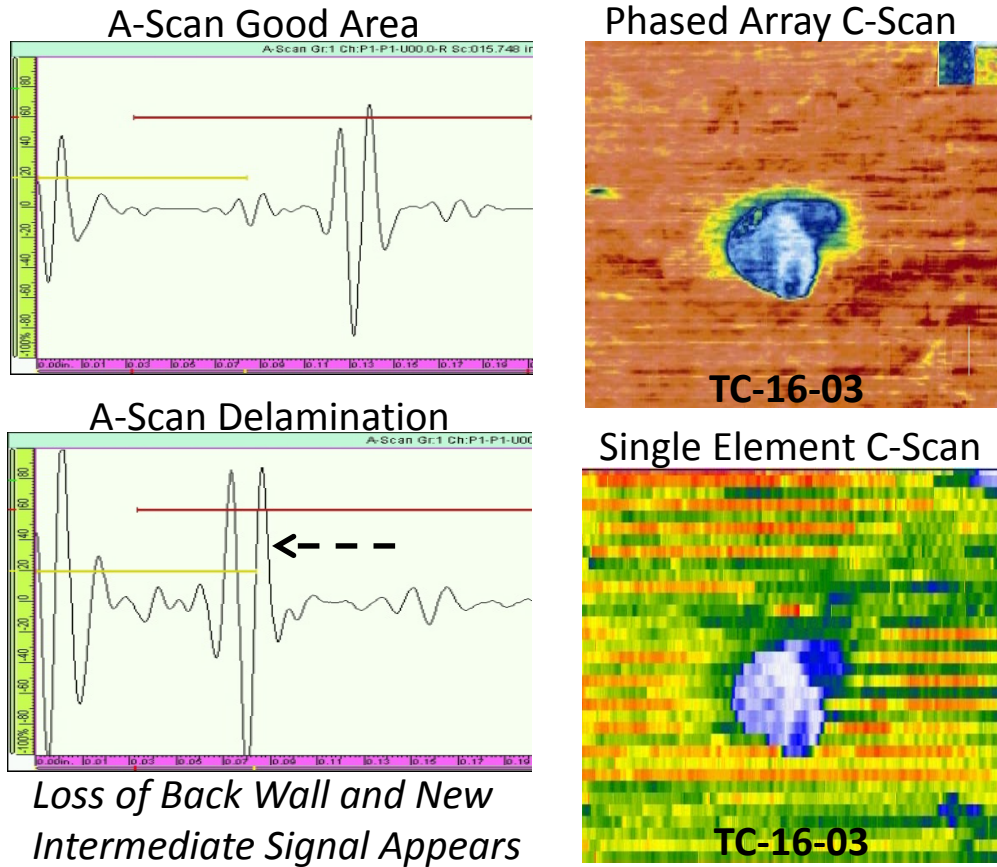
Figure 61. Typical OmniScan A-scan setup used to compose C-scans and resulting phased-array and single-element C-scan images for a select panel

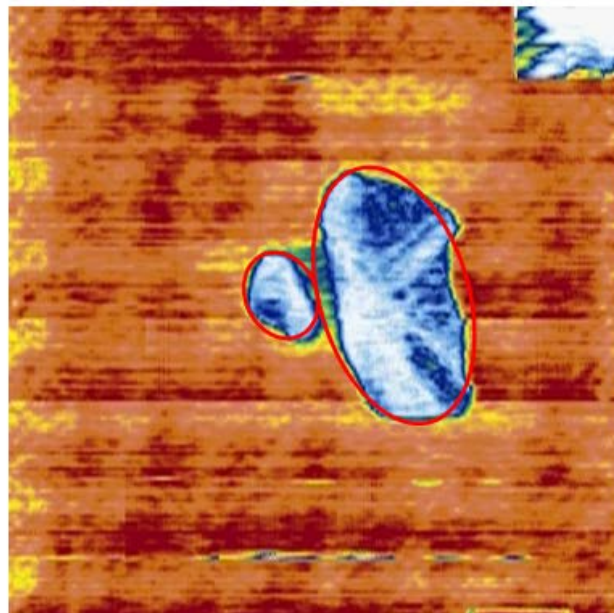
Damage Area
Estimated by Two
Ovals

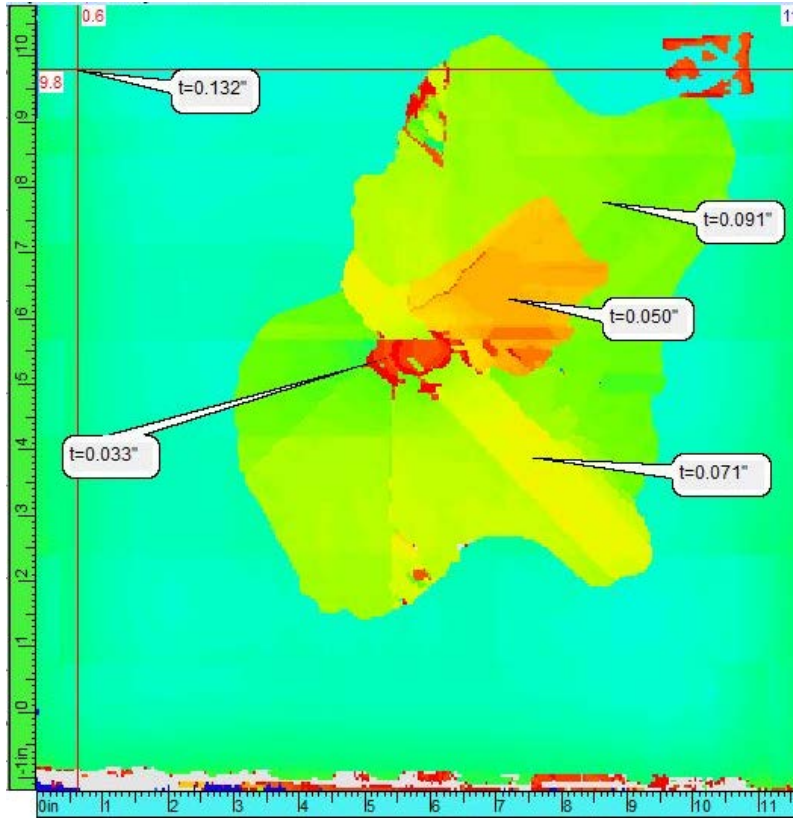
Figure 63. OmniScan phased-array TOF C-scan

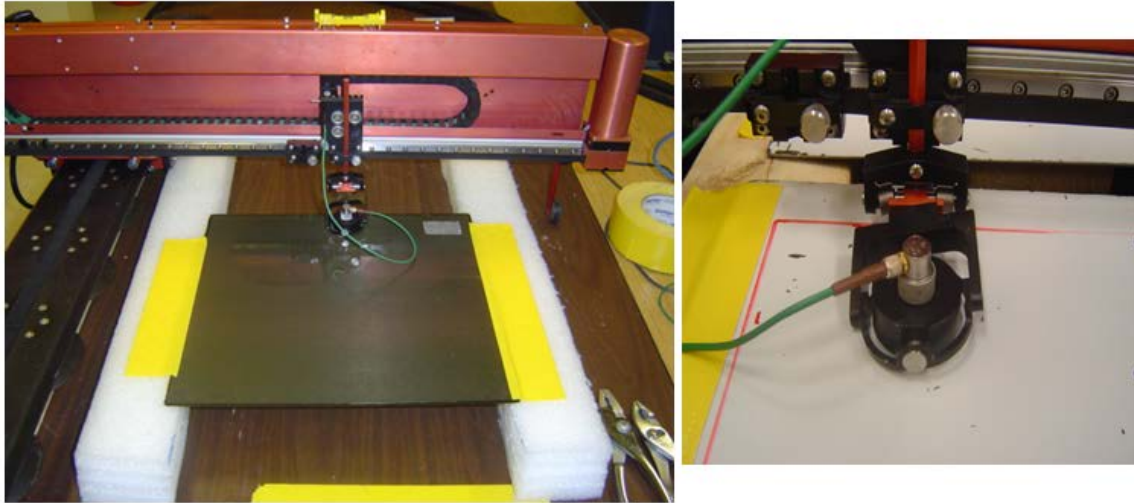
Figure 64. Boeing MAUS V pulse-echo setup used
