DOT/FAA/TC-16/8

Federal Aviation Administration
William J. Hughes Technical Center
Aviation Research Division
Atlantic City International Airport
New Jersey 08405

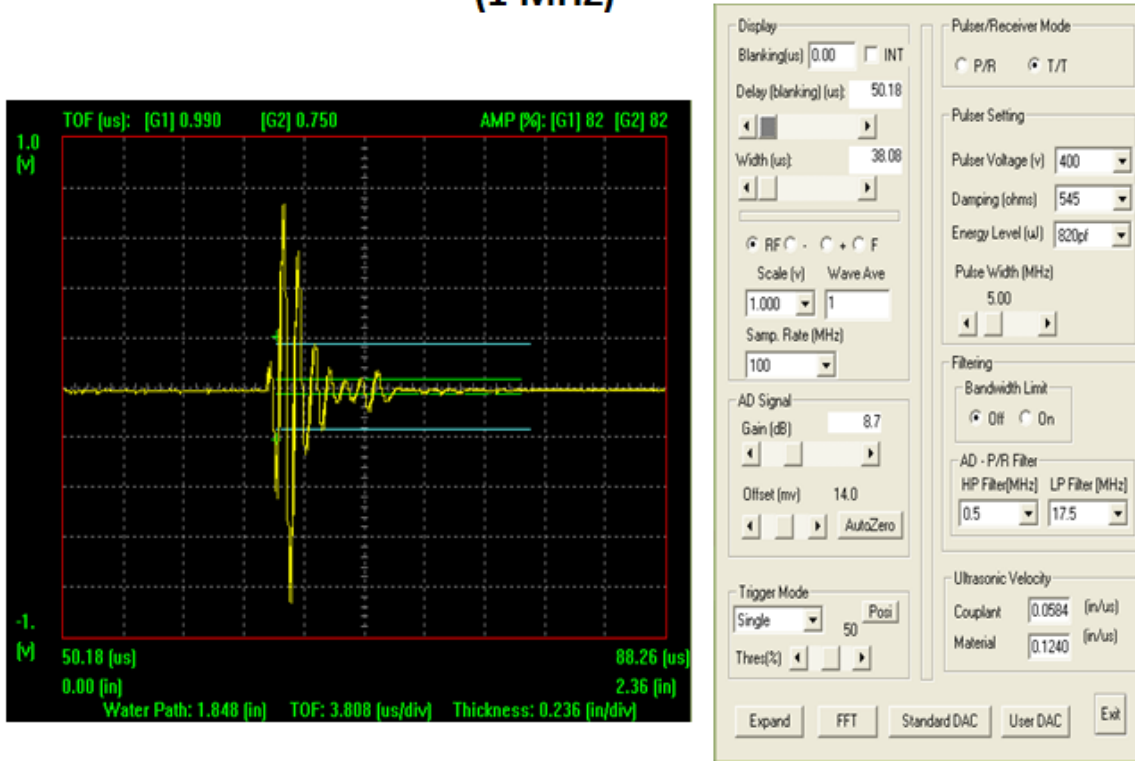
Figure 67. A-scan example from TTU inspection and settings screenshot

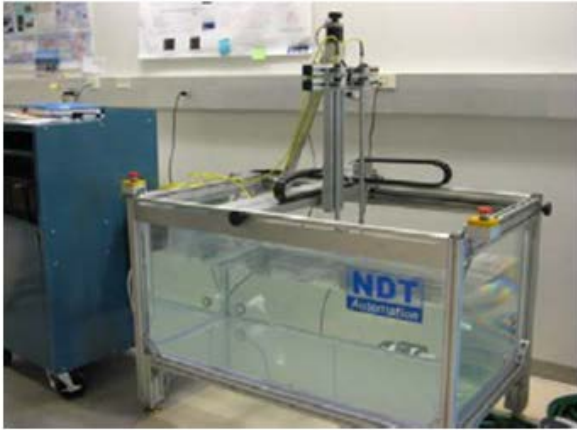
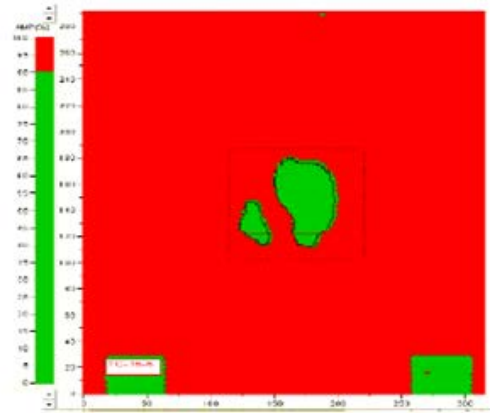
Figure 68. UT tank used at UCSD for TTU inspection and example C-scan result (TC-16-6) [16]

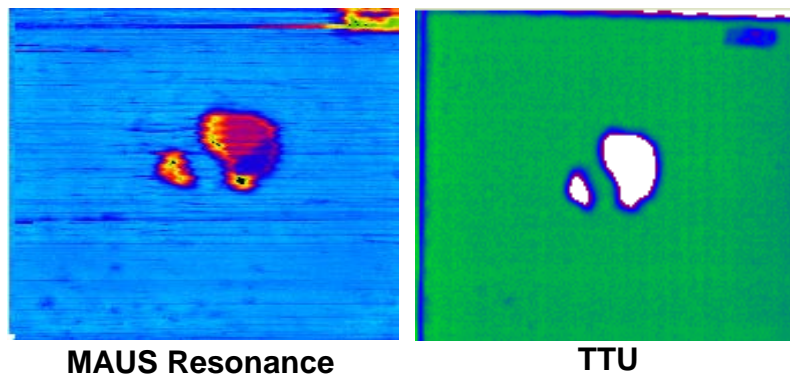
Figure 69. Example resonance inspection results compared to TTU (TC-16-6)

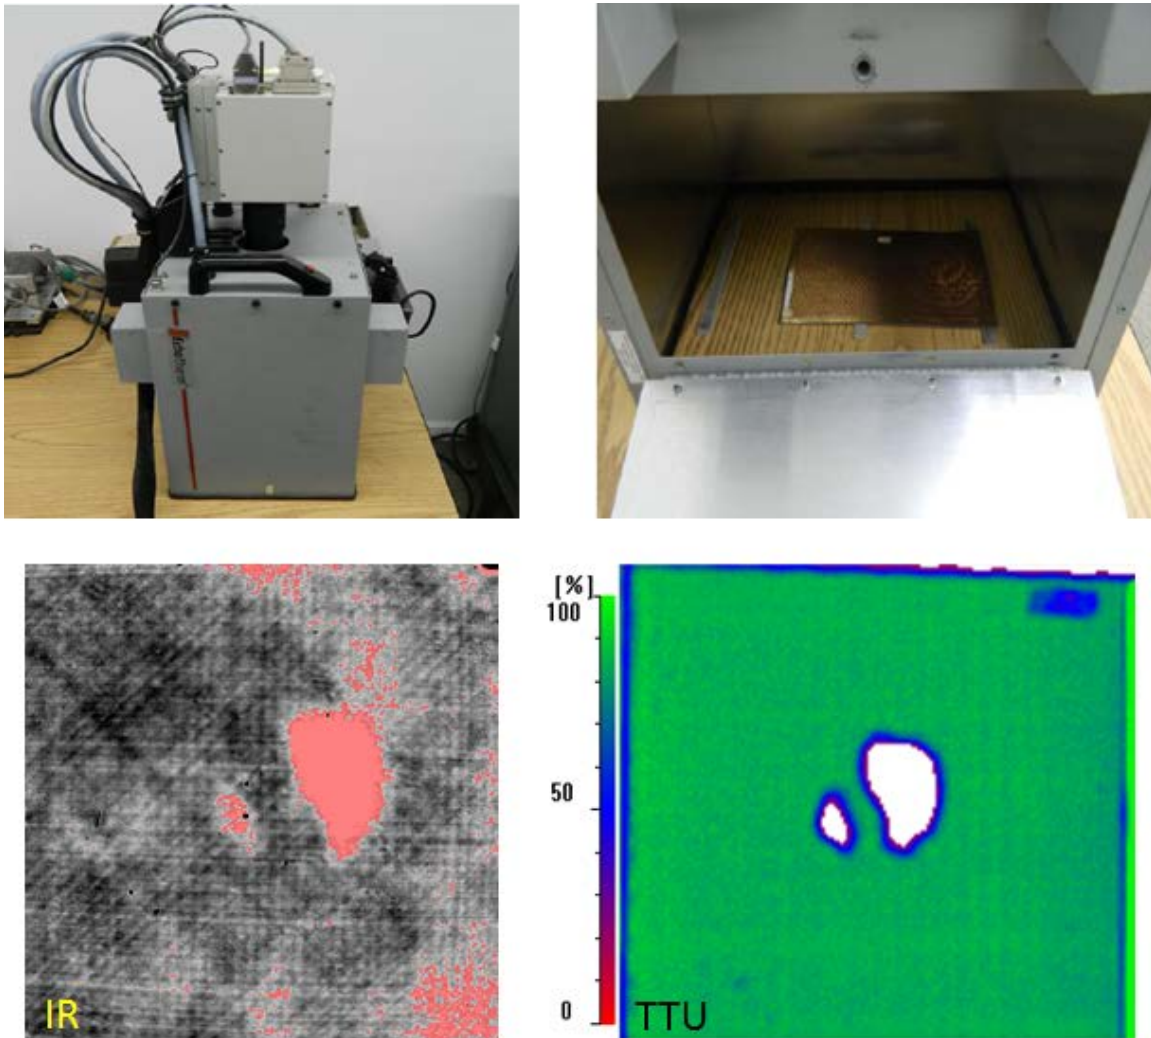
Figure 70. Pulse thermography setup used and example IR inspection results (TC-16-6)

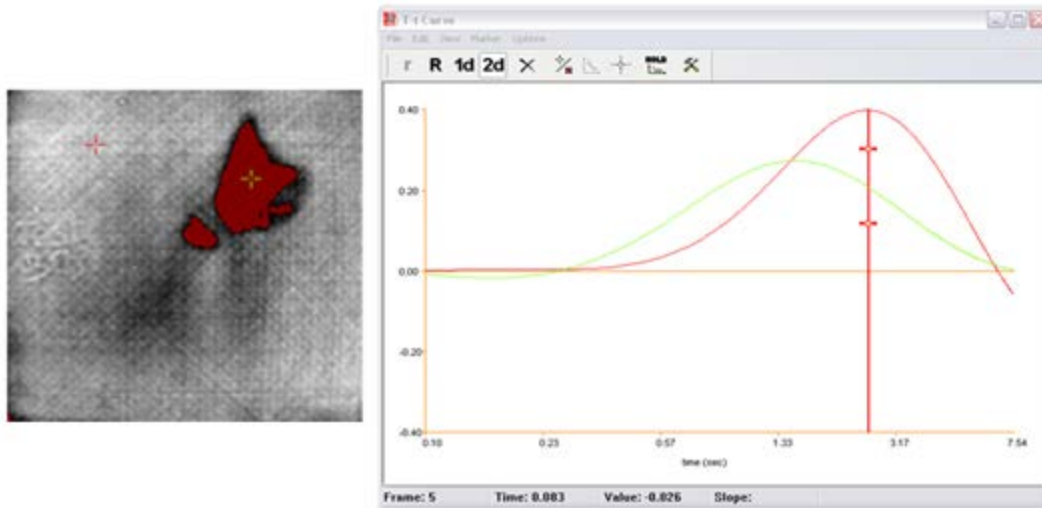
Figure 71. Example time vs. temperature plot and markers used to analyze impact damage

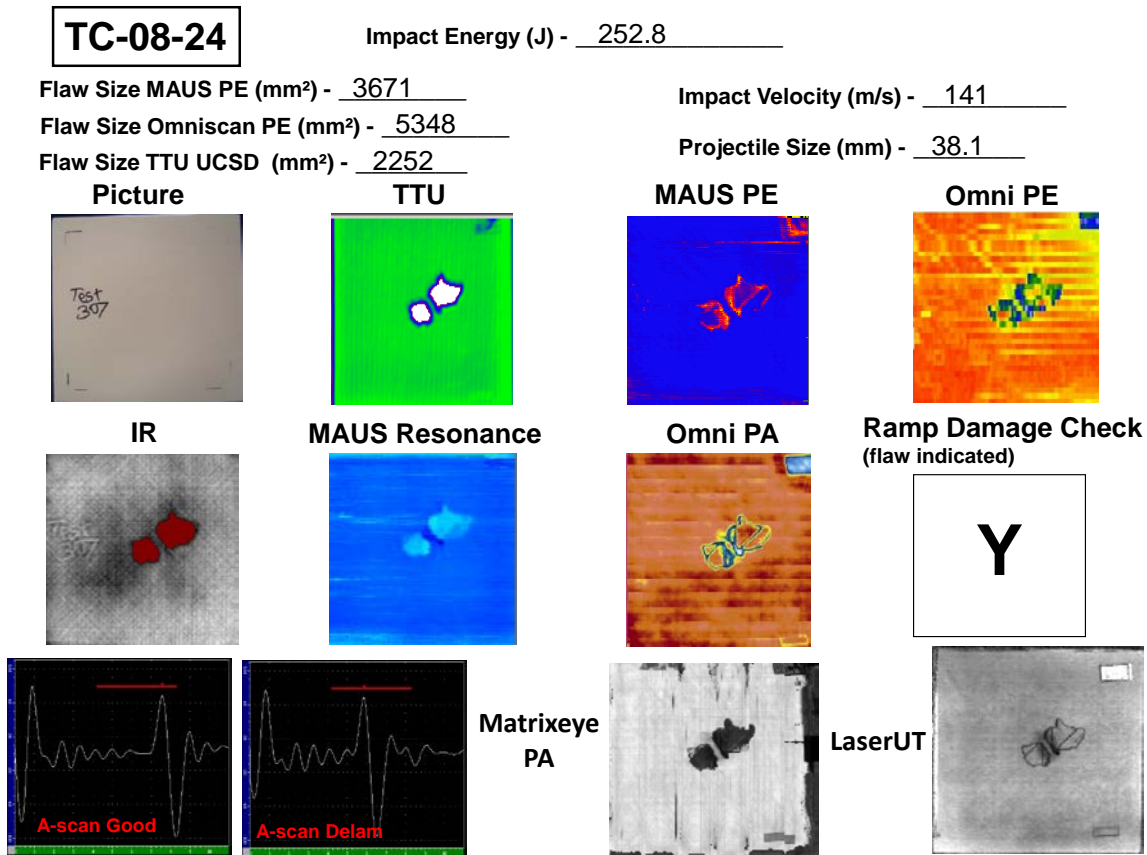
Figure 74. Inspection comparison on 8-ply flat plate panel

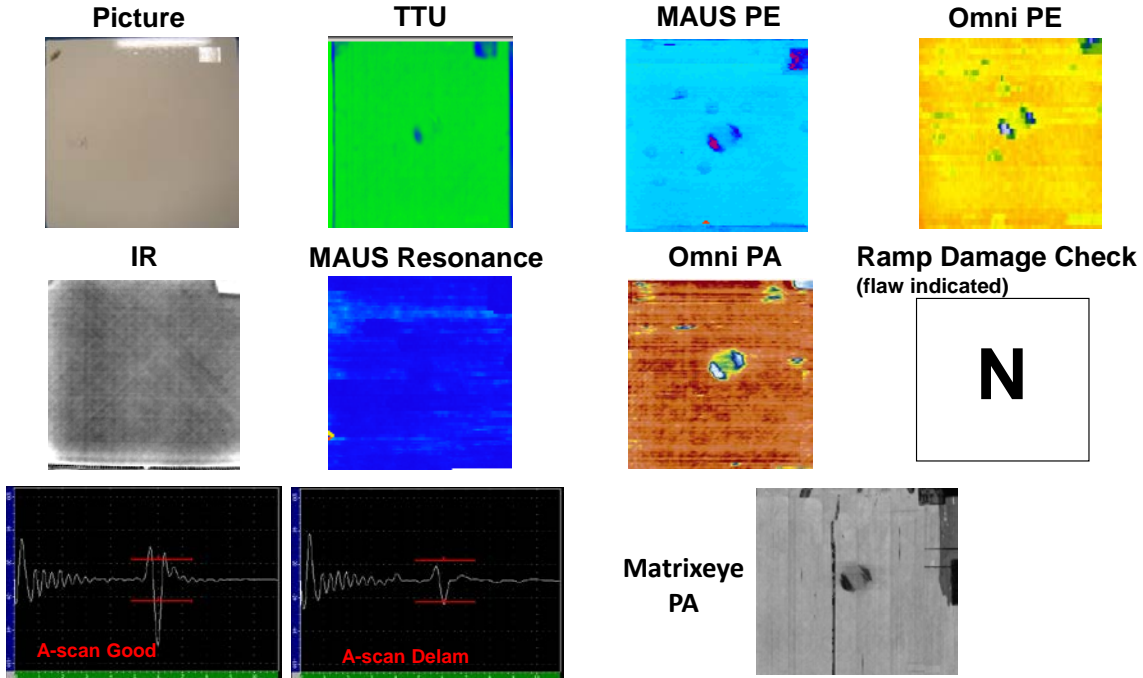
Figure 75. Inspection comparison on 16-ply flat plate panel

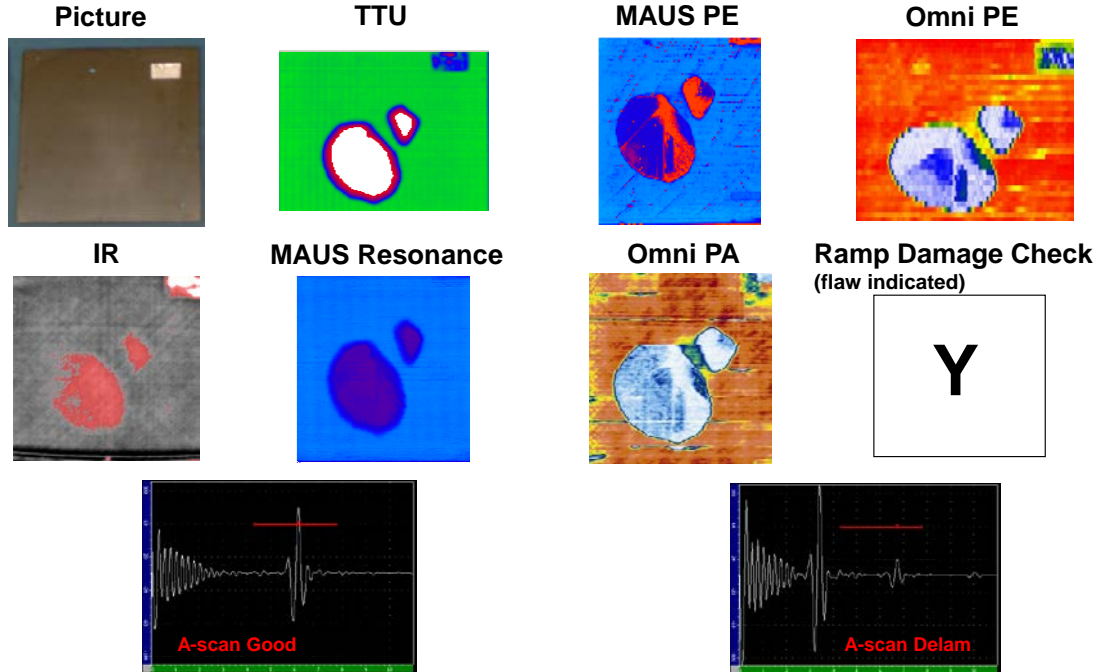
Figure 76. Inspection comparison on 24-ply flat plate panel

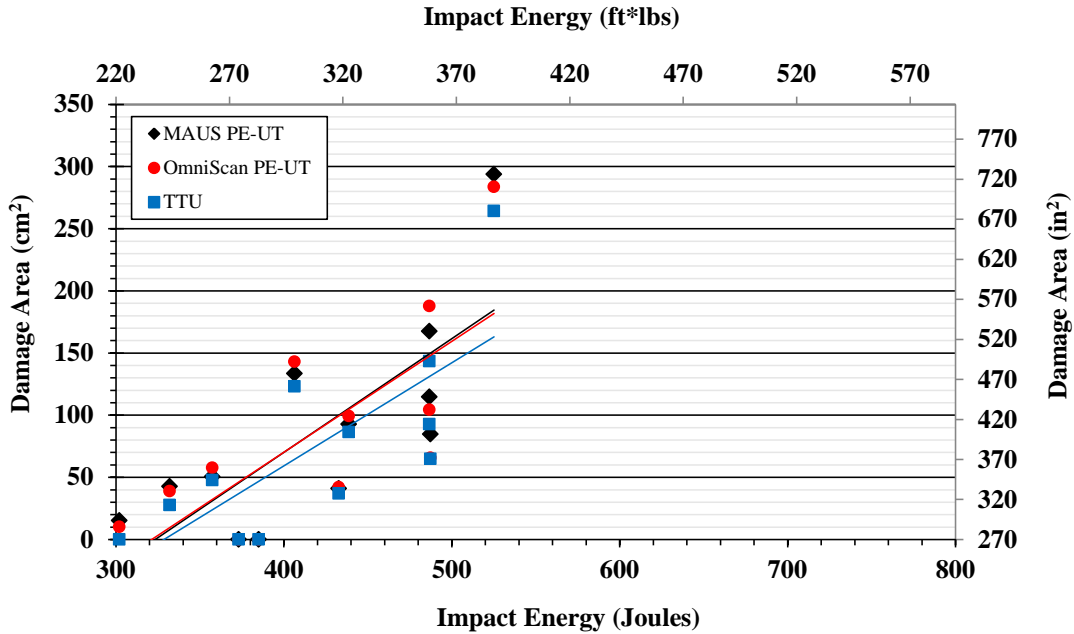
Figure 77. Impact damage area for 16-ply laminates – 38.1 mm. diameter simulated hail

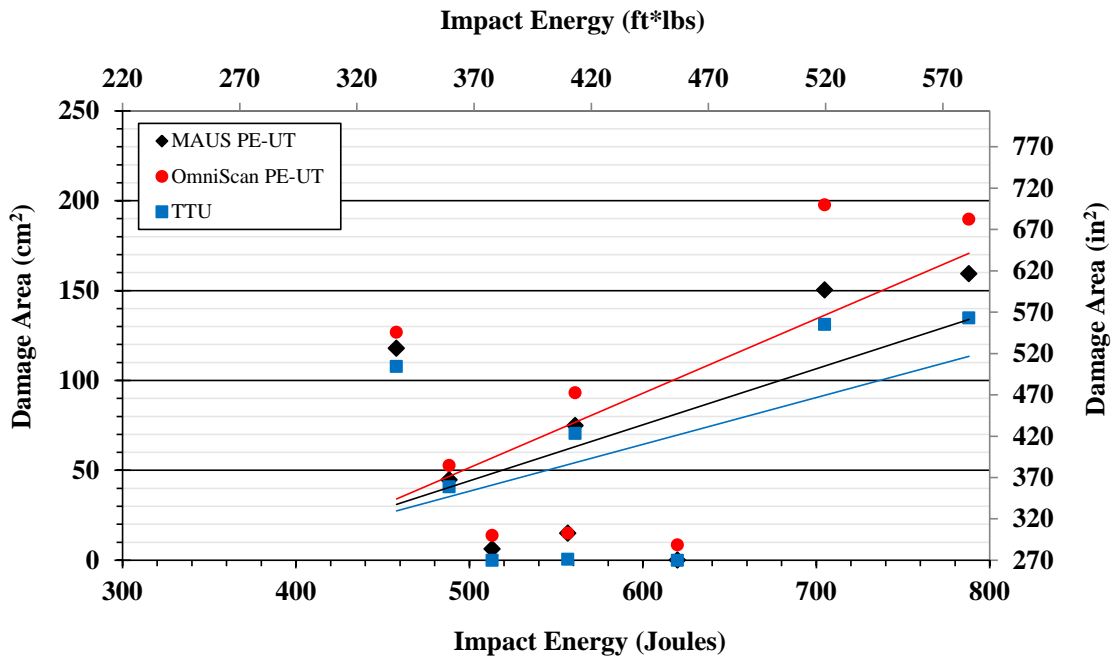
Figure 78. Impact damage area for 16-ply laminates – 50.8 mm. diameter simulated hail

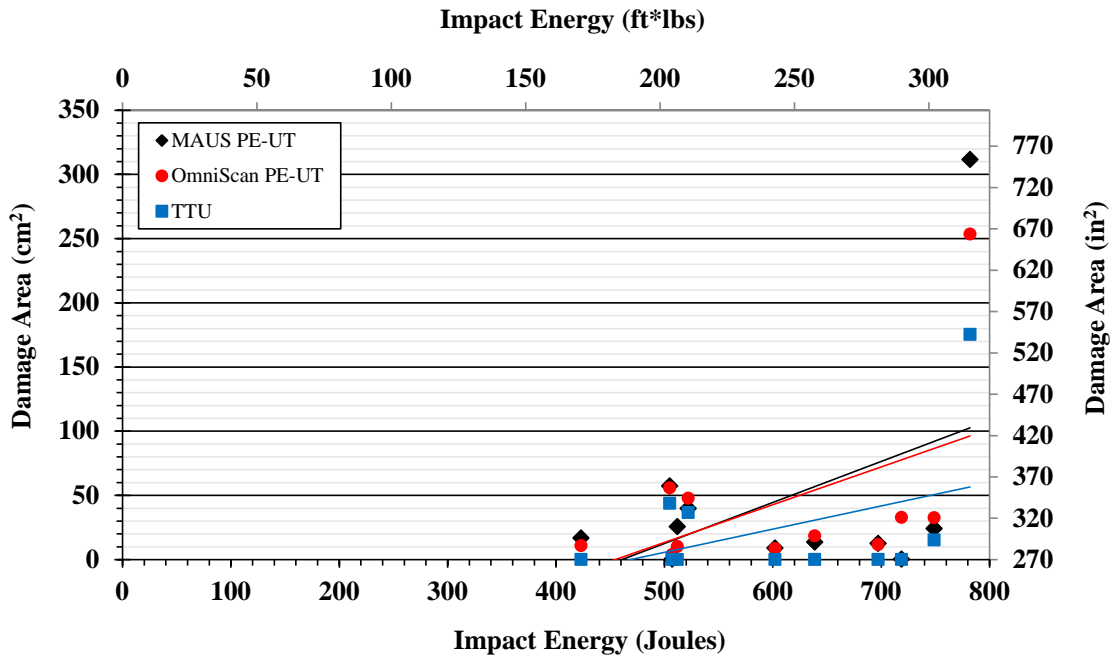
Figure 79. Impact damage area for 16-ply laminates – 61.0 mm. diameter simulated hail

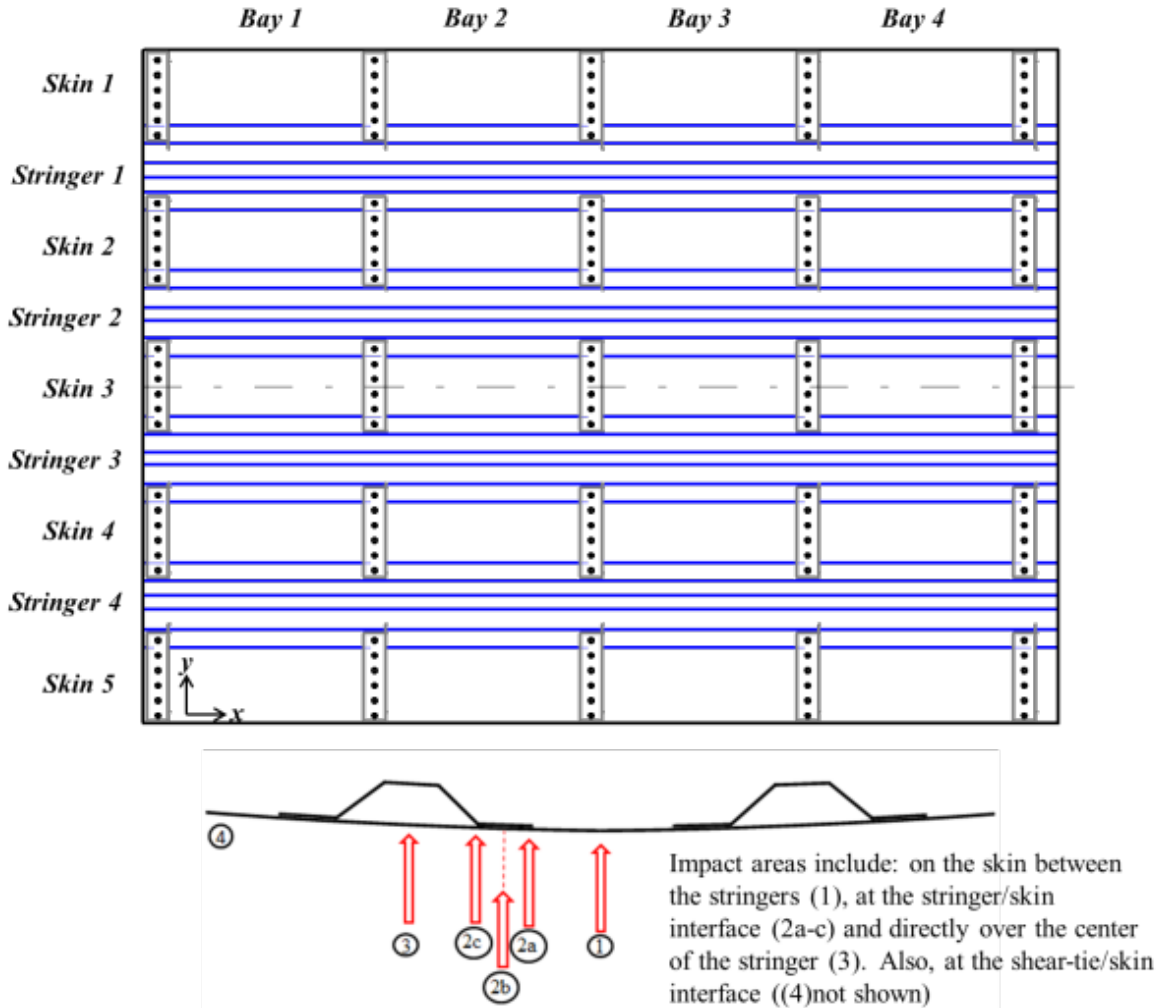
Figure 80. Schematic used to label and locate impact damage

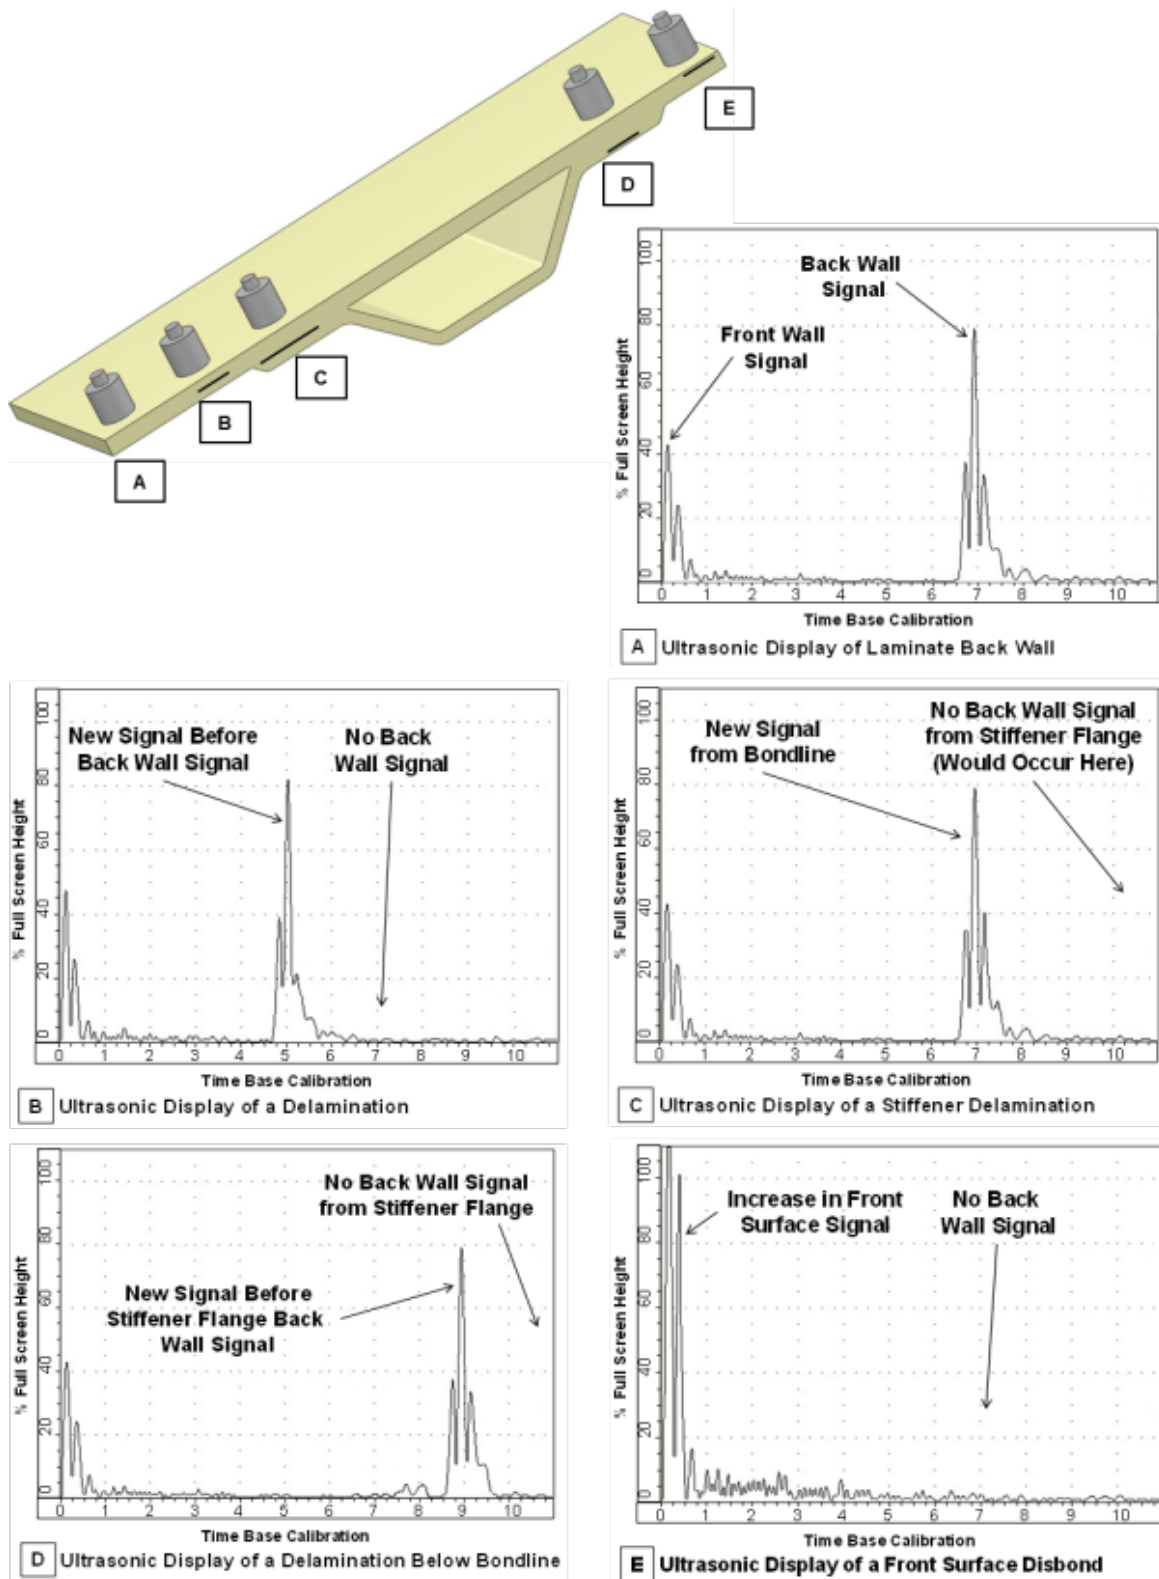
Figure 81. Example A-scan signals over different structural elements and damage

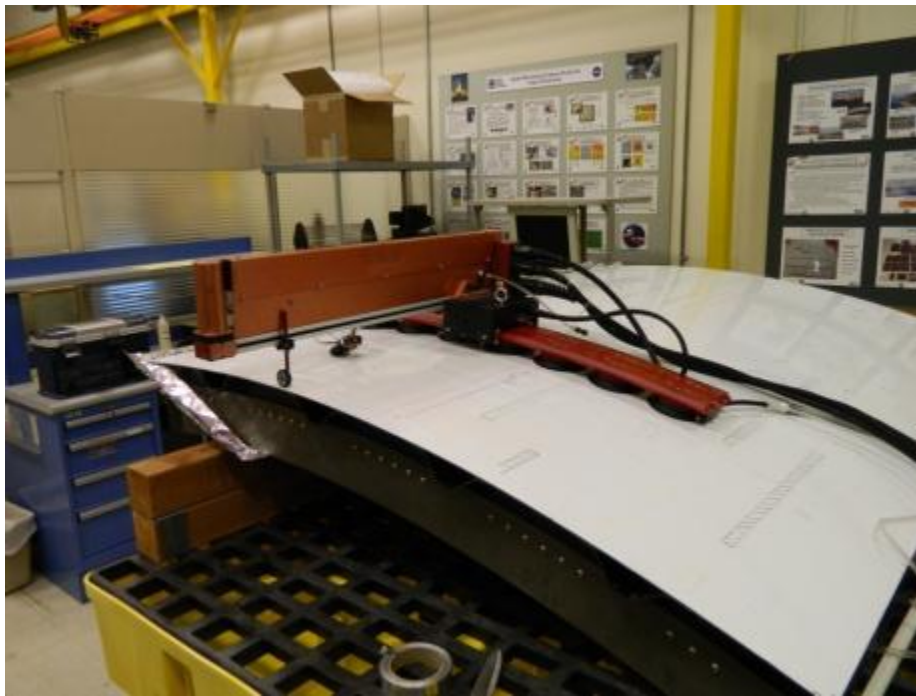
Figure 82. Boeing MAUS V scanning system conducting a UT inspection

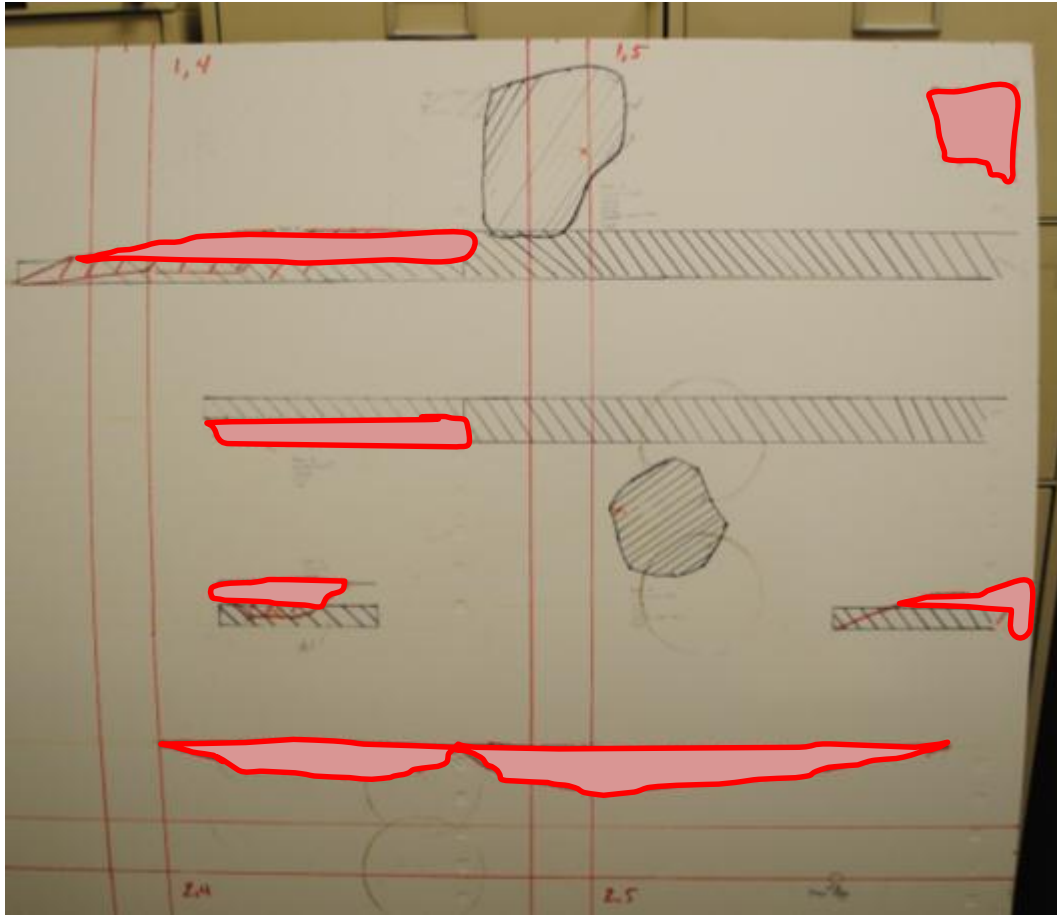
Figure 83. Top right side of panel B—black mapped damage was detected after impact with hand-held UT, and red mapped damage was additional damage detected and sized using the MAUS V scanning system

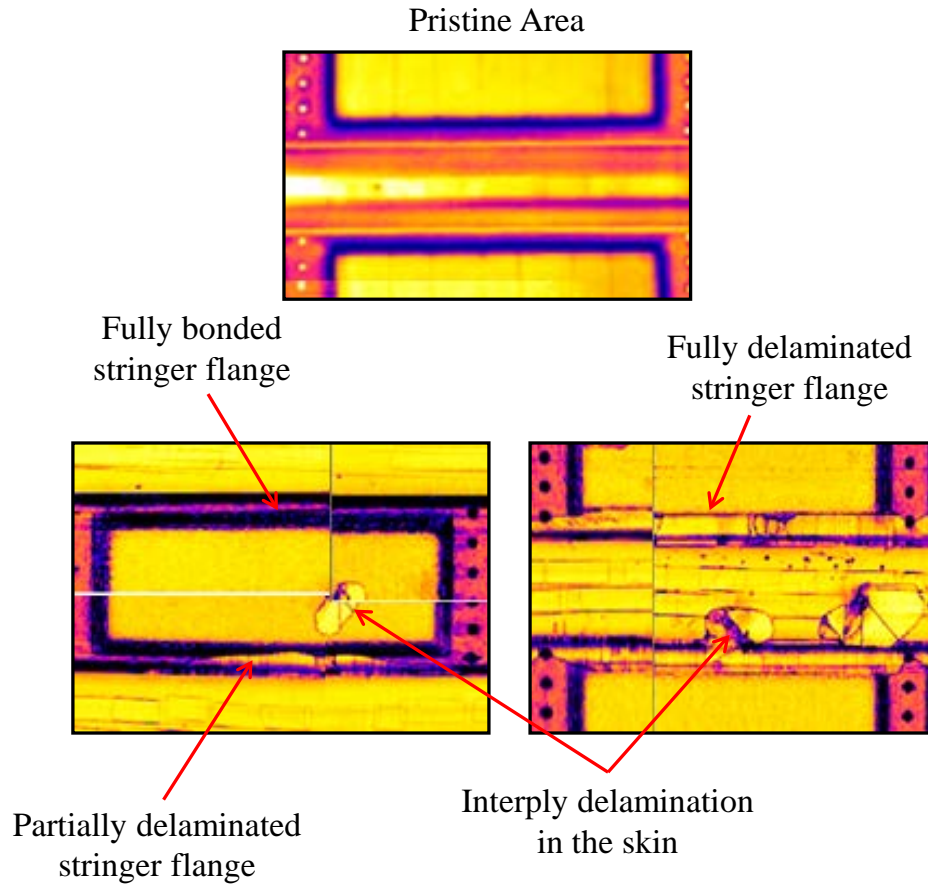
Figure 84. Impact damage induced on panel A showing the difference between interply delamination and stringer flange delamination

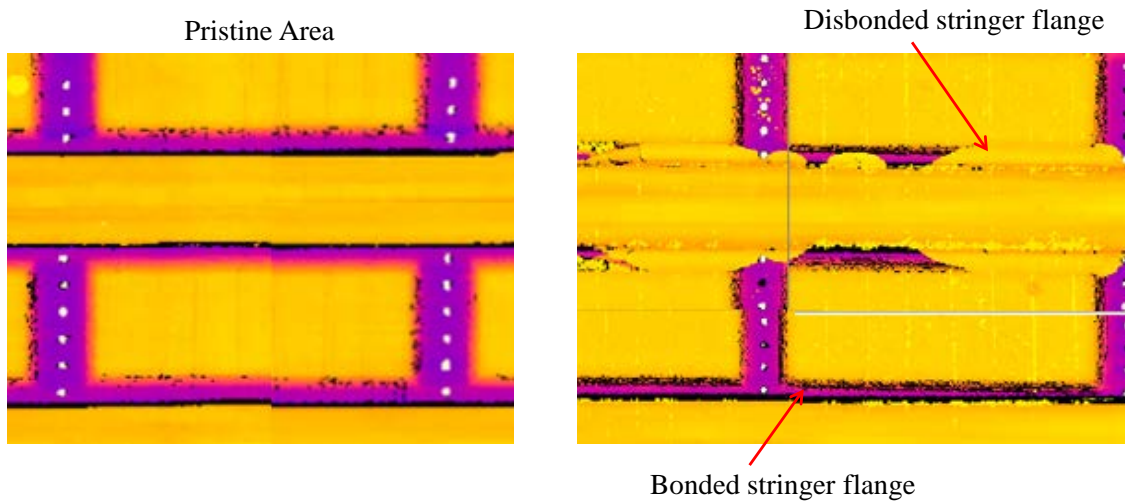
Figure 85. UT TOF C-scan showing delaminated stringer flanges

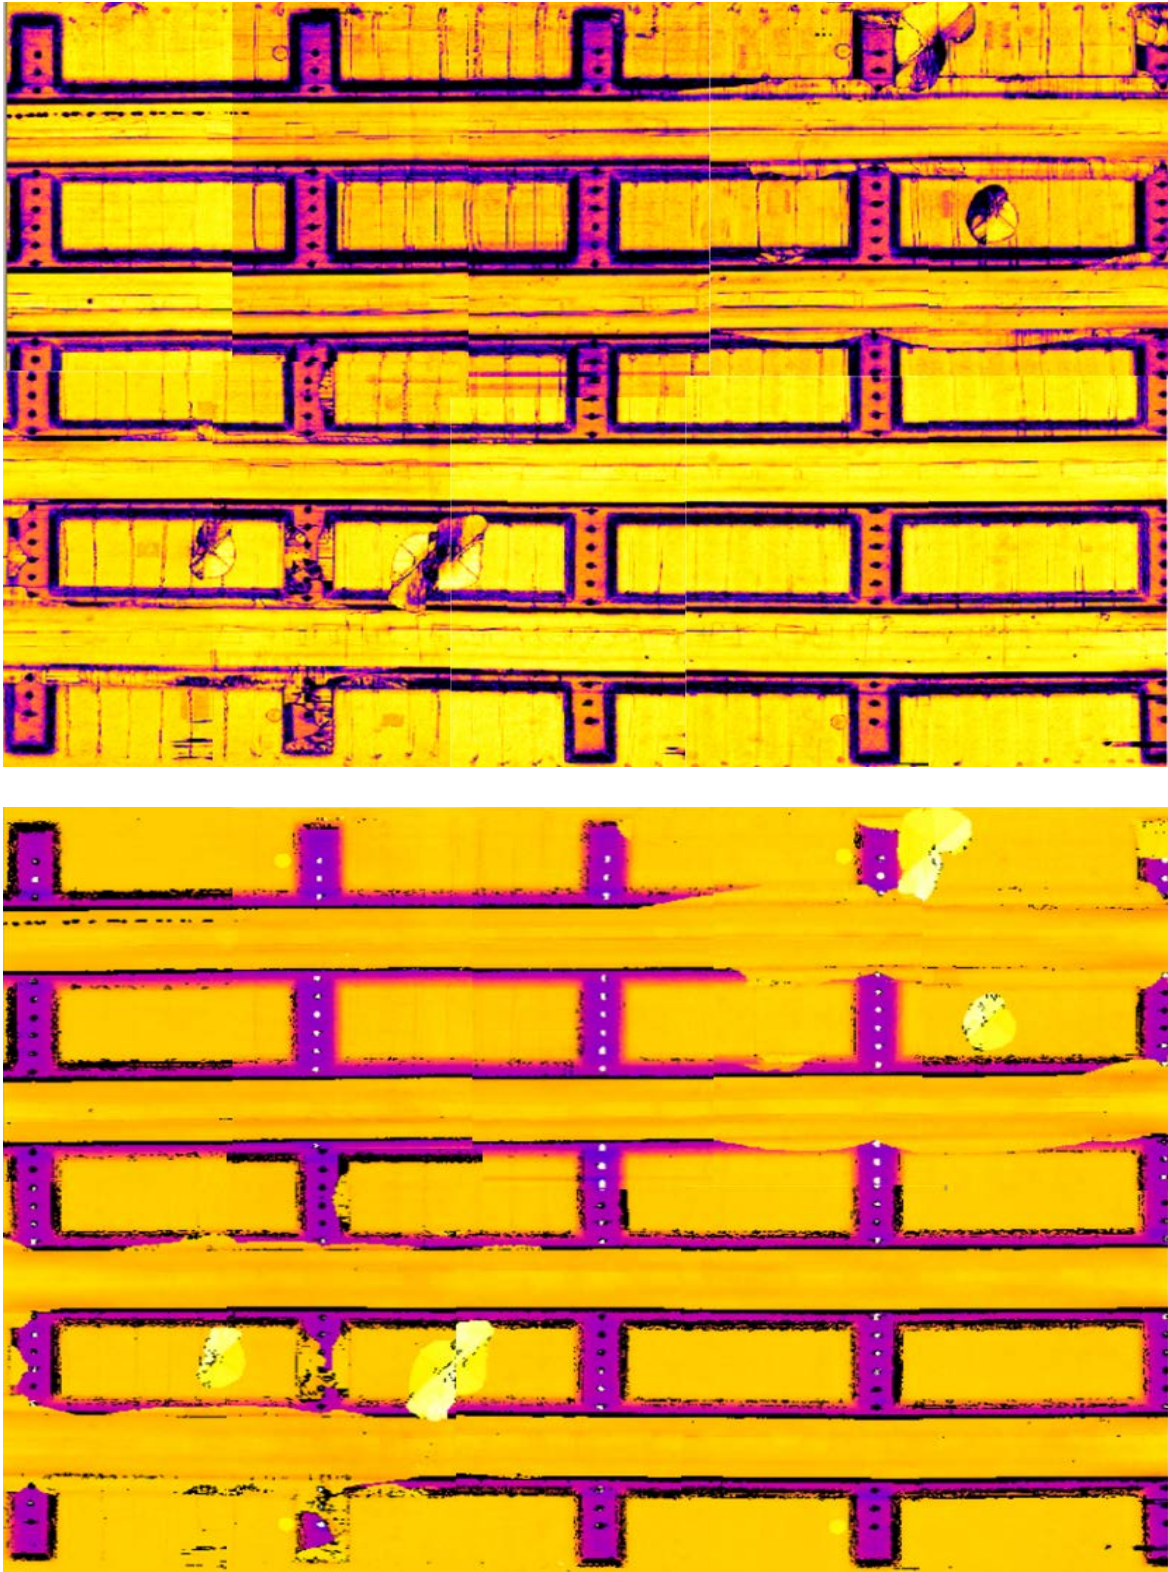
Figure 87. Panel B – UT amplitude (top) and TOF (bottom) C-scans

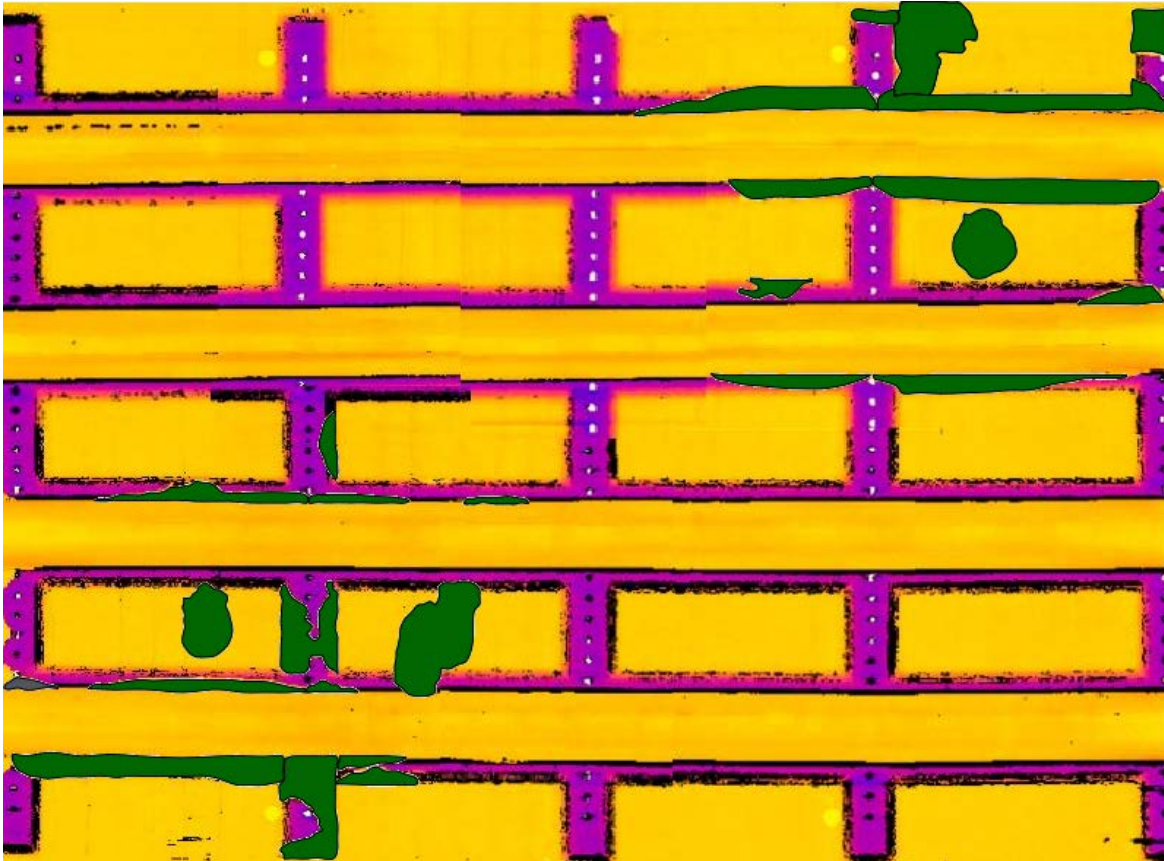
Figure 88. Green tracings used to determine damage area on Panel B

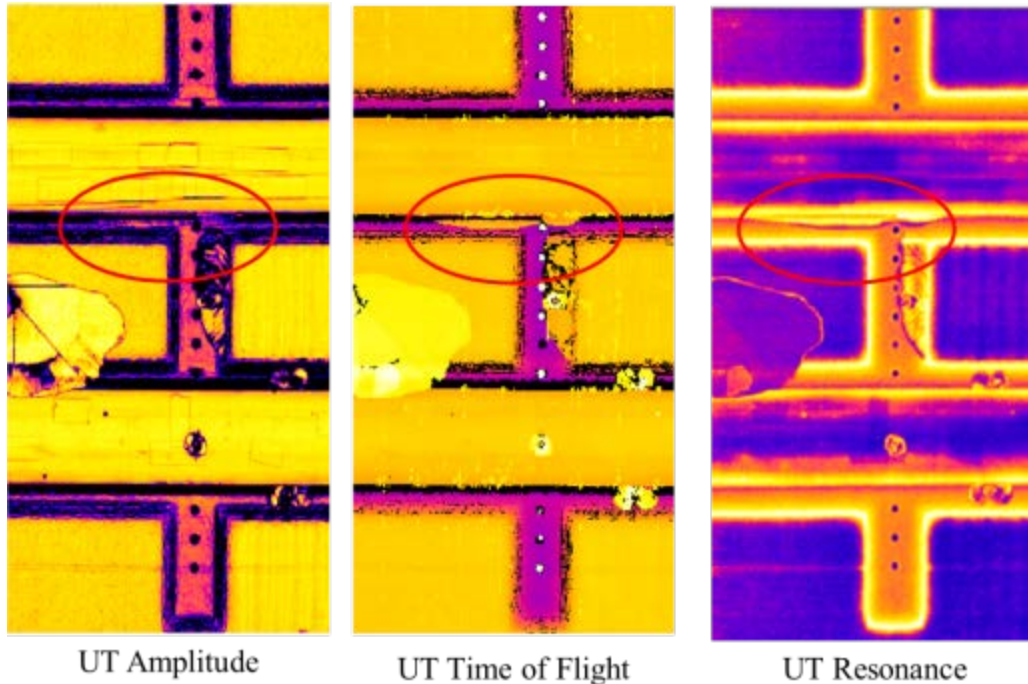
Figure 89. Comparison of UT amplitude, TOF, and resonance inspection results

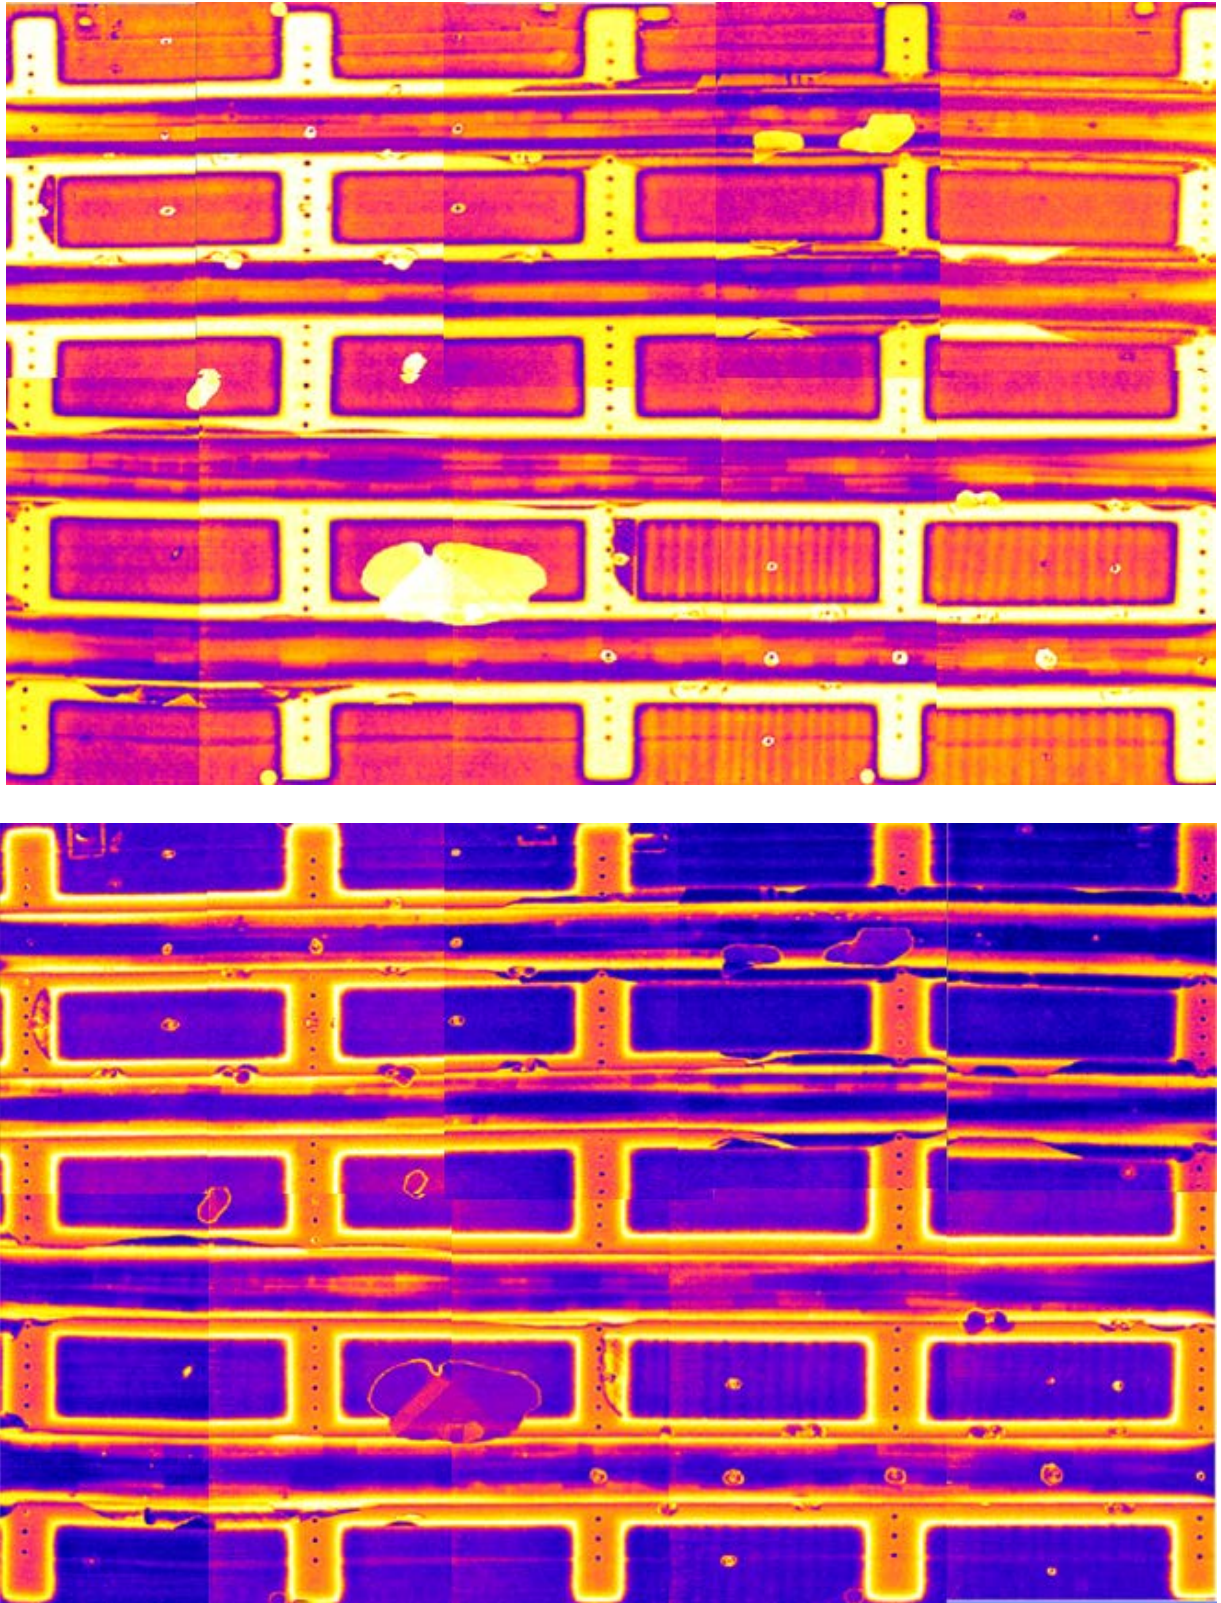
Figure 90. Panel A – resonance amplitude X plot (top) and Phase Y plot (bottom) C-scans

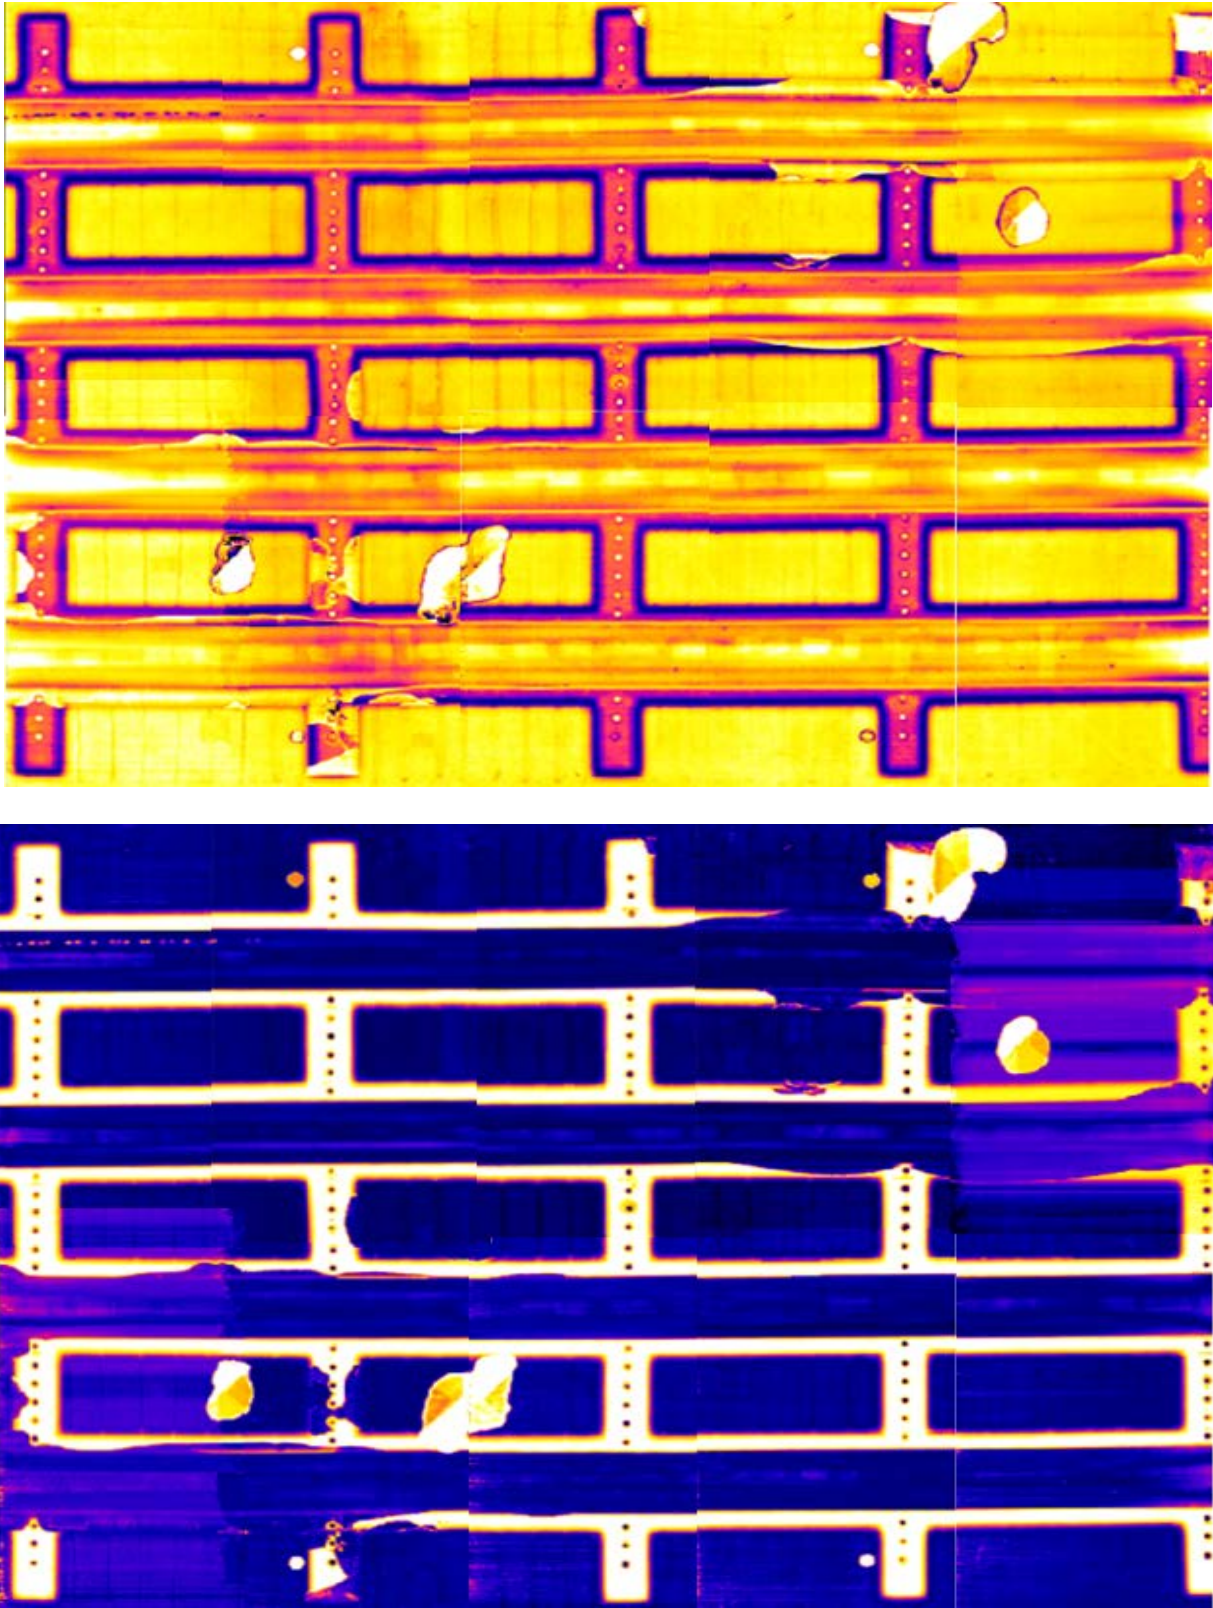
Figure 91. Panel B – Resonance amplitude X plot (top) and Phase Y plot (bottom) C-scans

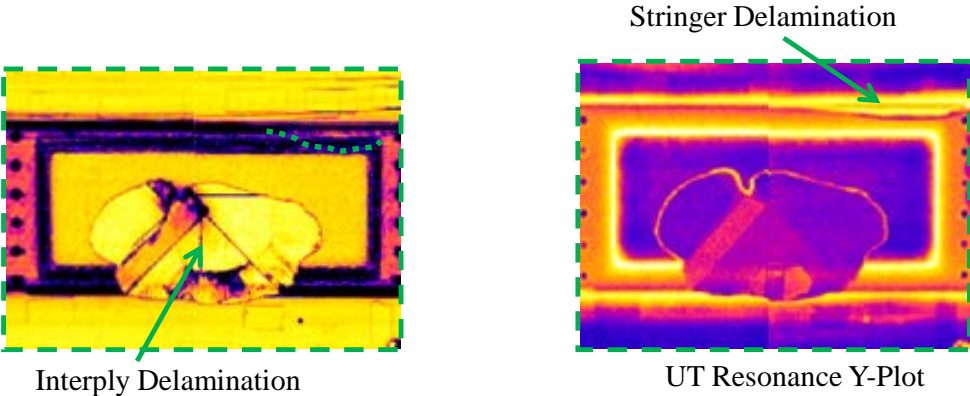
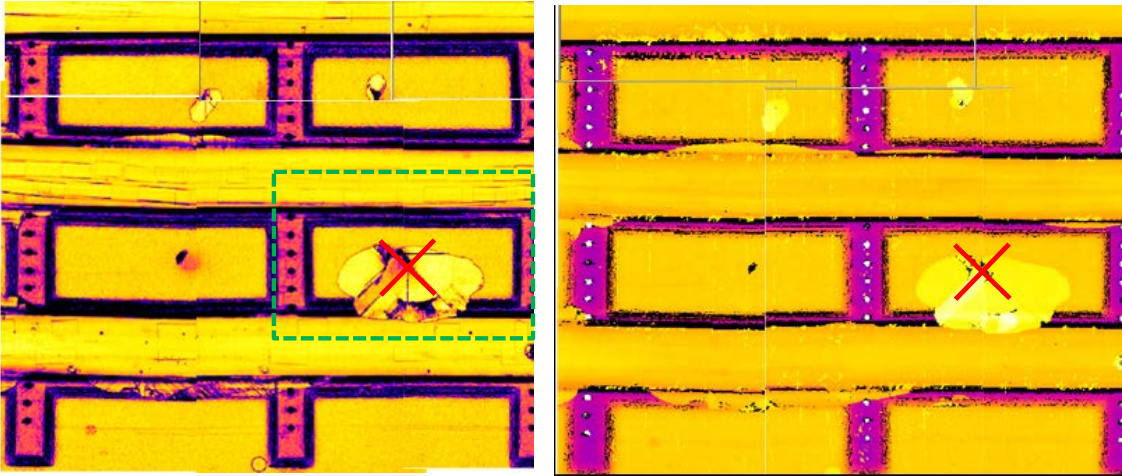
Type of Damage: Mostly interply delamination, small stringer disbond to the upper right of the impact area not detected in amplitude scan

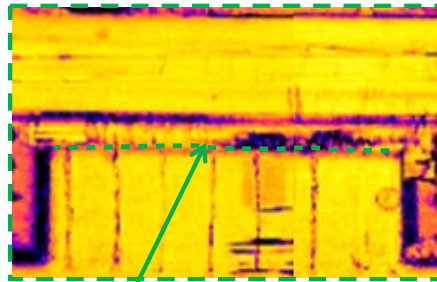
Full Stringer Disbond
