DOT/FAA/TC-16/8

Federal Aviation Administration
William J. Hughes Technical Center
Aviation Research Division
Atlantic City International Airport
New Jersey 08405

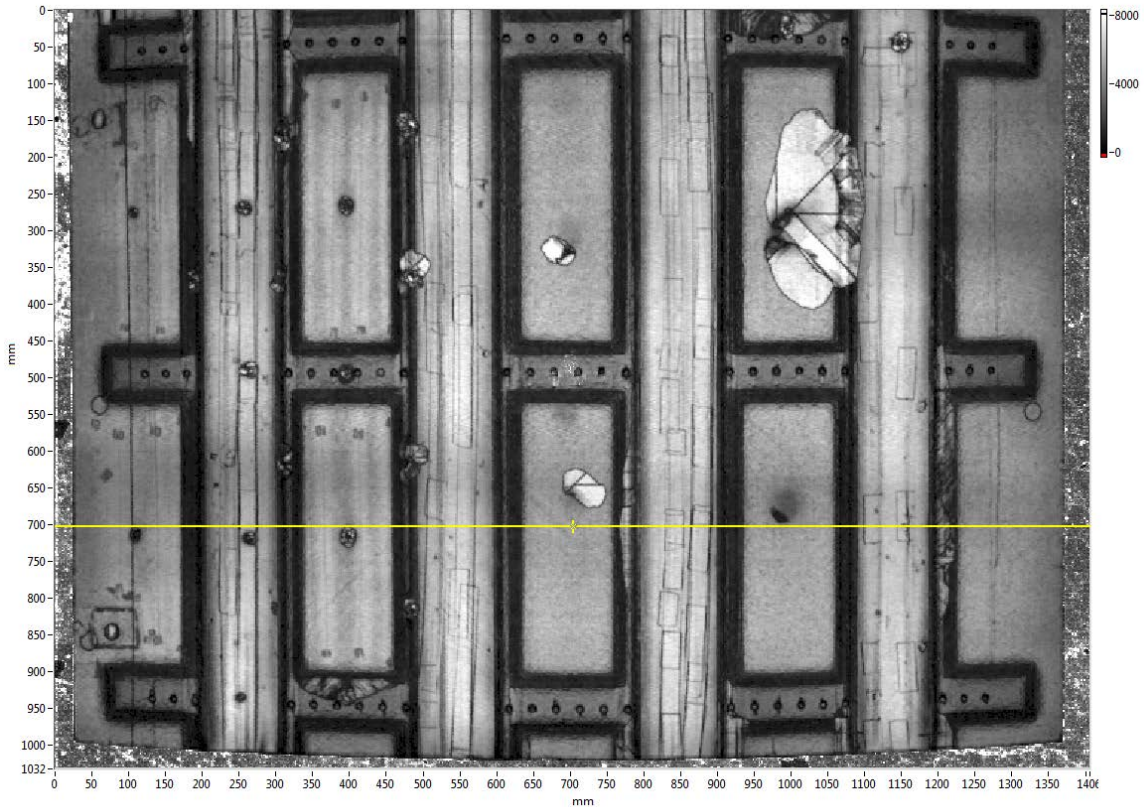
Figure 94. Amplitude C-scan result for laser UT inspection of full-scale fuselage panel

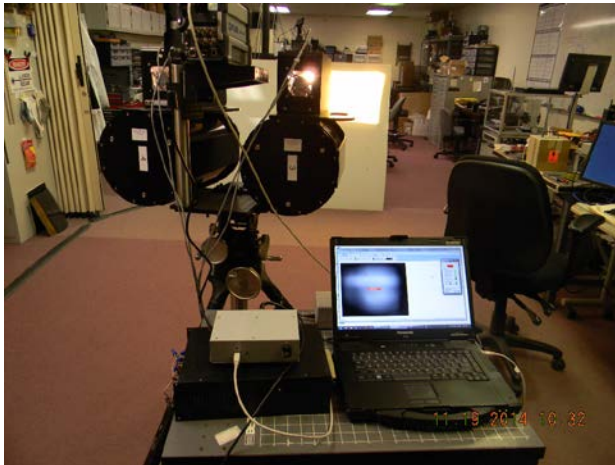
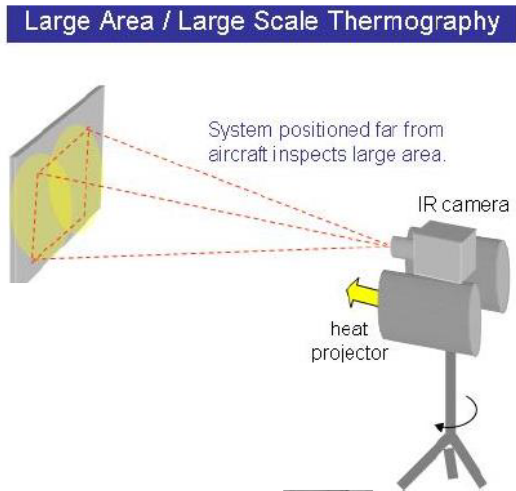
Figure 96. The projection thermography system being used to inspect panel A

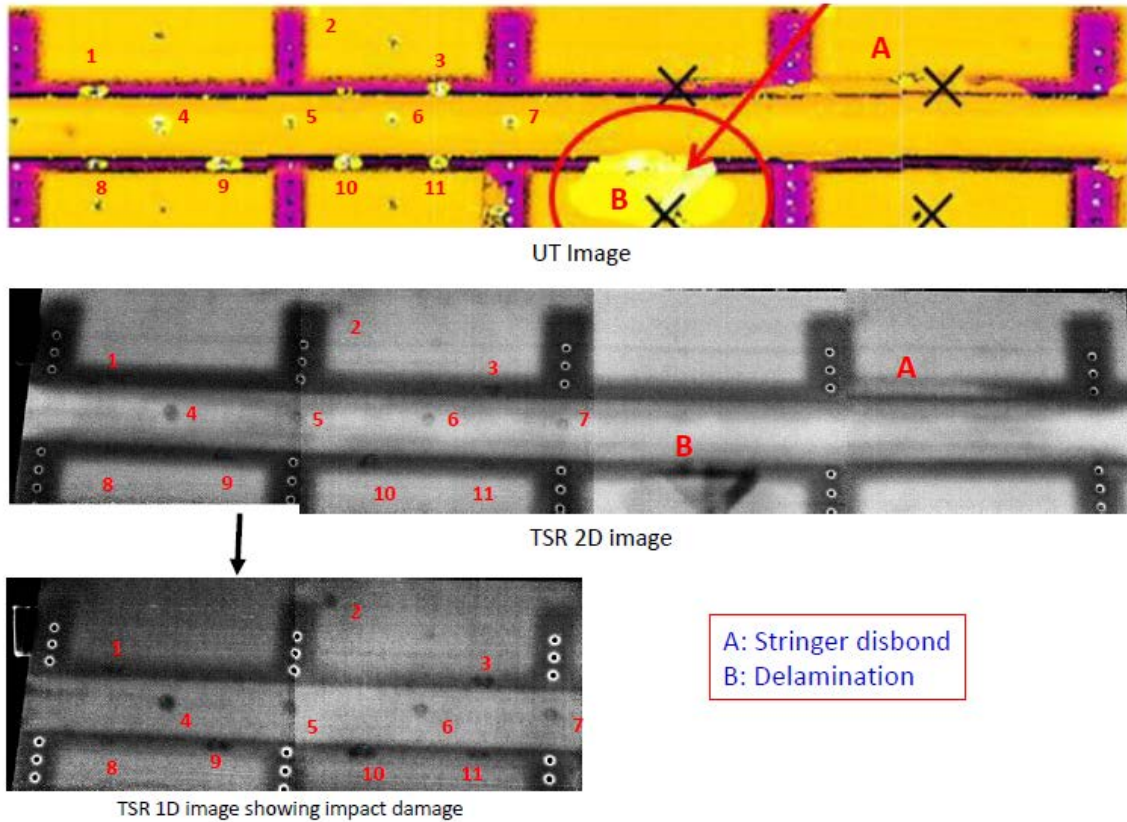
Figure 97. Projection thermography inspection results on panel A

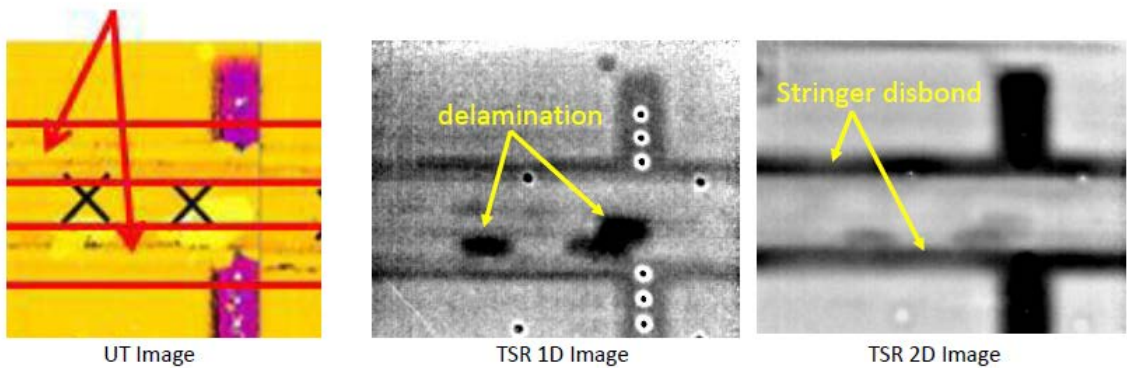
Figure 98. 1st and 2nd derivative thermal signal reconstruction images of delamination and stringer disbanding

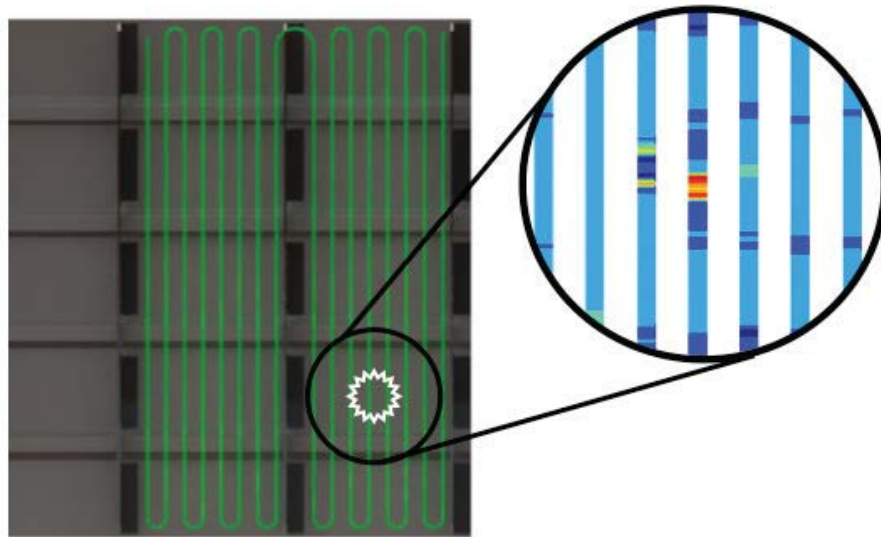
Figure 100. Strain map of first impact damage performed on panel A; only results obtained from embedded FO

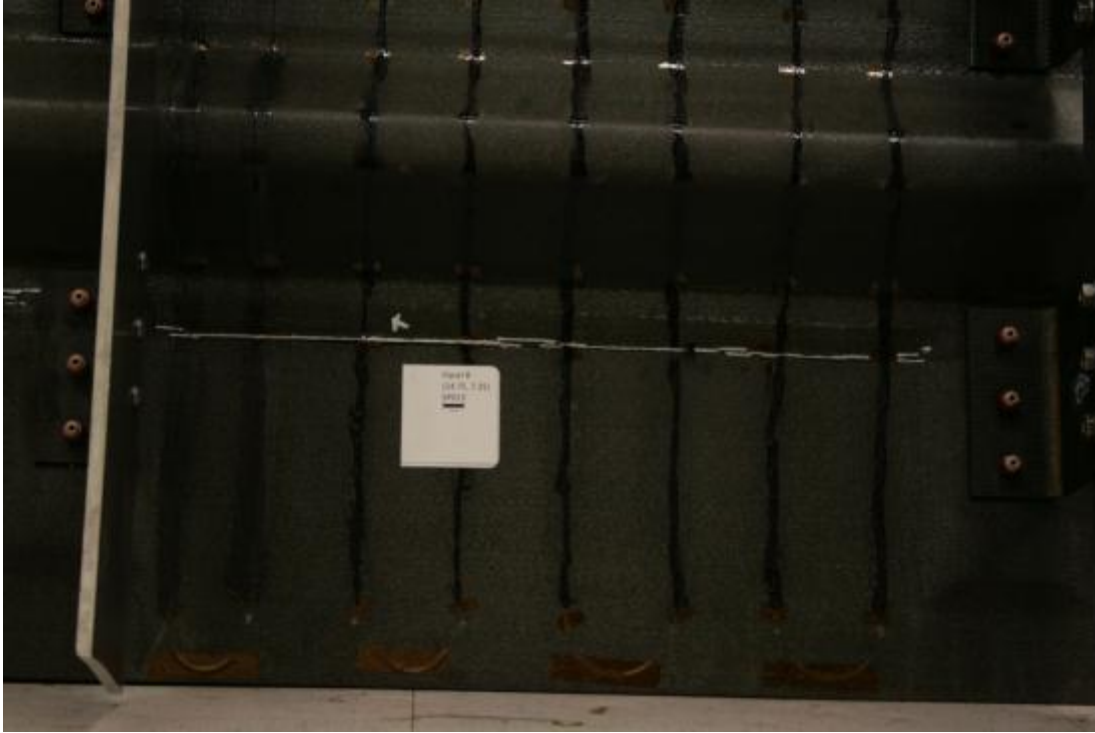
Figure 101. Broken FO due to stringer flange delamination

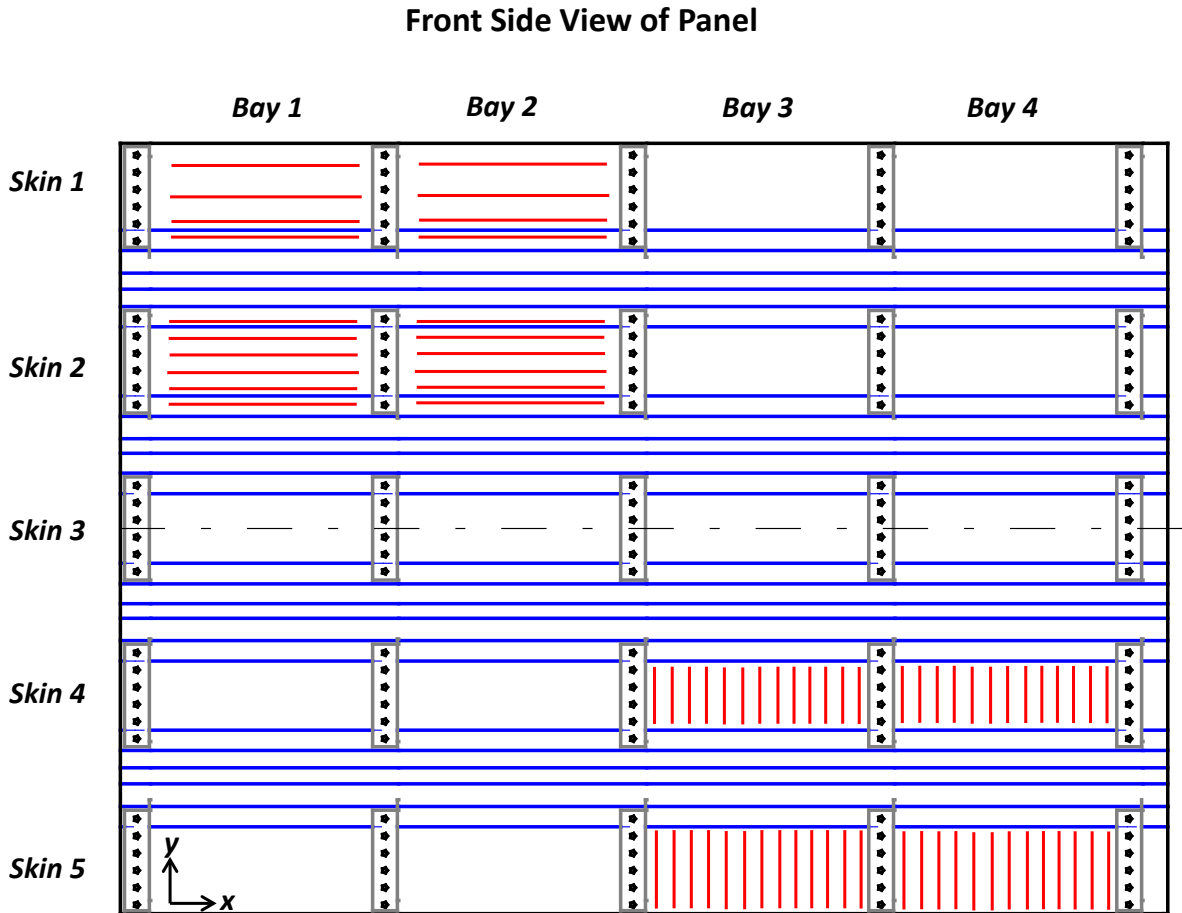
Figure 102. Bonded FO layouts used during 2" diameter, spherical tip impacts

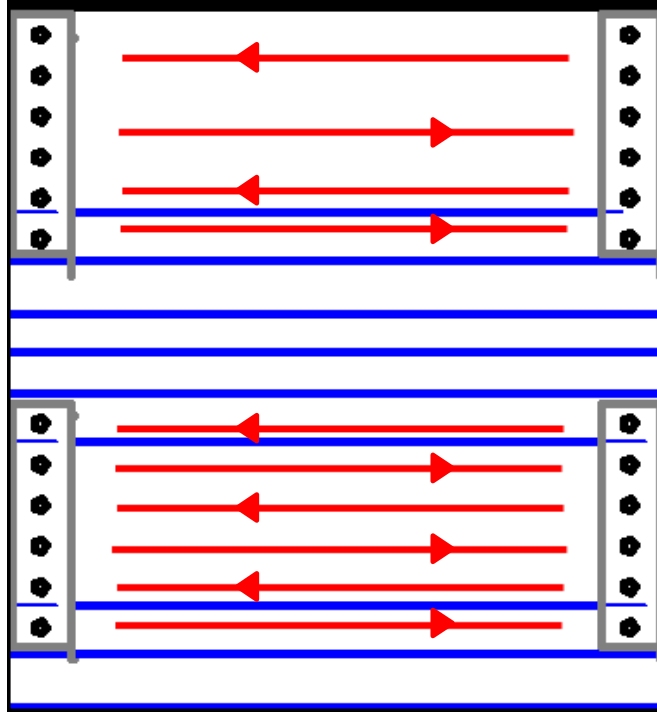
Figure 104. Linear strain position used for data plotting

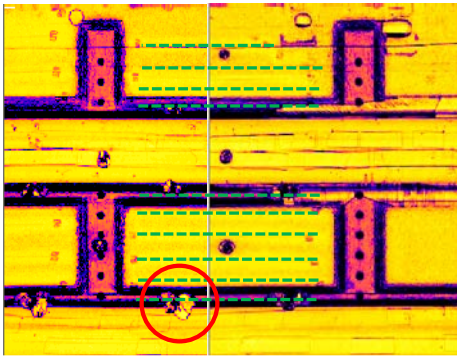
Center of Stringer Flange
Impact Energy: 90 Ft lbs
Damage Area: 3.46 in²
Type of Damage: Interply delamination
Strain Indication: Yes, clear detectable strain indication

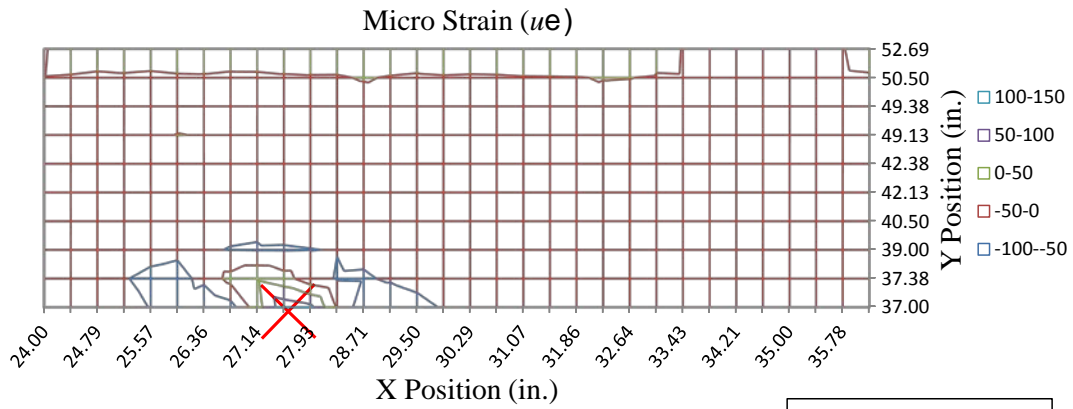
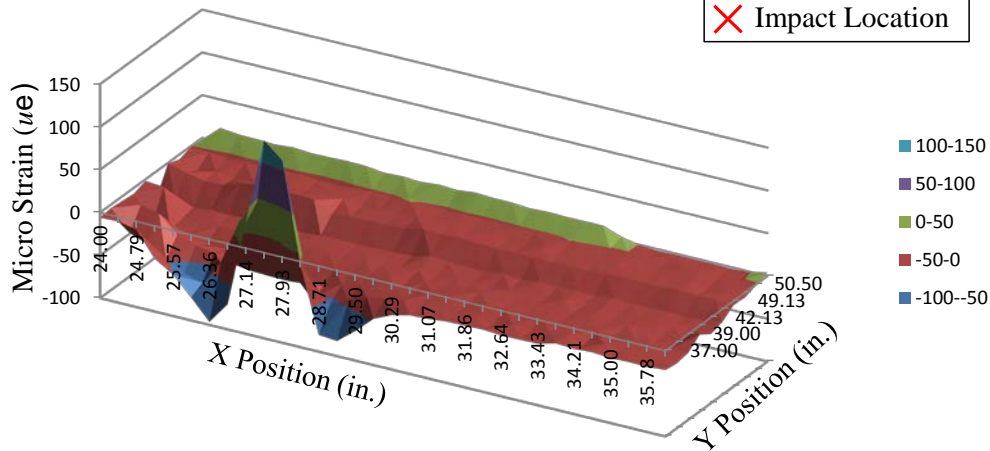
Figure 105. Example FO strain map of stringer flange impact

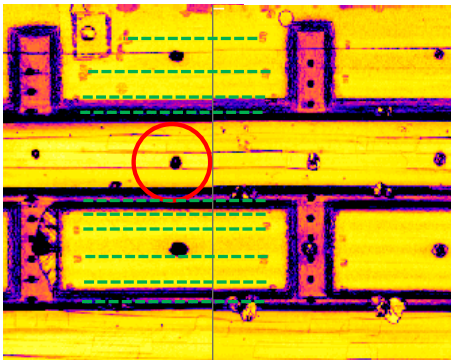
Mid-Stringer Between Flanges
Impact Energy: 45 Ft lbs
Damage Area: 0.47 in²
Type of Damage: Near surface fiber crushing
Strain Indication: No, possible temperature shift or change in panel loading

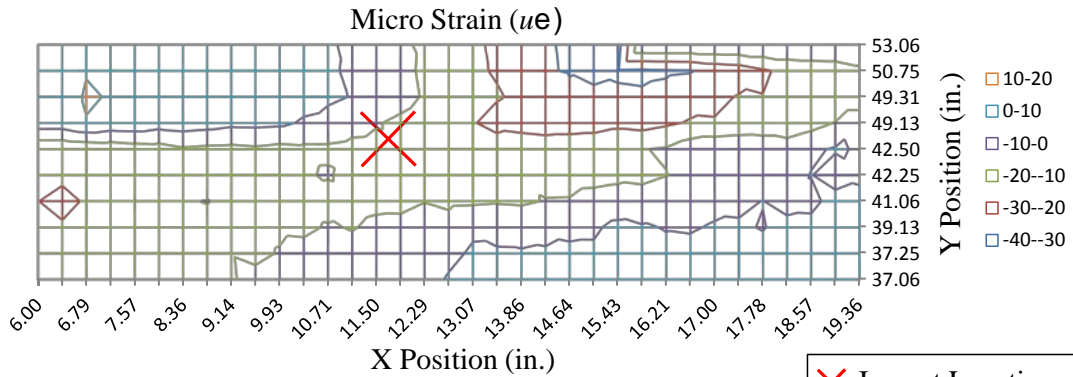
Ultrasonic Amplitude Scan

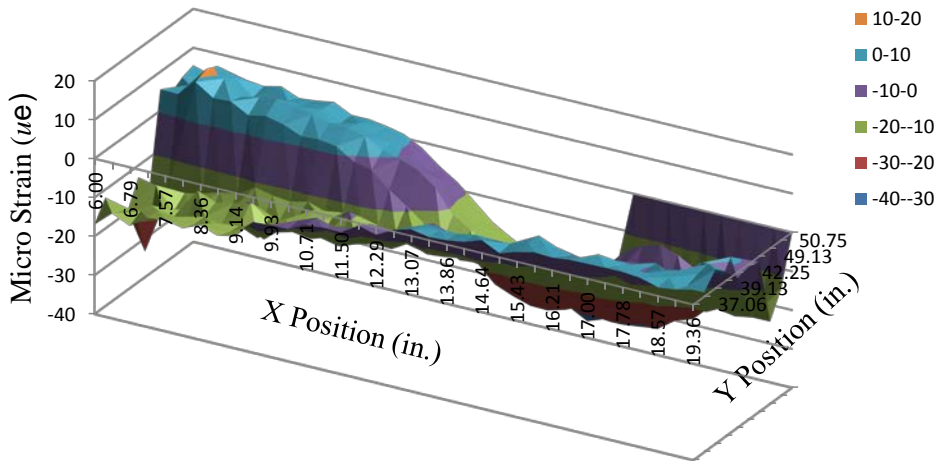
Figure 106. Impact at mid-stringer between flanges that was not detectable with the FO

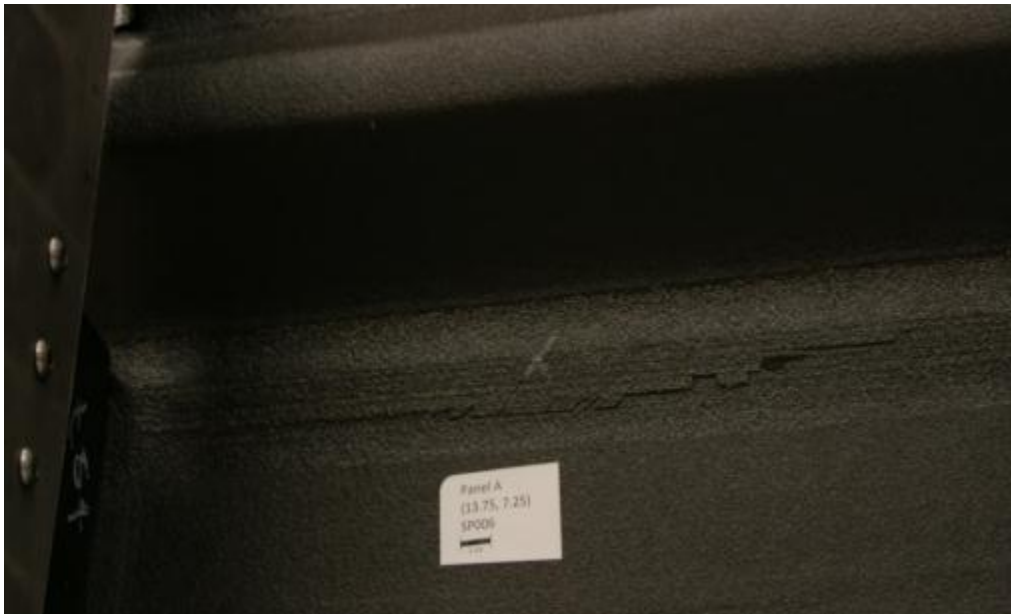
Figure 107. Stringer flange delamination detectable from backside of panel A

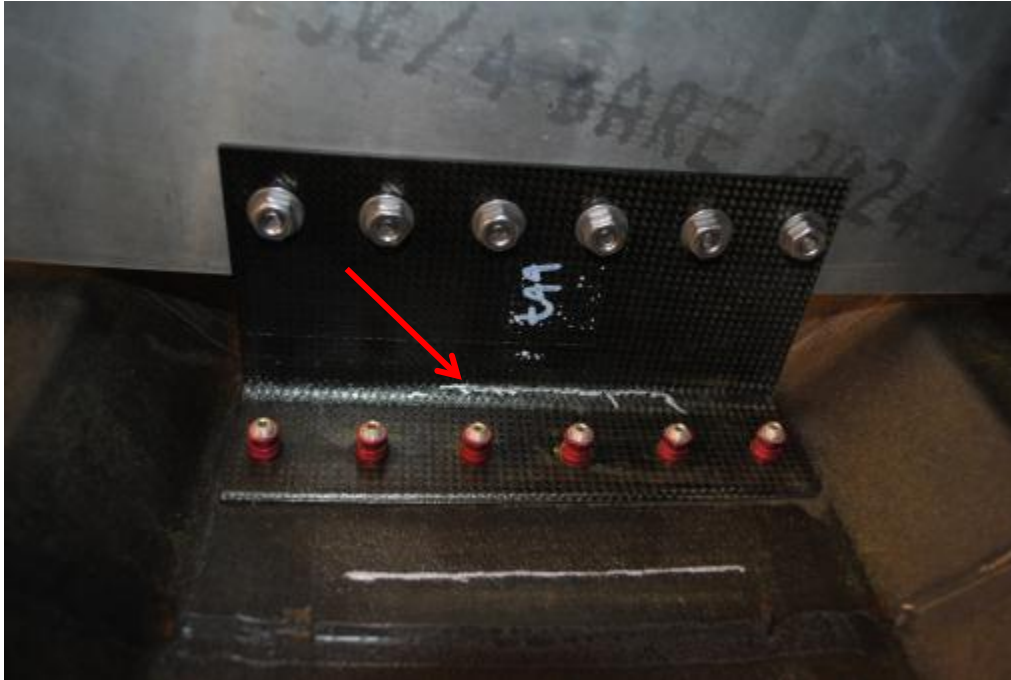
Figure 108. Crack on shear tie bend radius not detectable using NDI from front side of panel

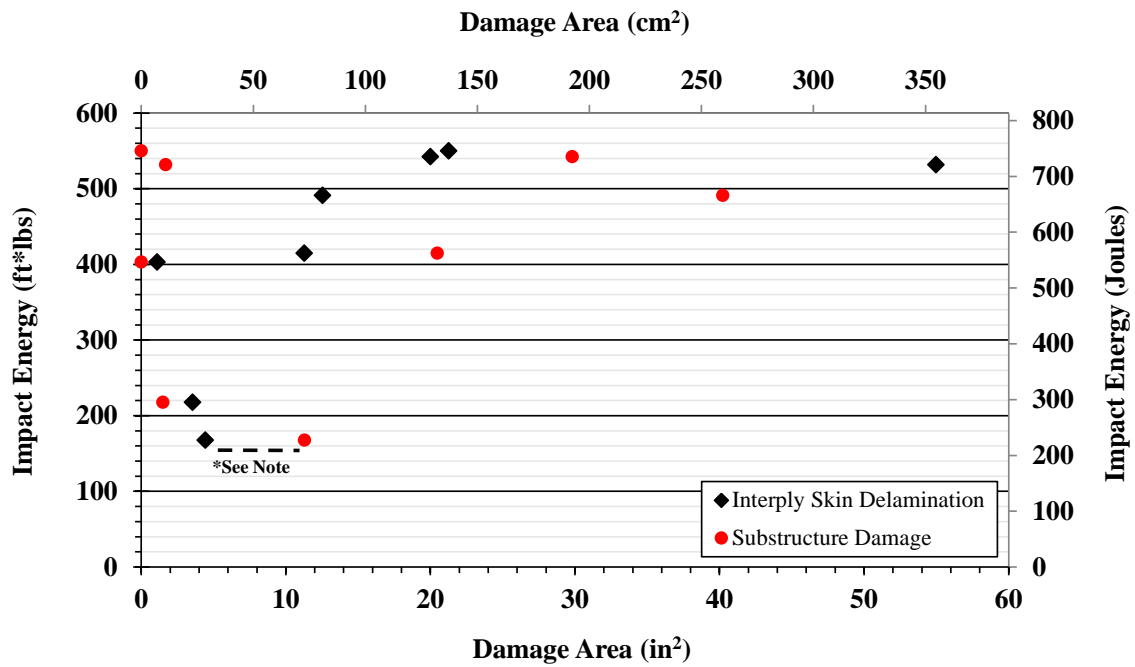
*Interply delamination and substructure damage on same horizontal line were produced by the same impact

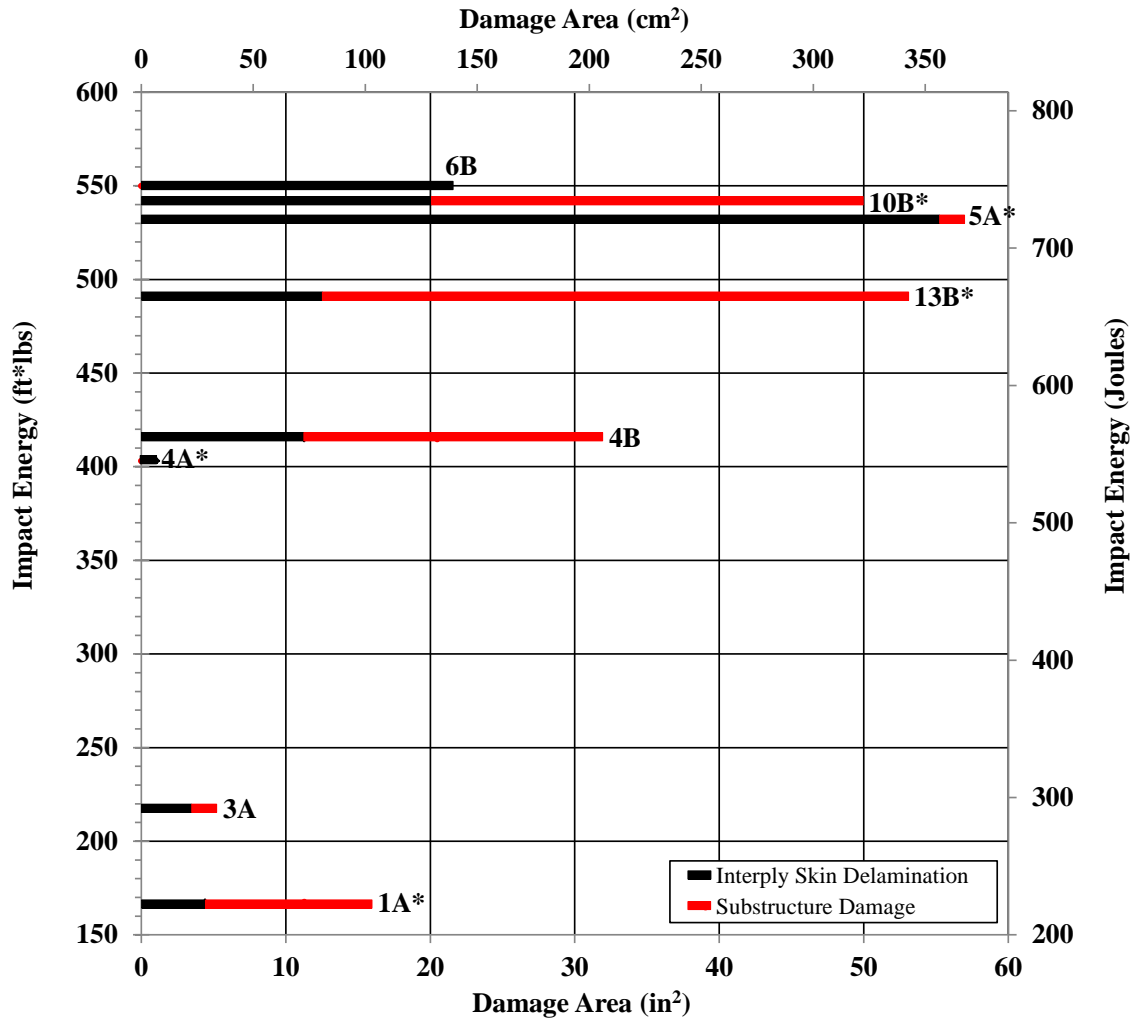
* Impacted multiple times to achieve intended level of damage

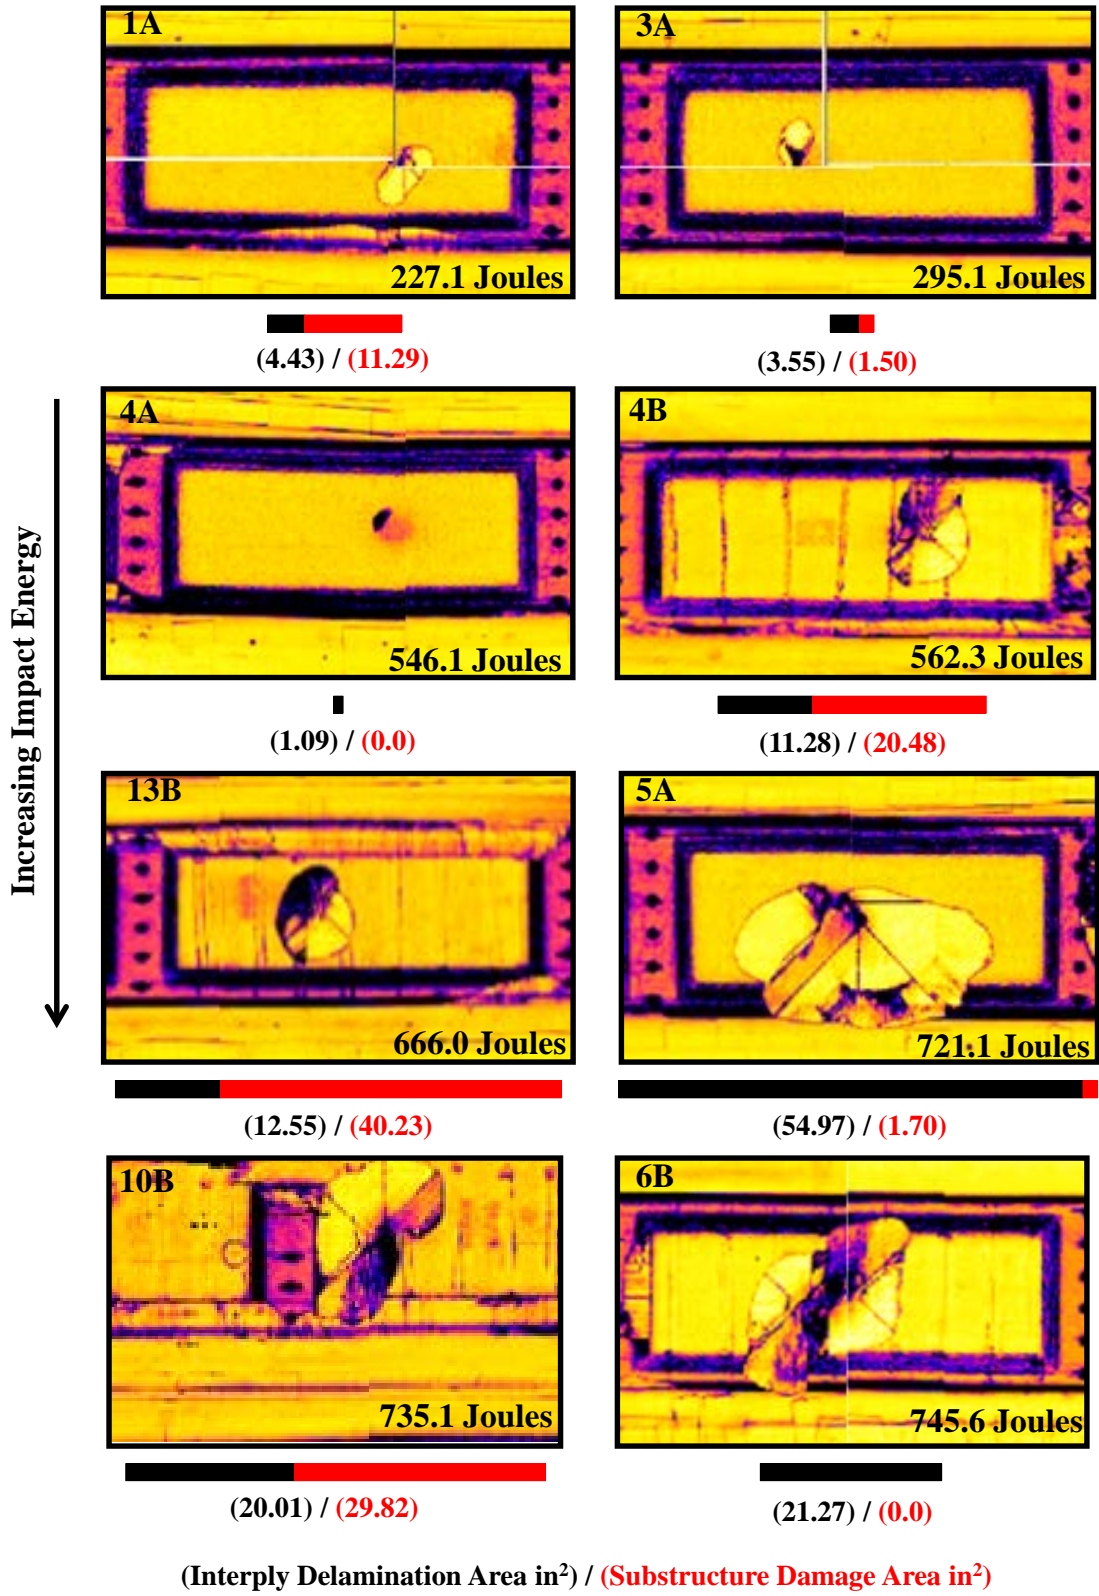
Figure 111. Amplitude C-scan results for simulated hail mid-bay impacts (type I1)

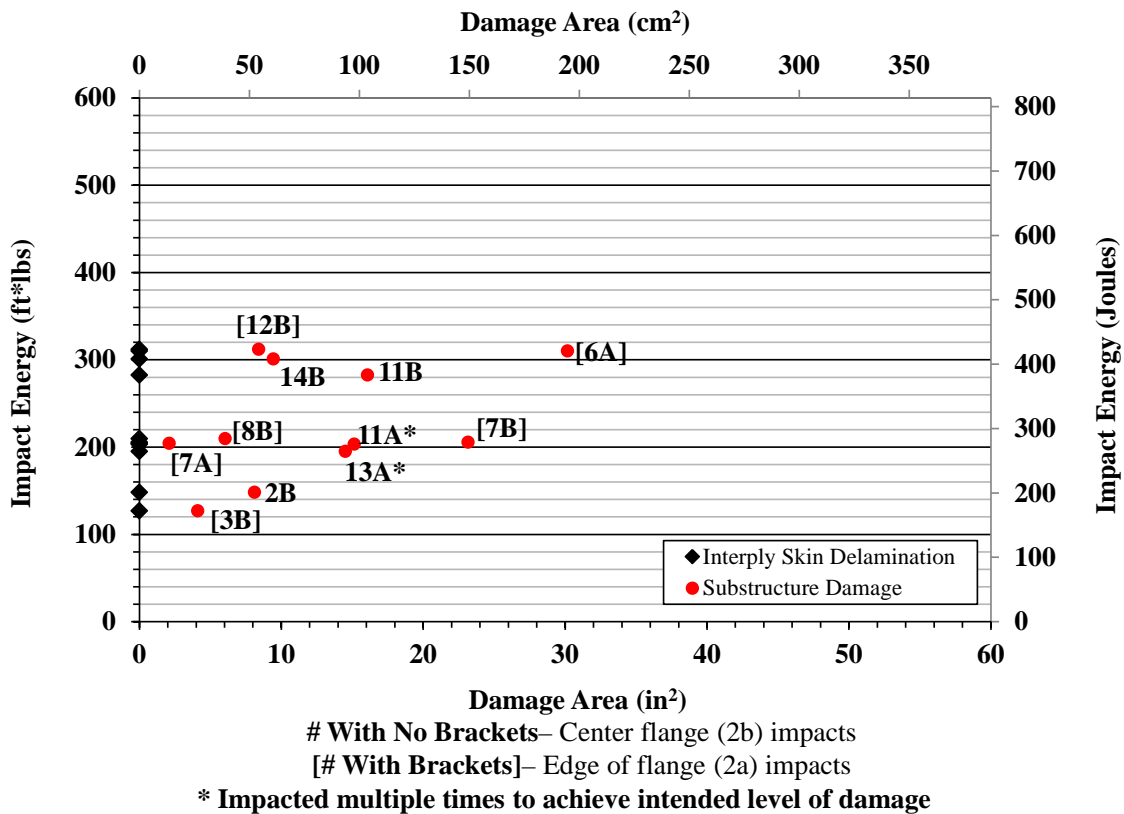
Figure 112. Substructure and skin delamination damage area created by simulated hail, stringer flange impacts

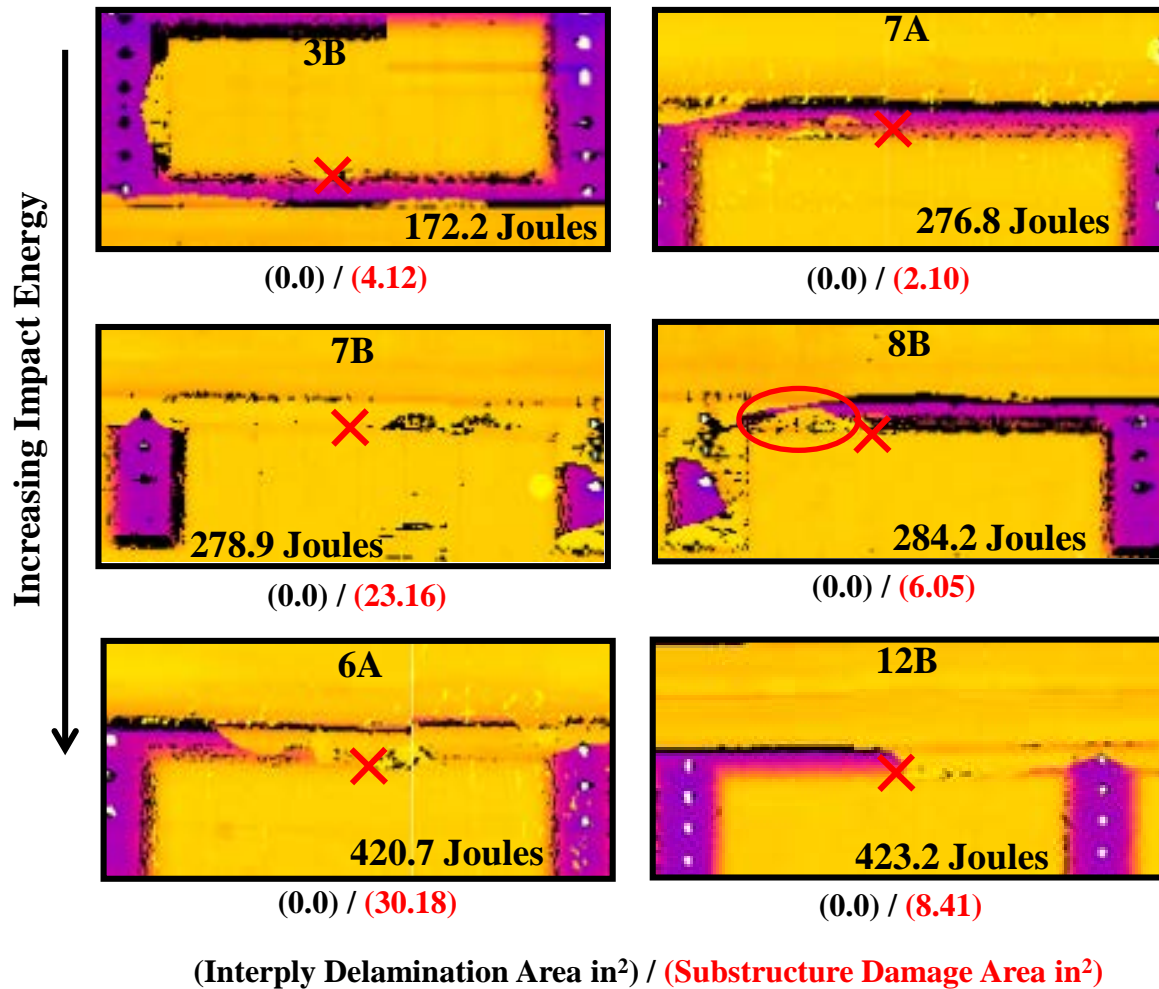
Figure 113. UT TOF C-scans of stringer flange edge impact damage produced by impact at X (type I2a)

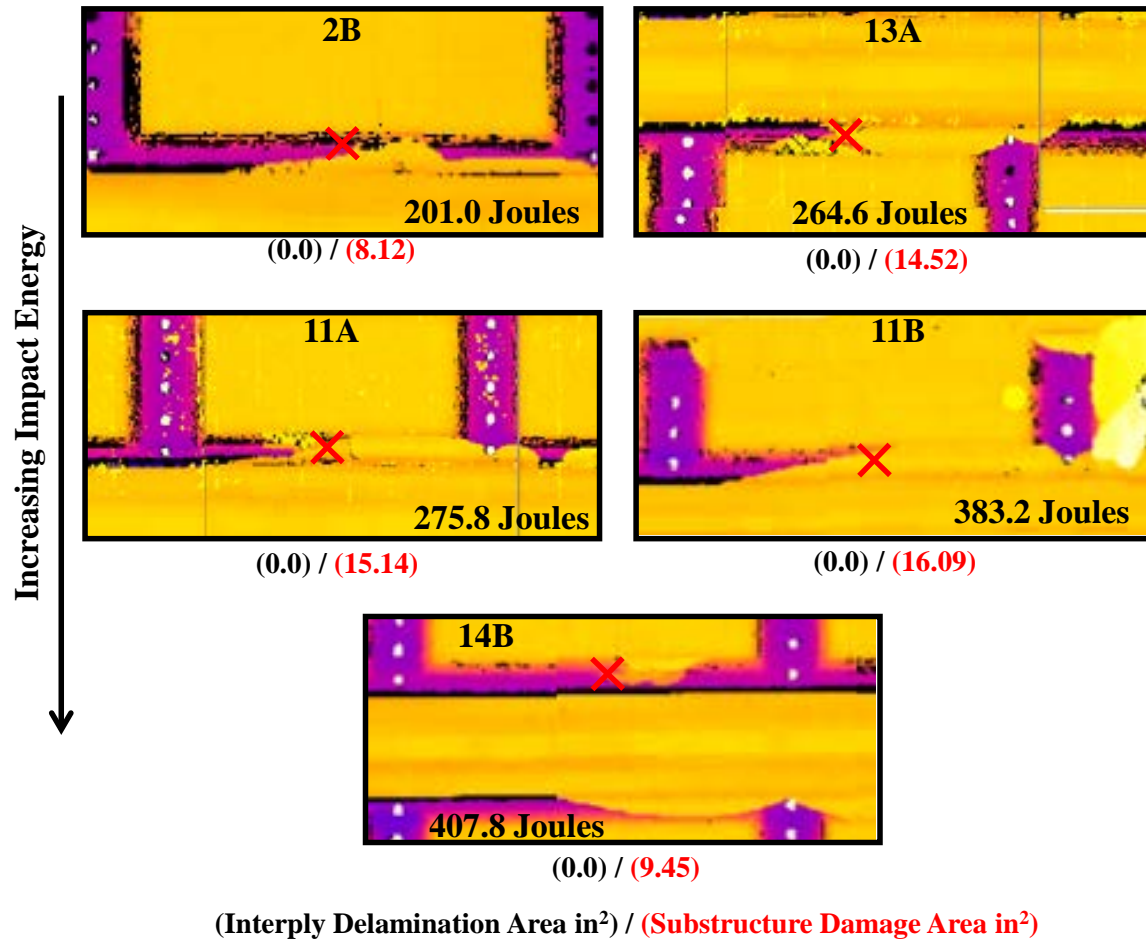
Figure 114. UT TOF C-scans of center stringer flange impact damage produced by impact at X (type I2b)

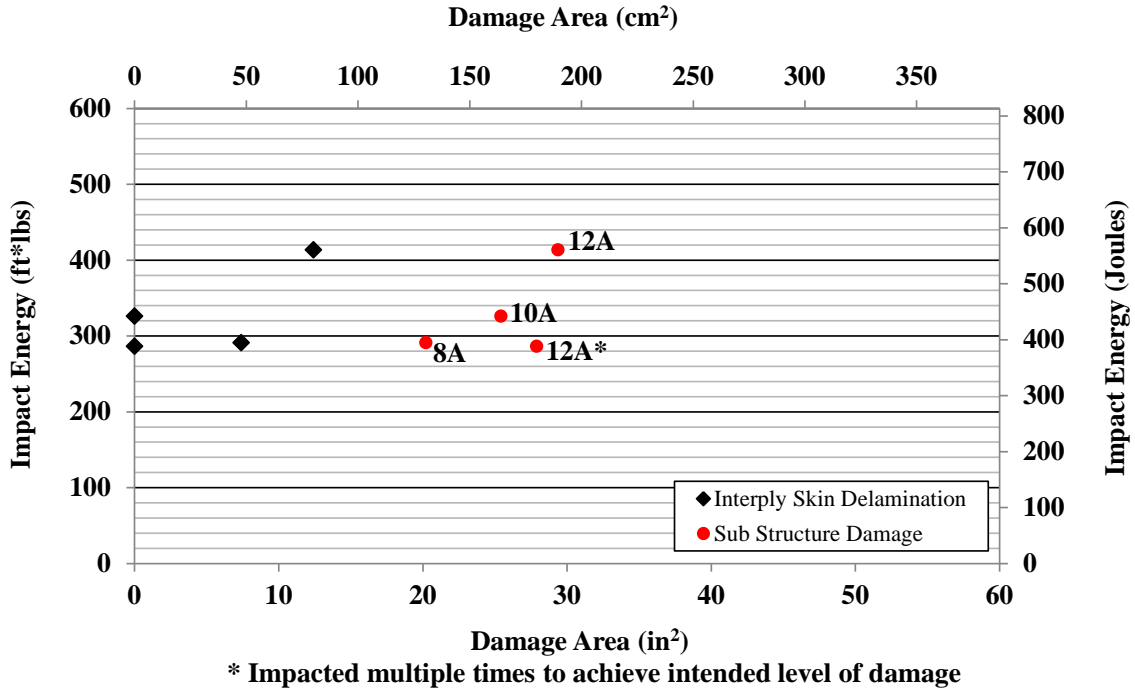
Figure 115. Substructure and skin delamination damage area created by simulated hail, mid-stringer impacts (type I3)

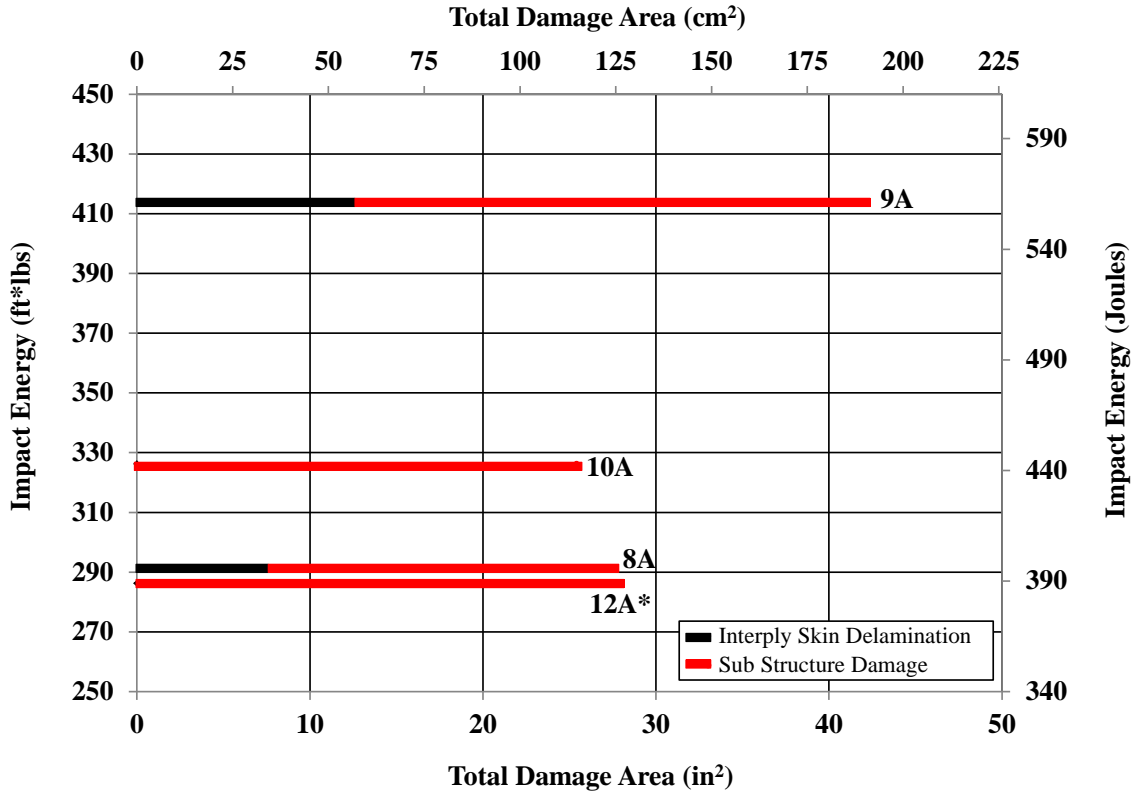
* Impacted multiple times to achieve intended level of damage

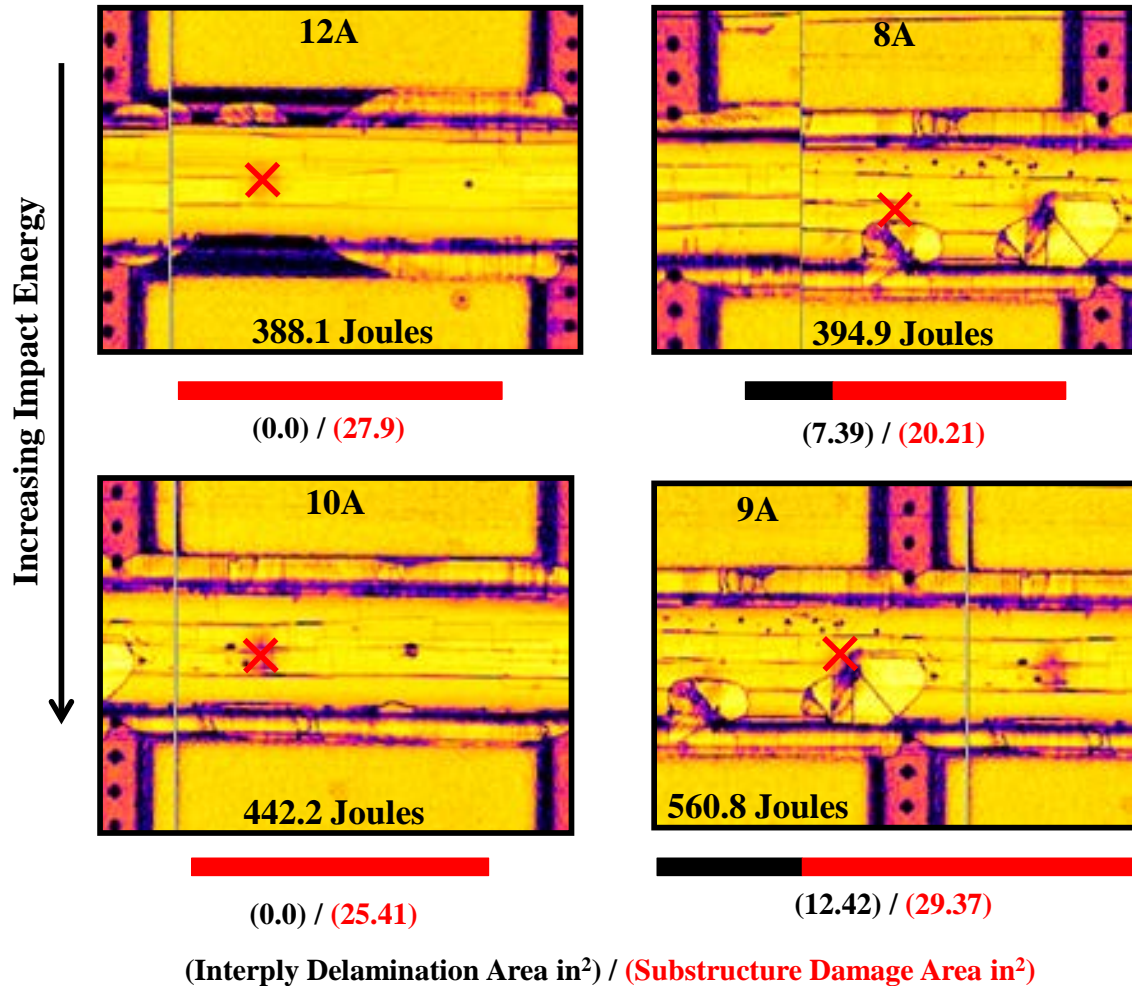
Figure 117. UT amplitude C-scans of mid-stringer impact damage (type I3)

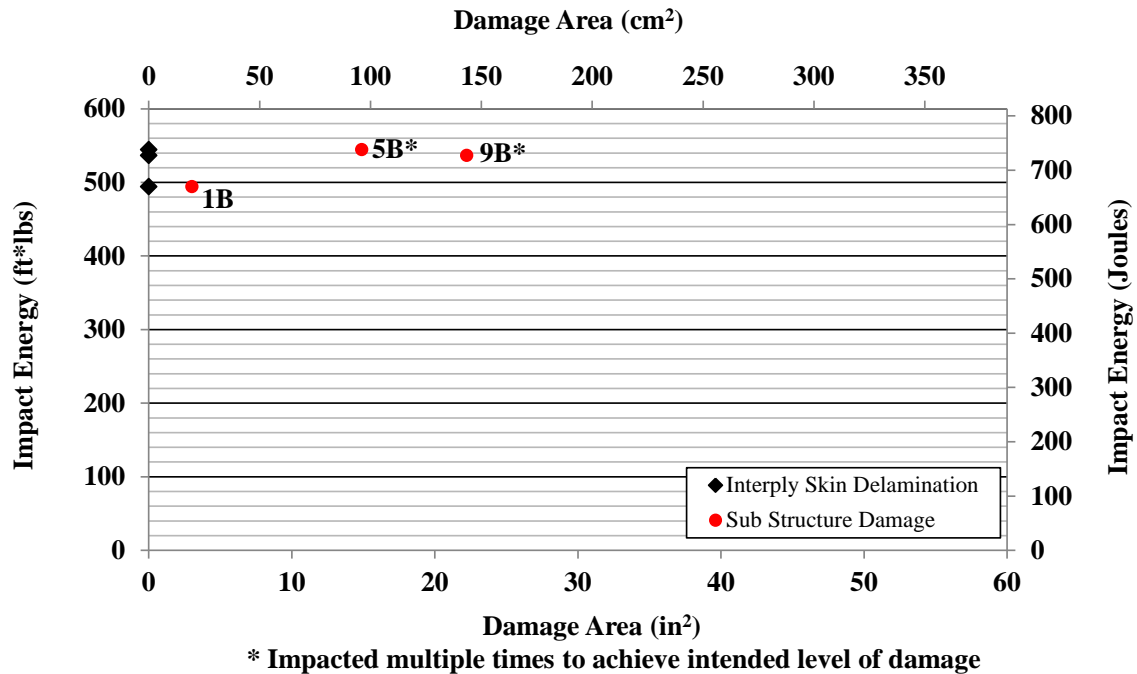
Figure 118. Substructure and skin delamination damage area created by simulated hail, shear tie impacts (type I4)

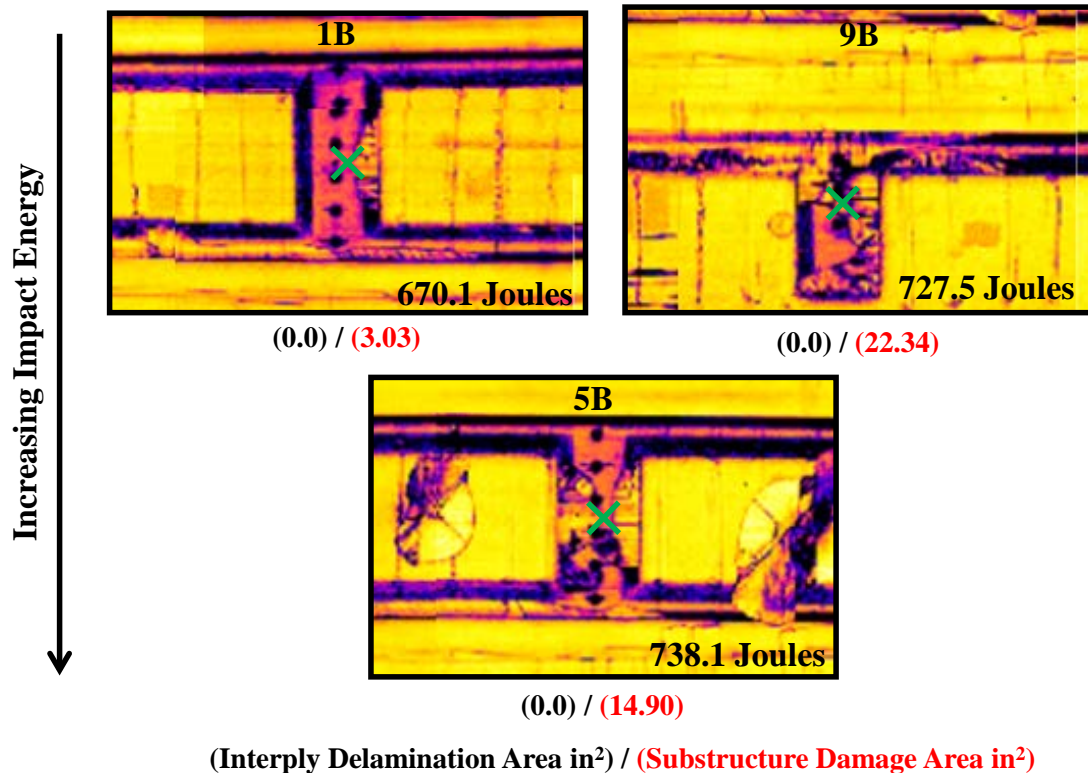
Figure 119. UT amplitude C-scans of shear tie impact damage (type I4)

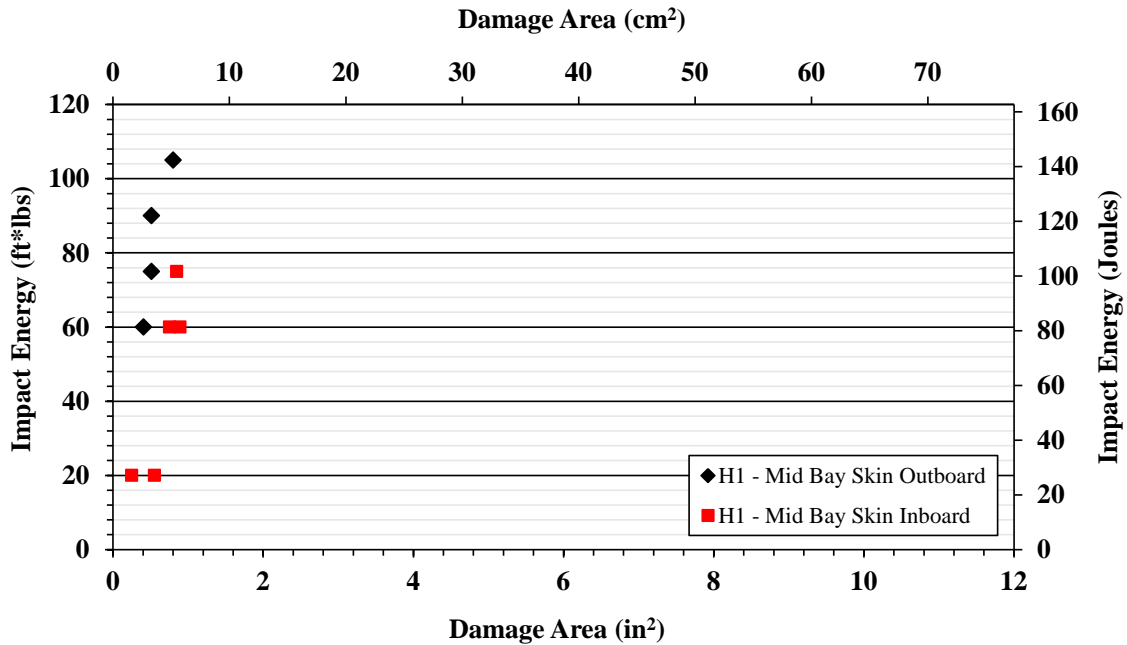
Figure 120. Damage area created by 2" diameter spherical tip mid-bay skin impacts (type H1)

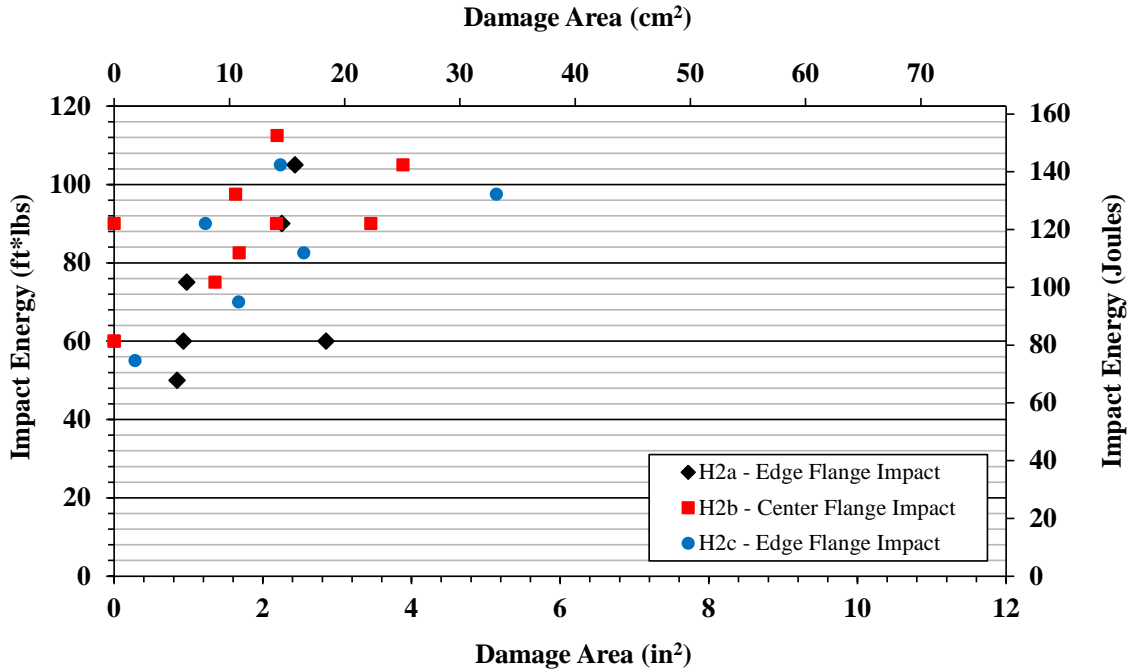
Figure 121. Damage area created by 2" diameter spherical tip stringer flange impacts (type H2)

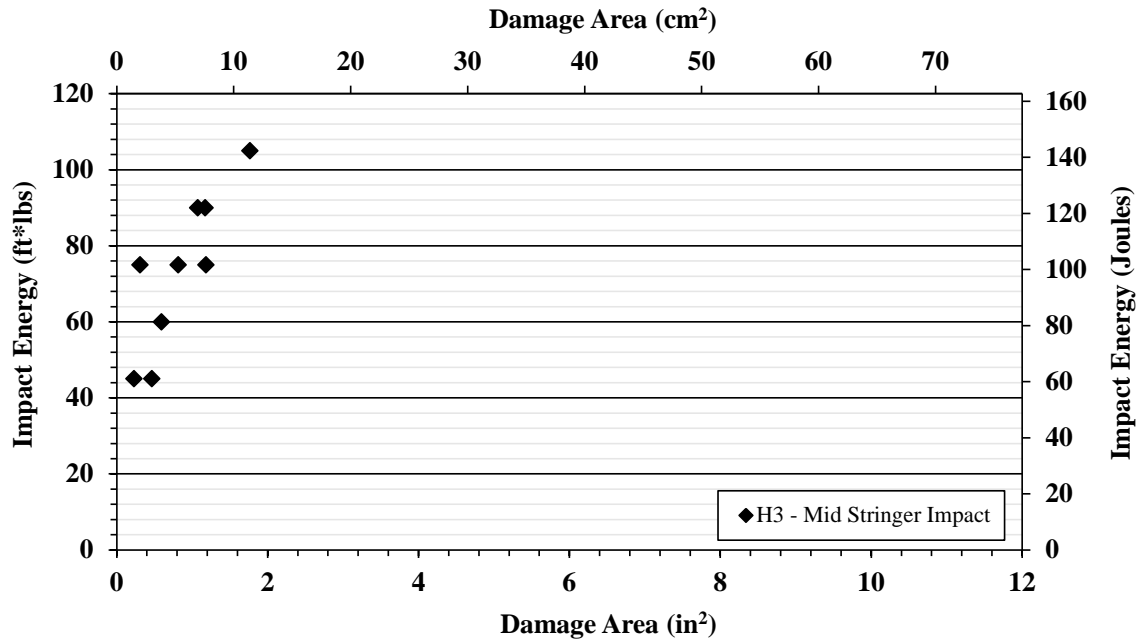
Figure 122. Damage area created by 2" diameter spherical tip mid-stringer impacts (type H3)
