DOT/FAA/TC-16/8

Federal Aviation Administration
William J. Hughes Technical Center
Aviation Research Division
Atlantic City International Airport
New Jersey 08405

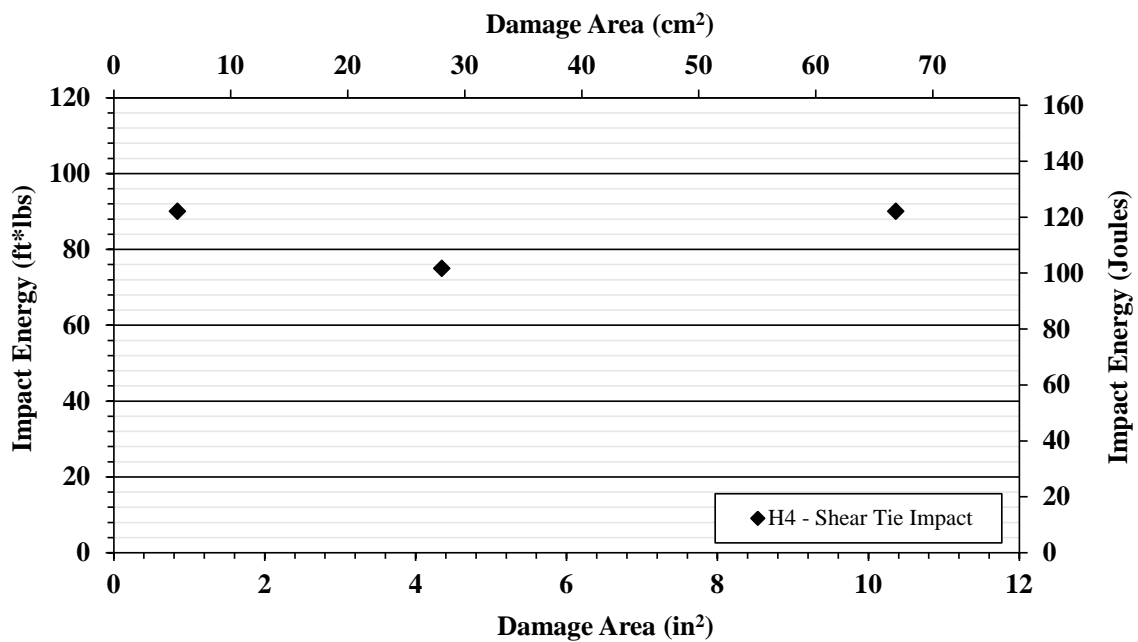
Figure 123. Damage area created by 2" diameter spherical tip shear tie impacts (type H4)

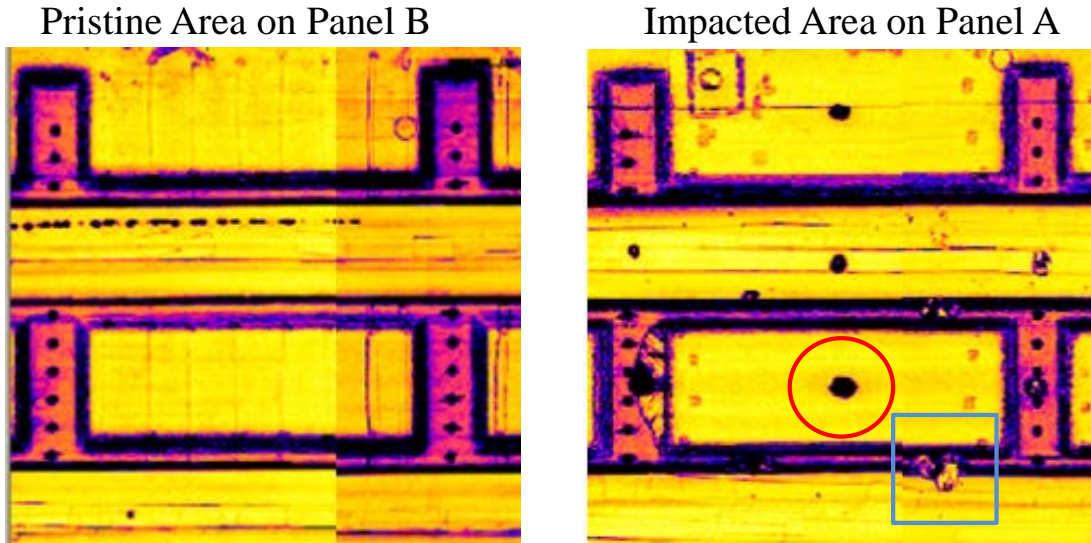
Figure 124. Example of spherical tip impact damage on panel A
