DOT/FAA/TC-18/31

High-Energy Wide-Area Blunt Impact Damage Formation to Stiffened-Skin Composite Structure

February 2019

Final Report

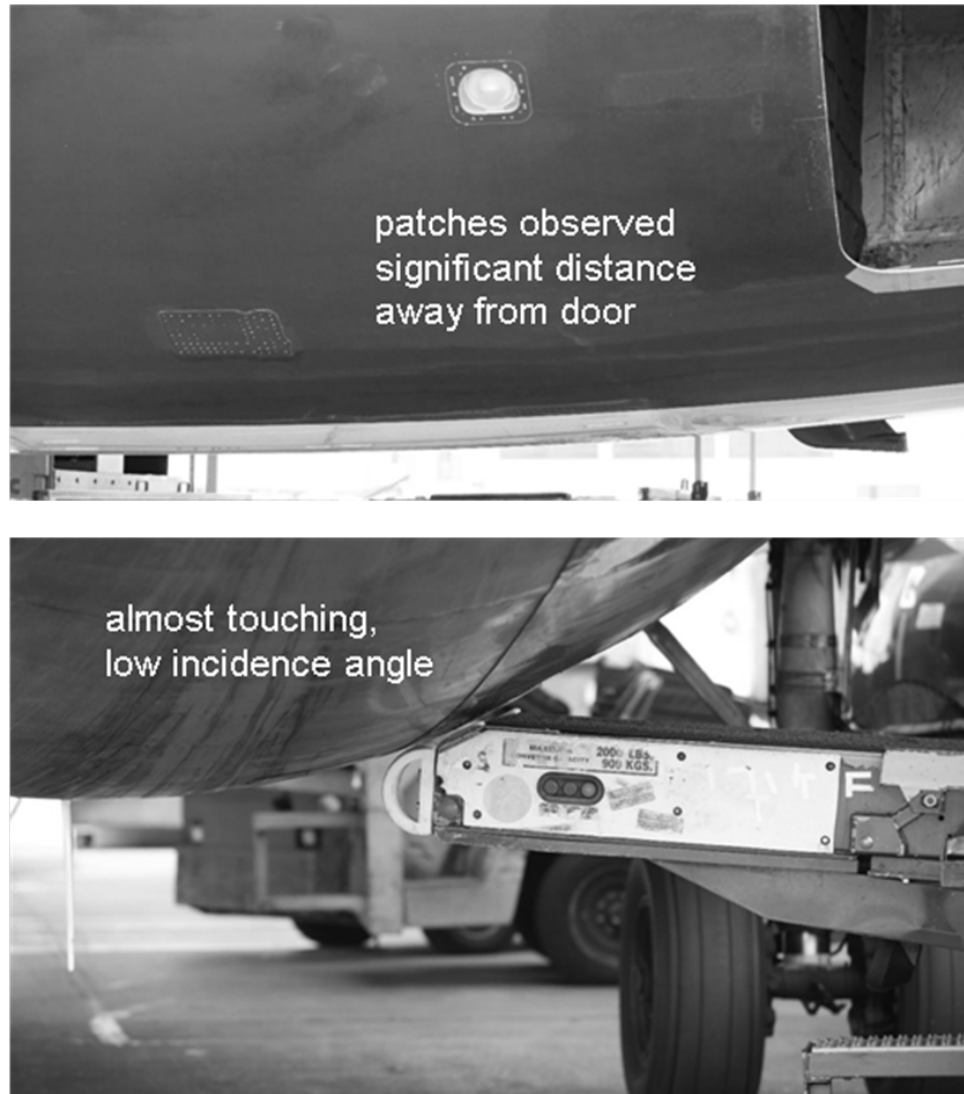
Figure 2. Examples of damage occurring in acreage of aircraft (i.e., away from doors) and interaction between belt-loader and fuselage of Boeing 737.

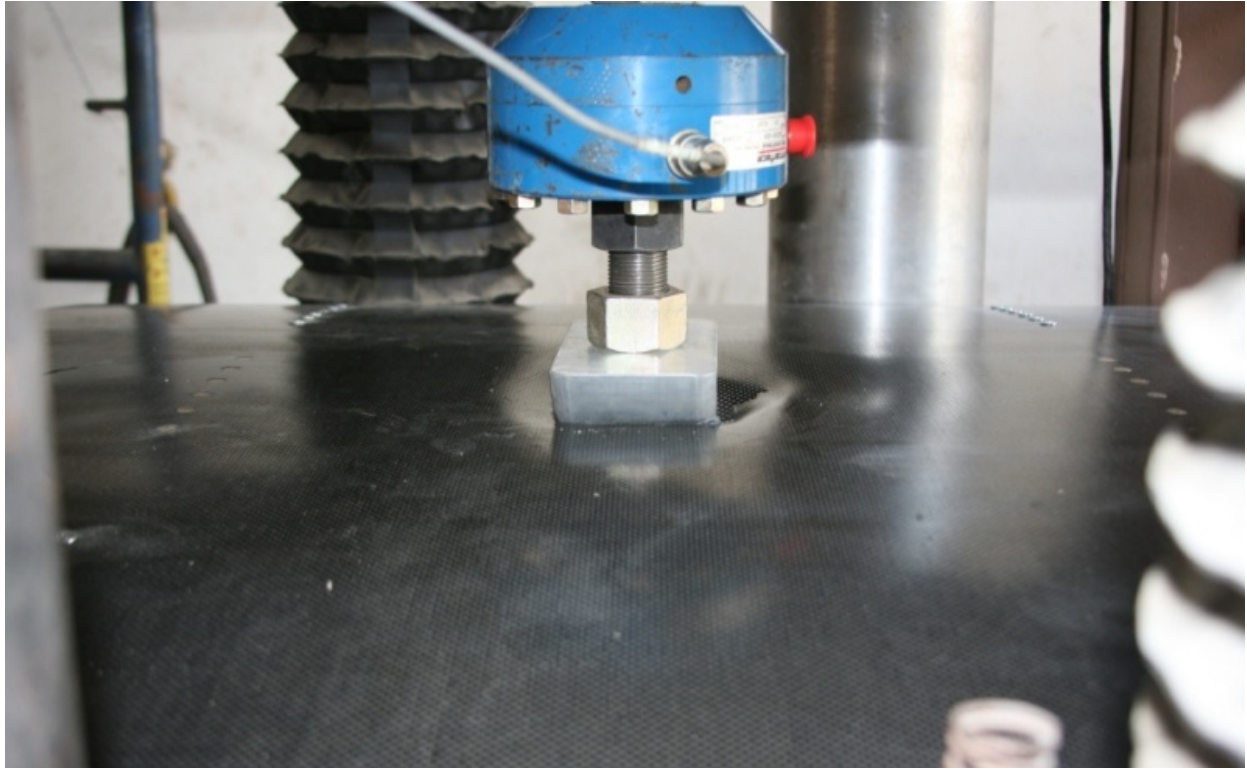
Figure 22. Stringer01 local skin penetration

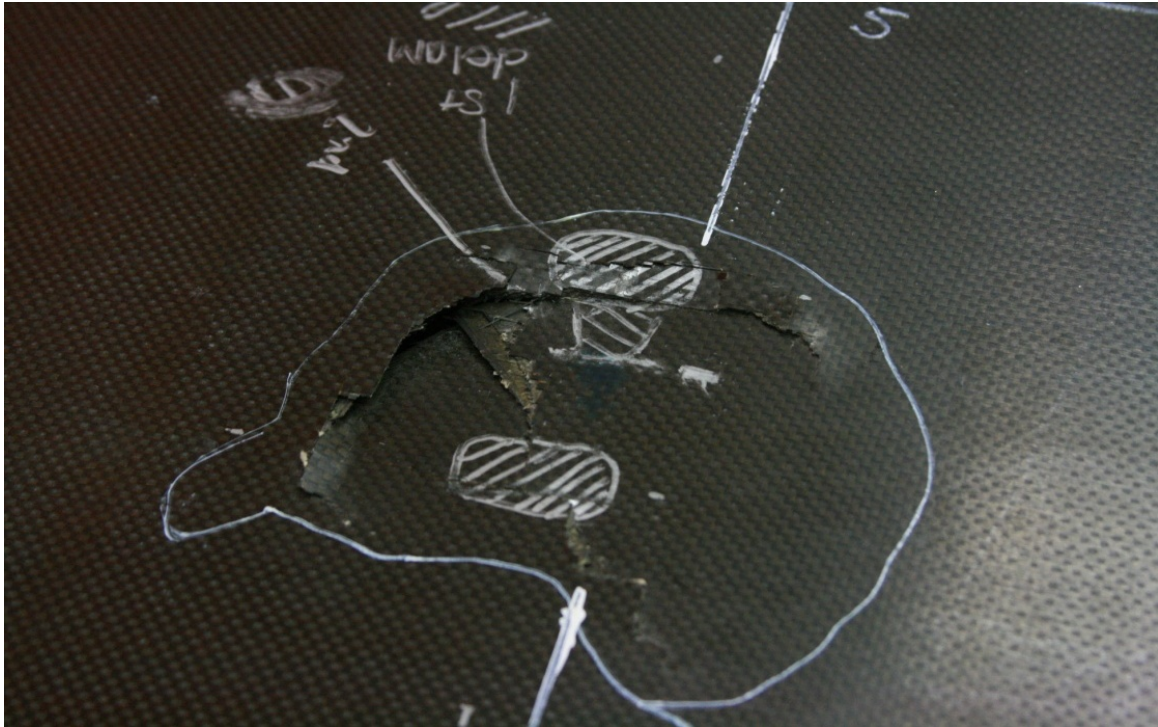
Figure 23. Stringer01 skin penetration and delamination damage

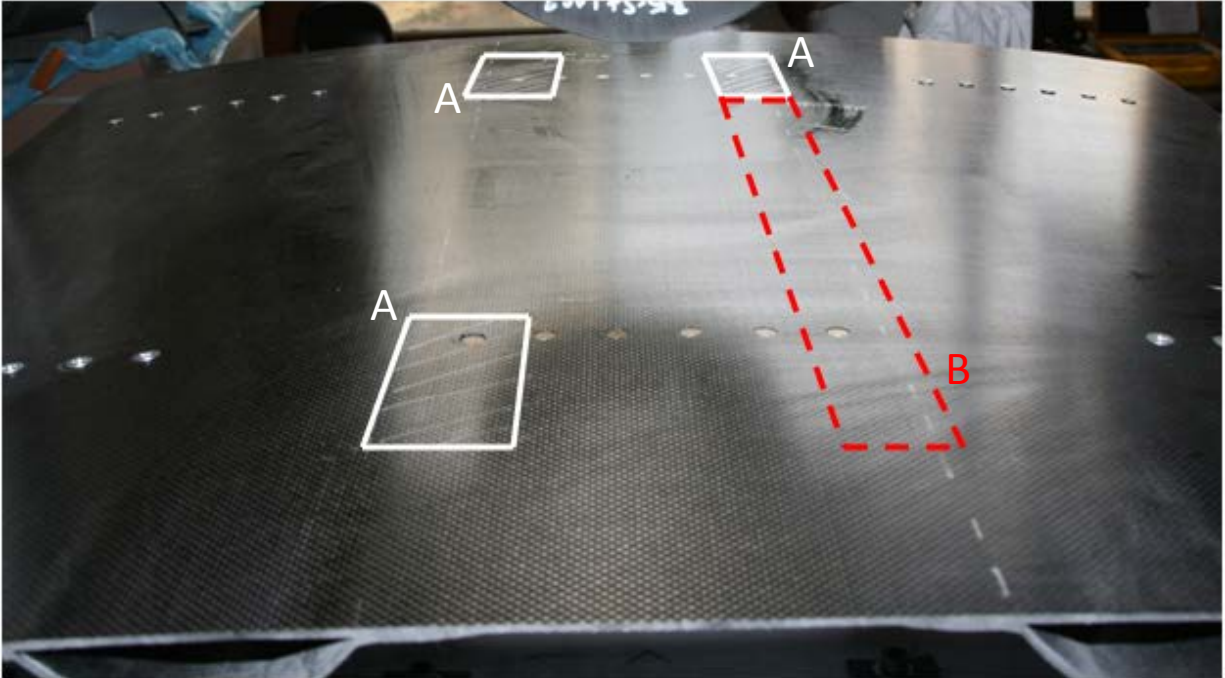
Major failures occurred from the third load cycle onwards in the form of stringer-to-skin delamination. In addition, continued shear-tie delamination and crushing damage also occurred throughout these load cycles. During the third loading, a load drop occurred at 57.96 kN and an indentation of 32.3 mm. The load drop coincided with the two stringers delaminating from the skin, initiating at the shear-tie support locations away from the loaded area. Figure 26 shows the area of stringer-to-skin delamination damage accumulation through the fourth loading. The initial delamination locations, detected after the third load, were at the shear-tie support locations (see figure 26). During the fourth loading, a major load drop occurred at 61.33 kN contact force and 34.5 mm indentation because of the large-sized delamination growth. An interior view of the panel with the stringer-to-skin delamination is shown in figure 27. However, no visible damage was found on the skin's external surface after the panel was unloaded, despite the significant stringer-skin delamination damage and the additional fiber-crushing damage occurring in the shear ties (see figure 28). Crushing damage occurred at the edge of the shear tie contacting the stringer flange, which was in the primary load path. At the end of the fourth load cycle, the panel could still sustain a load of 47.06 kN.

Figure 26. Stringer02 after fourth loading. The “A” boxes indicate area of delamination damage incurred during 3rd loading; the dashed “B” box indicates area of delamination incurred during 4th loading

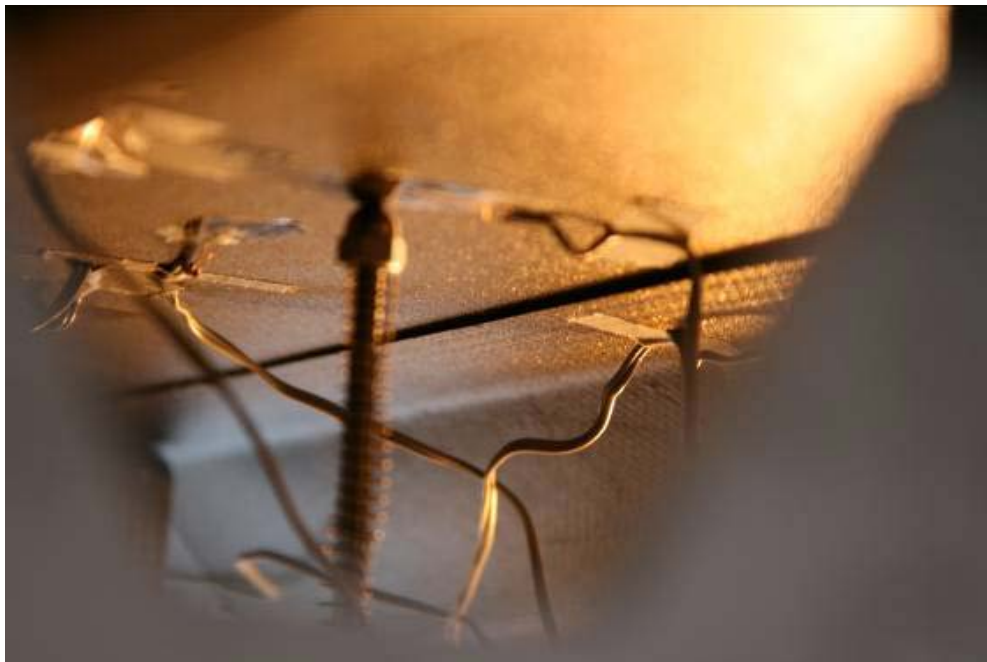
Figure 27. Interior view of the Stringer02 stringer-to-skin delamination following 4th loading

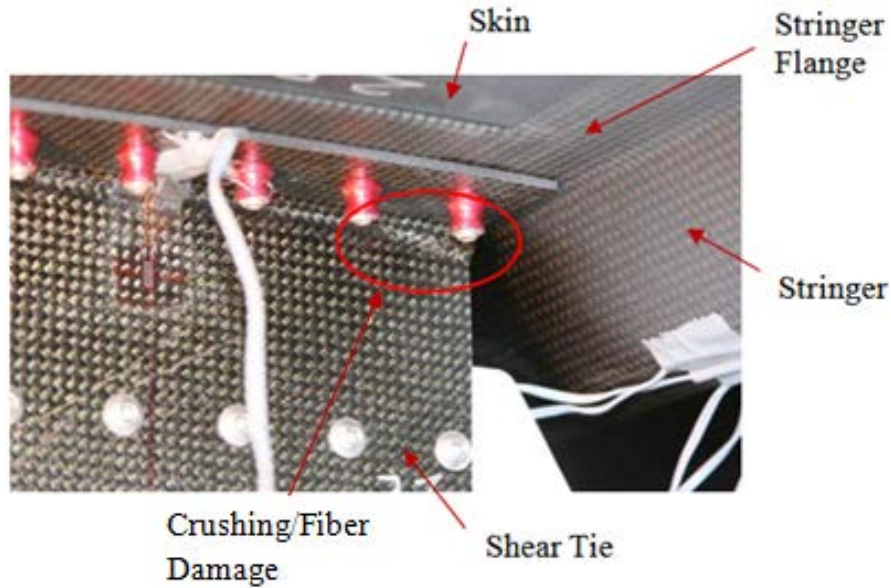
The first two loading cycles produced only shear-tie radius delamination failures due to shear-tie opening deformation, and some localized crushing/fiber failure at the shear-tie corners. During the first loading, clicking noises were heard at approximately 35 kN, signaling potential delamination failures in the shear ties. A loud cracking noise was heard when the panel held a load of 44.84 kN at an indentation level of 27.7 mm. When the panel was unloaded, the shear ties showed residual bending strains and visible crushing damage at the curved corners. During the second loading, active clicking sounds were again observed past 44.48 kN. Large panel deformation led to further opening of the shear ties and caused radius delamination at these locations. These shear-tie failure modes did not cause load distinct drops, but they contributed to stiffness losses.

Figure 28. Stringer02 cumulative crushing damage on one of the shear ties after the fourth loading; the damage is circled in red

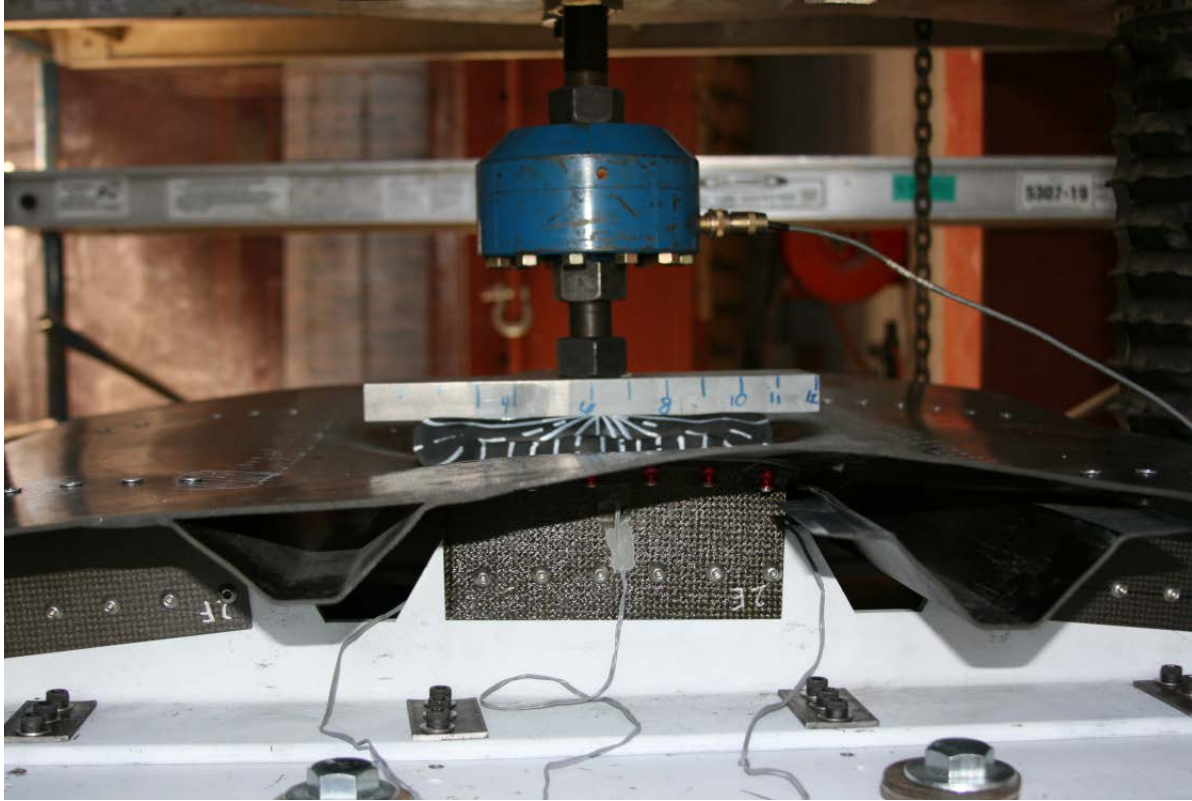
During the fifth load cycle, large asymmetrical panel deformation was observed because the delaminated stringer softened one side of the panel (see figure 29), and the load path was redirected toward the stringer that remained intact. The panel held a load of 55.34 kN before extensive skin-stringer delamination occurred on the second stringer as well. The delamination of the second stringer extended to the free edge of the panel. The final damage state of the panel before unloading is shown in figure 29. It was likely that the final delamination damage grew from the existing delaminations (from first to fourth loading) and extended out to the free edge rather than originating at the panel free edge and moving in.

Figure 29. Stringer02 following the 5th loading; delamination of the right-side Stringer out to the free edge is observed

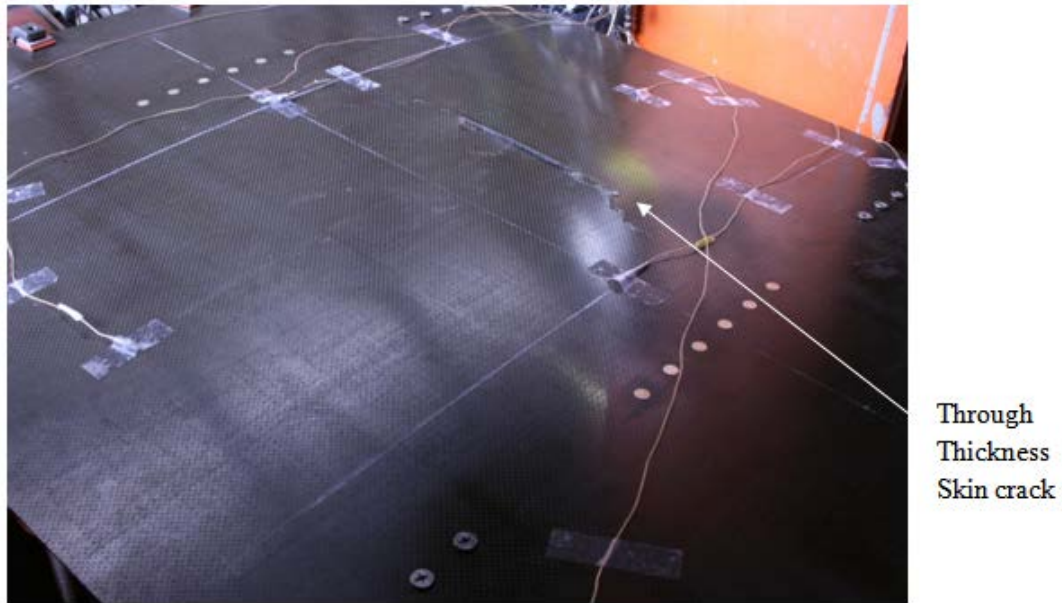
Figure 32. Post-test state of Stringer05 showing surface cracks along the skin-stringer connection at the impact location

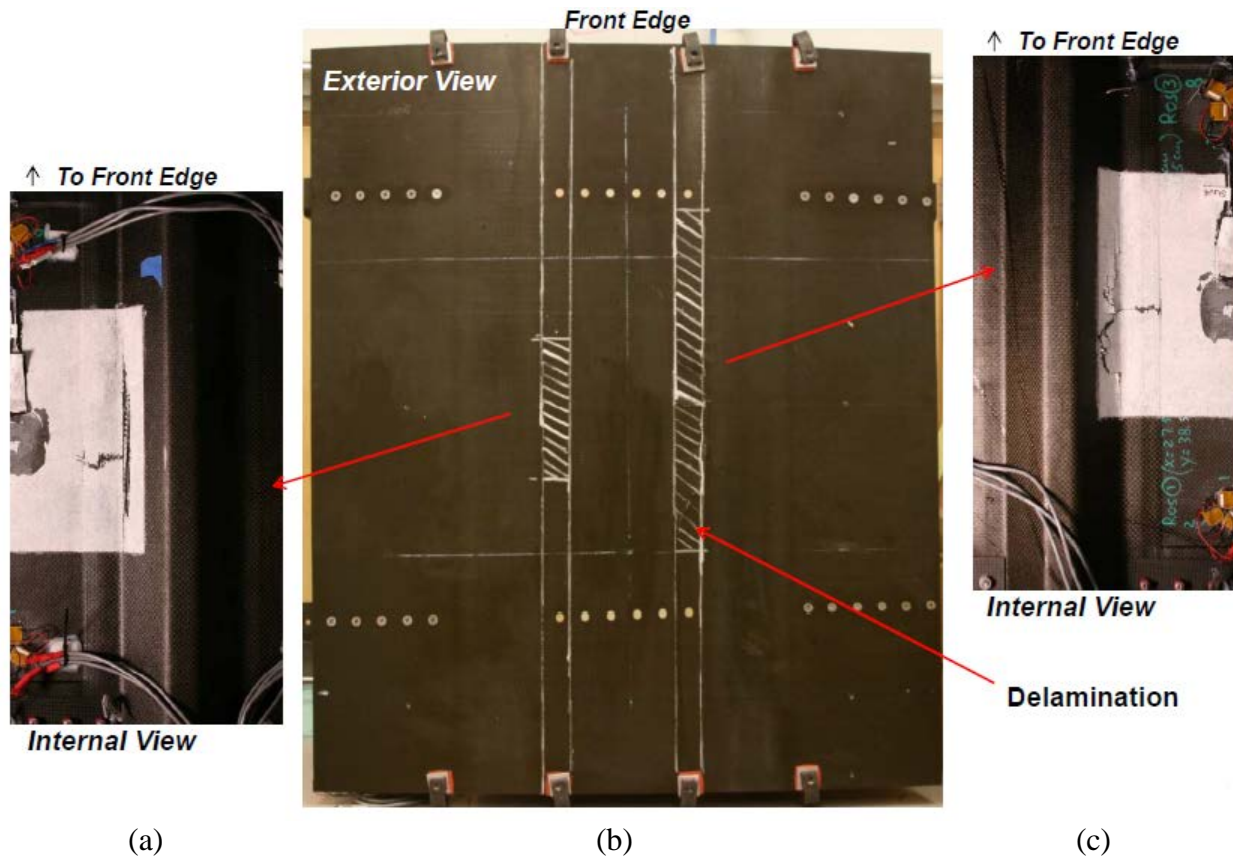
Figure 33. (a & c) crack formations along the stringer radii and on the flanges viewed from the interior side, and (b) post-test A-scan map of Stringer05 (hatched areas are locations of skin-to-stringer delamination);

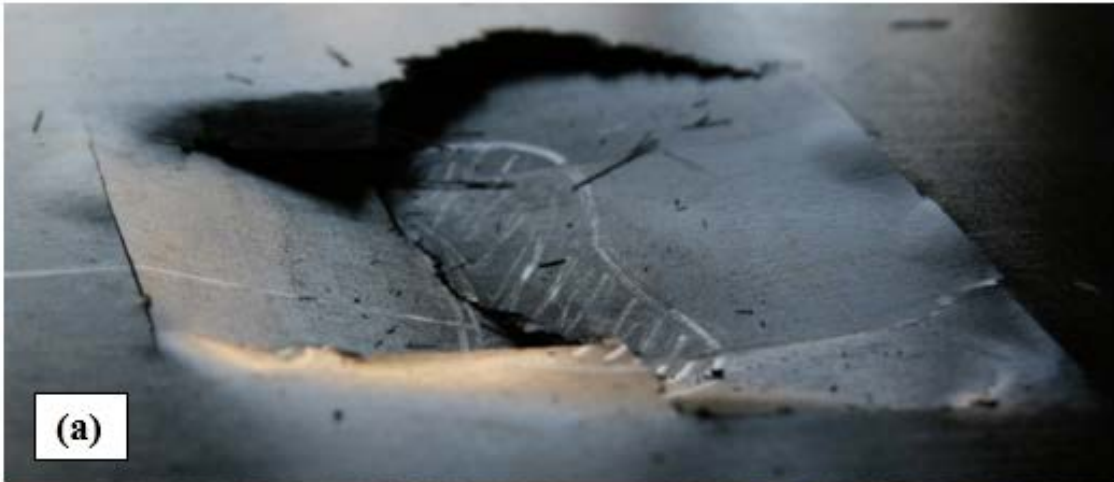
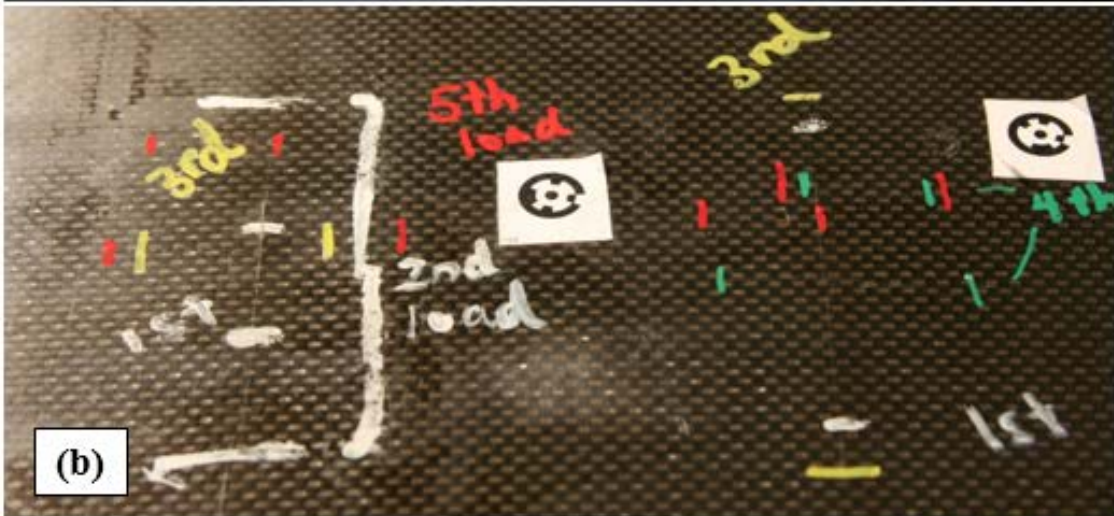
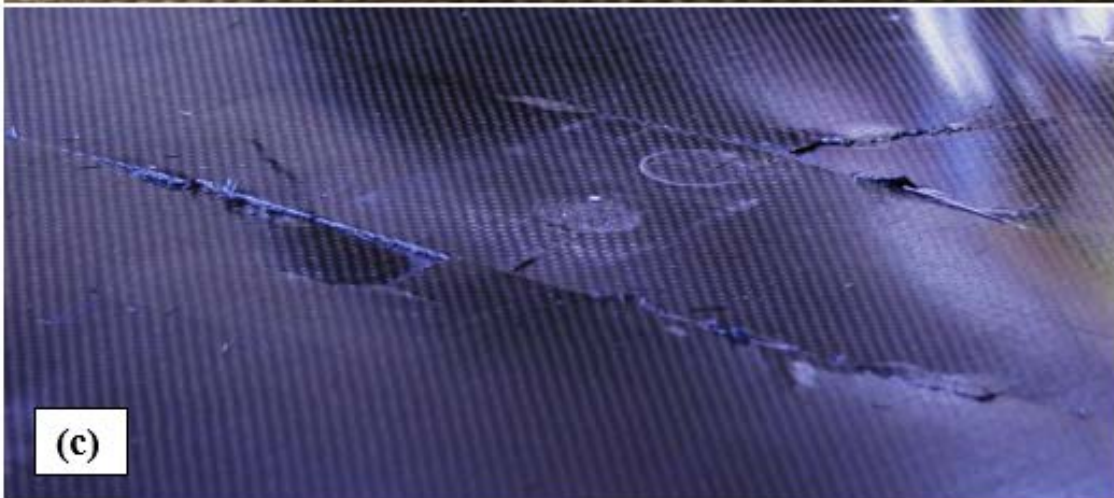
Figure 34. Final external damage states for (a) Stringer00, (b) Stringer03, and (c) Stringer06

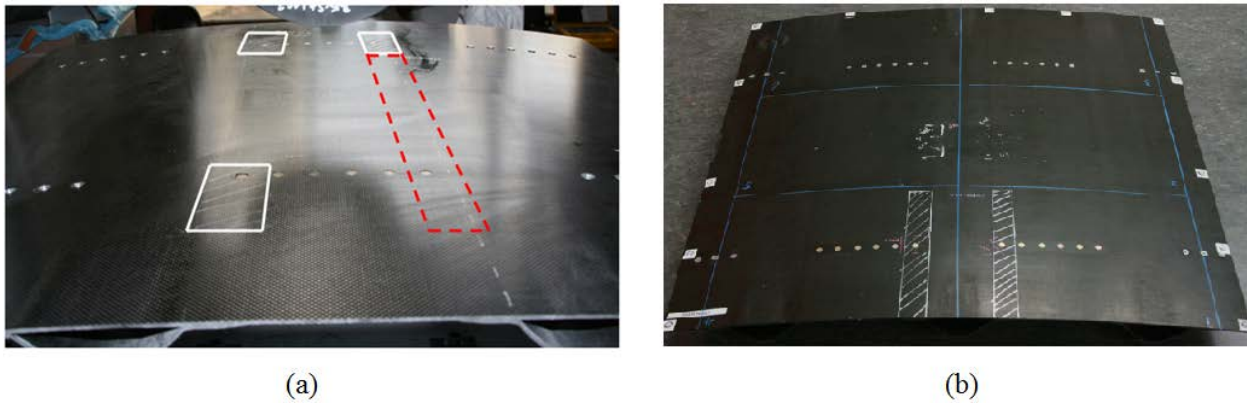
Figure 37. Final delamination area of (a) Stringer02 and (b) Stringer03

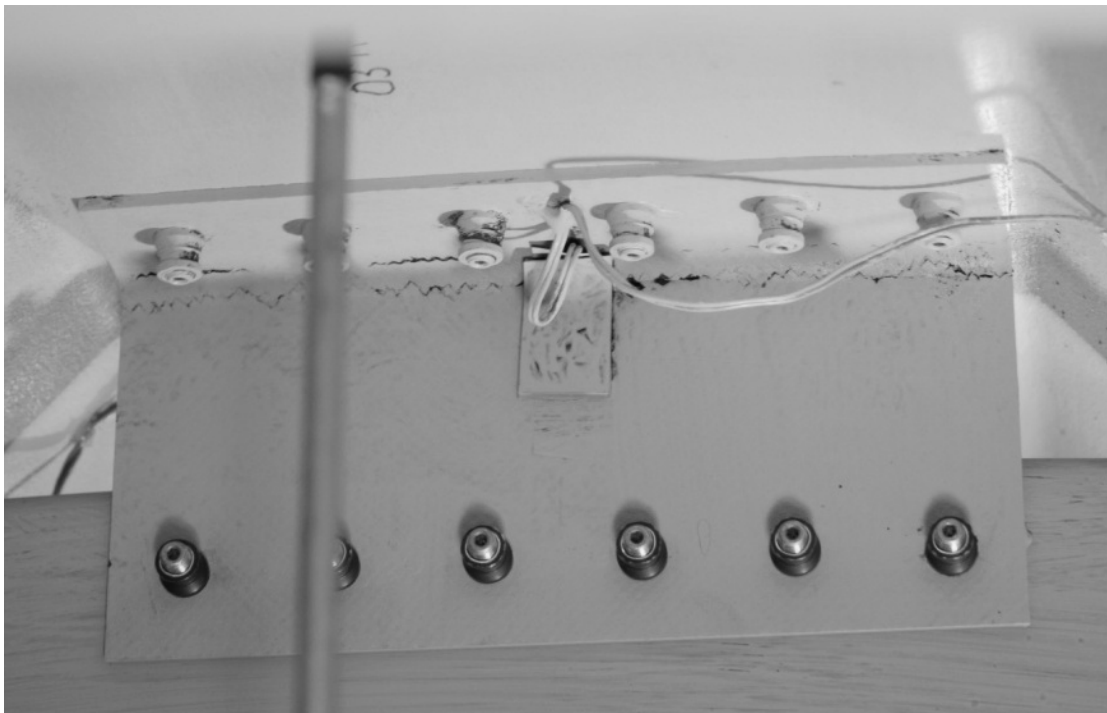
Figure 46. Shear-tie corner crushing failure after first loading of panel Frame03; shear tie painted white to visually accentuate cracks

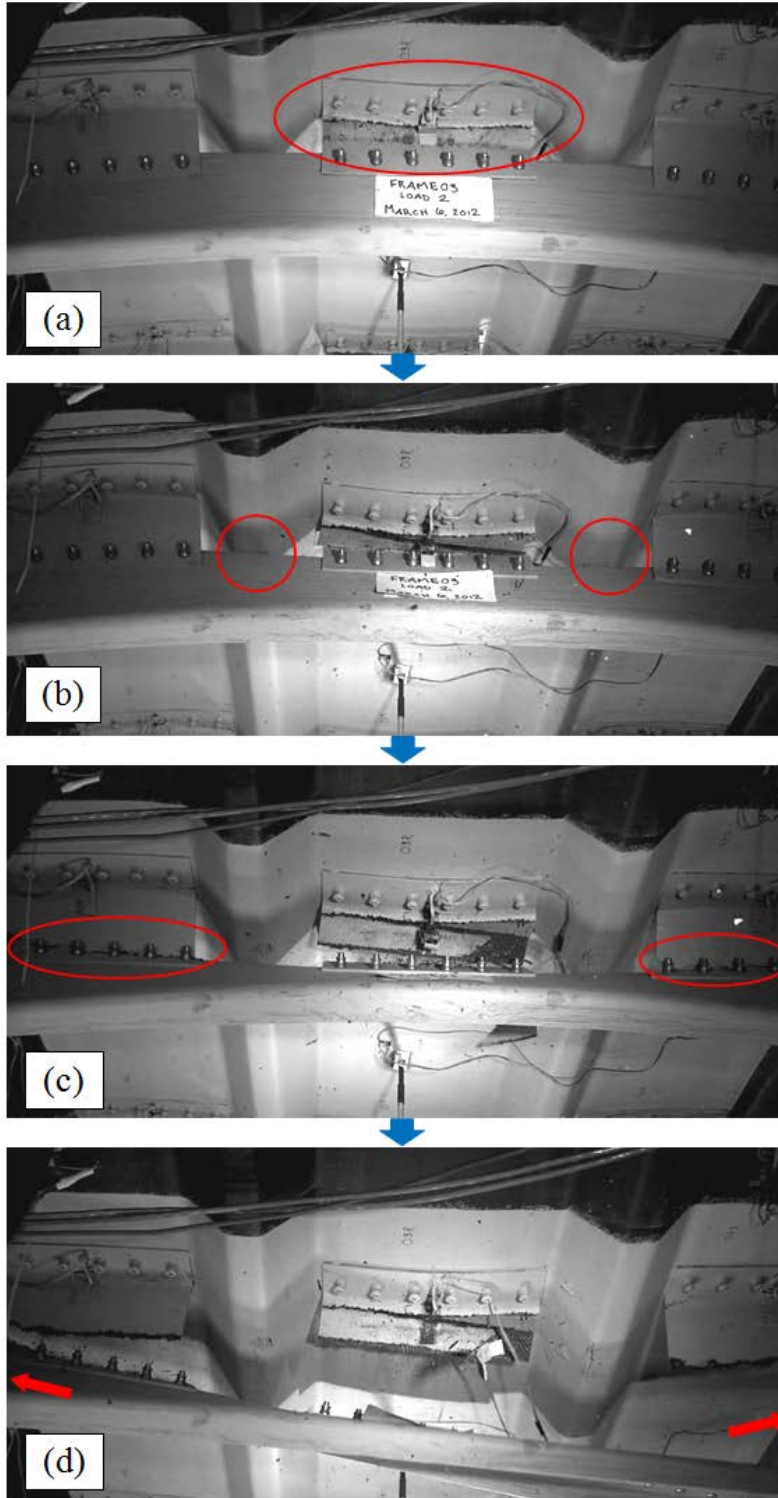
Figure 47. High-speed video stills of Frame03 2nd loading: (a) fracture of the impacted shear tie; (b) contact between the C-frame and stringers; (c) fracture of the shear ties adjacent to the impact zone; and (d) off-screen fracture of the C-frame at the boundary locations

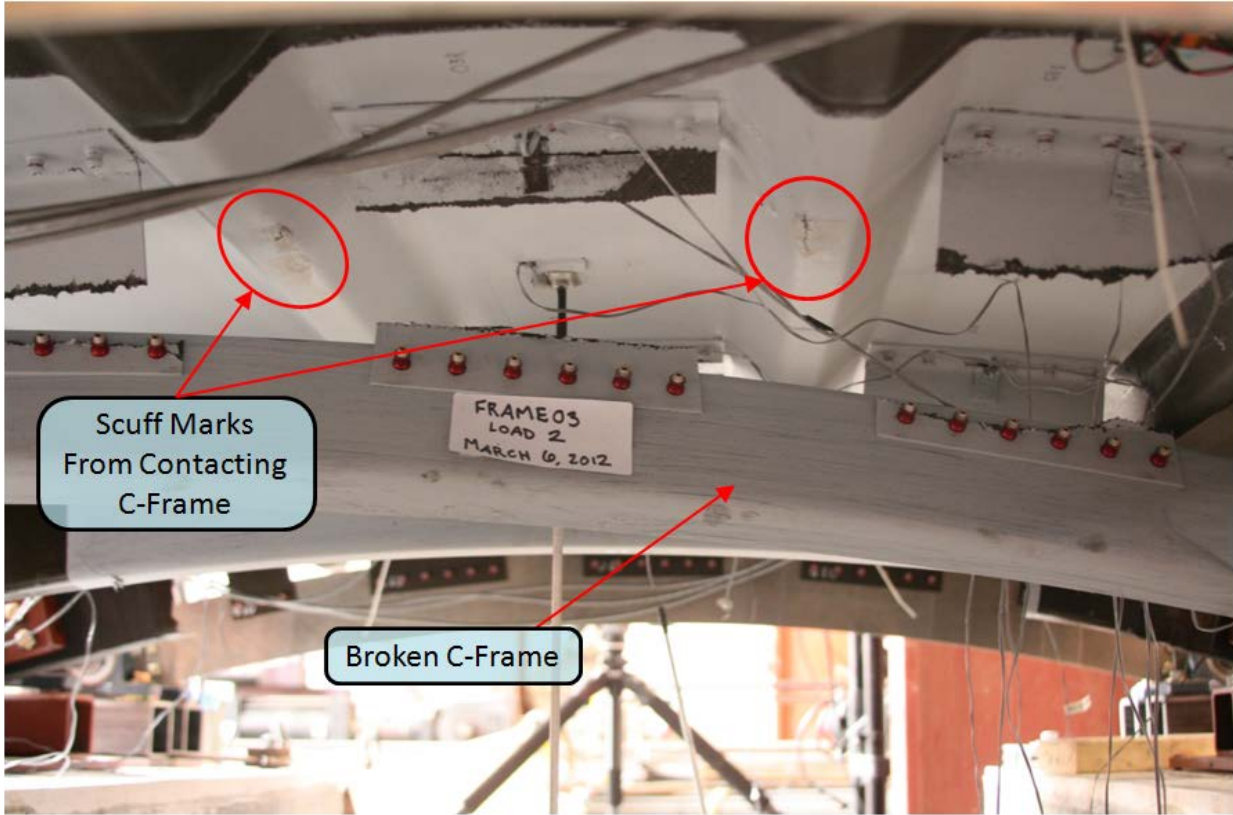
Figure 48. Frame and shear-tie damage of Frame03 after 2nd loading

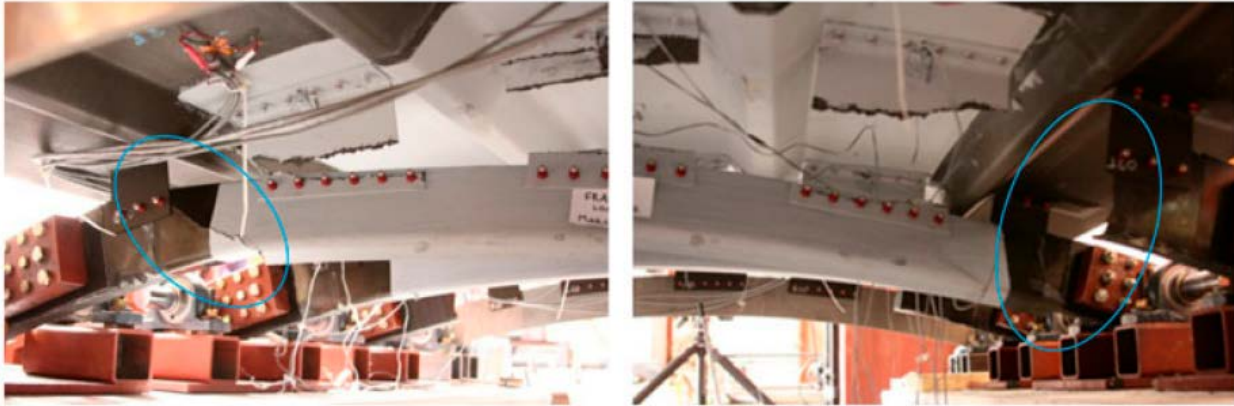
Figure 49. Frame03 C-frame fracture failures near boundary supports

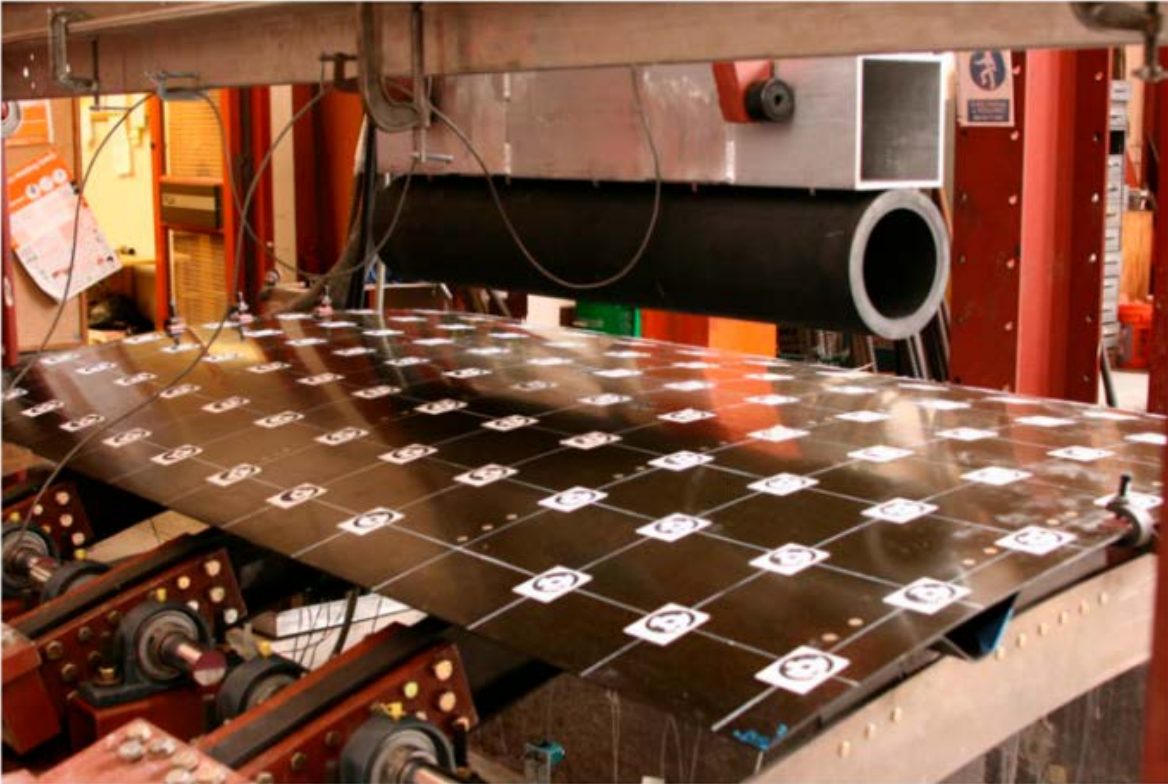
Figure 50. Frame03 external skin after loading sustaining internal C-frame damage; no externally visible damage

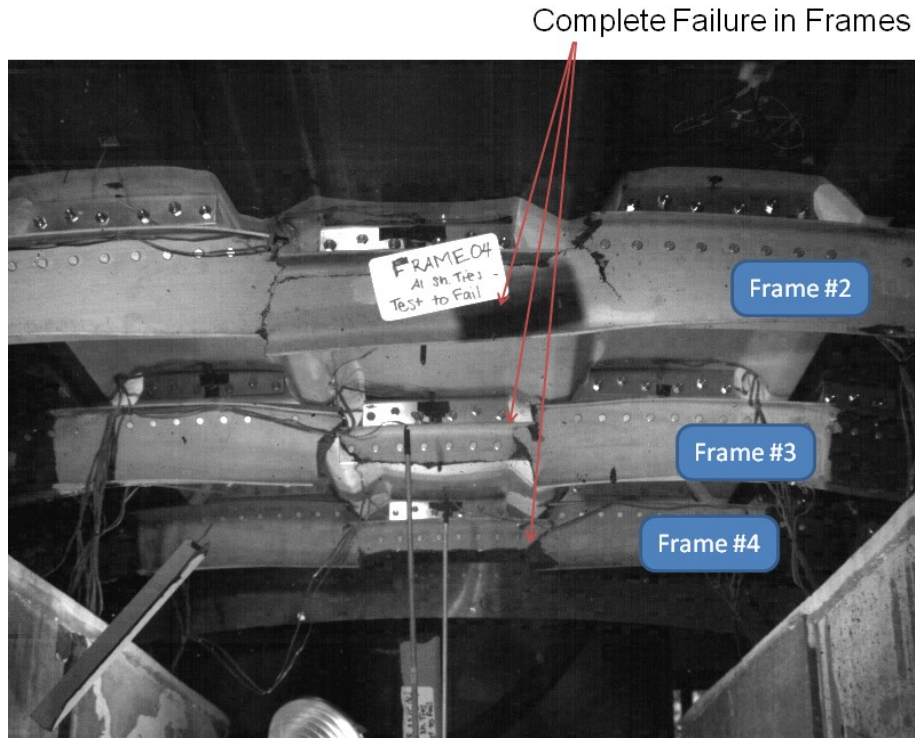
Figure 54. Frame04-2 local shear failure of the C-frames under the impactor
