**DOT/FAA/TC-19/10**

# **Large Engine Uncontained Debris Analysis—High-Bypass Ratio Engine Update**

April 2019

Final Report

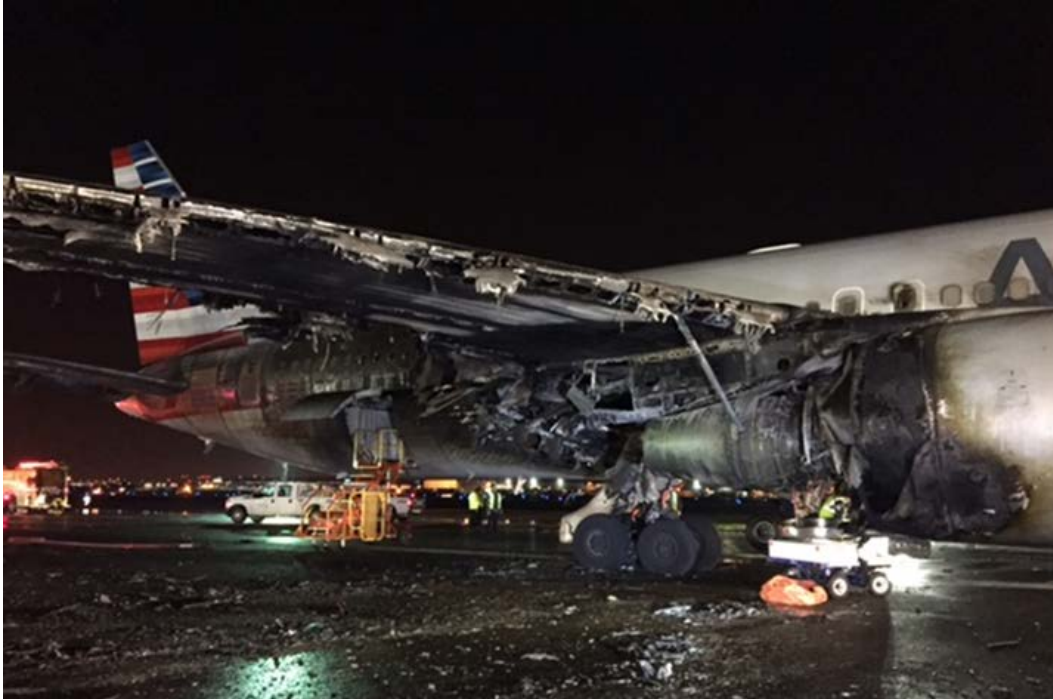
**Figure 1. Uncontained turbine disk event**

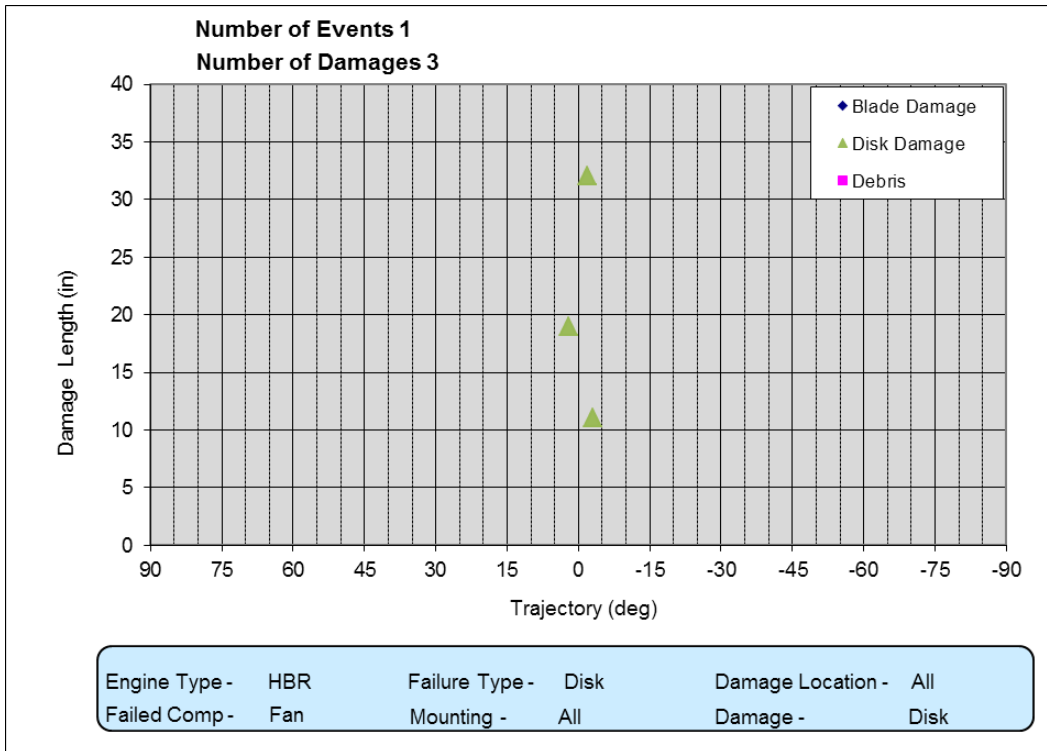
**Figure 26. Fan disk damage**

Aircraft damage generated from fan disk fragments liberated from a fan disk event is shown in figure 26. The fan disk damage chart shows a majority of the damage lengths up to 32 inches. The associated trajectory angles range from +2 degrees to -3 degrees. The damage ratio is shown in figure 27. Fan disk velocity and energy are shown in figure 28.

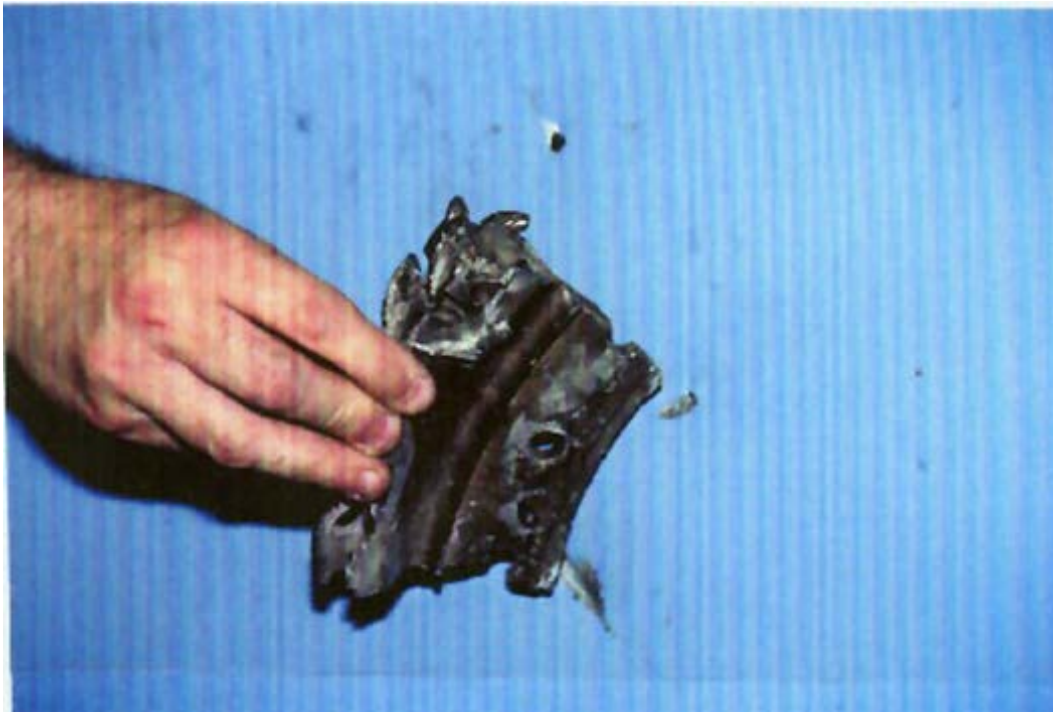
Compressor disks exit the engine casing and cowling at relative high velocities and energy levels, which can pass completely through fuselage structure (figure 41). Figure 42 shows a single-disk impact at a 0 degrees trajectory. The damage ratio for this single fragment is 60% of the disk diameter (figure 43). Initial energy levels are near 19,403 ft-lbf at 453 feet per second (figure 44). Compressor disk characterization is shown in table 14.

**Figure 41. Compressor disk fragment impact on opposite engine nacelle after passing through the fuselage**

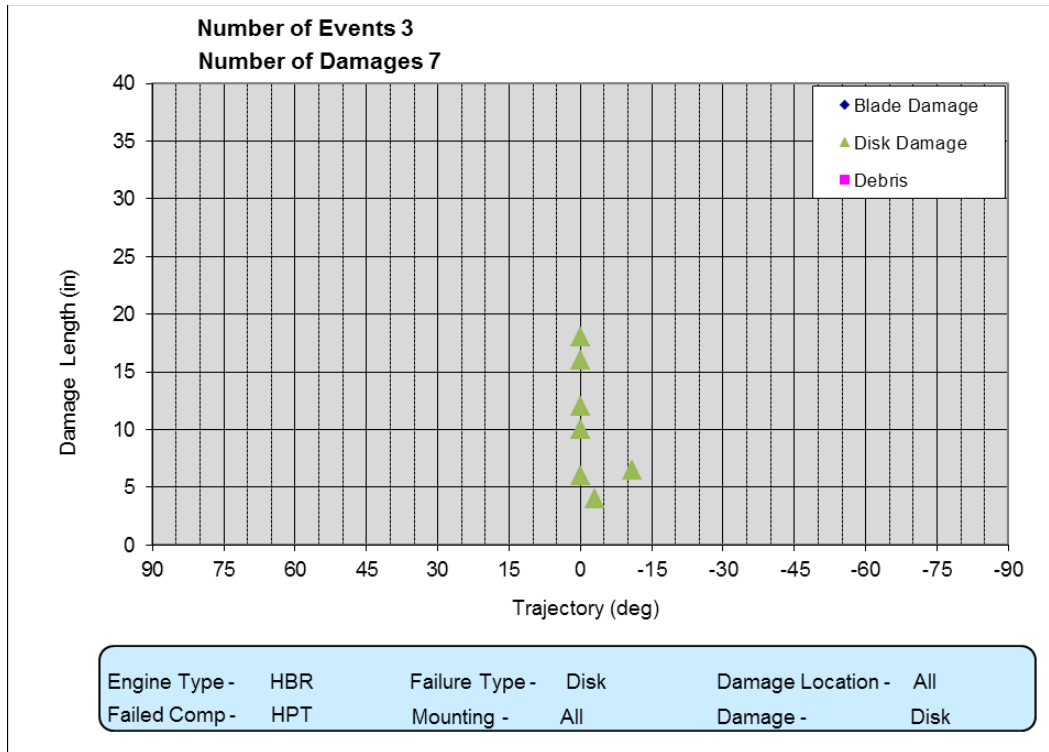
**Figure 62. HPT disk damage**

characterized as a 50% fragment, smaller than the 1/3 disk (90% fragment), defined by AC 20-128A. The trajectory angles range between 0 degrees and -11 degrees. For characterization, the trajectory spread angle ranges from +3 to -11 degrees to cover AC 20-128A requirements. Peak cowl exit velocity for a 50% disk fragment is 602 feet per second with energy of 117,470 ft-lbf (figure 64).

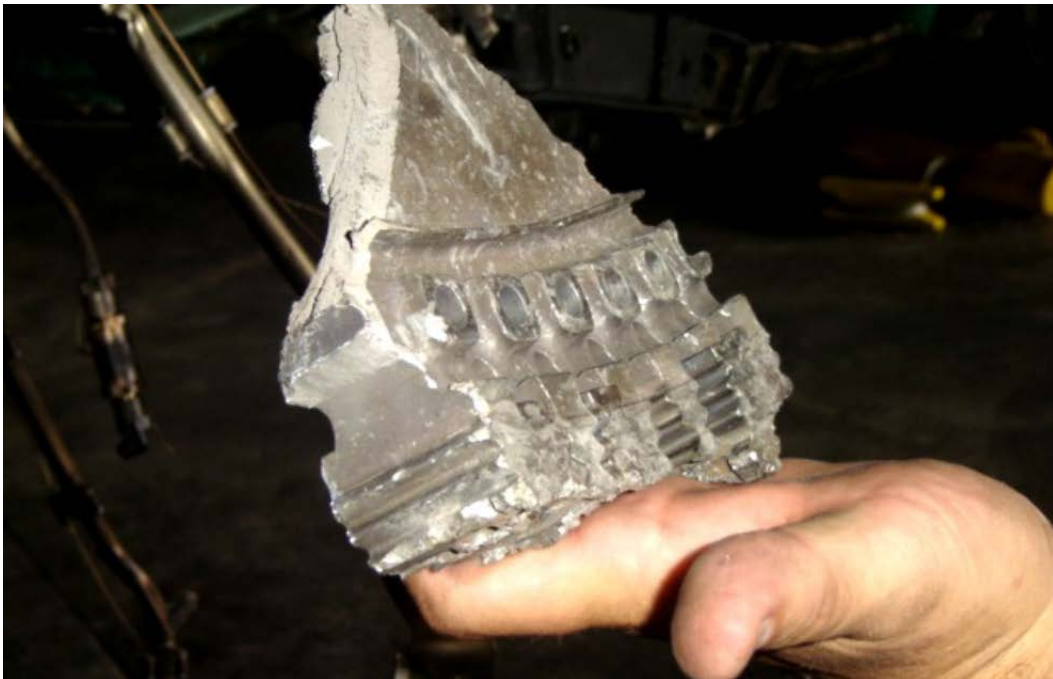
The rim of the disk is defined as the outer section of the disk where the blades attach through the fir-tree slots (figure 70). This is generally considered an intermediate fragment by AC 20-128A standards [5].

**Figure 70. Turbine rim fragment**

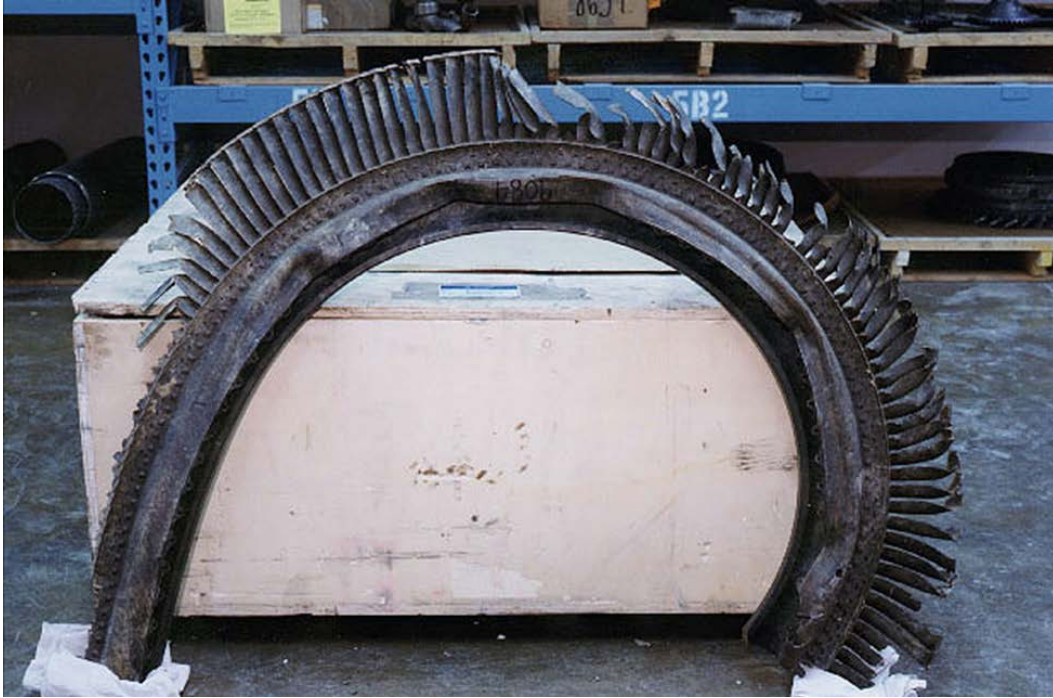
Low-pressure turbine (LPT) events were categorized by blade, rim, and disk-failure events (figure 74). There were nine LPT events, three LPT disk events, two LPT rim events, and four LPT blade events. Each of these failure modes is characterized below.

**Figure 74. Uncontained LPT disk segment**

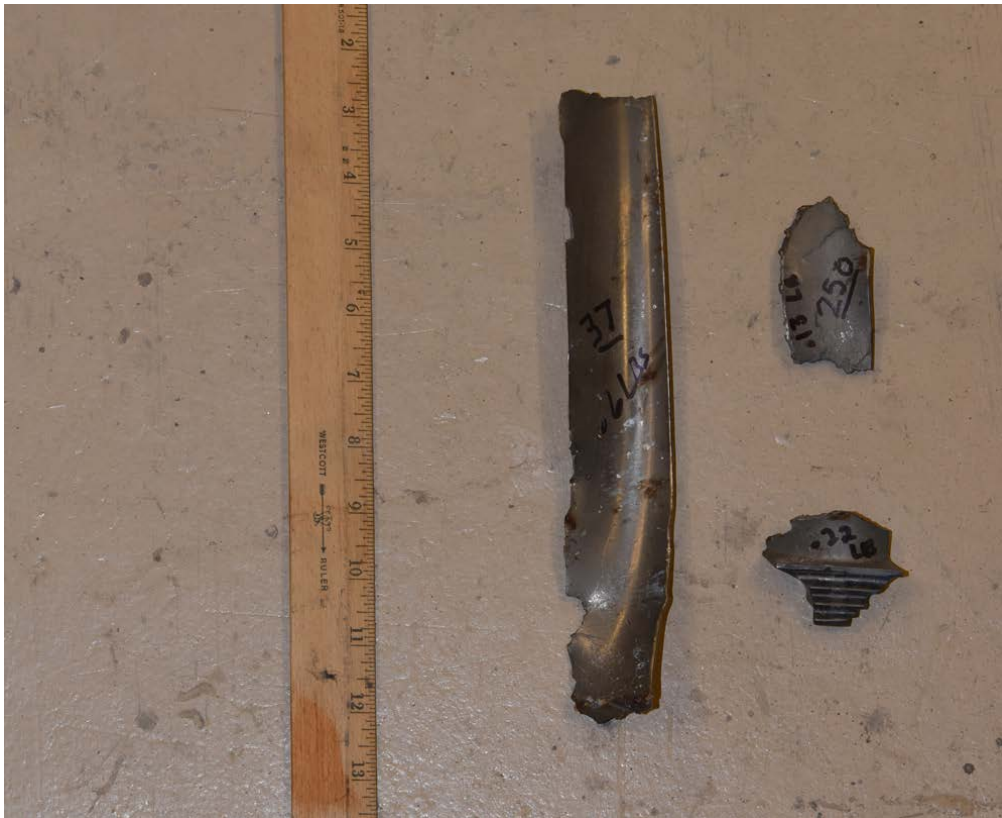
A subset of the LPT blade event data is the LPT last-stage event. Examples of this type of turbine-blade debris are shown in figure 97. These events have high potential for very large aft trajectories because debris exiting the tailpipe can also be included in the damage data. Aircraft damage recorded in the database is shown in figure 98. The damage ratio is shown in figure 99. Representative turbine blade debris size for characterization is 40% blade length. Three LPT blade failure events generated 26 damage locations. The average number of blade fragments per event is nine. The trajectory angle range for this event is +20 to -75 degrees; for characterization purposes, trajectory spread angle is defined as +20 to -60 degrees. Peak cowl exit velocity for a 40% blade fragment is 147 feet per second with energy of 90 ft-lbf (figure 100).

**Figure 97. LPT blade fragments**

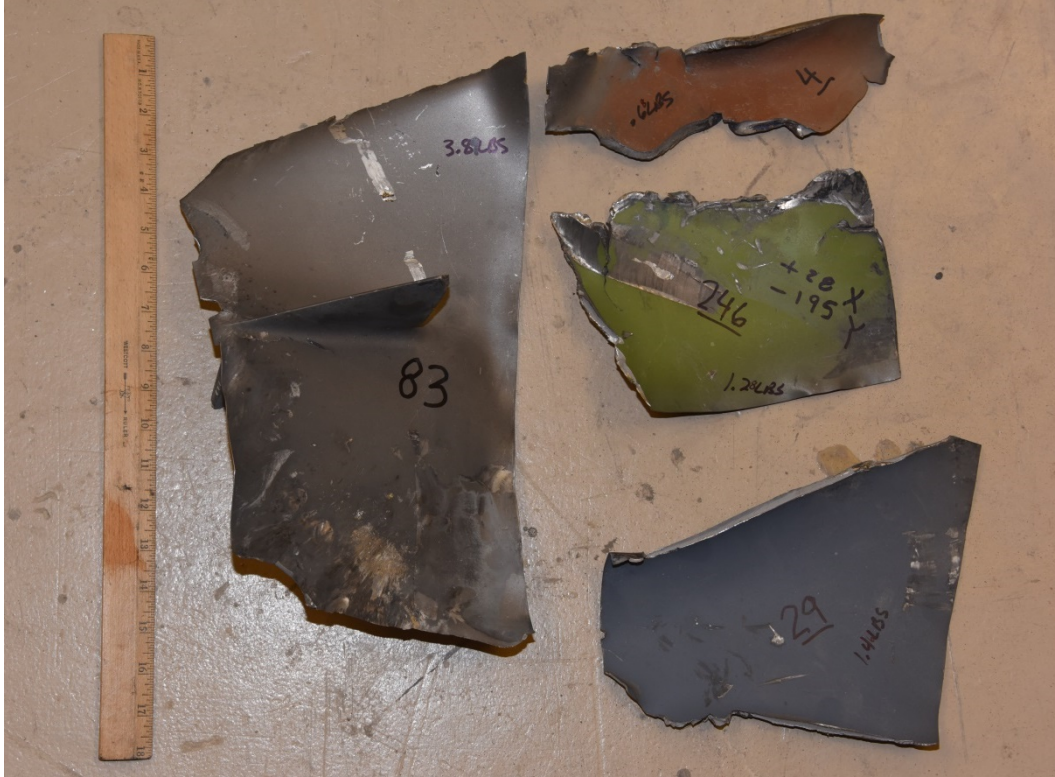
**Figure 107. Fan blade fragments from blade-separation event**
