DOT/FAA/TC-20/2

A Summary of Results from Two Full-Scale Fokker F28 Fuselage Section Drop Tests

May 2020

Final Report

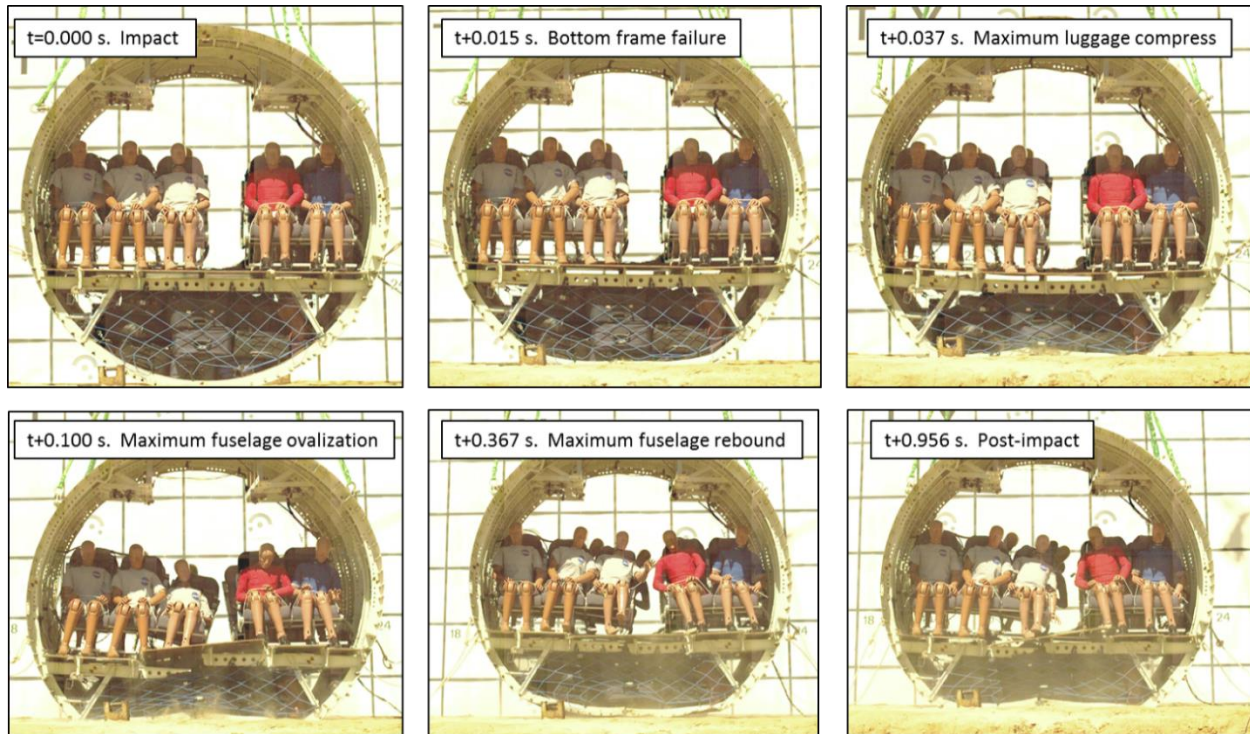
The negative values shown before 0.06 s were caused by inward motion of the port and starboard targets, which indicated an initial vertical ovalization of the fuselage at impact. This vertical ovalization was caused by floor bending, which pulled the sidewalls of the fuselage inward. After the initial vertical ovalization, the sides of the fuselage deformed outward to a maximum value of 5.1 in at 0.103 s after impact. The late time history in Figure 3.1 showed that the fuselage sustained a permanent deformation of approximately 1 in. post-test. The test sequence as captured from the forward viewing high-speed camera is shown in Figure 3.2 with highlighted notable events. Note the initial floor bending in the upper right image.

Figure 3.2. Sequence of events for forward section test

The upper left image shows the test article at impact where first ground contact was made. This time was also the datum time used for calculating the ovalization. The upper middle image shows the first visible failure in the test article, which occurred at FS 5305 at the bottom skin/soil impact location. The upper right image shows where the subfloor luggage had maximum compression. This time was noted because it affected both the airframe and ATD responses. The lower left image shows the fuselage at 0.100 s after impact, which was where maximum lateral ovalization occurred. This event was important due to its effect on the ATD response, described later in this section. The lower middle image shows the fuselage when it underwent a small rebound. Finally, the lower right image shows the last acquired frame of the high-speed camera almost one second after the impact event. This frame was beyond the time the major events occurred during the impact, although the onboard motion after the test did not stop until a full 2.5 seconds after impact. Between these two times, the fuselage gently rocked back and forth because of the dynamics in the still attached, but slack, lifting straps.

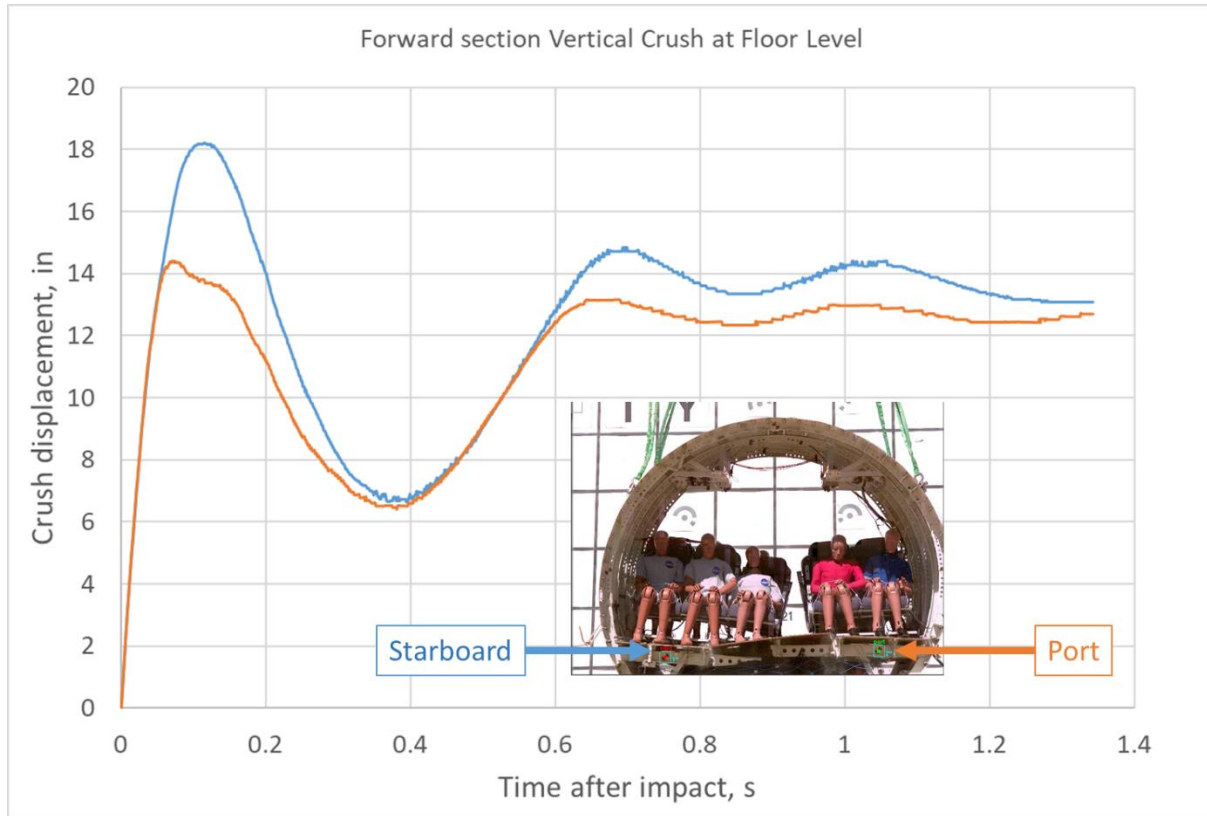
Figure 3.3. Forward section subfloor crush deformation

The two positions tracked in Figure 3.3 show an initial maximum crush displacement immediately after impact before rebounding at approximately 0.4 s. after impact. The initial crush displacement reached 18.2 inches for the starboard side and 14.4 inches on the port side. The difference is attributed to the failure of FS 5305 at approximately 0.1 s. after impact, causing the two sides to penetrate the underfloor luggage unevenly and independently. After the rebound at 0.4 s., the data begins to converge as the two sides settle into a post-impact deformed state. The convergence begins at approximately 0.7 s. Although the two sides did not reach identical crush values, they were in an equilibrium state. The data at the end of the tracking shows a starboard side total displacement of 13.1 inches and a port side displacement of 12.7 inches. The average subfloor crush was 12.9 inches.

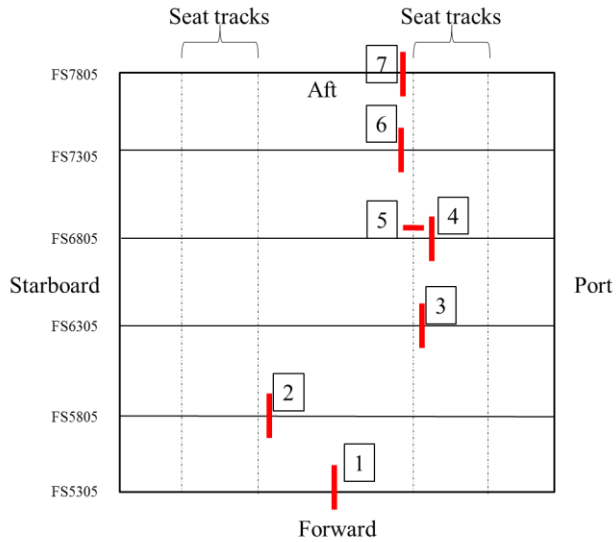
Post-test inspections of the airframe showed failures in all of the floor support lateral stiffeners. However, they were not uniform and did not have a discernable pattern. A diagram highlighting complete failures of floor support stiffeners, indicated by a red dash, is shown in Figure 3.4. The numbered items only show where a stiffener completely separated in half. Much of the other floor support structure also buckled, bent, and partially tore but, for clarity, are not included in Figure 3.4.

Figure 3.4. Failure locations in the floor support structure and seat tracks

The failure pattern in the floor support structure at first appeared to be random and did not correlate to either a seating position or place of overall stiffness discontinuity leading to high stress concentration (i.e. the cargo door). On closer inspection it was determined that many of the specific failure locations were caused by the luggage interaction with the specific floor stiffener locations throughout the impact. The onboard and ground cameras captured some of the exterior failures but could not cover all of the interior failures due to blockage of the failure from the luggage, floor, or both. Post-test inspections provided guidance in failure initiation and propagation for the interior members. The first interior failure inspected post-test was at location #2. A picture of the failure in location #2 from Figure 3.4 is shown in Figure 3.5. This failure was only visible once the floor and seats were removed.

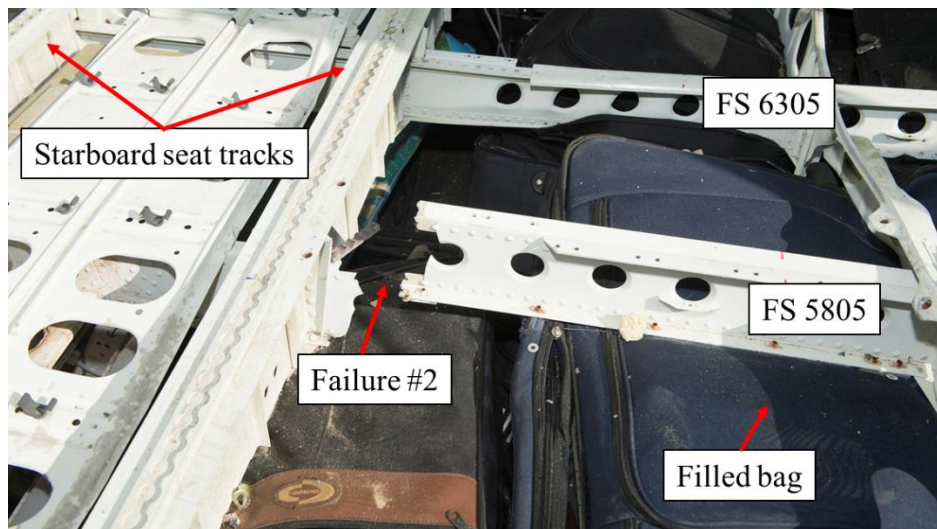
Figure 3.5. Failure of FS 5805 at location #2

A detailed inspection at failure location #2 revealed a probable cause. Inboard of the starboard seat tracks, there was a fully filled dark blue bag located at the top of the underfloor luggage stack centered underneath FS 5805. To the left of this bag was a black-with-brown-striped bag, stacked at a lower height. The difference in height was either from the black and brown striped bag being partially filled or simply from being stacked on top of slightly shorter bags. At impact and during the maximum luggage rebound, the upward bearing of only the blue bag against FS 5805, the highest in the stack, caused the failure to occur near the seat track junction. This was an area of differing localized stiffness. After the failure, the bag itself provided a surface for which FS 5805 to rest. Additionally, it is important to note that the blue bag was centered along FS 5805 and did not extend under either FS 5305, which is not shown, or FS 6305, which is shown in Figure 3.5. If this bag extended into the area underneath FS 6305, FS 6305 might have failed in a similar way. Failures #3, #4, and #5 also occurred adjacent to each other and are shown next in Figure 3.6.

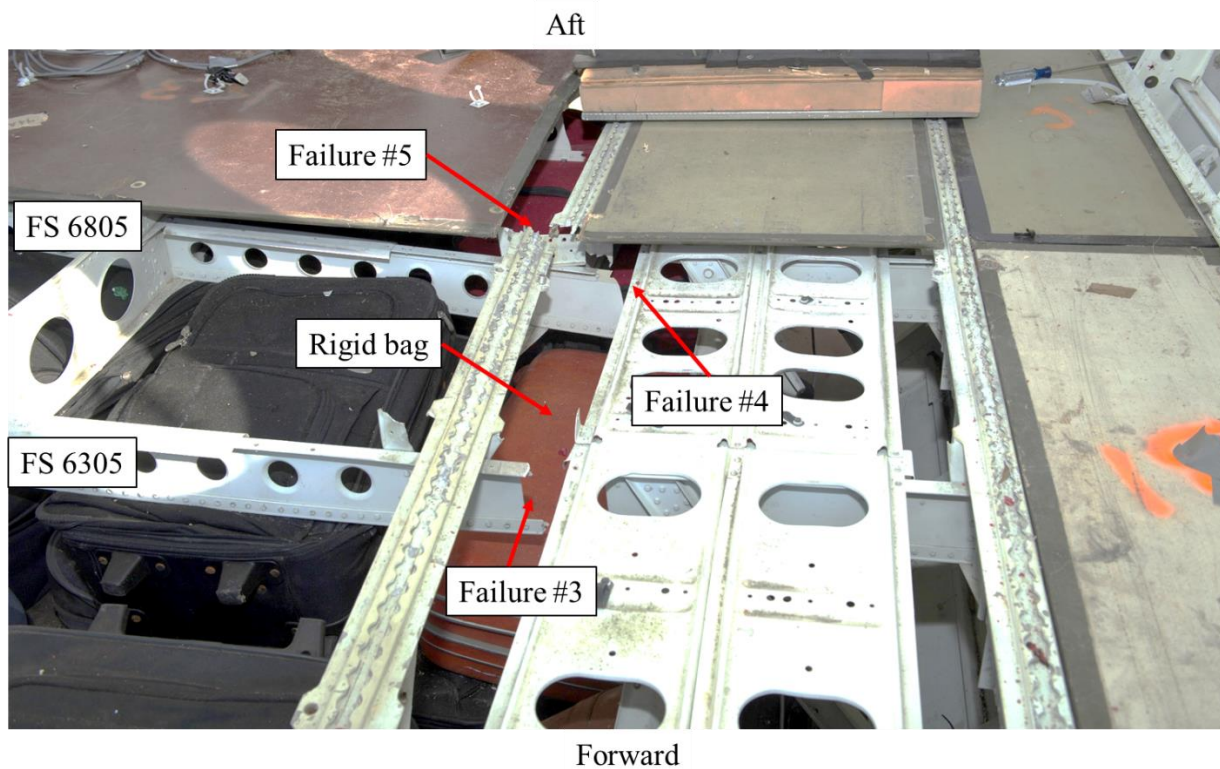
Figure 3.6. Failure locations #3, #4, and #5

The root cause of the failure in FS 6305 (failure #3), FS 6805 (failure #4), and the inboard port seat track (failure #5) was attributed to the rigid brown bag underneath this area of the floor. The bag was unintentionally centered between FS 6305 and FS 6805 slightly outboard of the port inner seat track position. The impact and, more importantly, the rebound of this bag against these areas caused failures in these locations. The failures at FS 6305 and FS 6805 occurred at almost identical locations, immediately outboard of the inner seat track and positioned directly over the bag. The reason for the failure of the seat track (failure #5) was not as straightforward. However, it is suspected that a combination of the failure of the two adjacent frame sections (failures #3 and #4), the added loading from the rear row double seat inboard leg attachment directly over FS 6805, and

the added localized rigidity in the adjacent rear structure due to the DAS pallet attachment just aft of the seat track failure location.

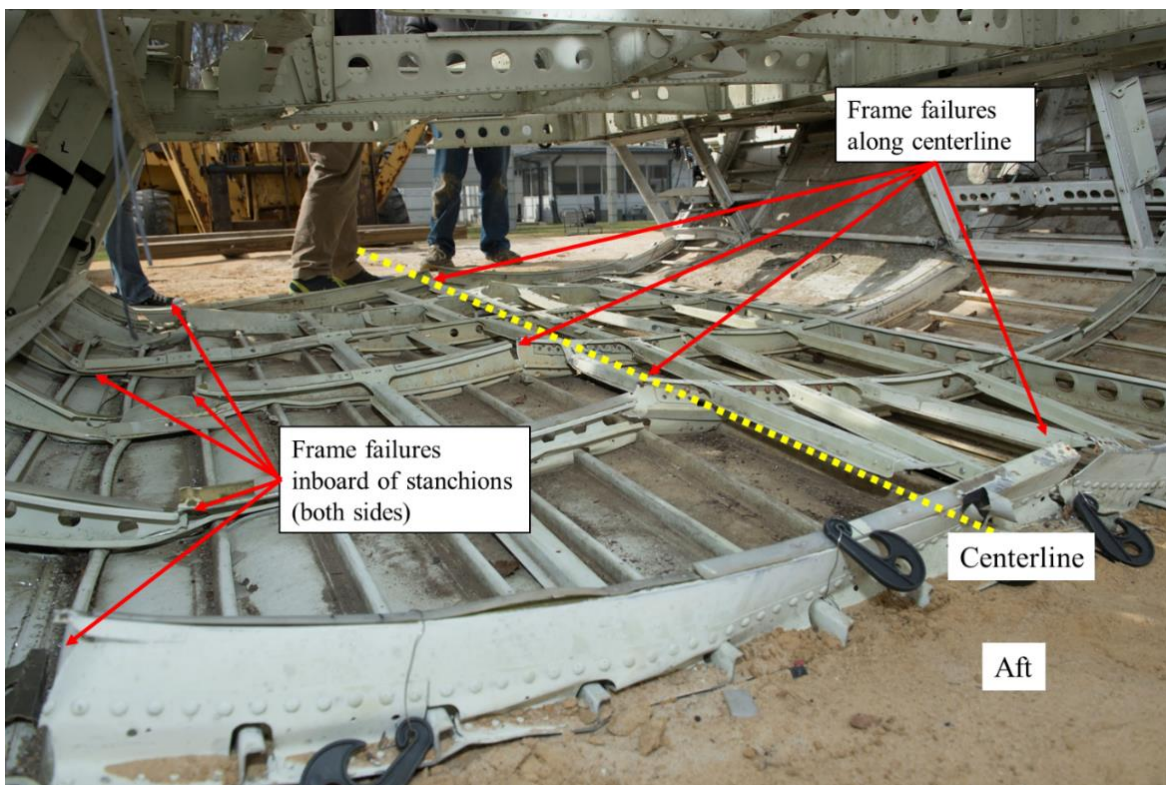
After the underfloor failures were thoroughly documented and photographed, the underfloor luggage was carefully removed to aid in the examination of the lower cavity and bottom skin areas of the test article. There were several failures in the lower section that were commonly seen in previous testing and in-service accident data. The first was the failure of the frame sections along the centerline at the very base of the fuselage. These failures were tensile failures at the inner end of the frame section caused by the ovalization of the test article in the bottom skin region. The second prominent failure was the crushing of the frame sections immediately inboard of the lower-stanchion-to-subfloor attachment locations. This crush was caused both by subfloor deformation from the under-floor luggage loading along with the outward motion of the frames during ovalization. These two failures are shown in Figure 3.7.

Figure 3.7. Lower cavity failure locations

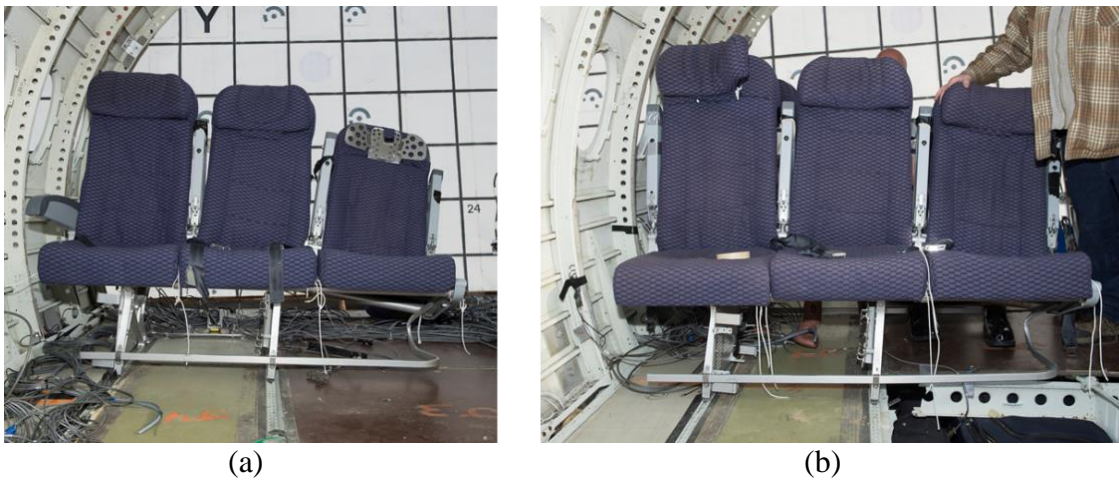
Figure 3.24. Post-test triple seats—rear (a) and front (b)

The maximum seat deformation occurred on seats 3 and 8, which are both overhung. - Both seat frame rear tubes deformed to a maximum of approximately 4.5 in. vertically when measured at the aisle armrest location. The luggage guard buckled at the aisle seat rear attachment location, which lead to a crack in the material. The middle and window seats and seat leg structure were undamaged for both of the triple seats. The double seats appeared undamaged when conducting post-test inspections. Figure 3.25 shows the underside of the triple seat in the rear row, noting the bent rear seat frame tube and cracked luggage guard.

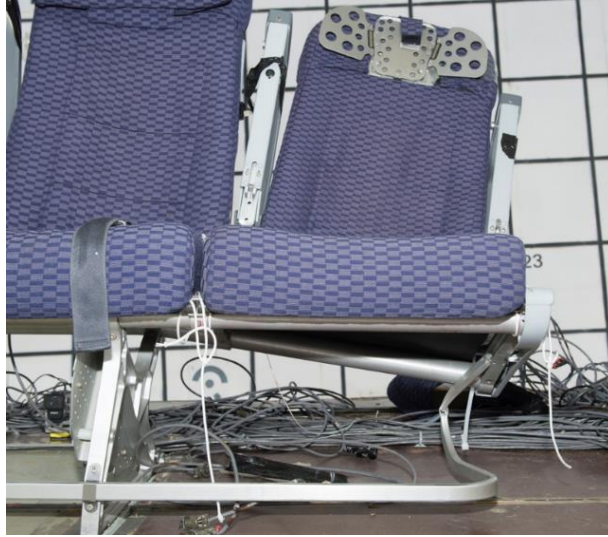
Figure 3.25. Post-test rear triple aisle seat deformation (seat 3)

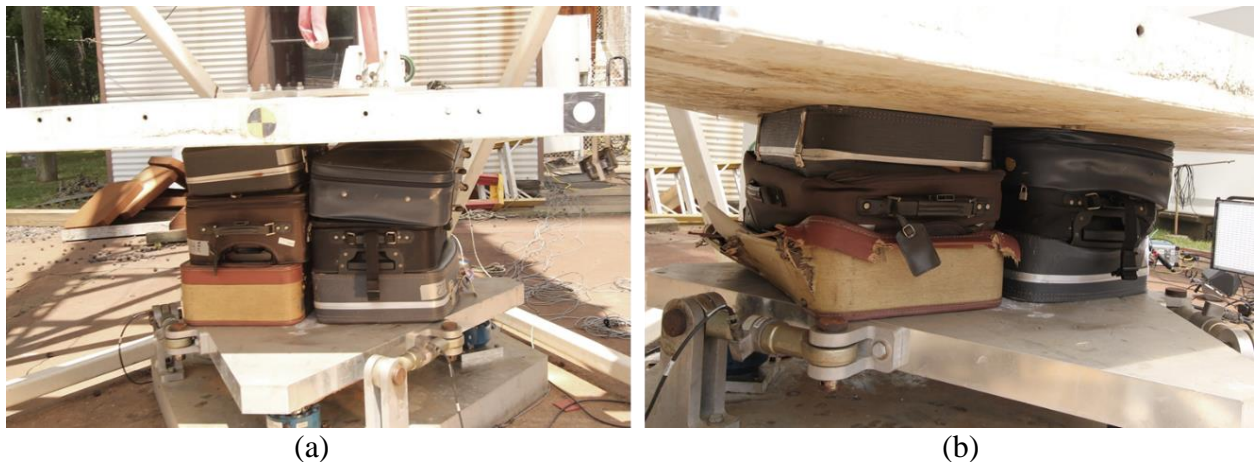
The first test was conducted with the impact velocity of the falling mass at 18 ft/s. The total luggage weight was 128.6 lb. A pre- and post-test picture is shown in Figure 4.2. Post-test inspections revealed that the impact shattered the rigid bags but left the soft bags mostly intact. The items inside were not examined for damage.

Figure 4.2. Luggage test 1 pre-test (a) and post-test (b)

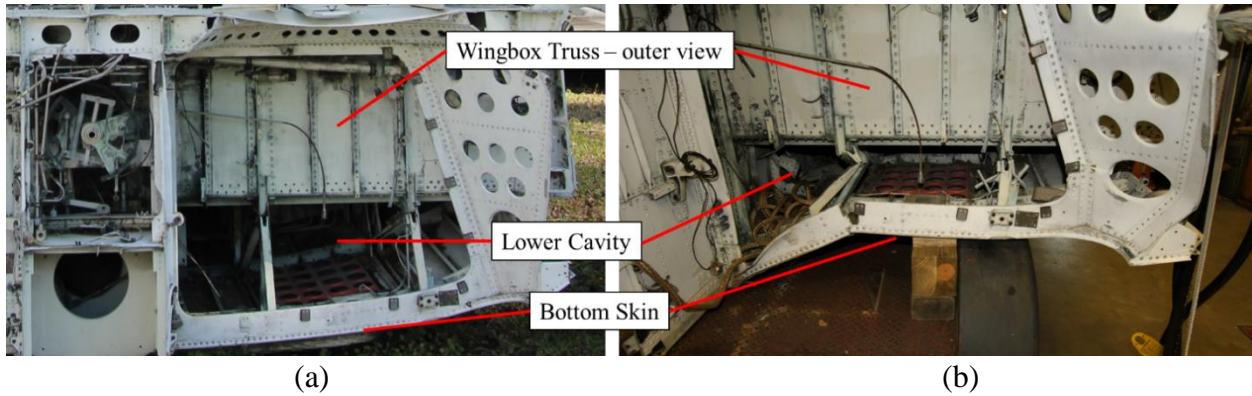
The aft response was dominated by the lower cavity portion of the wingbox section, located below the wingbox truss structure and the outer skin of the aircraft. There were vertical stanchions running through the lower cavity. These stanchions buckled during the impact, which caused the lower cavity to experience most of the subfloor deformation. Figure 5.6 shows pre- and post-test views of the lower cavity structure.

Figure 5.6. Wingbox lower cavity pre-test (a) and post-test (b)

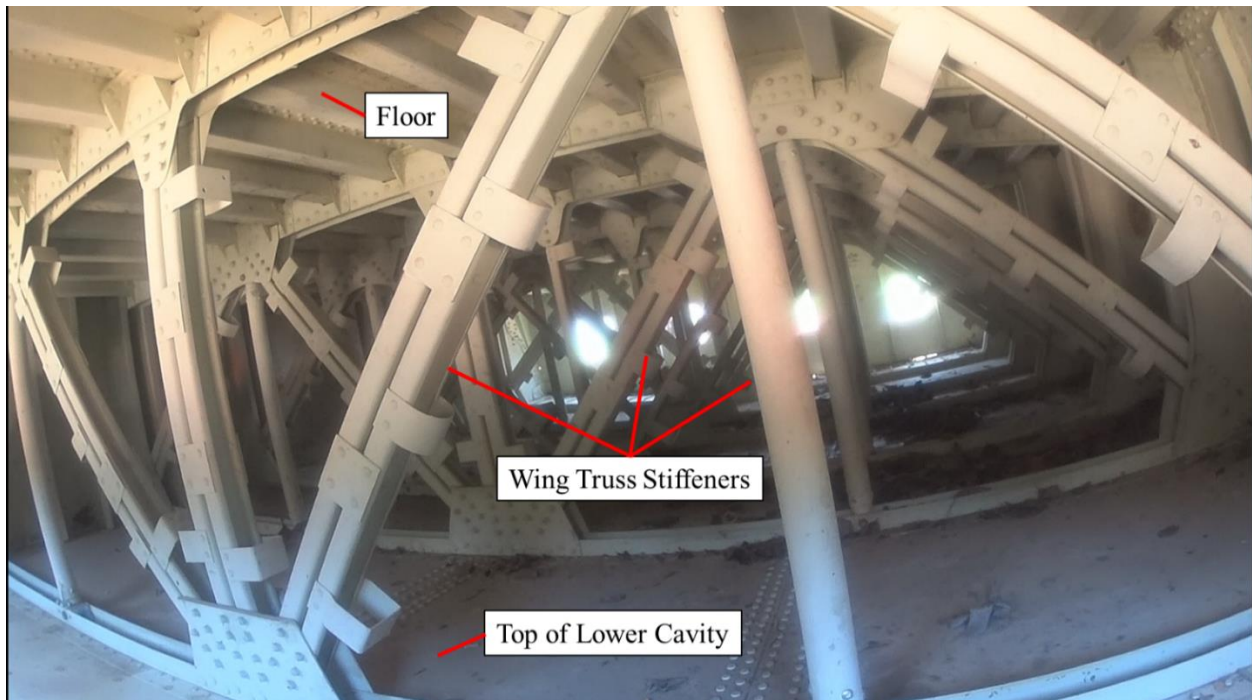
Additional images were taken from an onboard camera mounted inside the wingbox truss structure. Figure 5.7 shows a still image from a video taken from the camera post-test, which verified that the truss structure did not exhibit deformation or failure during the test.

Figure 5.7. Wingbox section truss structure post-test

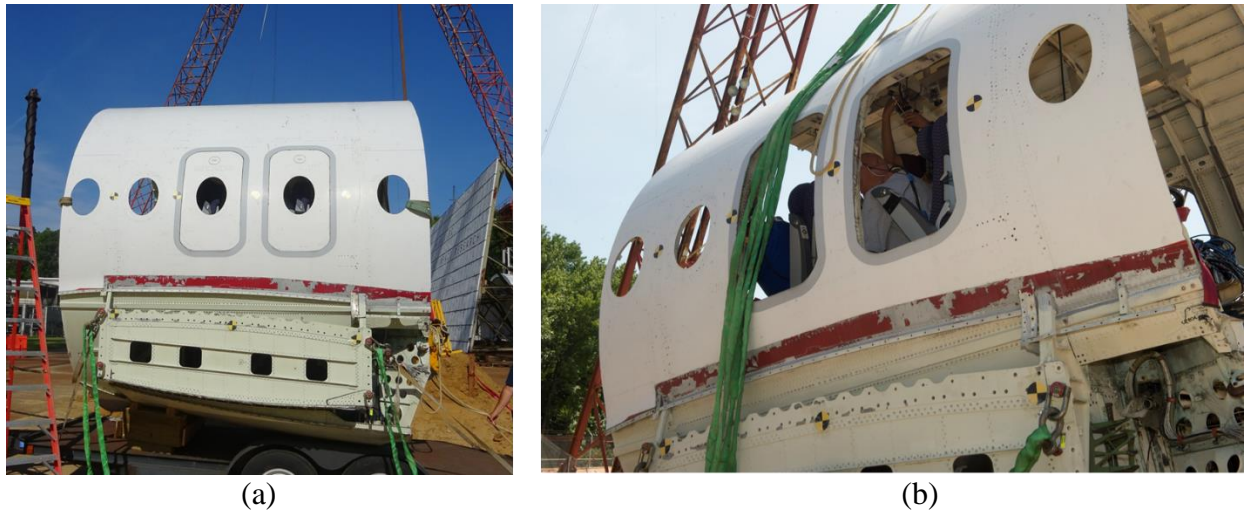
Other than the aft lower cavity region, the test article did not show noticeable signs of structural damage. The wingbox truss structure appeared to be undamaged, and the seat tracks did not show signs of fracture or tearing. Similar to the forward section, the structure above the floor did not appear damaged. Additionally, all four emergency exit doors opened nominally post-test, which indicated no permanent deformation or warpage around the door frames. Figure 5.8 shows the doors pre-test and the openings post-test on the port side of the test article.

Figure 5.8. Wingbox section port emergency exit doors pre-test (a) and removed post-test (b)

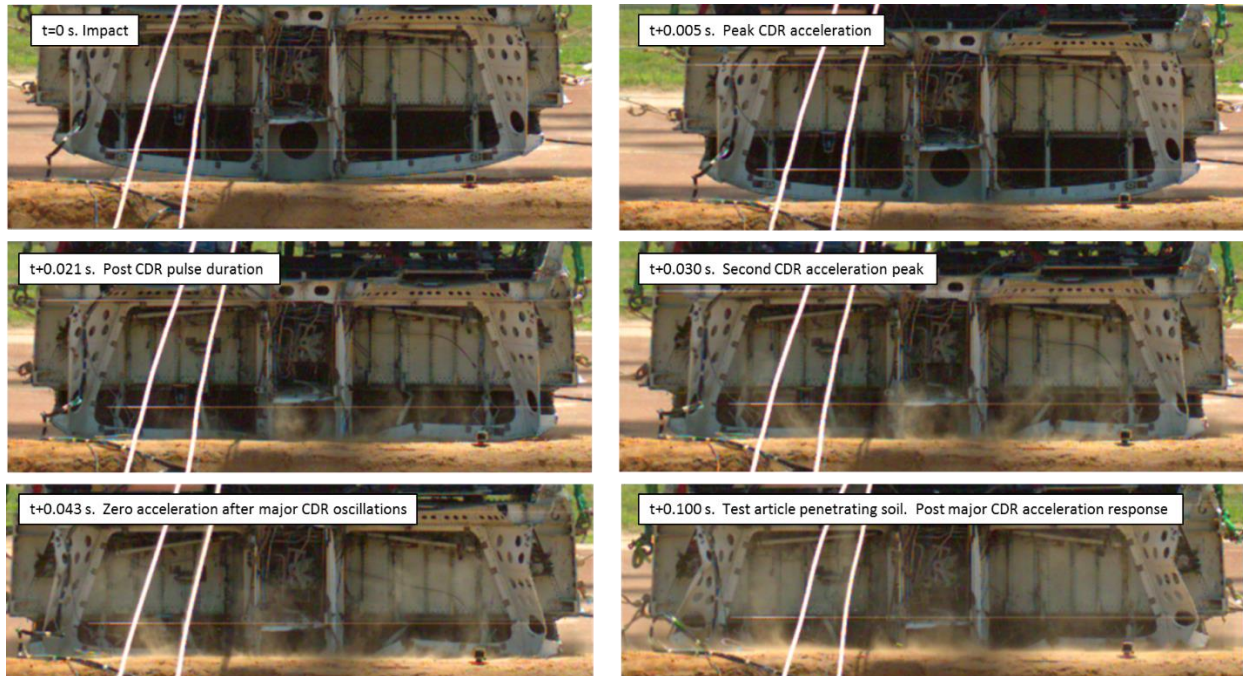
Figure 5.12. Aft lower cavity deformation image series
