DOT/FAA/TC-21/25

Assessment of Emerging Metallic Structures Technologies through Test and Analysis of Fuselage Structure: Panel 1

Feb 05, 2021

Final report

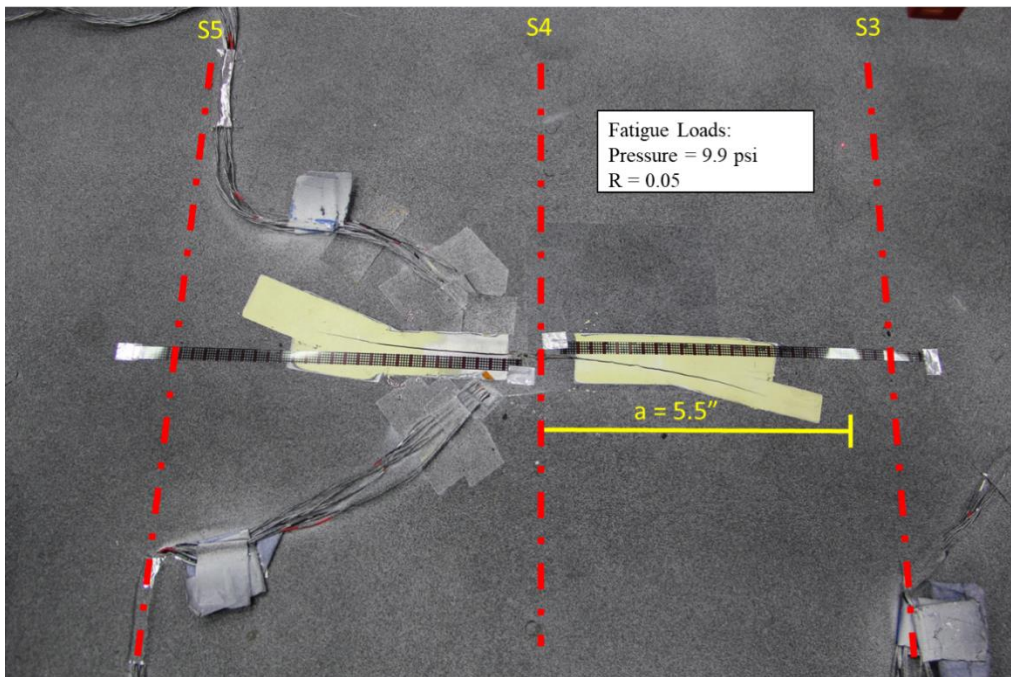
The panel was then fatigue tested under simulated flight load conditions for 33,600 cycles, during which the skin crack extended across two stringer bays to a final length of approximately 11 in., as shown in Figure 12 and Figure 13. In general, slow and stable crack growth was observed during the fatigue test. The crack surface morphology had distinct transition points where, on the left side, the surfaces changed from V (valley) to S (slant) fracture and on the right side transitioned from a +45° to a -45° slant fracture. Results indicate that crack-growth rates changed at these transition points similar to those observed in coupon tests conducted on M(t) specimens (Stonaker et al., 2019).

Figure 12. Picture of Phase 1 fatigue crack growth at 33,600 cycles

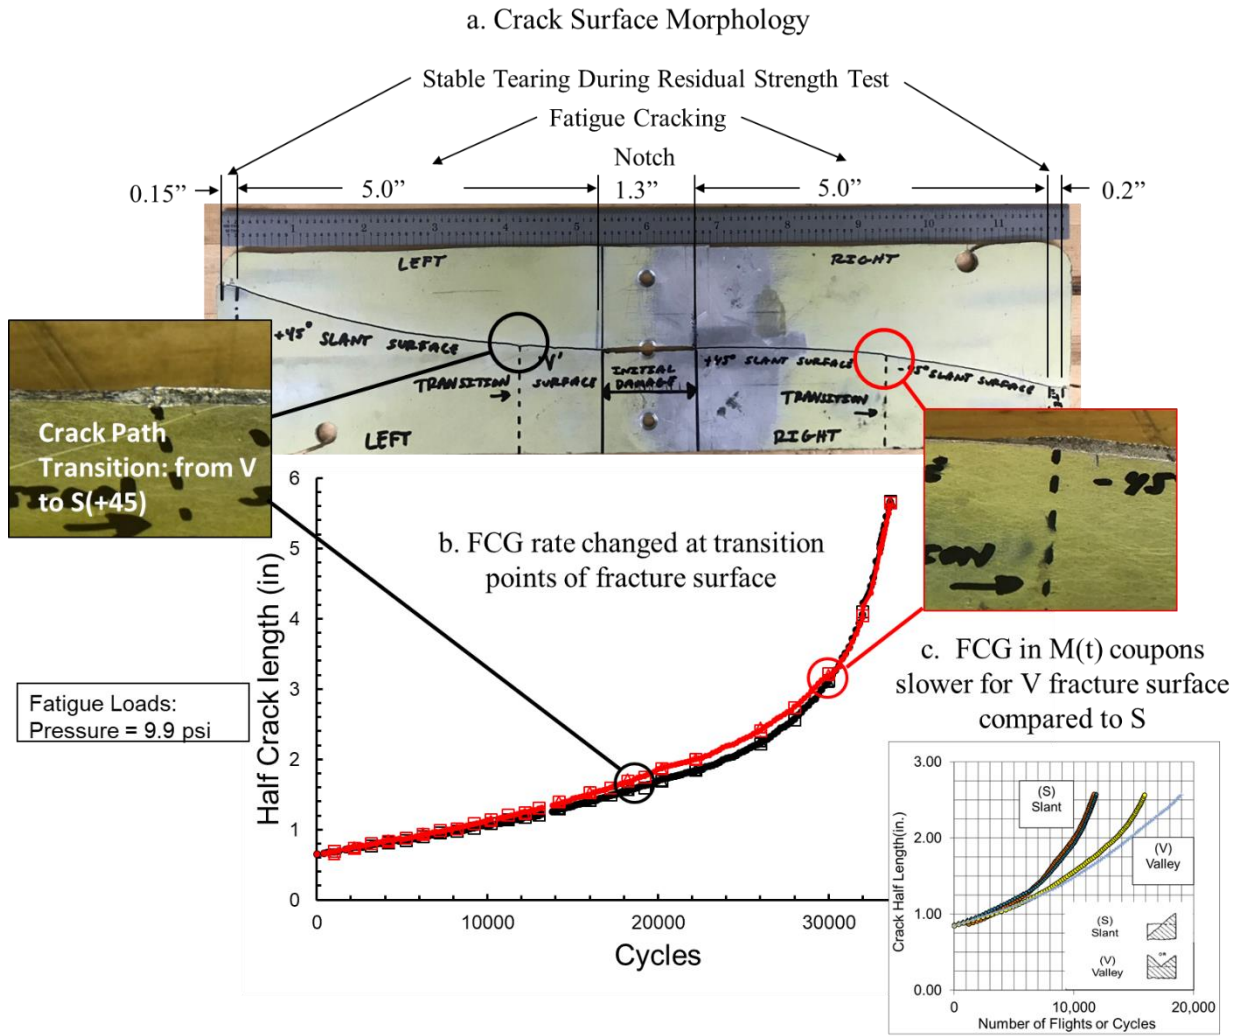
Figure 13. Phase 1 transition points of fracture surface morphology where FCG rates change

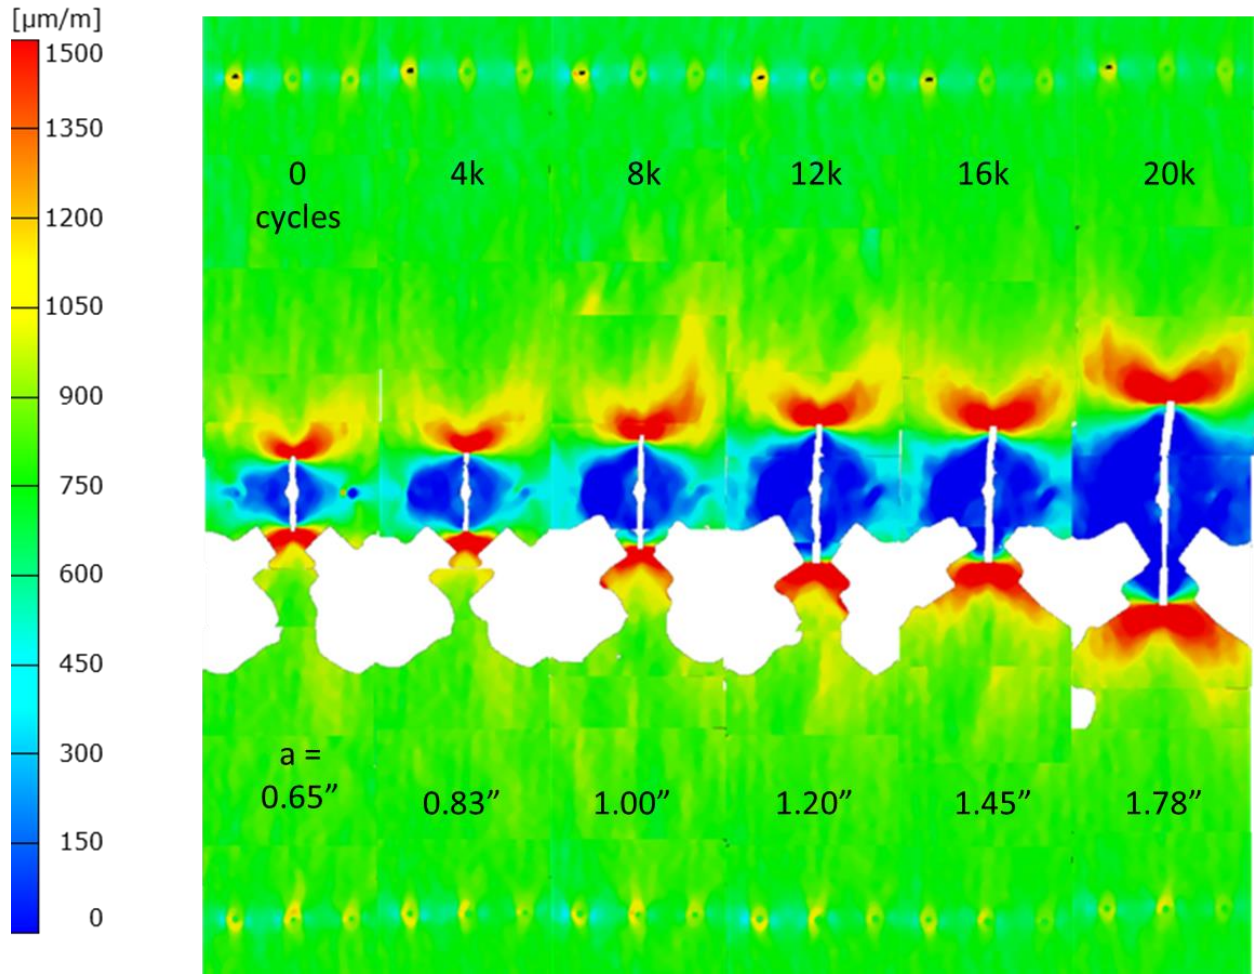
Figure 19. Narrow field of view ARAMIS data at different cycles

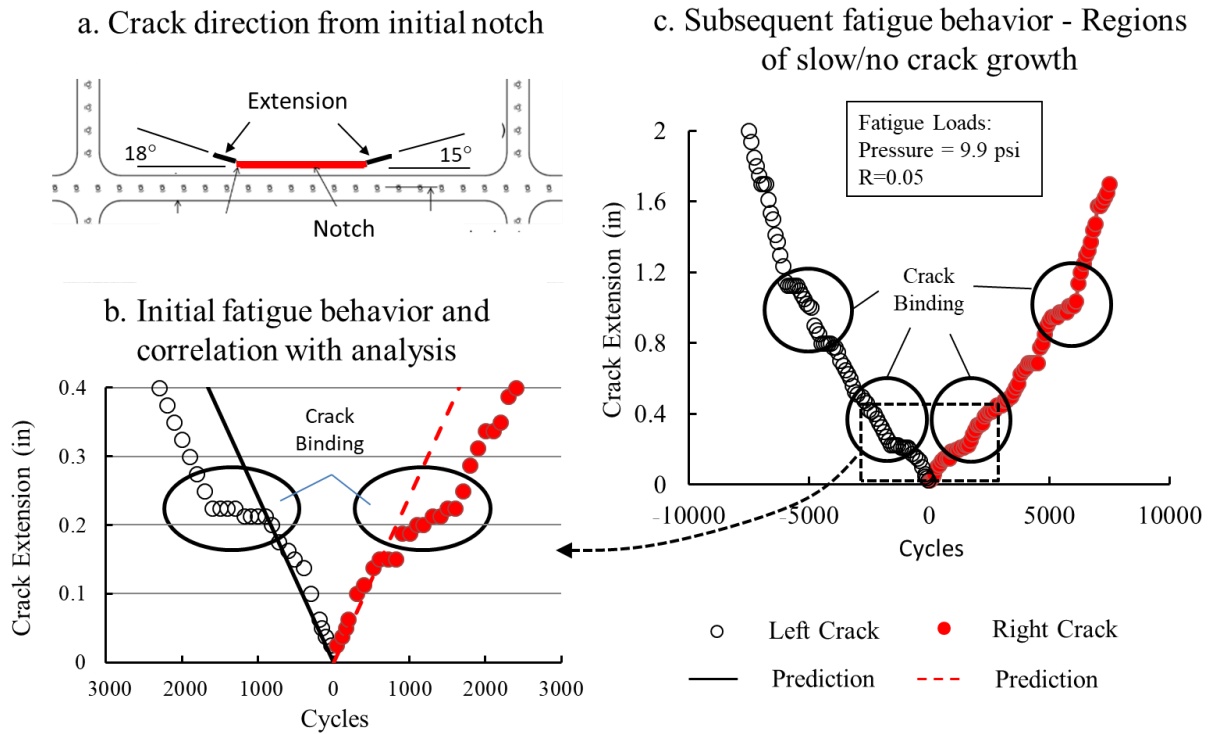
In this phase, the panel was fatigue tested under pressure load conditions for 7,500 cycles, in which the crack extended approximately 1.97 in. from each notch-tip. Representative results are shown in Figure 24. In general, natural cracks developed at 18° and 15° angles from the left and right notch-tips, respectively, which agreed with FEA predictions, as shown in Figure 24a. The initial crack growth increased steadily and correlated with analysis up to approximately 1,000 cycles, where crack extension reduced precipitously, as shown in Figure 24b. Subsequently, the fatigue behavior displayed additional slow/no growth intervals at 4,500 and 6,000 cycles, at which the crack wake surfaces were notched with 0.014 in. diamond wire, leaving the natural

Figure 24. Phase 2 FCG results revealed regions of slow/no growth due to crack binding

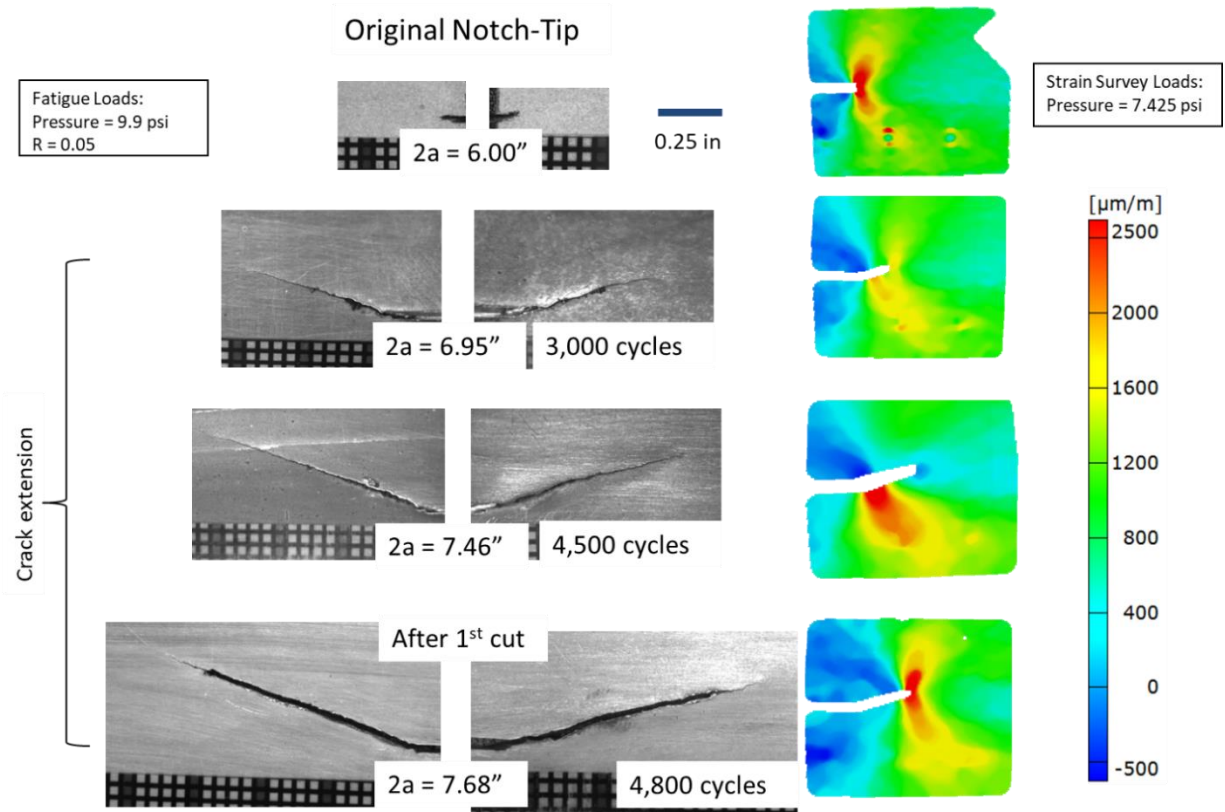
crack-tip (see Figure 25c). Results from DIC revealed crack binding where the highest tensile strains were measured in the wake of the crack during slow/no crack growth interval, as shown in Figure 25. After notching the crack wake, the high-tensile strain region transitioned back to the crack-tip (see Figure 25d).

Figure 25. Phase 2 FCG results reveal high strains in the crack wake due to binding

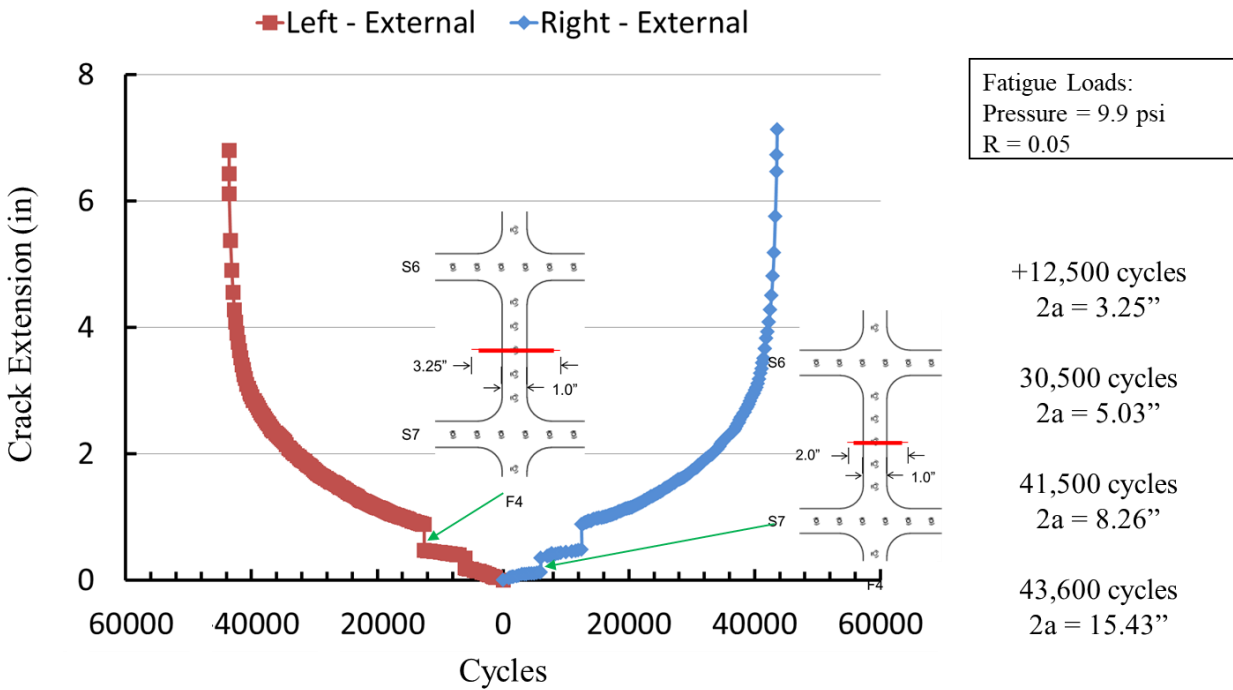
For this final phase, the panel was fatigue tested under pressure load conditions for 43,600 cycles, during which the skin crack extended across two frame bays to a final total length of approximately 16 in. Representative results are shown in Figure 28. The crack growth was quite slow in the initial stages of fatigue testing from the initial total notch length of 1.5 in. Consequently, the notch was extended twice to lengths of 2.0 in. and 3.25 in. after 6,000 cycles and 12,500 cycles, respectively. Local effects from the severed frame-end suppressed crack growth and caused binding for the shorter notch lengths (less than 3.25 in.).

Figure 28. Slow FCG for short crack lengths due to local effects of severed frame and binding

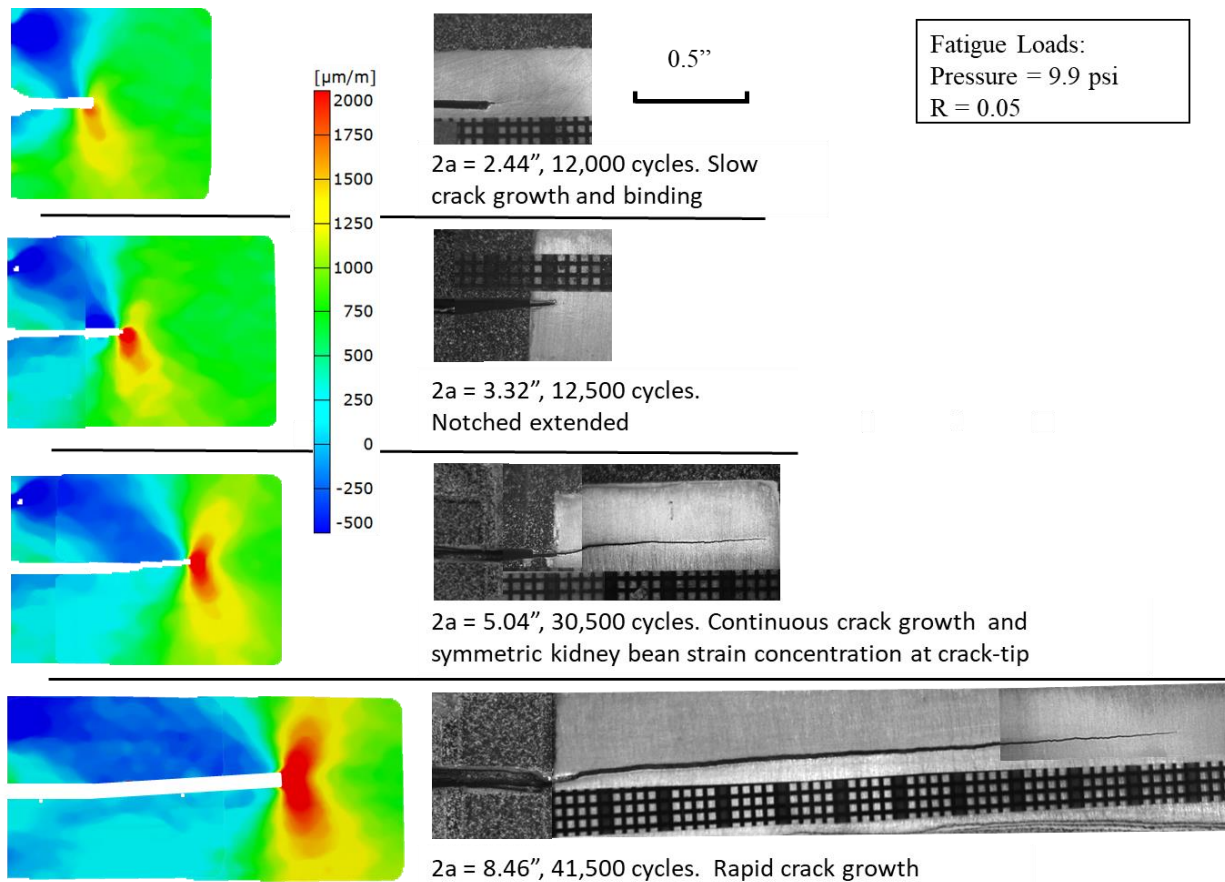
Figure 29. Phase 2 FCG results reveal high strains in the crack wake due to binding

DIC results shown in Figure 29 revealed dispersed and asymmetric crack-tip strains for the shorter cracks, which transitioned to the classical kidney bean strain field as the crack-tip extended from the central severed frame. Subsequent to the second notch inserted at 12,500 cycles, the fatigue crack growth was symmetric, stable, and continuous, as shown in Figure 28. After approximately 41,500 cycles, rapid, but stable, crack extension was observed.

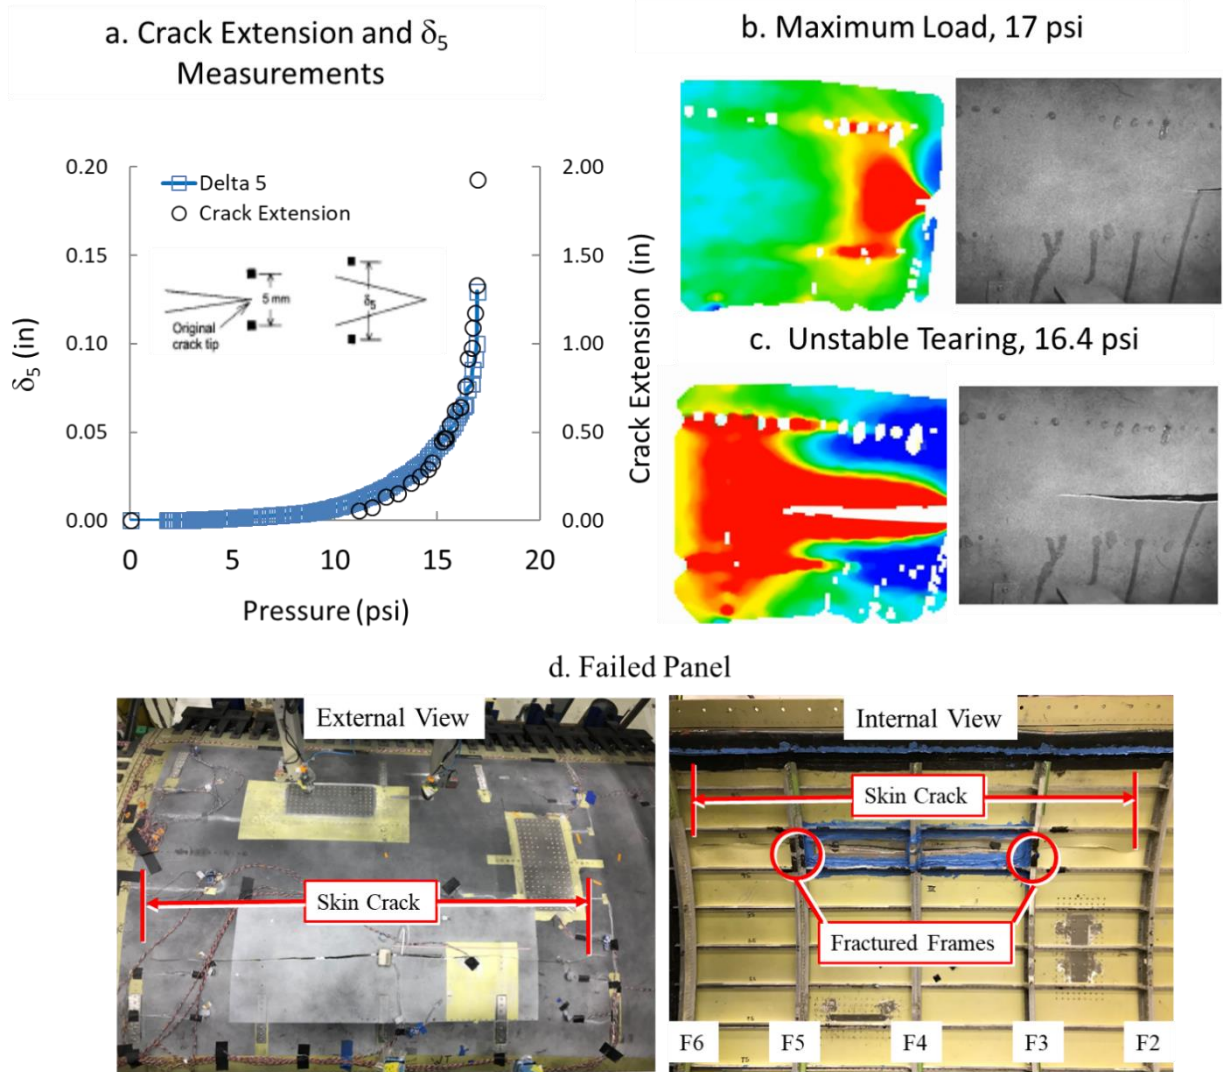
A residual strength test was then conducted under pressure loading applied quasi-statically. Representative results are shown in Figure 30. Both the crack extension and fracture parameter, δ_5 , were measured as a function of applied pressure (see Figure 30a). As shown, initial crack extension was measured at an applied pressure of 11 psi. Approximately 1.02 in. of stable tearing was observed from each crack tip prior to reaching the maximum applied pressure of 17 psi, as shown in Figure 30b. Unstable tearing then occurred, resulting in failure of the panel (see Figure 30c). Extensive damage occurred to the panel where the skin crack extended to a total length of 77 inches and severed two intact frames, as shown in Figure 30d. The pressure at failure exceeded the residual strength damage tolerance requirements in Title 14, Code of Federal Regulations 25.571.

Figure 30. Measurements of crack extension, δ_5 , progressive tearing, and final state of failure

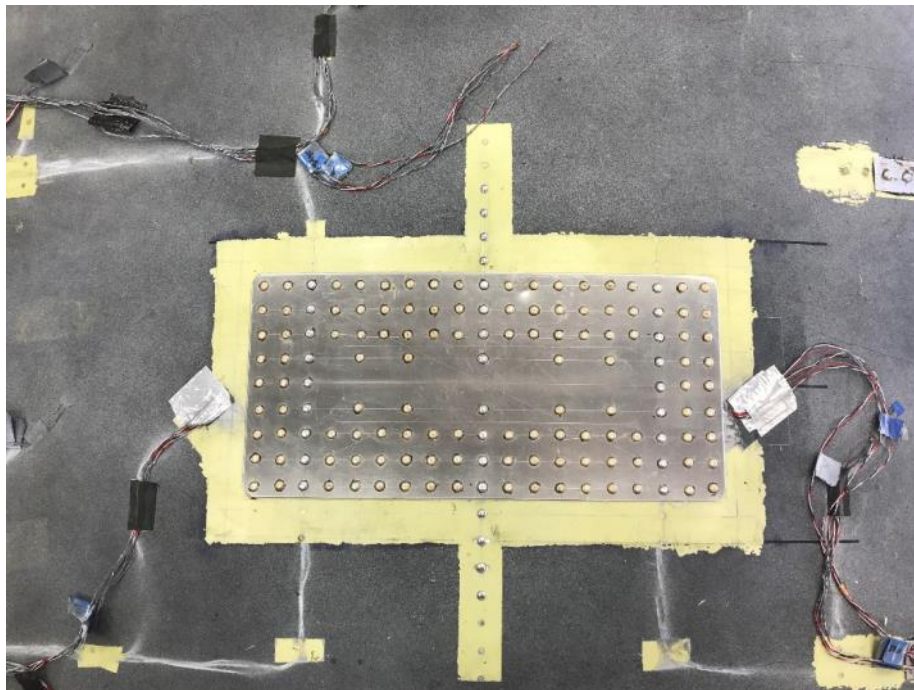
Figure 41. Phase 1 repair external view

After marking the crack tips, further procedures were followed in accordance with the B727 SRM skin repair instructions. The basic requirement is that for a minimum of three rows of rivets beyond the damage cutout, the repair doubler should be one gage thicker than the skin material and it is acceptable to use button head rivets instead of countersunk rivets, as shown in Figure 40. Figure 41 and Figure 42 show the actual image of the SRM repairs after installation.

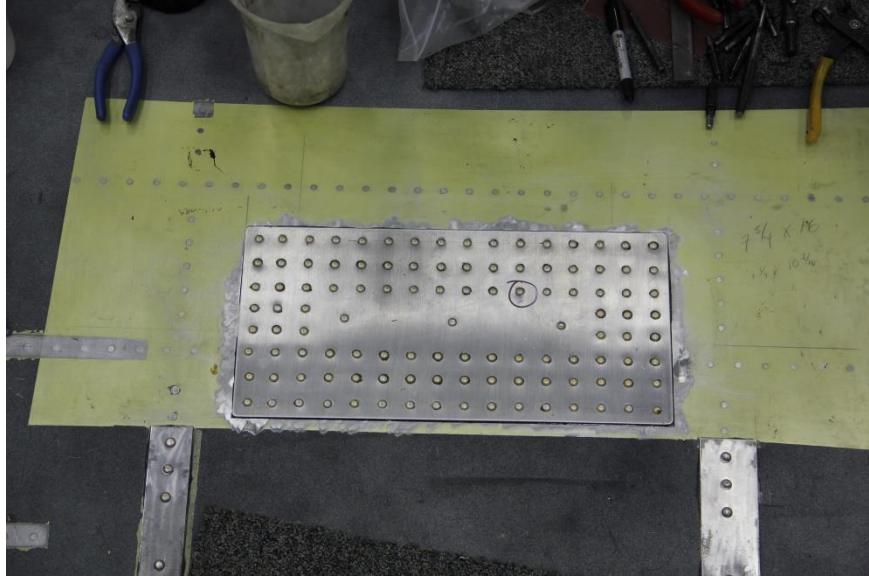
Figure 42. Phase 2 repair external view

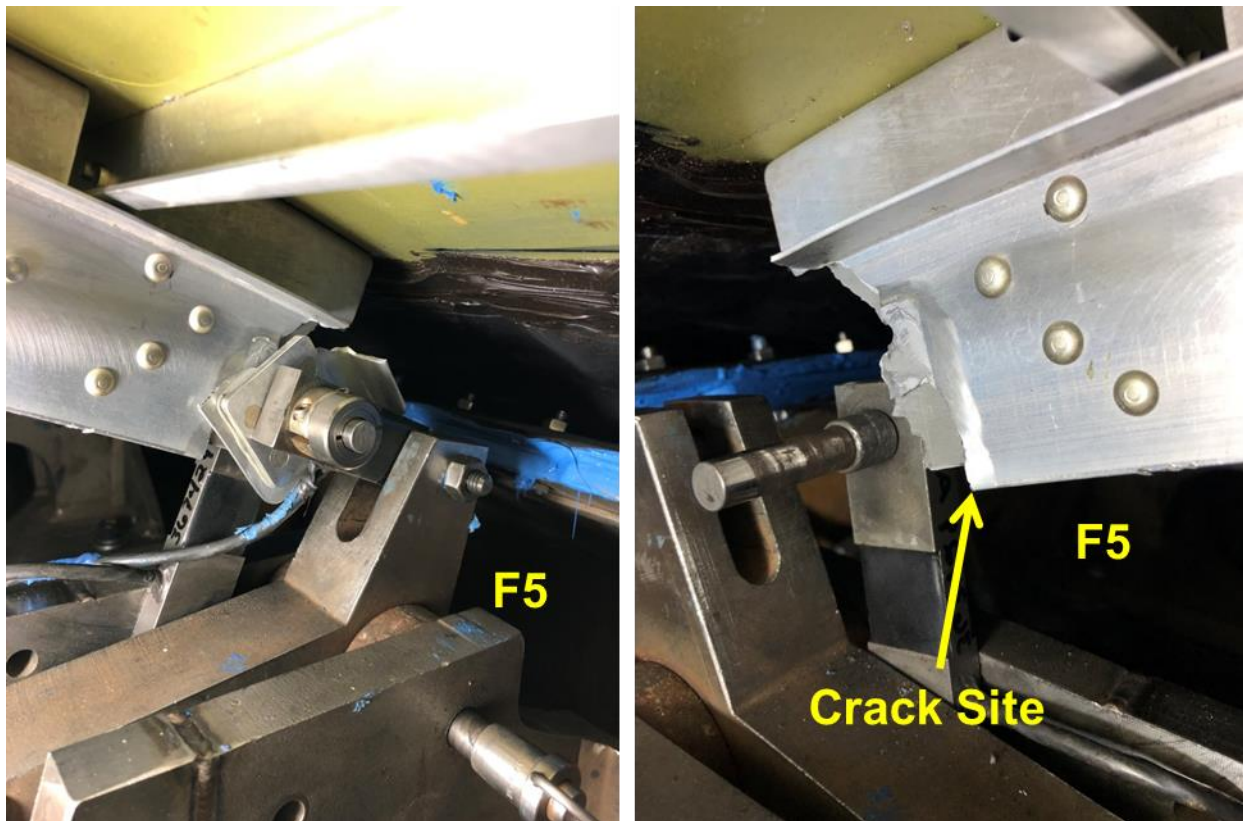
During the Phase 1 fatigue testing, the frame end of F5 was unexpectedly broken at 19,800 cycles due to the lack of a reinforcement doubler on frame ends, as shown in Figure 59. The frame end broke again during the Phase 2 fatigue test—at around 4,500 cycles—due to the use of general aluminum rivets and the absence of structural adhesive bonding. A thorough inspection was conducted, which found cracks in the majority of frame ends. The test panel was removed from the FASTER fixture due to the limitation of working space inside of the pressure box and the intensity of the repair work. The frame ends were reinforced on both ends as shown in Figure 60, Figure 61, and Figure 62. The extra frame end pieces from the previous 727 test panel were used to reinforce the frame ends. The new end stringer clips were fabricated based on the drawings in Appendix A. The panel was installed back on the FASTER fixture after the repair, and the strain survey was conducted to ensure the frame repair and reinforcements did not change load introduction, as shown in Figure 63.

Figure 59. Location of crack at frame end

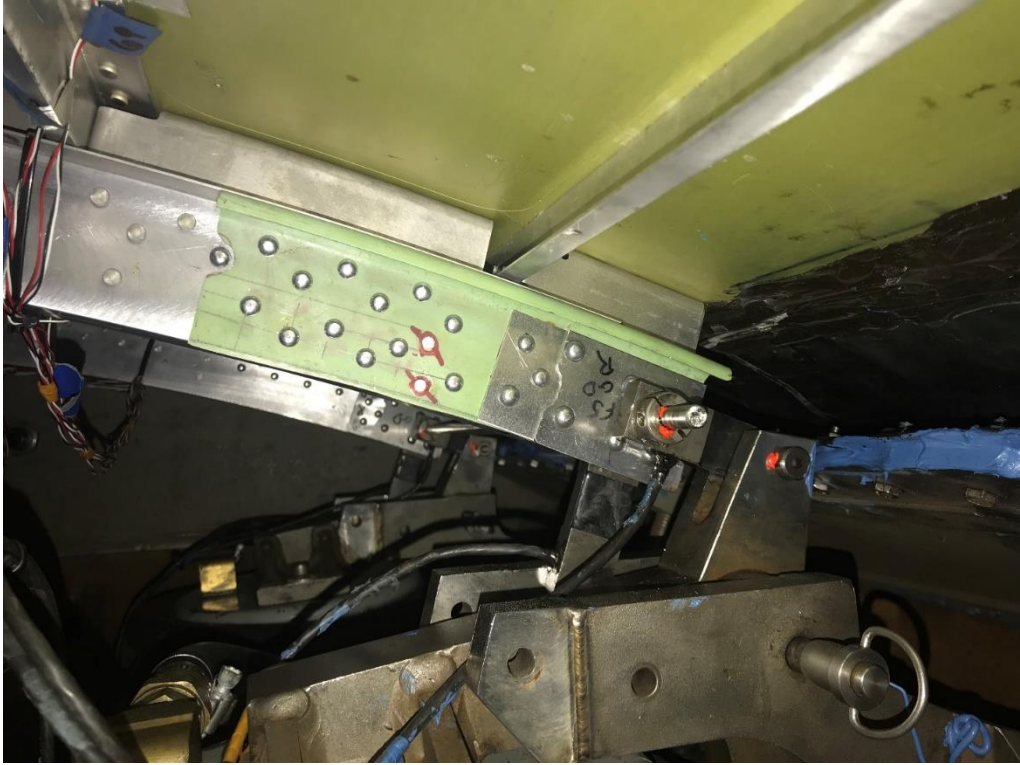
Figure 60. Picture of frame end repair at frame

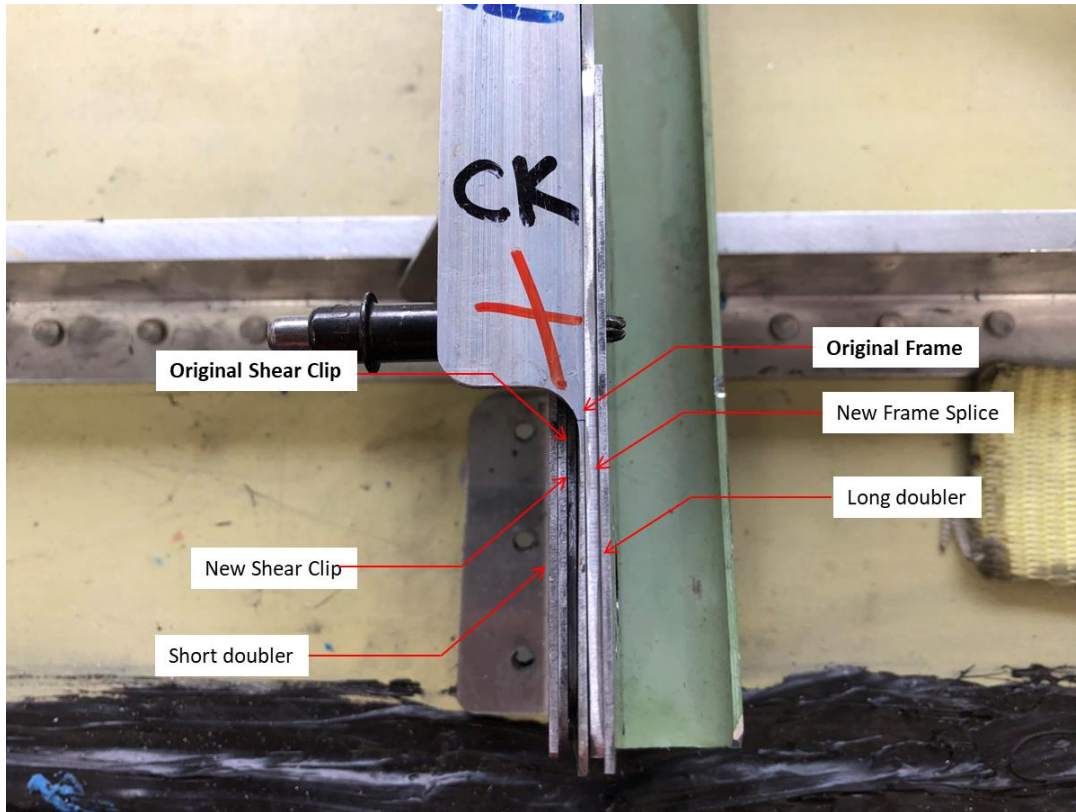
Figure 62. Frame end repair final layup
