# Human Factors Evaluation of Airfield Lighting Configuration and Intensity Control at Boston Logan International Airport

December 2017

DOT/FAA/TC-TN17/65

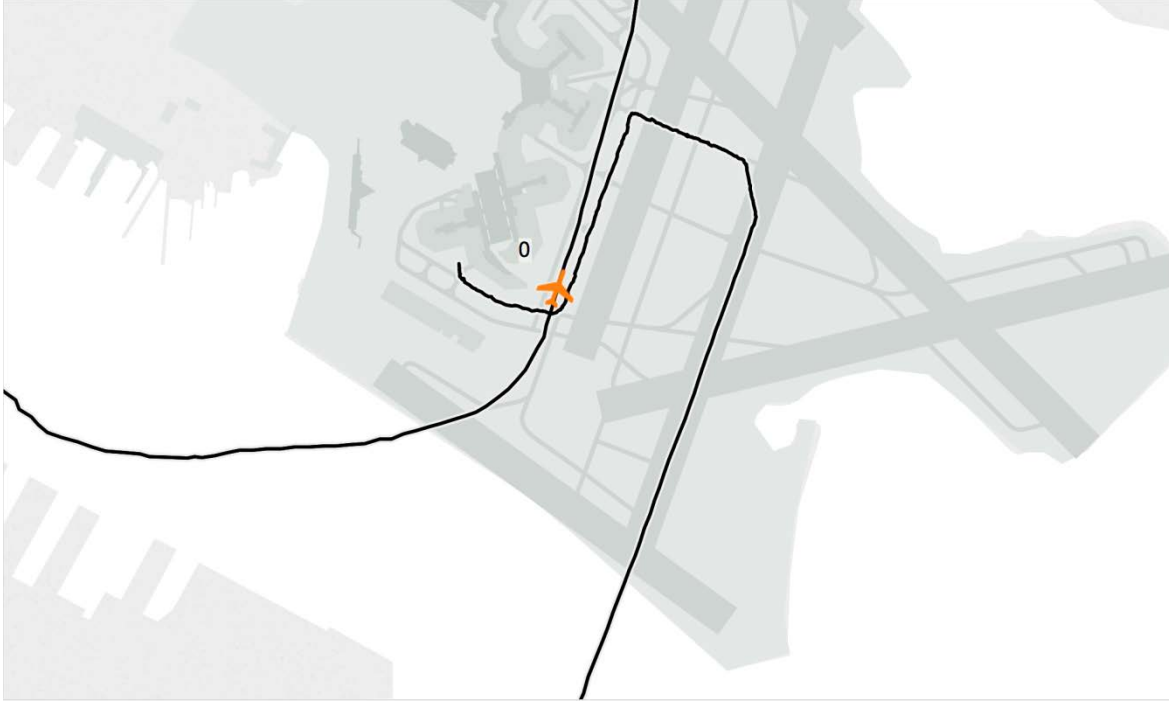
Figure 6. Incident 2 Ground Track [1]

Figure 6 shows the ground track of the incident 2 aircraft. Airport Technology R&D Branch personnel used this ground track to calculate an approach for the FAA test aircraft to fly, essentially a straight-in visual approach to RWY 4L with a 20° offset from the threshold instead of flying the channel to avoid creating noise for Boston residents. This information was then used for several test runs described later in the document.

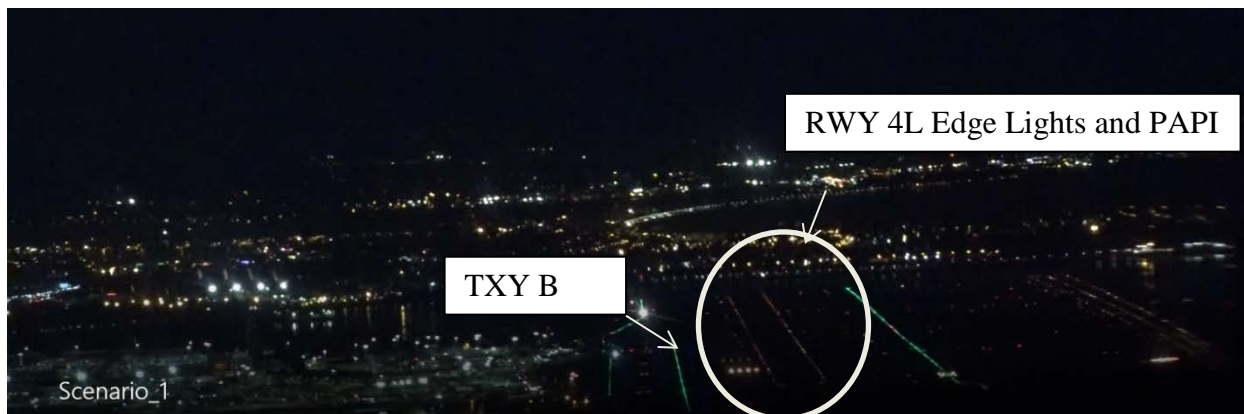
Figure 11. Flight Test Run 1 Aircraft Site View

The first two flight test runs were designed to recreate Incident 1 conditions, which included a straight-in visual approach. During Flight Test Run 1, the airfield lighting configuration on the night of the incident was recreated. In particular, the RWY 4L centerline lights were turned off, as they were not installed when the incident occurred. Figure 11 shows the aircraft view of BOS on the approach for Flight Test Run 1. RWY 4L is clearly visible with the precision approach path indicators (PAPI) on the left side of the runway. TXY B is also clearly identified by the green centerline lights.

As the aircraft began the approach, PAPIs on RWY 4L and 4R first; then, the pilots identified the white runway lights on RWY 4L and noted that RWY 4R runway lights were visible but slightly dimmer (normal for viewing the runway lights from over the taxiway). Researchers noted that the green centerline lights of TXYs B and M were clearly visible and perceived to be brighter than RWY 4L. When the aircraft got closer to the runway, both REILs on RWY 4L were visible; the green taxiway centerline lights still appeared green, and RWY 4R was more visible than 4L because of the centerline and approach lights. RWY 4L’s edge lighting was observed to be not uniform (i.e., “spotty”). Given the angle of approach and background illuminance, visibility would likely have improved if the edge lights on RWY 4L were set to step 3 instead of step 2. Blue taxiway edge lights on TXYs B and M were visible. Researchers determined there was no mistaking the taxiway for a runway during approach.

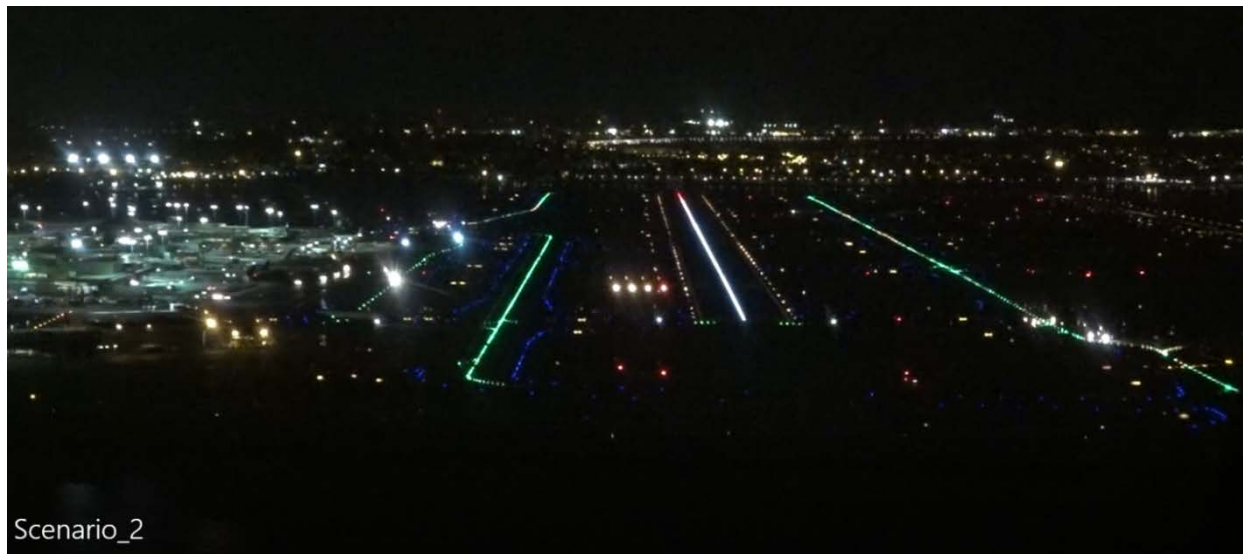
Figure 12. Flight Test Run 2 Aircraft Site View

As the aircraft began the approach, researchers identified the PAPIs on RWY 4L and RWY 4R first; then, they identified the white lights of RWY 4L, and noted that RWY 4R's lights were visible but slightly dimmer. After initial identification, it was noted that the RWY 4L centerline lights definitely appeared whiter than any other white lights in view. RWY 4L edge lights looked more yellow, dimmer, and still spotty. RWY 4L centerline lights were noticeably brighter than RWY 4L edge lights. All lights on RWY 4R, where visible, appeared yellow and dimmer than the RWY 4L centerline lights. When the aircraft was closer to the runway, both REILs on RWY 4L were visible, and the green centerline lights on TXY B appeared green. Blue taxiway edge lights were visible for TXYs B and M. Researchers determined there was no mistaking TXY B for a runway during the approach.

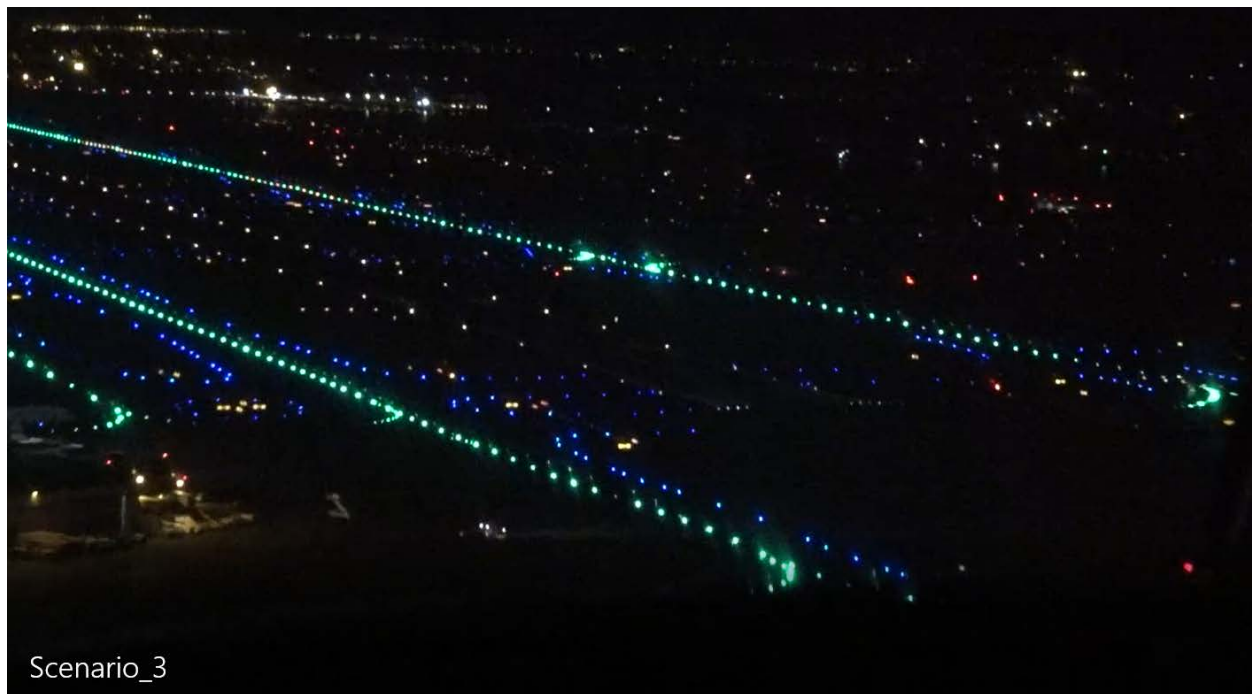
Figure 13. Flight Test Run 3 Aircraft Site View

As the aircraft began the approach, PAPIs on RWYs 4L and 4R were not visible. However, green centerline lights for both TXYs B and M were clearly visible. At about 3 miles, only one REIL (later identified as the right REIL) on RWY 4L was visible, and RWY 4L runway lights were identified. Green taxiway centerline lights appeared green. The green centerline lights of TXYs B and M were clearly visible. As the aircraft came closer to the edge of TXY B, RWY 4L's left REIL and edge lights became visible. TXY B lights were noticeably brighter than RWY 4L lights. With the angle of approach and background illuminance, visibility could have

been improved if RWY 4L edge lights had been set on step 4 instead of step 3. The green centerline lights of TXY A were visible. Blue edge lights of TXY B and M were visible. Researchers determined there was no mistaking TXY B for a runway during the approach.

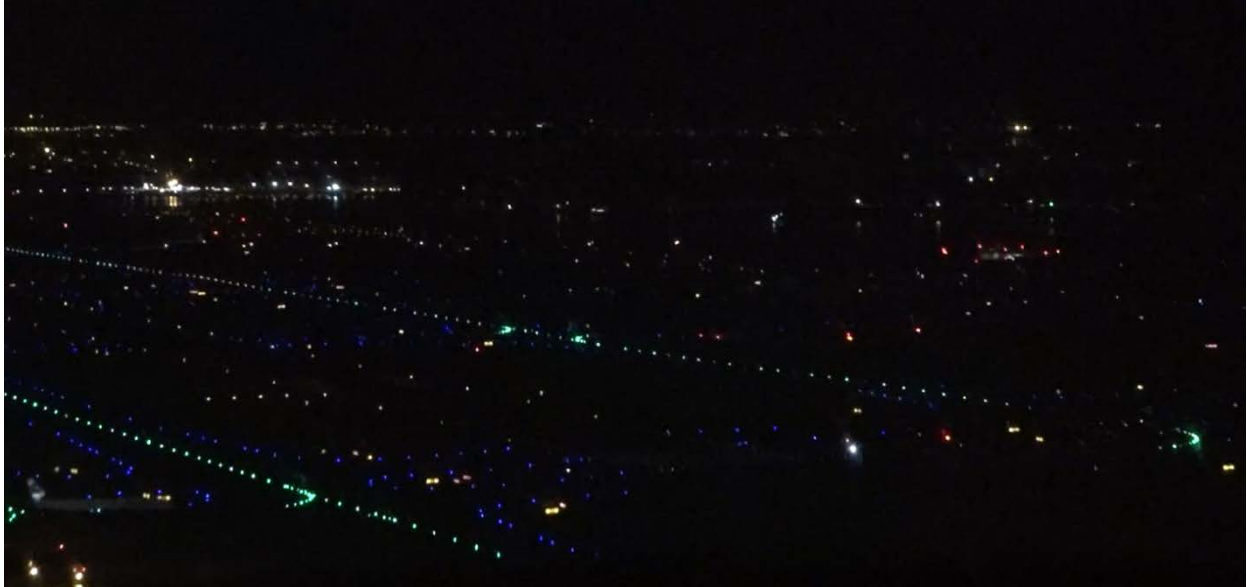
Figure 14. Flight Test Run 4 Aircraft Site View

As the aircraft began the approach, PAPIs on RWY 4L and RWY 4R were not visible. However, as in all previous flight test runs, the green centerline lights of both TXYs B and M were clearly visible. The researchers could still not see the runway lights; and as a result, one pilot commented that “the runway must be between the two long green lines, so let’s keep going.”

At about 3 miles, only one REIL (later identified as the right REIL) on RWY 4L was visible, RWY 4L runway lights were identified, TXY B and M green centerline lights were clearly visible and appeared unmistakably green. RWY 4L edge lights came into view.

When closer to the edge of TXY B, RWY 4L’s left REIL became visible. TXY B lights were noticeably brighter than the RWY 4L lights. With the angle of approach and background illuminance, better visibility would likely be achieved if the RWY 4L lights were set to step 3. The blue TXY B and M edge lights were visible. Researchers determined there was no mistaking TXY B for a runway during the approach.

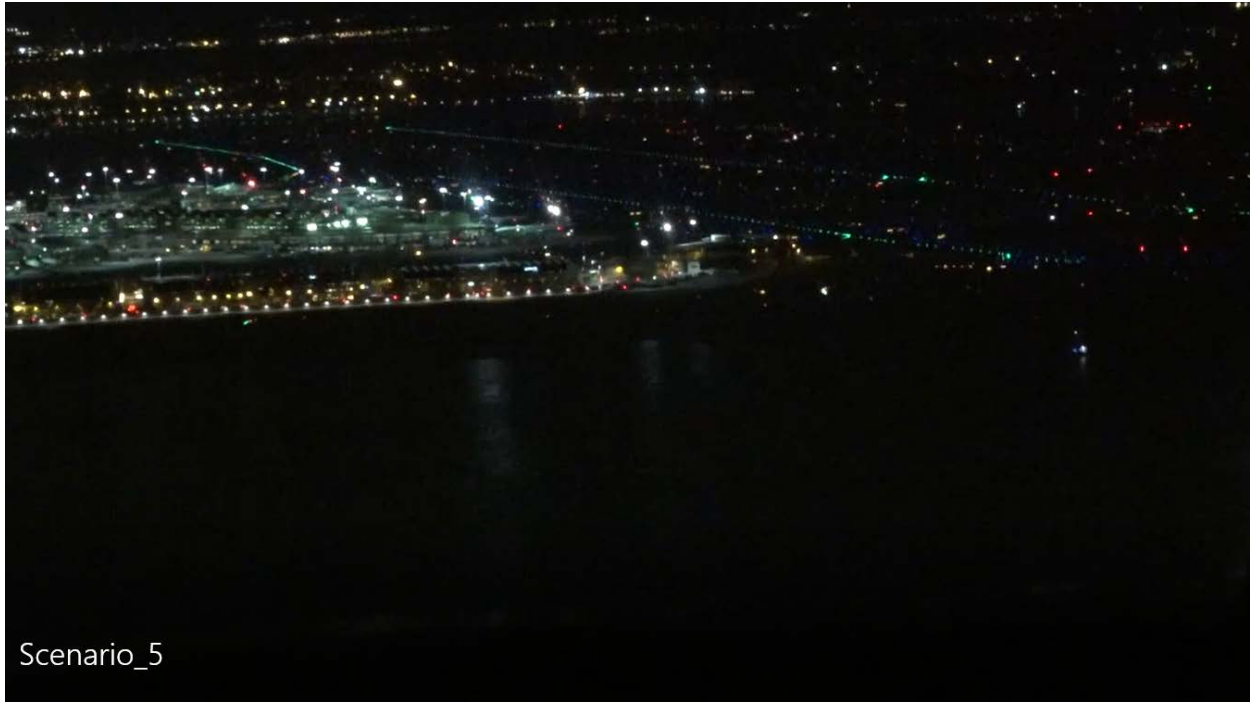
Figure 15. Flight Run 5 Aircraft Site View—Over Channel

Initially, from a distance, RWY 4L and RWY 4R PAPIs were not visible. However, as in all previous flight test runs, both TXY B and M green centerline lights were clearly visible. Having flown the previous approaches, the test aircraft pilots knew that the runway was between the two long green lines, as shown in figure 16.

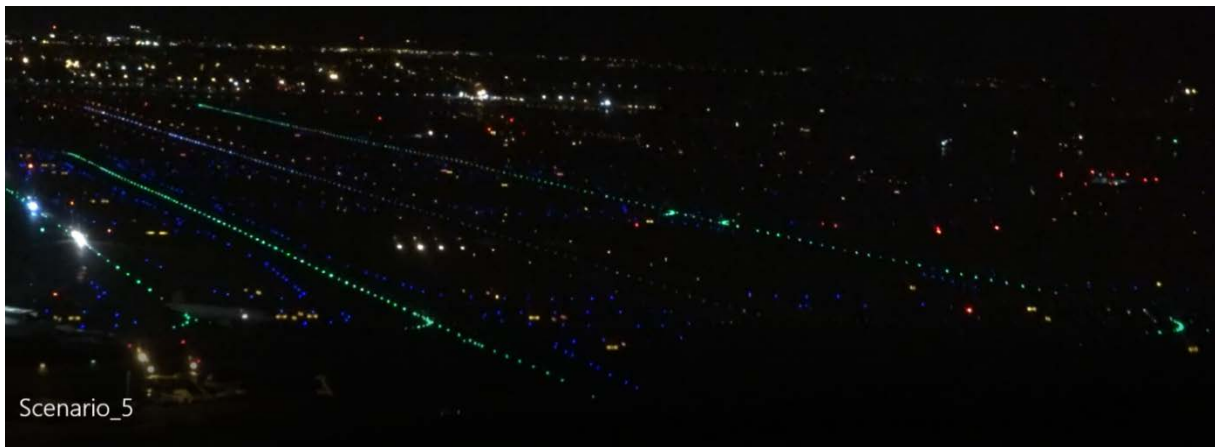
Figure 16. Flight Test Run 5 Aircraft Site View

At about 3 miles, only one REIL (later identified as the right REIL) on RWY 4L was visible; RWY 4L lights were identified, and TXY B and M green centerline lights were visible and appeared unmistakably green. RWY 4L edge lights became visible. TXY B lights were noticeably brighter than RWY 4L lights. From this angle, having RWY 4L centerline lights activated did not aid in identifying the runway.

As the aircraft approached the edge of TXY B, RWY 4L's left REIL became visible. With angle of approach and background illuminance, better visibility would probably be achieved if RWY 4L lights were set to step 3. The blue TXY B and M edge lights were visible. There was no mistaking TXY B for a runway during the approach.

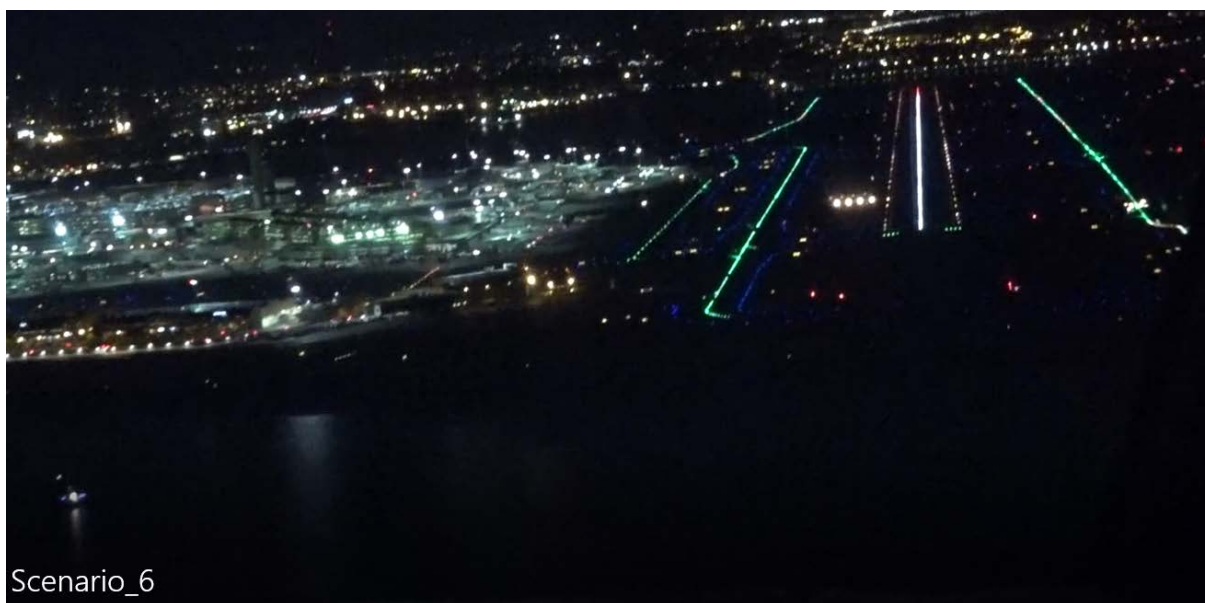
Figure 17. Flight Test Run 6 Aircraft Site View

Initially, from a distance, PAPIs on Runways 4R and 4L were identified, RWY 4R's yellow-white runway edge lights were identified, and RWY 4L's centerline light was clearly visible. The RWY 4L white centerline lights appeared brighter than any other white lights on the airfield. The green lights on TXY B and M were visible.

At a closer distance, the TXY B green centerline lights and the RWY 4L lights became visible, and both REILs were visible. Although all RWY 4L lights were visible, the runway edge lights appeared yellow and dimmer compared to the RWY 4L centerline lights. The blue TXY B and M edge lights were visible. Researchers determined that there was no mistaking TXY B for a runway during the approach.

The pilots noted there were mechanical construction cranes located across the water between RWYs 4R and 4L and about 2 miles from the RWY 4L threshold. The pilots suggested that the side-step height from RWY 4R to RWY 4L be increased by 100' from the current 800' AGL to provide more clearance.

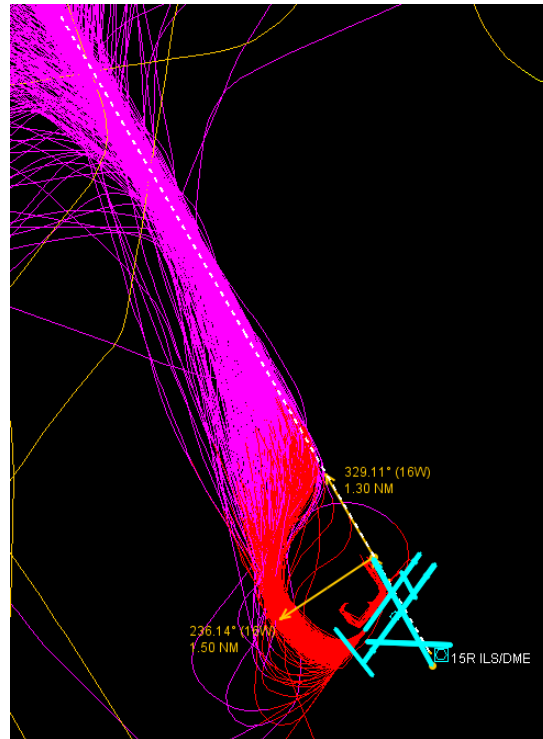
Figure 18. Analysis of Aircraft Arrivals on 15R ILS Visual Transition to RWY 4L (January 2015-July 2016) [1]

In October 2016, an analysis was performed of the aircraft approaches into BOS RWY 4L using the 15R ILS transition procedure from January 2015 through July 2016. Researchers determined that 2480 aircraft used the 15R ILS visual transition to RWY 4L procedure within this time period, of which there were four missed approaches and zero aircraft that lined up on TXY B. Figure 18 is a mapping of the approach routes by altitude and shows the majority of aircraft flew the route at under 2000' AGL.
