# Evaluation of Premature Cracking in Urban Concrete Pavement

Research Report No. FHWA-ICT-21-001

A report of the findings of  
**ICT PROJECT R27-193-4**  
**Premature Cracking Mechanism for**  
**Jointed Plain Concrete Pavement**

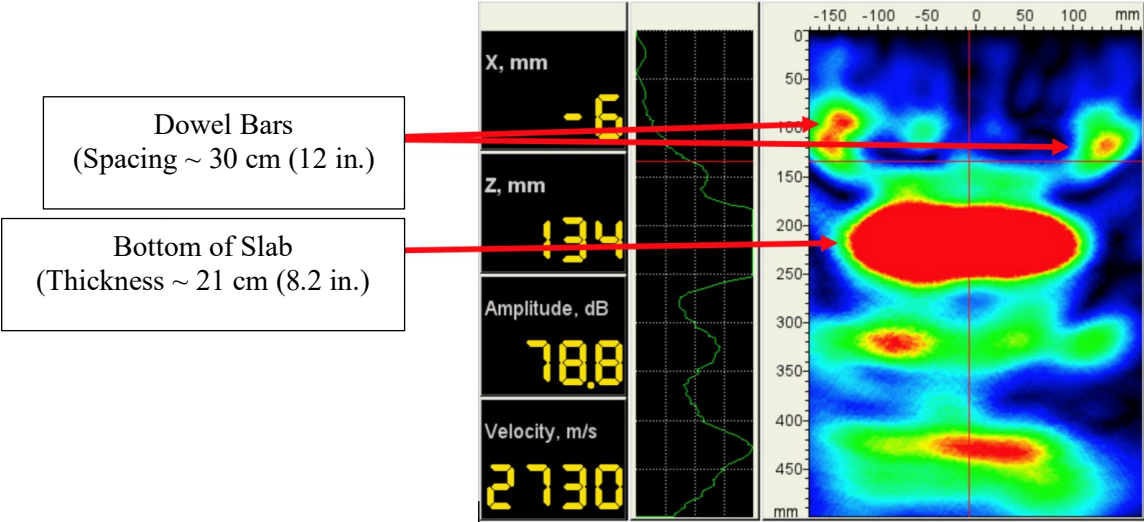
Figure 3. Photo. Ultrasonic tomographic image from example concrete pavement section.

The recorded ultrasonic image can be used to detect slab thickness, dowel and tie bar placement (depth and spacing), and whether a contraction joint is activated. Figure 3 shows an example of the tomographic image taken from a specific project and its interpretation.

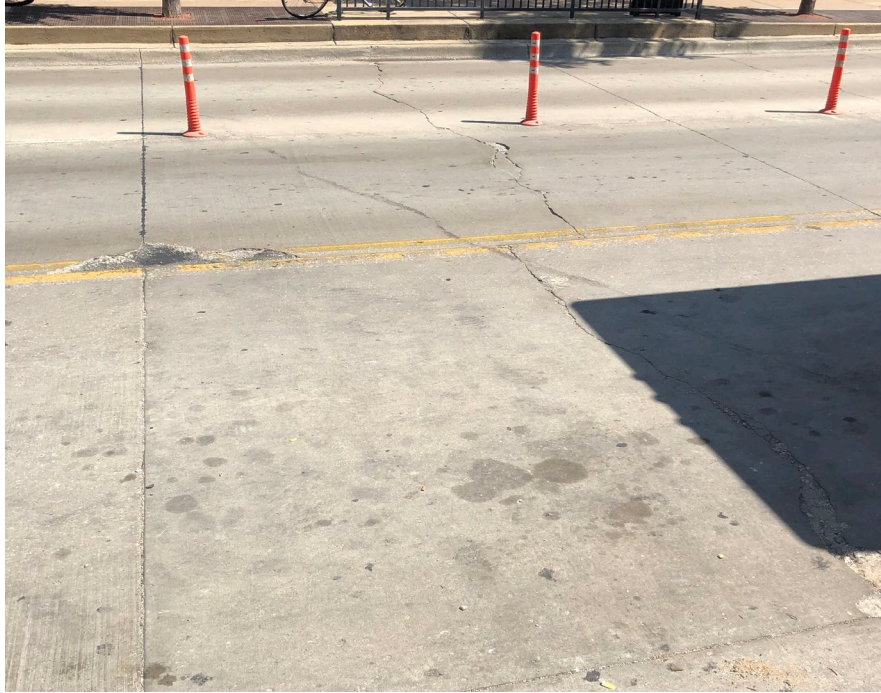
**Figure 20. Photo. Transverse cracking on Green Street (Champaign, IL).**

Green Street is in the heart of the University of Illinois at Urbana-Champaign. The road had a full reconstruction around 2005 and developed transverse cracking distresses within the first few years. Figure 20 shows an image of Green Street with the commonly observed transverse cracking.

The ultrasonic evaluation was performed in five different testing locations to have a better representation of the JPCP section. The ultrasonic evaluation showed inconsistencies between the thickness at the different locations, as well as the tie bar spacing. The obtained thickness measurements ranged from 8 in. to 10 in., and the tie bar spacing ranged from no tie bars detected to 36 in. Table 13 summarizes the ultrasonic evaluations for Green Street.

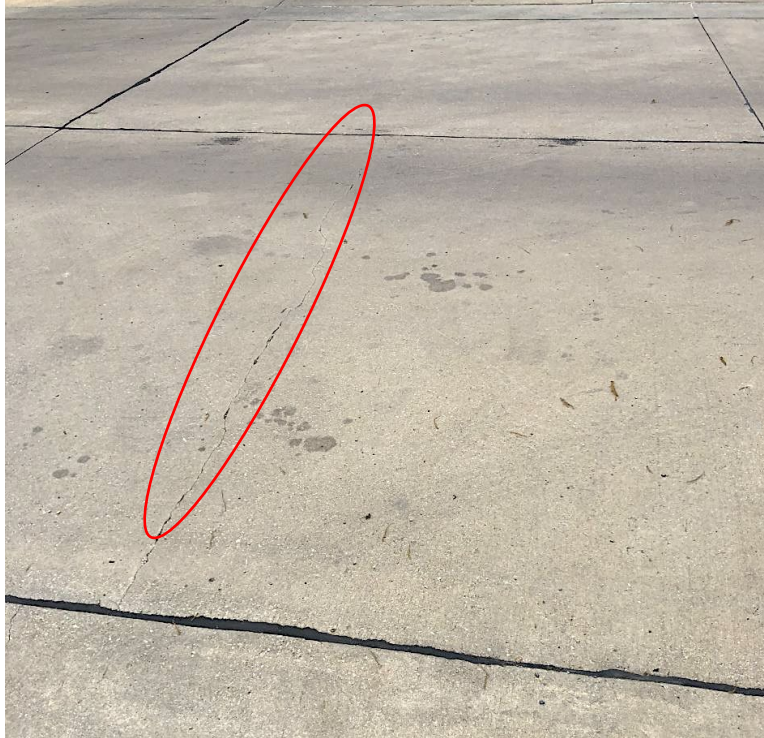
**Figure 21. Photo. Healey Street premature mid-panel crack.**

Healey Street is a road that runs parallel to Green Street but is located one block north. Healey Street is a local street and has only car traffic. This recently reconstructed urban JPCP section is showing premature transverse cracks in about 30% of the slab panels (see Figure 21). The images from the ultrasonic evaluation showed significant distortion near the surface of the concrete (Figure 22). This may be related to poor consolidation of the concrete and may have contributed to premature cracking with another mechanism.

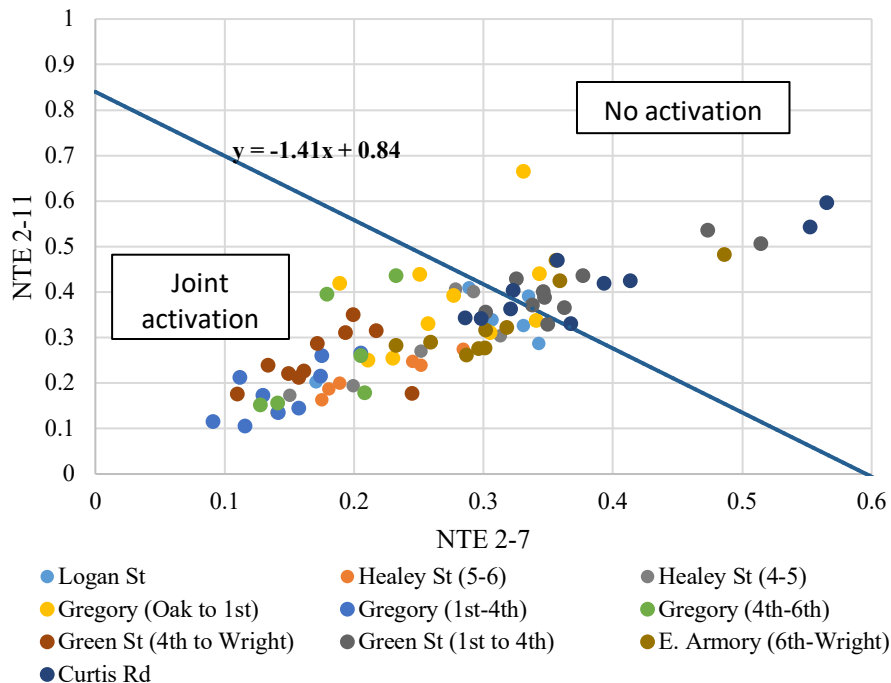
**Figure 28. Graph. Hyperplane joint activation results.**

This MIRA analysis shows that some joints may not be activated and could be contributing to premature cracking. Additionally, these joints were all tested a minimum of 5 years after

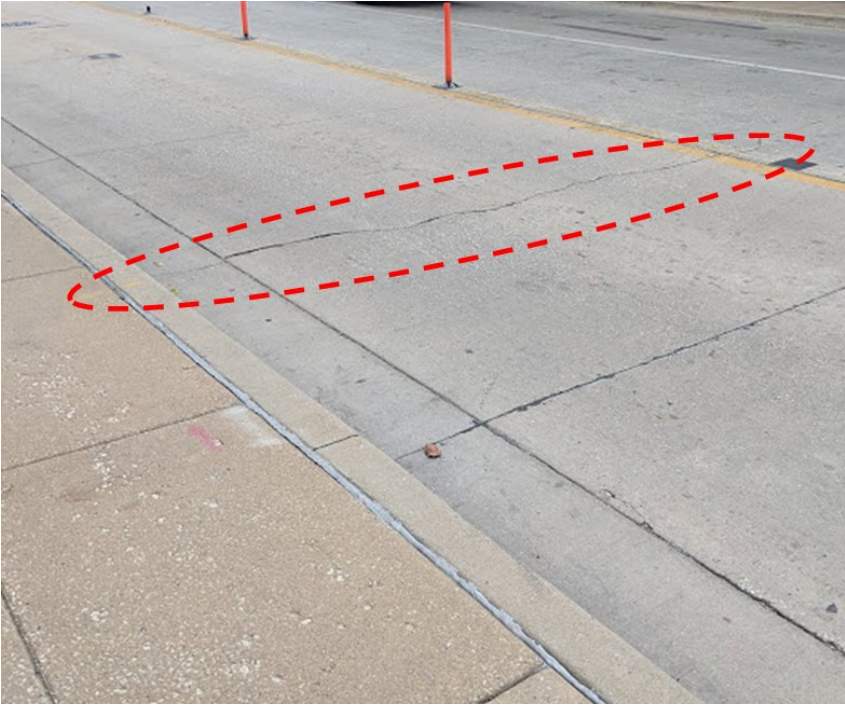
Figure 128. Photo. Transverse crack on Green Street near Wright Street.

Street is a very busy street in Champaign, Illinois, which made testing more challenging than other sections. Therefore, only three to four adjacent joints were able to be evaluated per location. Table 92 summarizes the results of the joint evaluation conducted on the three testing locations on Green Street between Wright Street and Fourth Street in Champaign, Illinois. From this ultrasonic joint analysis, all joints tested along Green Street are activated and are not likely the main contribution to the transverse cracking (see Figure 129).
