# Crash Test Between a 6-KG/M U-Channel Sign Support and a 1997 Geo Metro: FOIL Test Number 99F010

PUBLICATION NO. FHWA-RD-01-046

MARCH 2001

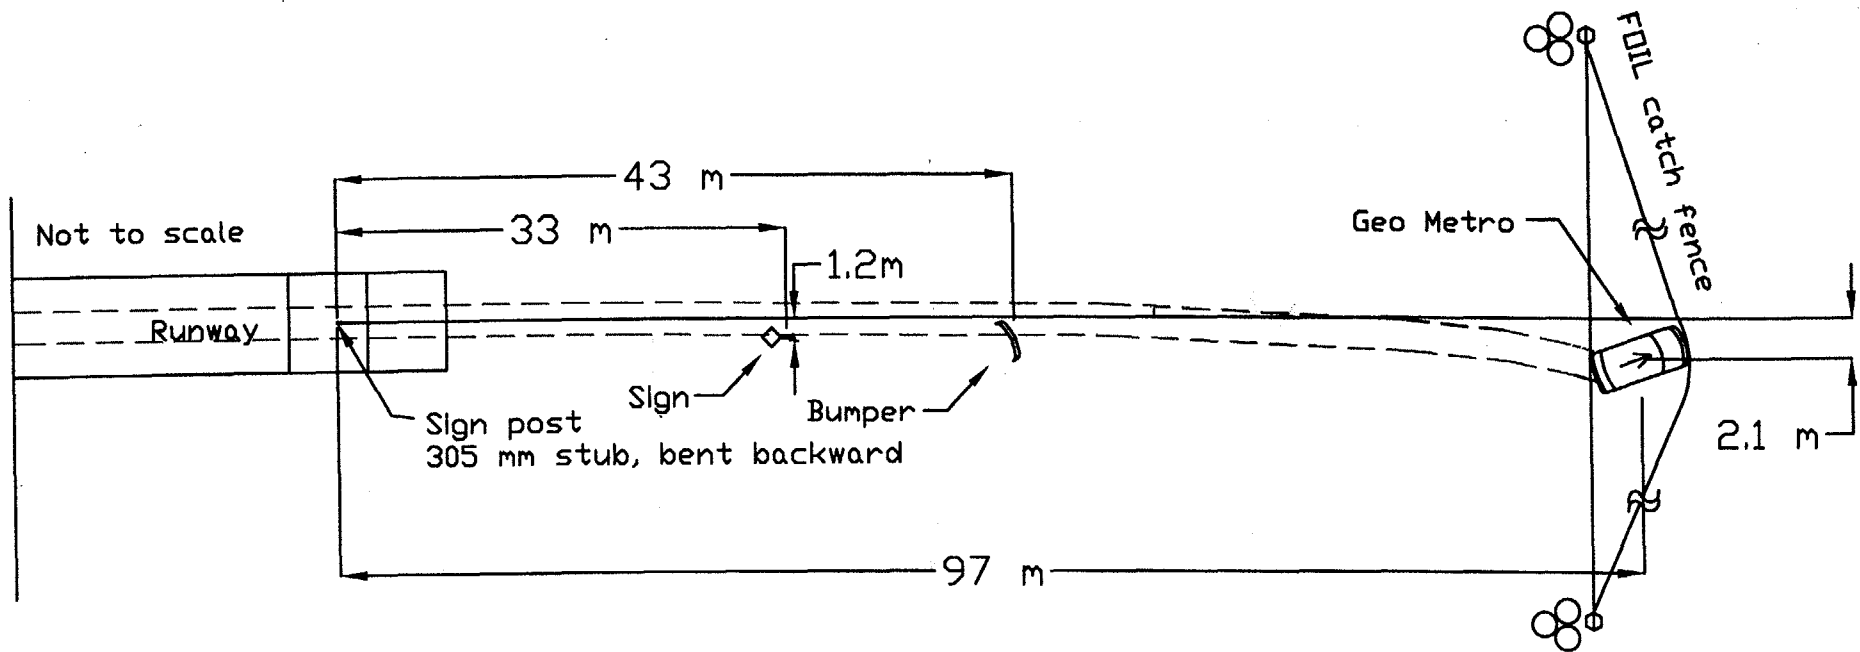
Figure 4. Summary of results, test 99F010.

The results summarized in figure 4 indicate that the 6-kg/m small sign support embedded in strong soil did not meet the safety performance criteria outlined in *NCHRP Report 350* (test designation 3-61). The sign support did fracture as anticipated and the longitudinal OIV (1.7 m/s) was below the allowable limit (5 m/s). However, the sign post contact with the vehicle caused a significant amount of denting to the roof and shattered the windshield, diminishing a driver's visibility. Table 6 summarizes the safety performance of the small sign support.

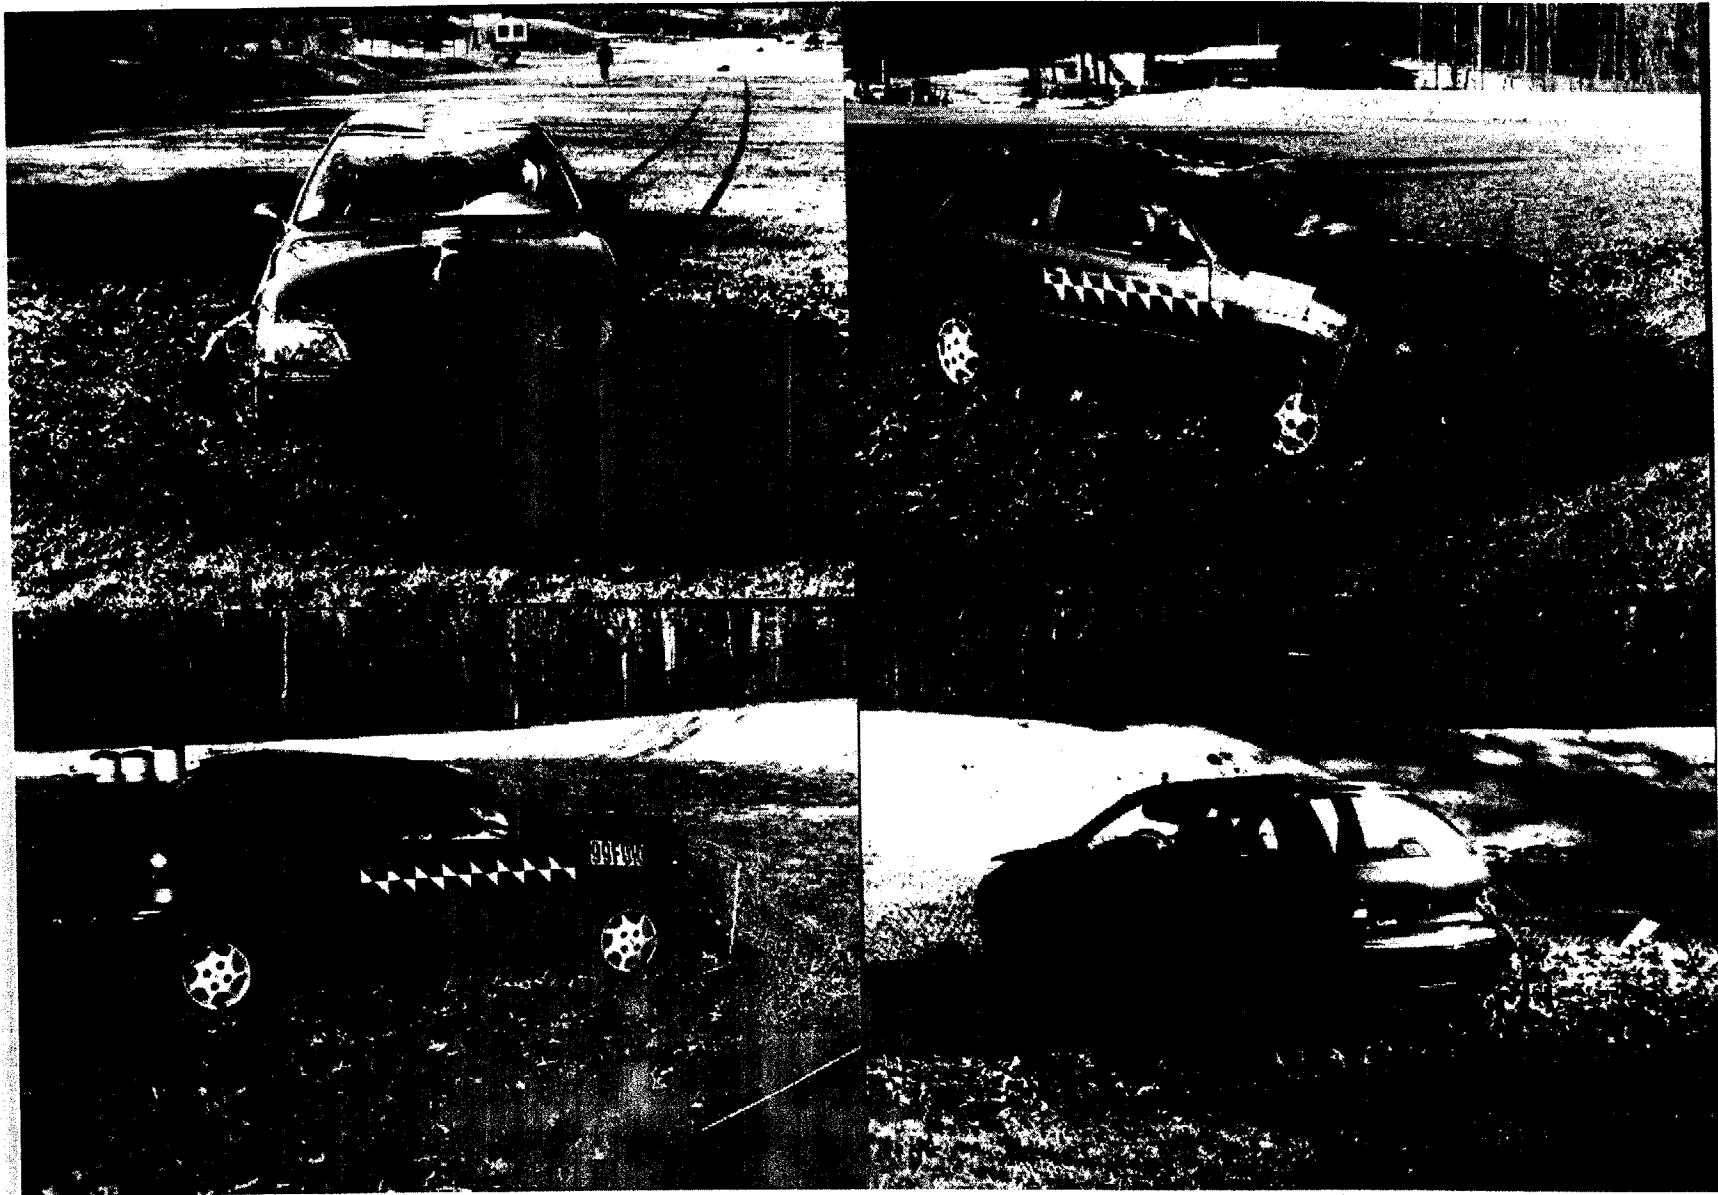
Figure 8. Post-test photographs, test 99F010.

Vehicle damage. Damage to the vehicle was extensive. The hood, roof, grill, head lights, and core supports were either crushed and/or dislodged from the vehicle. The bumper and lower front cross-member were torn from the vehicle. The windshield was shattered. Both air-bags were deployed.

Sign damage. The sign support fractured approximately 305 mm above ground. The remaining stub was bent backward and the sign

panel and post were launched downrange approximately 43 m. The trajectory of the sign post was in line with the vehicle trajectory. There was no evidence of post pull-out before fracture. The sign post could not be reused.

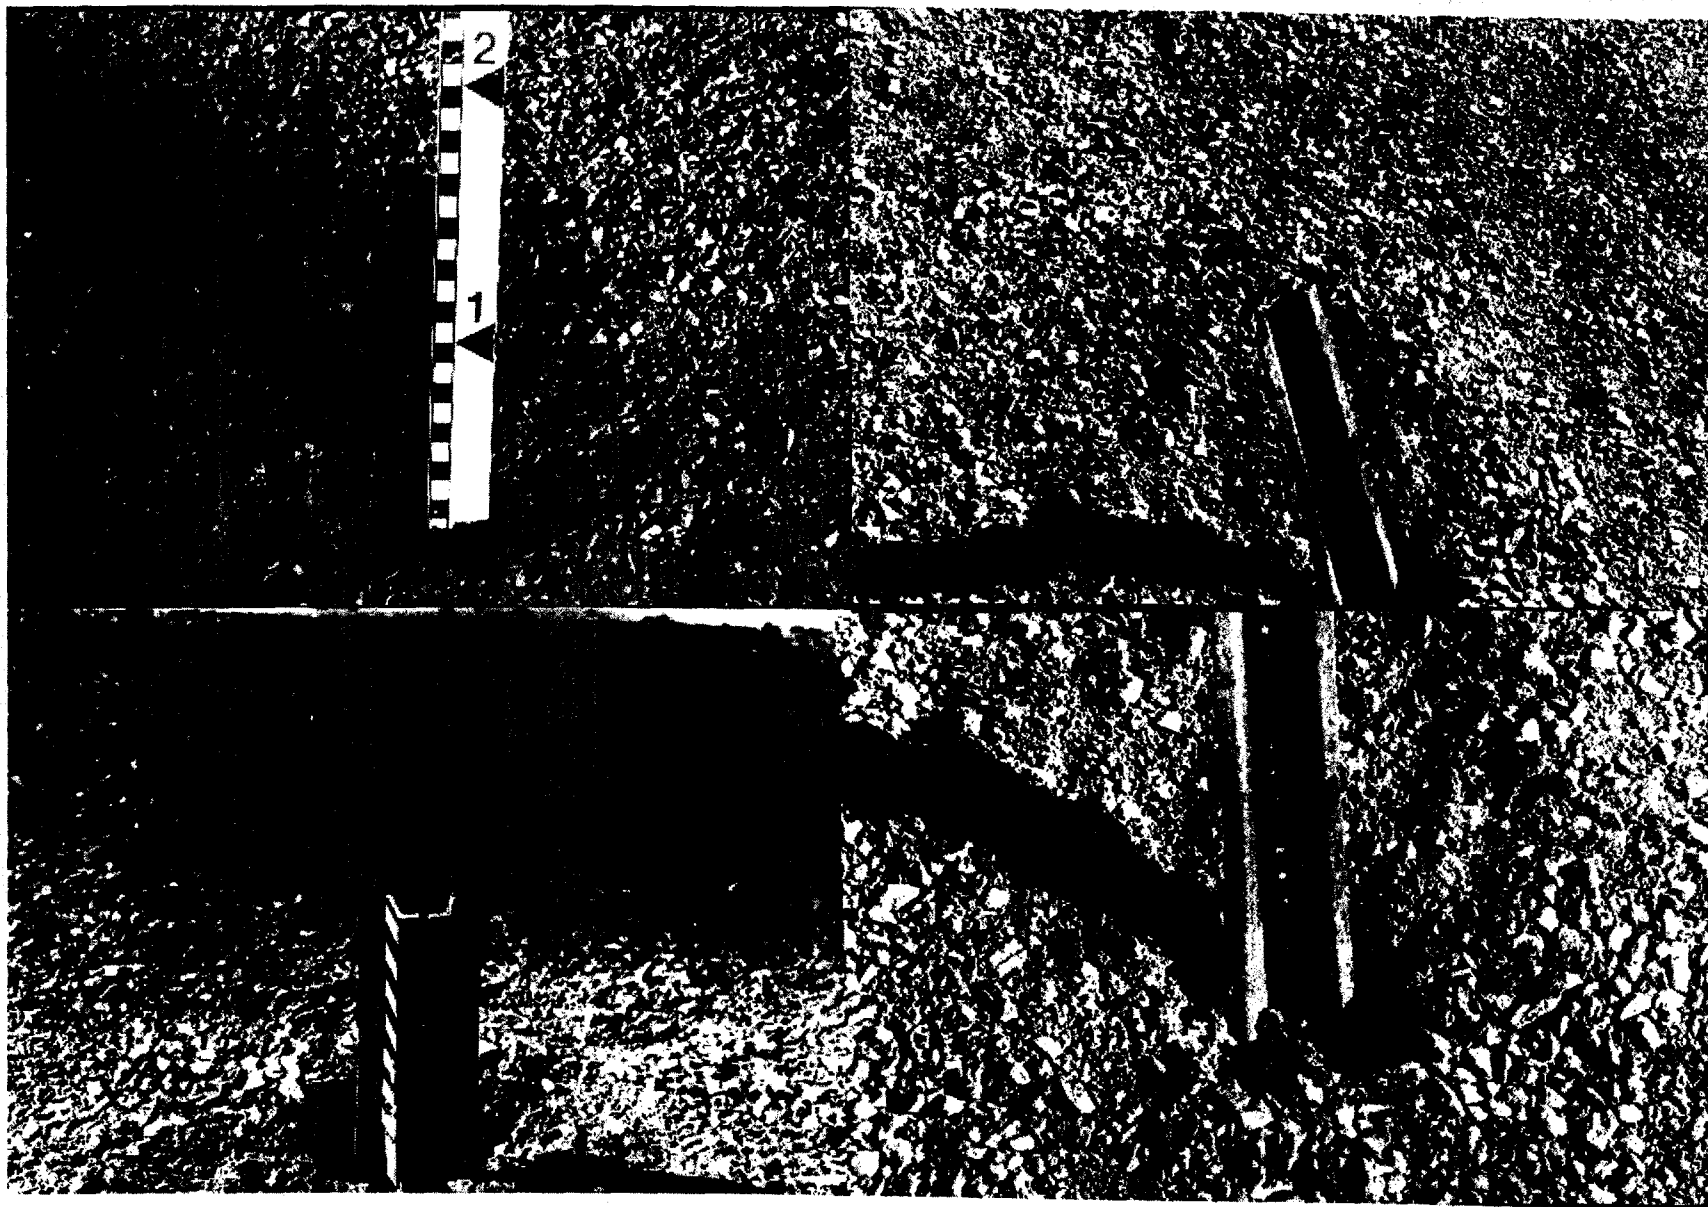
Figure 10. Additional post-test photographs, test 99F010.

The data were successfully collected and the high-speed film successfully taken during the sign support test. The data and film will aid in the development and validation of a Geo Metro FEM and will help make sign mounting height recommendations. Computer simulations predicted that, for a sign support with these material properties, the sign support would strike a Geo Metro's windshield. The sign post fractured as anticipated and severely dented the vehicle's roof and shattered the windshield.
