Crash Test Between a 6-KG/M U-Channel Sign Support and a 1997 Geo Metro: FOIL Test Number 99F007

PUBLICATION NO. FHWA-RD-01-049

MARCH 2001

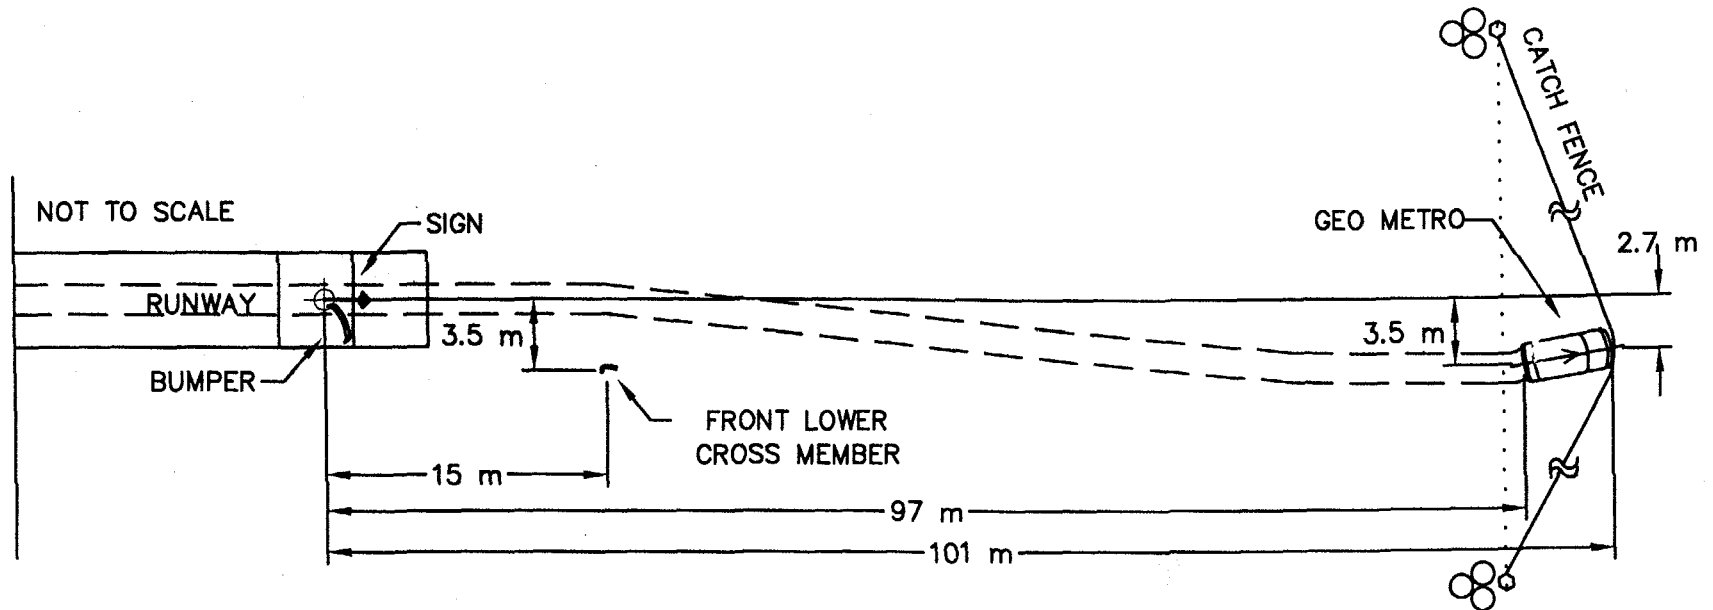
Figure 4. Summary of results, test 99F007.

The results summarized in figure 4 indicate that the 6-kg/m small sign support embedded in strong soil did not meet the safety performance criteria outlined in *NCHRP Report 350* (test designation 3-61). The sign support did not fracture as anticipated and the longitudinal OIV (5.2 m/s) was higher than the allowable limit (5.0 m/s). Table 6 summarizes the safety performance of the small sign support.

Occupant Risk:	<u>Observed</u>	<u>Design/Limit</u>
Longitudinal:		
Occupant delta V at 0.6 m.....	5.2 m/s	3/5 m/s
Ridedown acceleration.....	1.1 g's	15/20 g's
Lateral:		
Occupant Delta V at 0.3 m.....	no contact	NA
Ridedown acceleration.....	no contact	NA
Peak 50 ms acceleration:		
Longitudinal.....		7.1 g's
Lateral.....		0.9 g's
Vehicle Damage:		
Traffic Accident Data (TAD).....		12-FC-4
Vehicle Damage Index (VDI).....		12FCEN3
Static crush.....		305 mm
Post fracture.....		460 mm vertical tear in web
Exit speed.....		73.9 km/h
Exit angle.....		0.0°

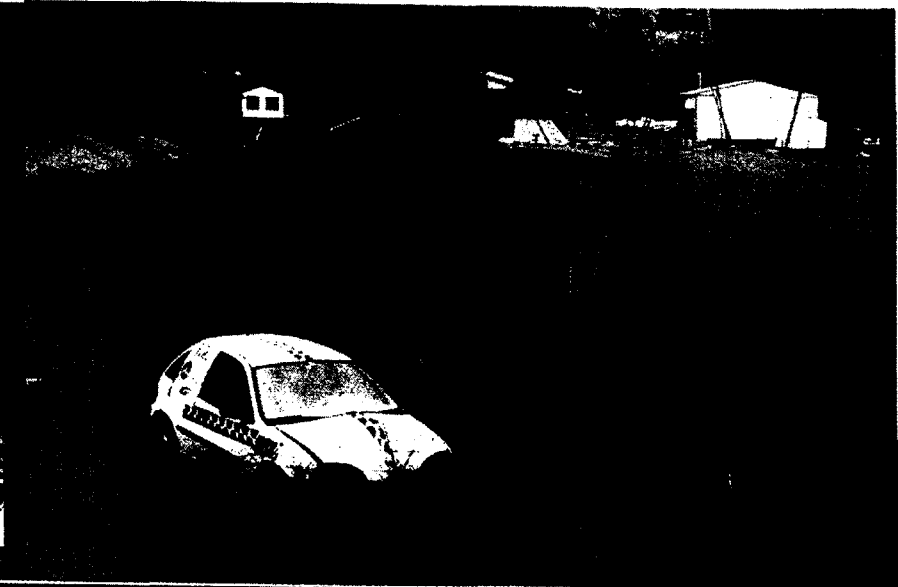
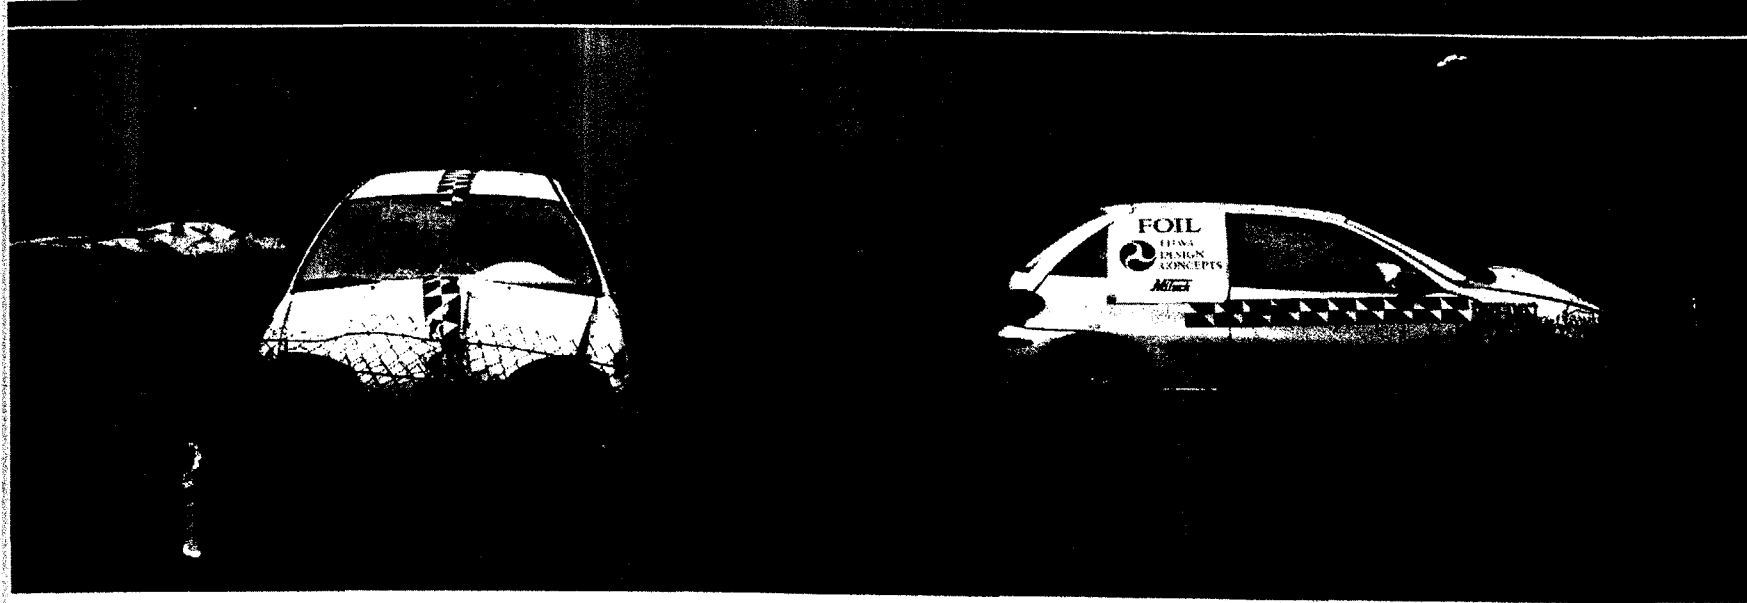
Figure 8. Post-test photographs, test 99F007.

Vehicle damage. Damage to the vehicle was extensive. The hood, grill, head lights, and core supports were either crushed and/or dislodged from the vehicle. The bumper and lower front cross-member were torn from the vehicle and remained next to the sign support. Both air-bags were deployed.

Sign damage. The sign support was bent and twisted and laid flat. The post did pull out of the soil. The u-channel web was torn vertically (approximately 460 mm). The sign post did not fracture or shear. The sign post could not be reused.
