DYNAMIC TESTING AND EVALUATION OF CULVERT-MOUNTED, STRONG-POST MGS TO TL-3 GUIDELINES OF MASH 2016

WISCONSIN DEPARTMENT OF TRANSPORTATION

MwRSF Research Report No. TRP-03-383-20-R1

November 2, 2020

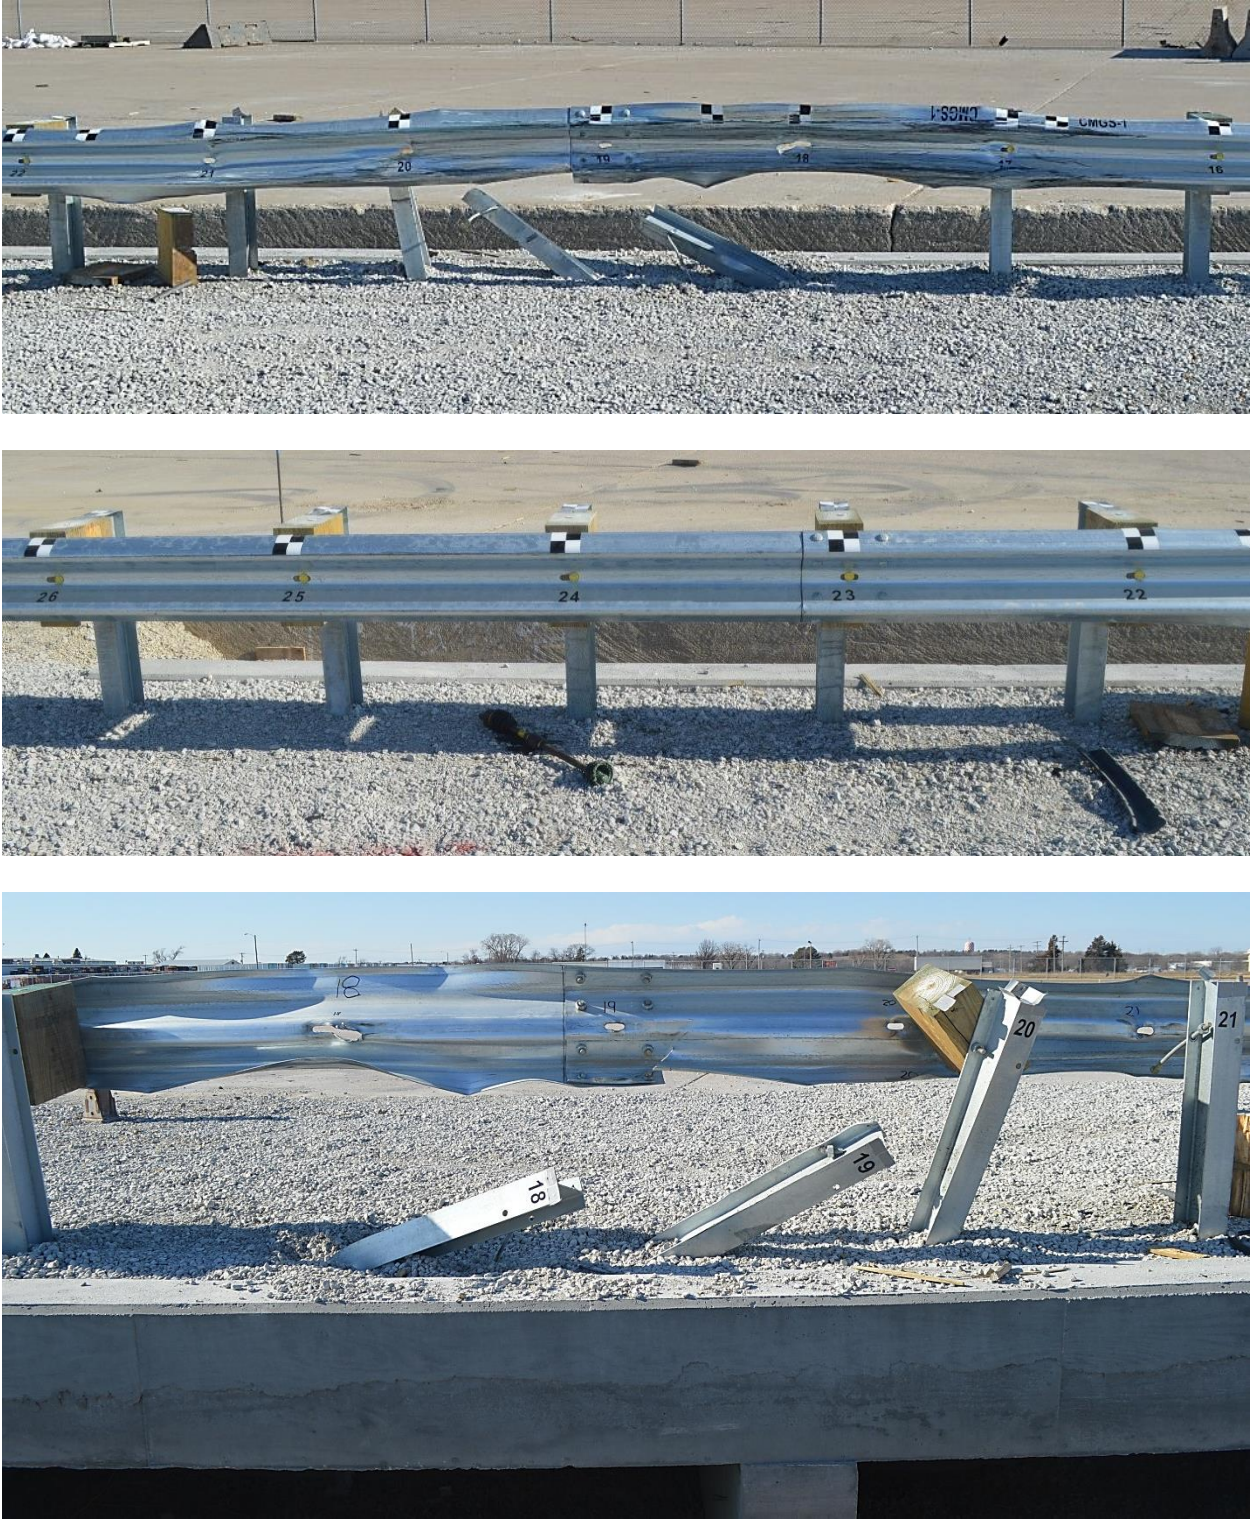
Figure 60. System Damage, Test No. CMGS-1

Damage to the barrier was moderate, as shown in Figures 60 through 66. Barrier damage consisted mostly of deformed W-beam, contact marks on the guardrail sections, and deformed posts. The length of vehicle contact along the barrier was approximately 16 ft which spanned from 12 $\frac{5}{8}$ in. (321 mm) downstream from post no. 16 to 15 $\frac{1}{2}$ in. (394 mm) downstream from post no. 21.

The guardrail damage consisted moderate deformation and flattening of the impacted section of the W-beam between post nos. 16 and 22. The W-beam was pulled out from the bolts at post nos. 18 through 21. Contact marks were found on the guardrail between post nos. 16 through 21. A partial rail tear was observed through the lower hump of the W-beam rail at the downstream end of the rail splice at post no. 19, as shown in Figures 60 and 61. No significant guardrail damage occurred upstream from post no. 16 nor downstream from post no. 22.

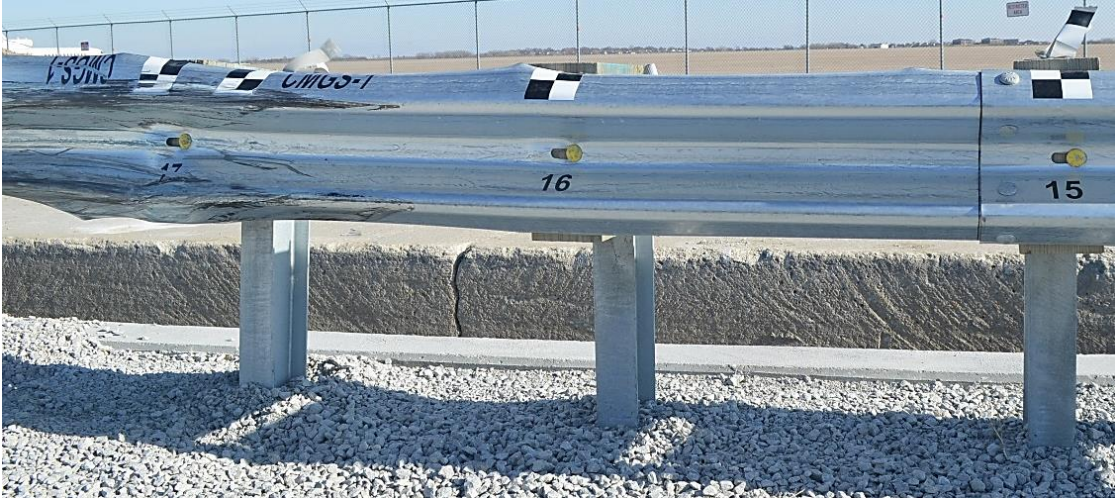
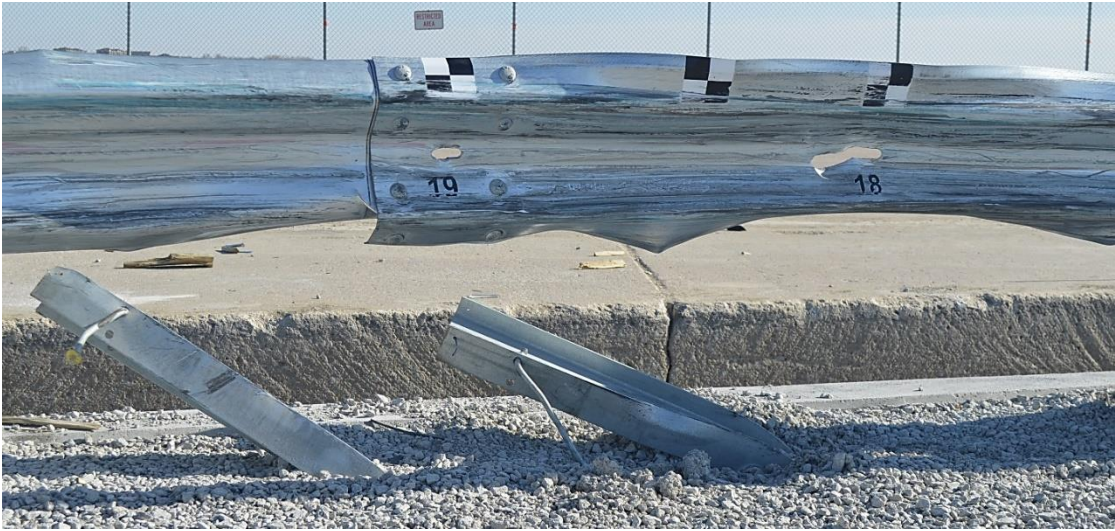
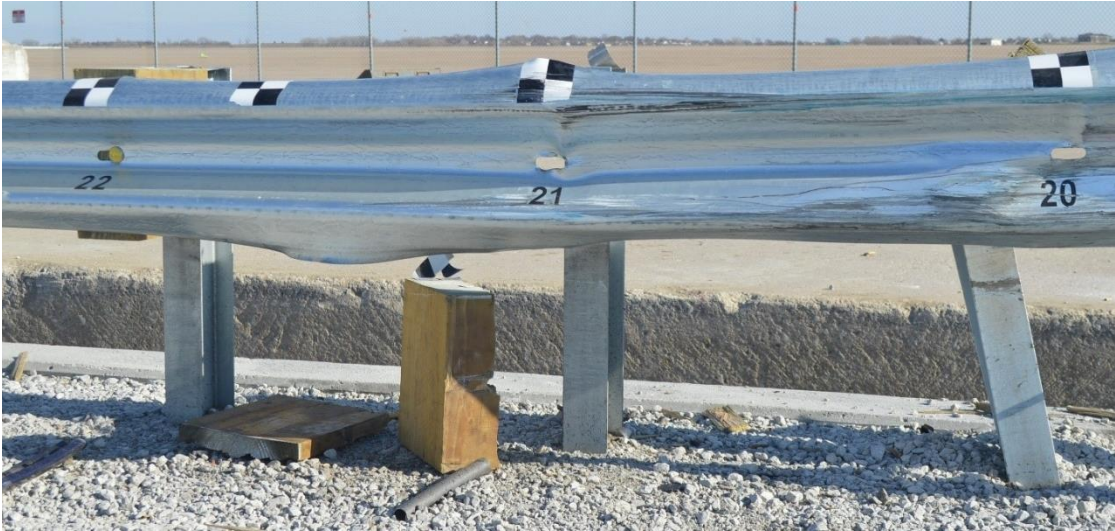
Figure 61. Damage to Post Nos. 15 through 22, Test No. CMGS-1

Post no. 17 slightly deflected backward. Post nos. 18 and 19 were bent longitudinally toward the ground in the downstream direction. Post no. 20 was bent slightly longitudinally downstream. Contact marks were found on the front face of post nos. 18 and 19. No significant post damage occurred to post nos. 1 through 16 nor 21 through 41. The upstream and downstream anchorage systems remained unmoved and the posts in both anchorage systems were not damaged. The wooden blockout at post nos. 18, 19, and 21 disengaged from the system. The blockout at post no. 20 rotated but did not disengage. The blockouts at post nos. 3 through 17 and 22 through 39 were undamaged.

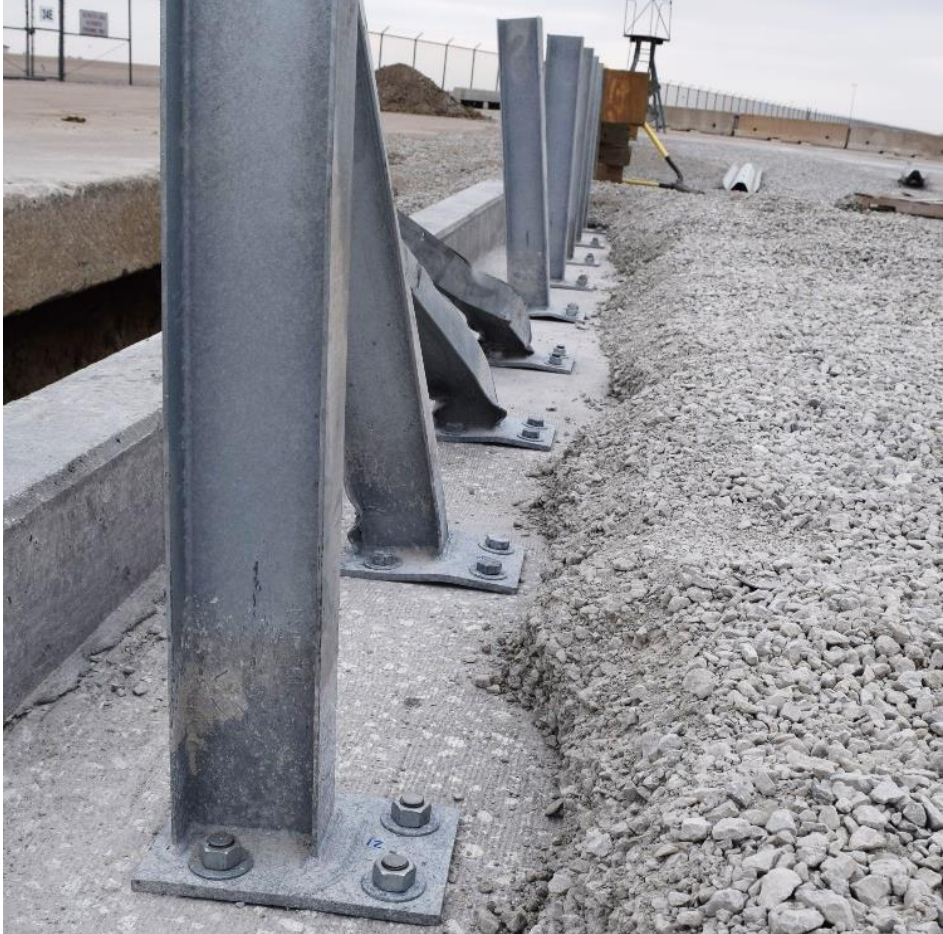
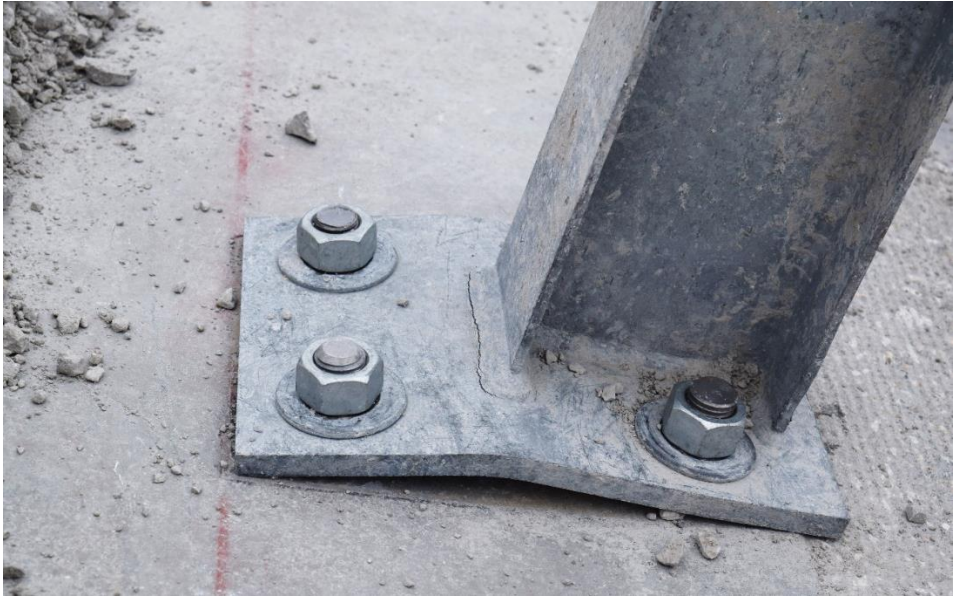
Figure 62. Damage to Post and Base Plate Nos. 17 through 21 (After Removal of Soil Fill Post and Base), Test No. CMGS-1

Following the test, the soil on top of the culvert headwall was removed for inspection of the damage to the posts and base plates as well as to review any potential damage to the culvert. Deformation of the post base plates was observed on post nos. 17 through 21. Minor cracking was observed on the weld at the front flange of the base plate of post no. 17. The upstream side of the front flange of post no. 18 was torn up to the web near the base plate weld. All anchorage bolts and epoxied threaded rods were intact and remained secure, although some minor deformation of the bolts and rods was observed. No damage was observed to the concrete culvert slab or the headwall.

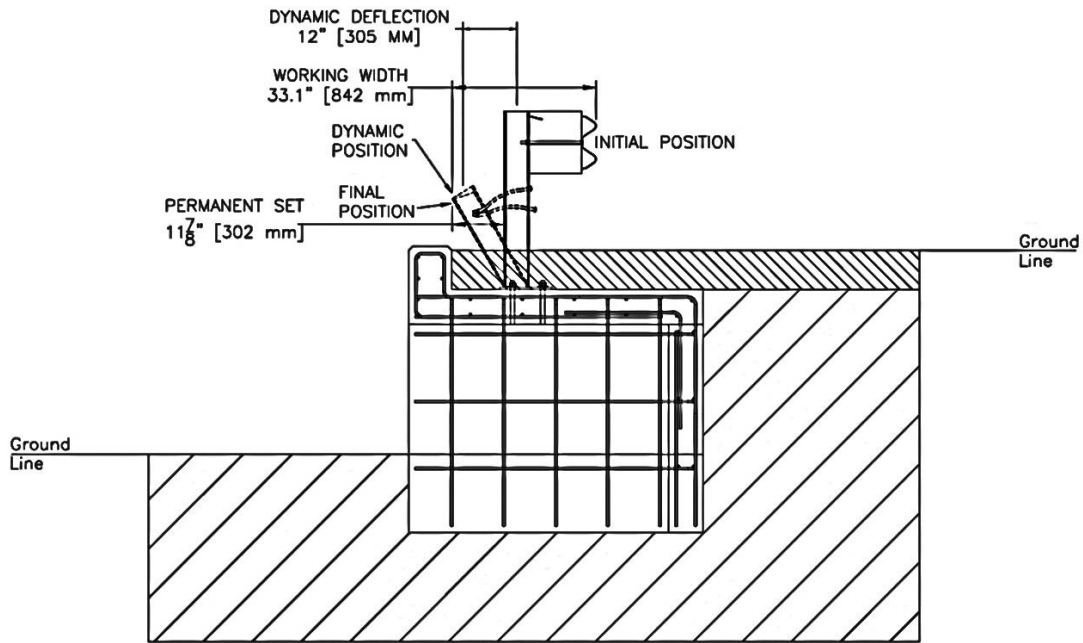
Figure 67. Permanent Set Deflection, Dynamic Deflection, and Working Width, Test No. CMGS-1

The maximum lateral permanent set of the barrier system was 11 $\frac{7}{8}$ in. (302 mm), which occurred at the back of post no. 18, as measured in the field. The maximum lateral dynamic deflection was 12 in. (305 mm) at post no. 18, as determined from high-speed digital video analysis. The working width of the system was 33.1 in. (842 mm) at post no. 18, also determined from high-speed digital video analysis. A schematic of the permanent set, dynamic deflection, and working width is shown in Figure 67.

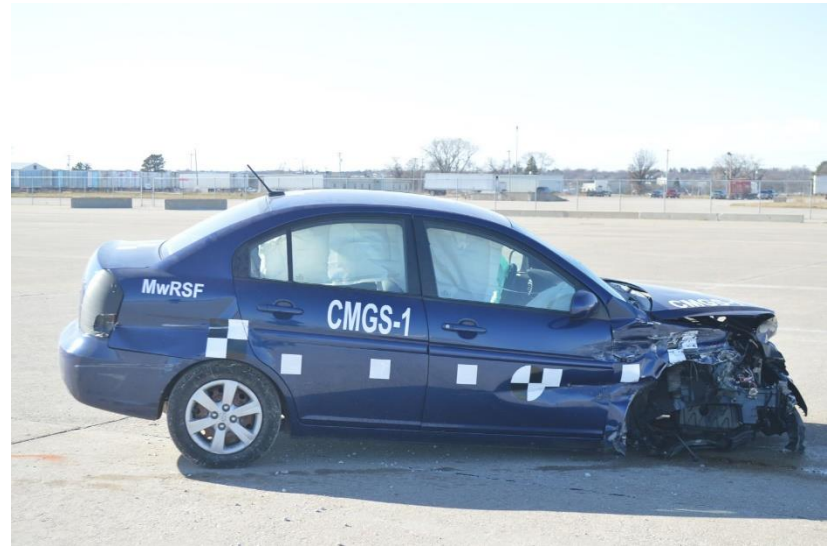
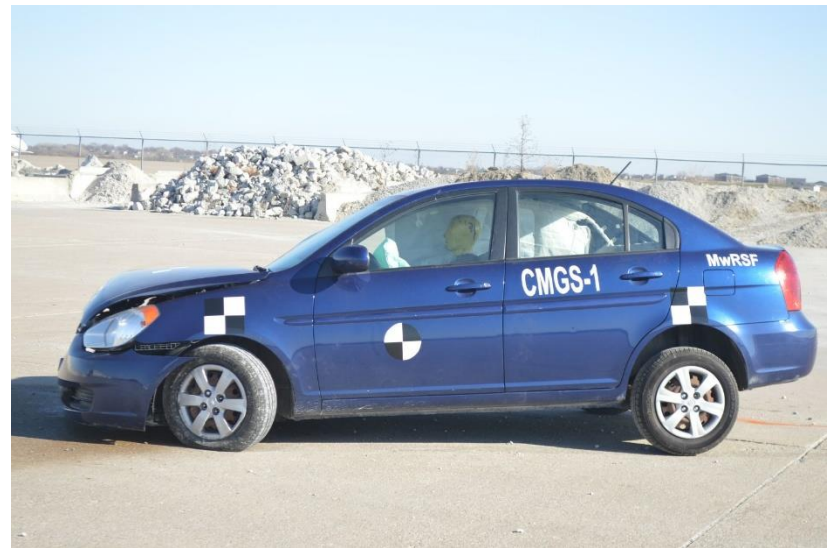
Figure 68. Vehicle Damage, Test No. CMGS-1

The damage to the vehicle was moderate, as shown in Figures 68 through 72. The maximum occupant compartment deformations are listed in Table 6 along with the intrusion limits established in MASH 2016 for various areas of the occupant compartment. MASH 2016 defines intrusion or deformation as the occupant compartment being deformed and reduced in size with no observed penetration. The maximum deformation of the windshield was measured to be $3\frac{3}{8}$ in. (86 mm) which was not observed on the test day, as shown in Figure 70. Prior to the vehicle deformation measurements, the snow and ice on the windshield caused an additional caving in deformation. Therefore, this deformation exceeding the MASH deformation criteria was not due to the impact event and is not critical to the test evaluation. All other occupant compartment deformations were within MASH limits. Complete occupant compartment and vehicle deformations as well as the corresponding locations are provided in Appendix D.

Majority of the vehicle damage was concentrated on the right-front corner, where primary impact occurred. The right-front wheel contacted post nos. 18 and 19 and was disengaged, and the left-front tire was deflated. The right corner of the hood buckled. The side and front airbags on both the passenger and driver side deployed, which caused the windshield on the passenger side to shatter but remain intact. The right-rear quarter panel was crushed inward.

The roof, the left side, and the rear of the vehicle remained undamaged. The left-side and rear window glass also remained undamaged. The front right strut broke at the weld point on the top of the gas cylinder, and only the top portion of the shock absorber was still intact. The right-side wheel hub attachment point detached from the steering rack, and the tie rod was bent. The right-front brake assembly disengaged from the car. There was no damage to the vehicle's frame, rear suspension, or rear shocks and springs.

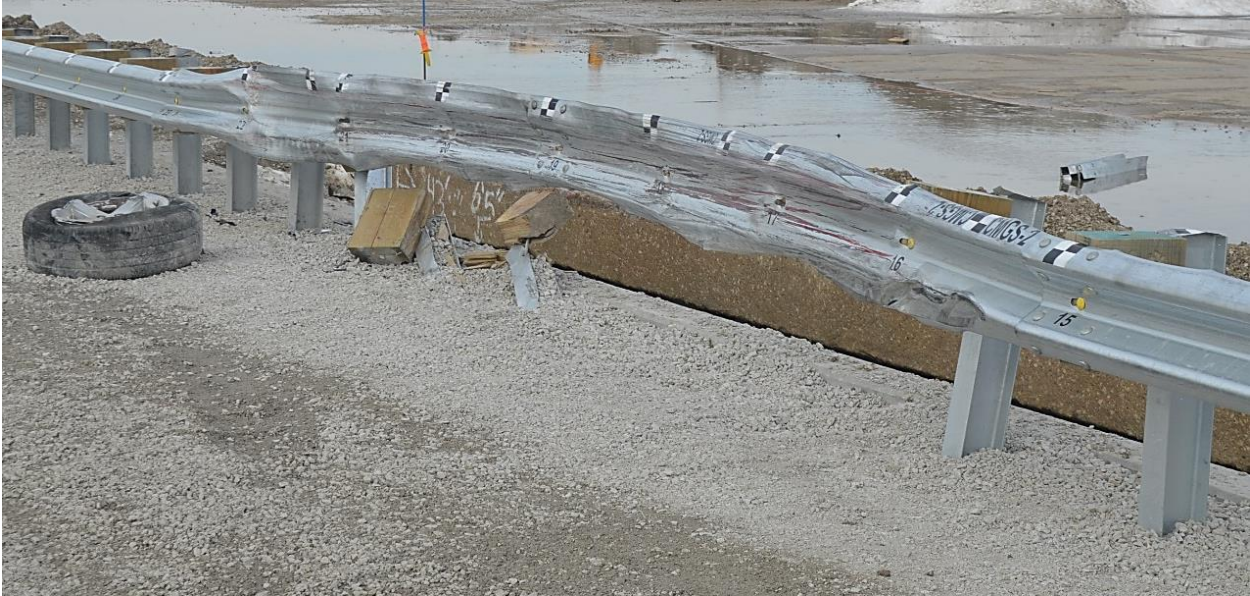
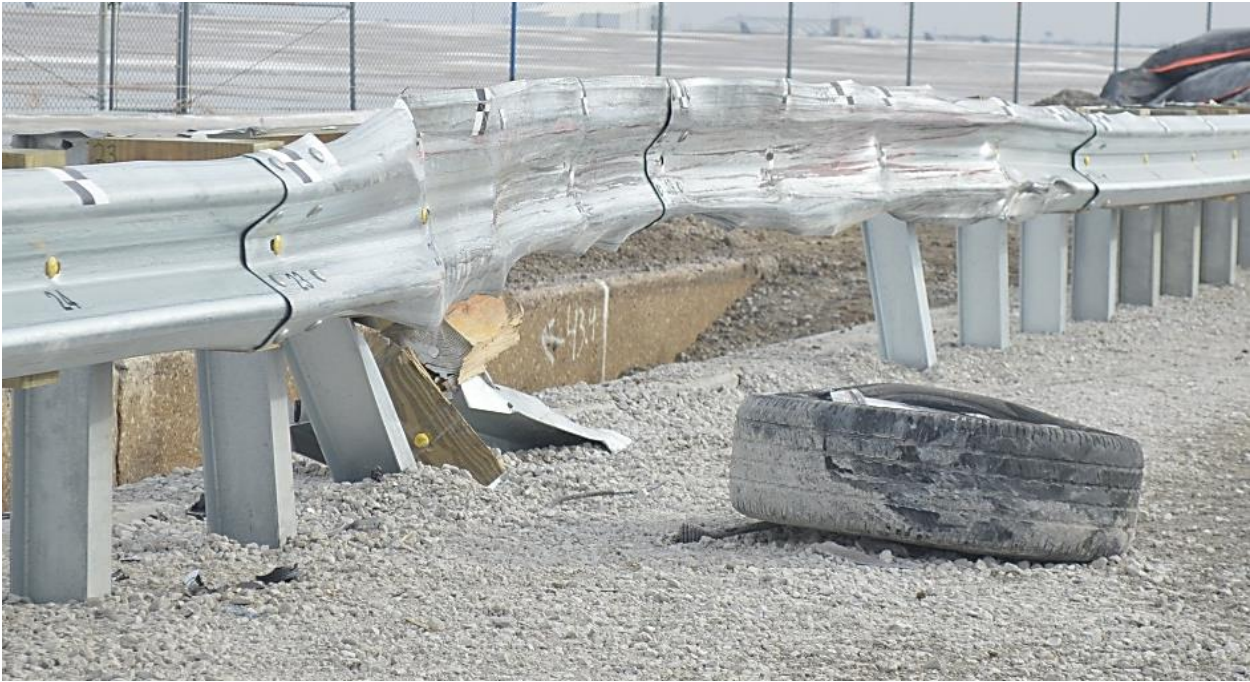
Figure 80. System Damage, Test No. CMGS-2

Following the test, the soil on top of the culvert headwall was removed for inspection of the damage to the posts and base plates as well as to review any potential damage to the culvert. Deformation of the post base plates was observed on post nos. 16 through 22. Post nos. 17 and 18 fractured at the base of the post above the weld line at the front flange and web of the post and through the weld at the back flange of the post. The upstream side of the front flange of post nos. 20 and 21 was torn up to the web near the base plate weld. All anchorage bolts and epoxied threaded rods were intact and remained secure, although some minor deformation of the bolts and rods was observed. No damage was observed to the concrete culvert slab or the headwall.

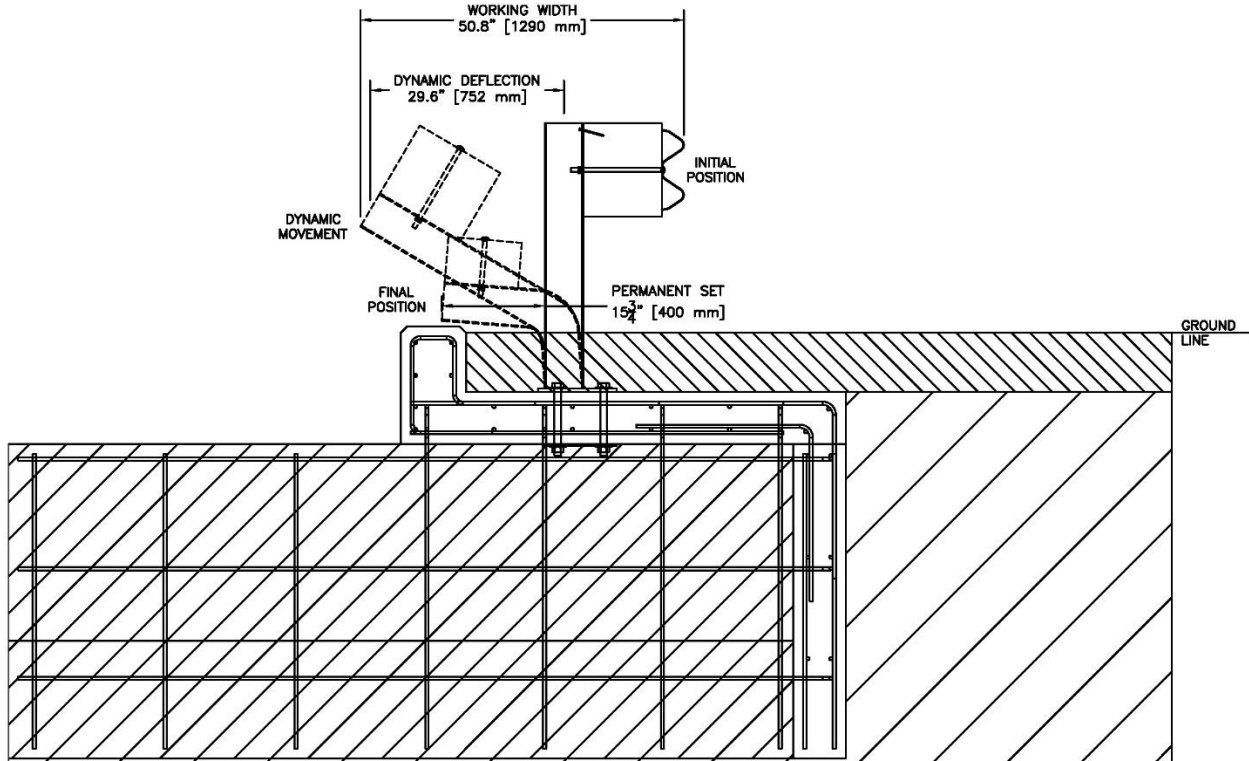
Figure 90. Permanent Set Deflection, Dynamic Deflection, and Working Width, Test No. CMGS-2

The maximum lateral permanent set of the barrier system was 15¾ in. (400 mm) which occurred at the back of rail at post no. 19, as measured in the field. The maximum dynamic barrier deflection was 29.6 in. (752 mm) at post no. 17. The working width of the system was 50.8 in. (1,290 mm) at post no. 17, also determined from high-speed digital video analysis. A schematic of the permanent set deflection, dynamic deflection, and working width is shown in Figure 90.

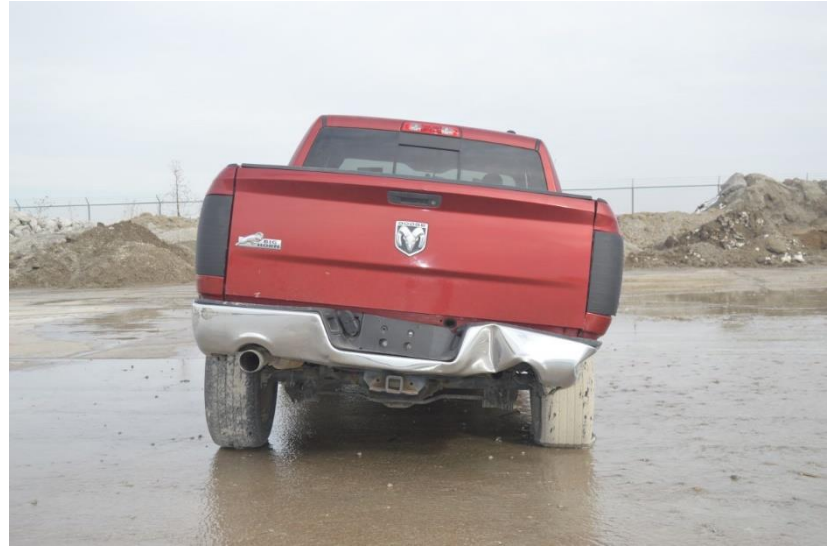
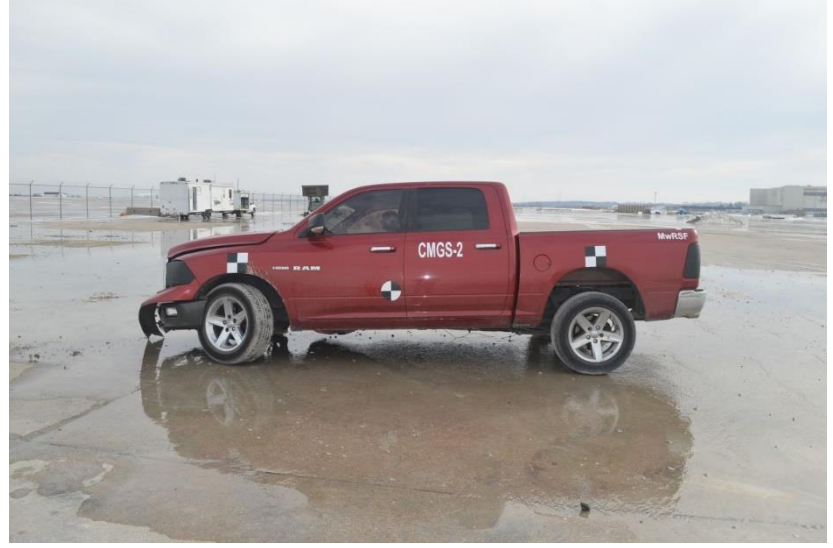
Figure 91. Vehicle Damage, Test No. CMGS-2

The majority of the vehicle damage was concentrated on the right-front corner, where primary impact occurred. The vehicle's front bumper was crushed inward. The lower passenger side grille was broken. The front bumper cover was torn off except for the two bolts on the driver side. The vehicle right-front wheel was disengaged, and right-rear tire was deflated. The airbags did not deploy during the impact. The right corner of the rear bumper on the passenger side buckled inward and the rear corner of the right-rear fender was deformed from the impact with the barrier.

The roof, the hood, and the left side remained undamaged. The left-side and rear window glass also remained undamaged. The airbags did not deploy during the impact. The overall undercarriage damage included a 2-in. (51 mm) bend in the lower control arm, and the steering knuckle broke along with the steering arm on the passenger side. The front passenger-side brake line was disconnected. Interior occupant compartment deformations were moderate with a maximum of 1 1/8 in. (29 mm), which did not violate the limits established in MASH 2016.
