Louisiana Transportation Research Center

Final Report 626

Evaluating Louisiana New Continuity Detail for Girder Bridges

4. Sponsoring Agency Name and Address
Louisiana Department of Transportation and Development
P.O. Box 94245
Baton Rouge, LA 70804-9245
5. Report No.
FHWA/LA.17/626

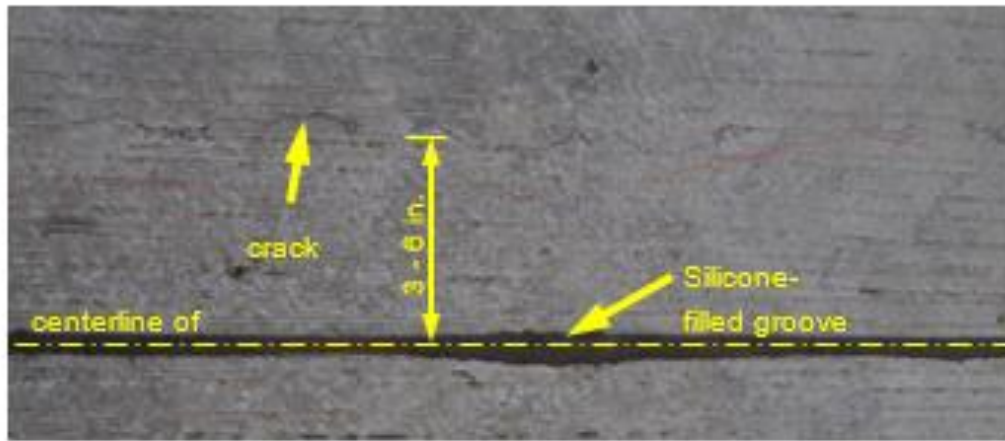
Figure 54. Top view of transverse deck cracking at sample link slab locations

(a) picture of a typical link slab crack location

(b) link slab cracks at four bents with different support configurations

2. The transverse crack control detail (groove) at the center of link slab was not effective in arresting expected transverse cracks at the joint. Therefore, it is not deemed a necessary detail, especially that the crack widths are not alarming and do not require intervention.
